37 THE WALK, NEW INN, PONTYPOOL

CRACK REMEDIATION

Drawn:	Checked:	Scale(s) at A1:		
AB	AB	NTS		
Date:	Job No.	Drawing No.	Revision:	Suitability:
25.07.25	P0560	SK05s	-	-
Drawing Status:				
FOR INFORMATION

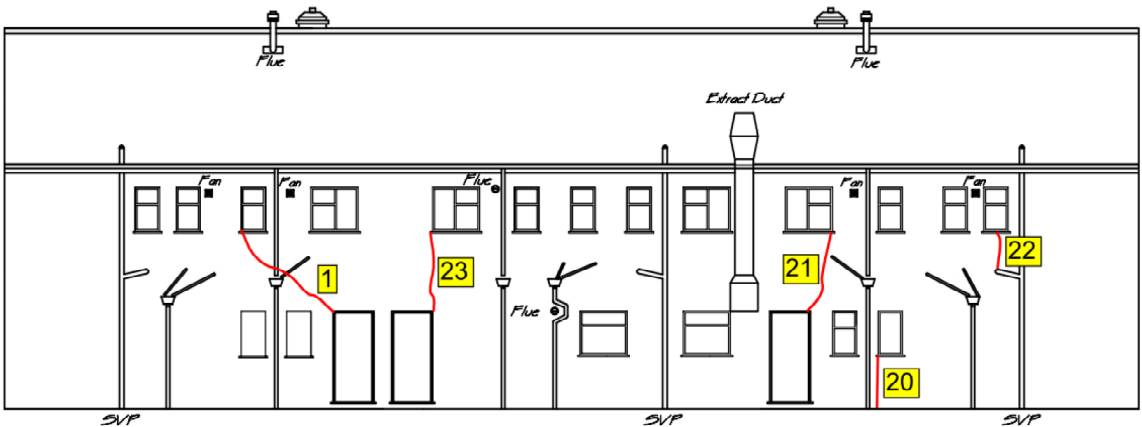
Rear Elevation - South West

- 1. Diagonal crack - REM 1
- 2. Vertical crack - REM 2
- 3. Vertical crack - REM 2
- 4. Diagonal crack - REM 1
- 5. Vertical crack - REM 2
- 6. Diag/Vert crack - REM 2
- 7. Vertical crack - REM 2
- 8. Horizontal crack - REM 2
- 9. Vertical crack - REM 2
- 10. Horizontal gap/crack - REM 2
- 11. Horizontal gap - REM 2
- 12. Vertical crack - REM 2
- 13. Vertical crack - REM 2
- 14. Vertical crack - REM 2
- 15. Vertical crack - REM 2
- 16. Vertical crack - REM 2
- 17. Vertical crack - REM 2
- 18. Vertical crack - REM 2
- 19. Vertical crack - REM 2
- 20. Vertical crack - REM 2
- 21. Diagonal crack - REM 1
- 22. Vertical crack - REM 2
- 23. Vertical crack - REM 2
- 24. Horizontal gap - REM 2

- 1. Helifix Helibar with Heli bond grout to be used to strengthen masonry panel in crack location.
- 2. Render to be hacked off in location of required Helibar slots.
- 3. Slots to be chased out between 25-35mm into existing masonry outer skin bedjoint and 500mm beyond the crack location on both sides and 300mm vertical ctrs.
- 4. Slots to be wetted down and primed with SBR or similar before filling slots with Helibond grout.
- 5. 6mm helibar to be placed in formed chase for full length of chase i.e. 500mm beyond the crack on both sides.
- 6. Actual crack to then be filled with Crackbond TE3 before re-rendering and painting remediation area.

- 1. Render to be hacked off locally to the crack to enable inspection of brick. If crack has progressed through the brick itself, use remedial measure 1 "REM1" above.
- 2. If crack is in render only and/or in the bed joints, utilise Helifix crackbond TE epoxy resin.
- 3. Once resin has cured re-render and paint remedial area.
