Asbestos Survey Report
Refurbishment Survey
(with Priority Assessments)
Block 35-37 (A) The Walk
New Inn, Pontypool Torfaen, NP4 0PU
1360378
Craig Allford

Job Number: W192238/1
Issue Date: 14/04/2025
Issue No: 1

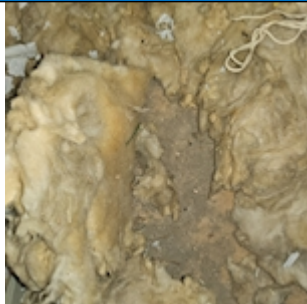
Building	Block 35-37 (A) The Walk			Floor	2		
Location Description	002: Loft above 35A			Record Origin Report	W192238		
Item	FLOOR

Level of Identification (ID)	Inspected Area (IA)	Sample No.					
Material		Extent					
Accessibility							
Identification							
Material Assessment							
Product Type		Condition		Surface Treatment		Asbestos Type	
Priority Assessment (for more detail see Section 6.0)							
Occupant Activity		Disturbance		Human Exposure		Maintenance Activity	
Scoring Summary							
Material Score		Priority Score		Total Risk		Risk Priority	
Recommended Action	No Recommendation Required						
Further Information	Plasterboard floor covered in MMMF insulation.

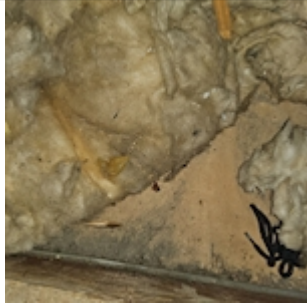
Building	Block 35-37 (A) The Walk			Floor	2		
Location Description	002: Loft above 35A			Record Origin Report	W192238		
Item	FLOOR

Level of Identification (ID)	Inspected Area (IA)	Sample No.					
Material		Extent					
Accessibility							
Identification							
Material Assessment							
Product Type		Condition		Surface Treatment		Asbestos Type	
Priority Assessment (for more detail see Section 6.0)							
Occupant Activity		Disturbance		Human Exposure		Maintenance Activity	
Scoring Summary							
Material Score		Priority Score		Total Risk		Risk Priority	
Recommended Action	No Recommendation Required						
Further Information	Plasterboard floor covered with MMMF insulation.

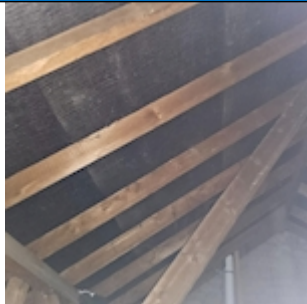
Building	Block 35-37 (A) The Walk			Floor	2		
Location Description	002: Loft above 35A			Record Origin Report	W192238		
Item	ROOFFELT

Level of Identification (ID)	Sample (S)	Sample No.	S0001				
Material	Bitumen Product	Extent	70 m²				
Accessibility							
Identification	No Asbestos Detected						
Material Assessment							
Product Type	0	Condition	0	Surface Treatment	0	Asbestos Type	0
Priority Assessment (for more detail see Section 6.0)							
Occupant Activity	0	Disturbance	0	Human Exposure	0	Maintenance Activity	0
Scoring Summary							
Material Score	0	Priority Score	0	Total Risk	0	Risk Priority	N/A
Recommended Action	No Recommendation Required						
Further Information	Bituminous roof felt to ceiling of loft

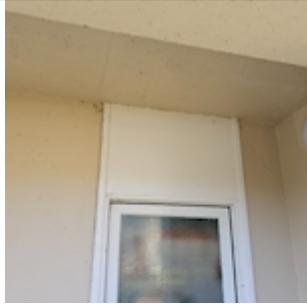
Building	Block 35-37 (A) The Walk			Floor	Ext		
Location Description	001: External			Record Origin Report	W192238		
Item	PANEL

Level of Identification (ID)	Inspected Area (IA)	Sample No.					
Material		Extent					
Accessibility							
Identification							
Material Assessment							
Product Type		Condition		Surface Treatment		Asbestos Type	
Priority Assessment (for more detail see Section 6.0)							
Occupant Activity		Disturbance		Human Exposure		Maintenance Activity	
Scoring Summary							
Material Score		Priority Score		Total Risk		Risk Priority	
Recommended Action	No Recommendation Required						
Further Information	Door header panels above doors to shops are timber, no suspect materials.,

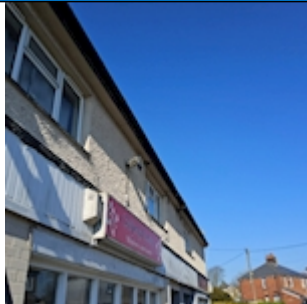
Building	Block 35-37 (A) The Walk			Floor	Ext									
Location Description	001: External			Record Origin Report	W192238									
Item	SOFFITS

Level of Identification (ID)	Inspected Area (IA)	Sample No.												
Material		Extent												
Accessibility														
Identification														
Material Assessment														
Product Type		Condition		Surface Treatment		Asbestos Type								
Priority Assessment (for more detail see Section 6.0)														
Occupant Activity		Disturbance		Human Exposure		Maintenance Activity								
Scoring Summary														
Material Score		Priority Score		Total Risk		Risk Priority								
Recommended Action	No Recommendation Required													
Further Information	Timber soffits to front and rear of building.

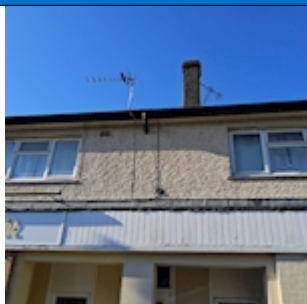
Building	Block 35-37 (A) The Walk			Floor	Ext									
Location Description	001: External			Record Origin Report	W192238									
Item	DOWNPIPE

Level of Identification (ID)	Inspected Area (IA)	Sample No.												
Material		Extent												
Accessibility														
Identification														
Material Assessment														
Product Type		Condition		Surface Treatment		Asbestos Type								
Priority Assessment (for more detail see Section 6.0)														
Occupant Activity		Disturbance		Human Exposure		Maintenance Activity								
Scoring Summary														
Material Score		Priority Score		Total Risk		Risk Priority								
Recommended Action	No Recommendation Required													
Further Information	Lead down pipes to high level rainwater goods. Plastic guttering above.

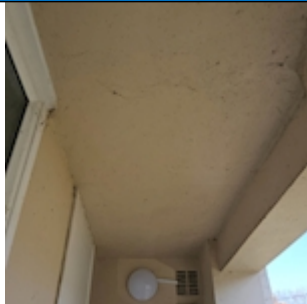
Building	Block 35-37 (A) The Walk			Floor	Ext		
Location Description	001: External			Record Origin Report	W192238		
Item	CEILING

Level of Identification (ID)	Inspected Area (IA)	Sample No.					
Material		Extent					
Accessibility							
Identification							
Material Assessment							
Product Type		Condition		Surface Treatment		Asbestos Type	
Priority Assessment (for more detail see Section 6.0)							
Occupant Activity		Disturbance		Human Exposure		Maintenance Activity	
Scoring Summary							
Material Score		Priority Score		Total Risk		Risk Priority	
Recommended Action	No Recommendation Required						
Further Information	Ceiling to external porch areas outside flat entrances. Plasterboard. No suspect materials

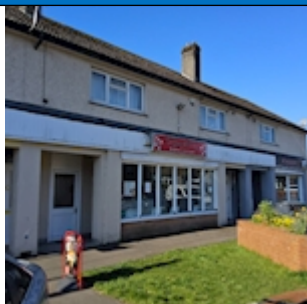
Building	Block 35-37 (A) The Walk			Floor	Ext		
Location Description	001: External			Record Origin Report	W192238		
Item	OTHER

Level of Identification (ID)	Limited Access (LA)	Sample No.					
Material		Extent					
Accessibility							
Identification							
Material Assessment							
Product Type		Condition		Surface Treatment		Asbestos Type	
Priority Assessment (for more detail see Section 6.0)							
Occupant Activity		Disturbance		Human Exposure		Maintenance Activity	
Scoring Summary							
Material Score		Priority Score		Total Risk		Risk Priority	
Recommended Action	No Access – Inspection Required						
Further Information	No access behind shop signage, as this would cause damage.

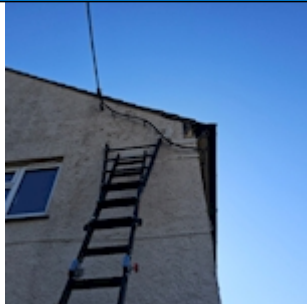
Building	Block 35-37 (A) The Walk			Floor	Ext		
Location Description	001: External			Record Origin Report	W192238		
Item	UNDERCLOAKING

Level of Identification (ID)	Sample (S)	Sample No.	S0002				
Material	Cement Product	Extent	0.5 lm				
Accessibility							
Identification	No Asbestos Detected						
Material Assessment							
Product Type	0	Condition	0	Surface Treatment	0	Asbestos Type	0
Priority Assessment (for more detail see Section 6.0)							
Occupant Activity	0	Disturbance	0	Human Exposure	0	Maintenance Activity	0
Scoring Summary							
Material Score	0	Priority Score	0	Total Risk	0	Risk Priority	N/A
Recommended Action	No Recommendation Required						
Further Information	Cement undercloaking replacent tiles to edges of roofline. Rest of undercloaking consists of clay tiles.

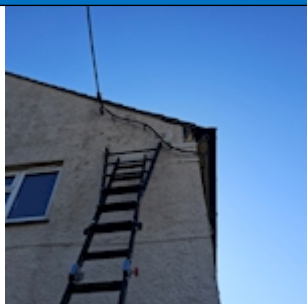
Building	Block 35-37 (A) The Walk			Floor	Ext		
Location Description	001: External			Record Origin Report	W192238		
Item	MASTIC

Level of Identification (ID)	Sample (S)	Sample No.	S0003				
Material	Mastic	Extent	0.5 lm				
Accessibility	Usually inaccessible or unlikely to be disturbed						
Identification	Chrysotile						
Material Assessment							
Product Type	1	Condition	1	Surface Treatment	0	Asbestos Type	1
Priority Assessment (for more detail see Section 6.0)							
Occupant Activity	0	Disturbance	0	Human Exposure	0	Maintenance Activity	1
Scoring Summary							
Material Score	3	Priority Score	1	Total Risk	4	Risk Priority	VERY LOW
Recommended Action	Manage / Remove if Affected by Scope of Works						
Further Information	Mastic residue to high level wall in soffit and fascia area.

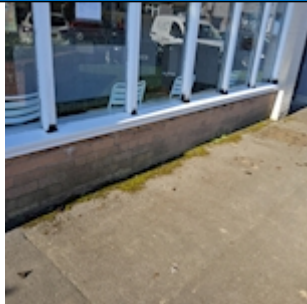
Building	Block 35-37 (A) The Walk			Floor	Ext		
Location Description	001: External			Record Origin Report	W192238		
Item	DPC

Level of Identification (ID)	Sample (S)	Sample No.	S0004				
Material	Bitumen Product	Extent	70 lm				
Accessibility							
Identification	No Asbestos Detected						
Material Assessment							
Product Type	0	Condition	0	Surface Treatment	0	Asbestos Type	0
Priority Assessment (for more detail see Section 6.0)							
Occupant Activity	0	Disturbance	0	Human Exposure	0	Maintenance Activity	0
Scoring Summary							
Material Score	0	Priority Score	0	Total Risk	0	Risk Priority	N/A
Recommended Action	No Recommendation Required						
Further Information	Bituminous damp proof course to external walls.

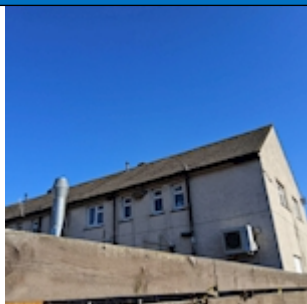
Building	Block 35-37 (A) The Walk			Floor	Ext		
Location Description	001: External			Record Origin Report	W192238		
Item	SOILPIPE

Level of Identification (ID)	Strongly Presumed (SP)	Sample No.					
Material	Cement Product	Extent	0.3 lm				
Accessibility	Usually inaccessible or unlikely to be disturbed						
Identification	Chrysotile						
Material Assessment							
Product Type	1	Condition	1	Surface Treatment	1	Asbestos Type	1
Priority Assessment (for more detail see Section 6.0)							
Occupant Activity	0	Disturbance	0	Human Exposure	0	Maintenance Activity	1
Scoring Summary							
Material Score	4	Priority Score	1	Total Risk	5	Risk Priority	VERY LOW
Recommended Action	Manage / Remove if Affected by Scope of Works						
Further Information	Cement soil pipe (top part) to external roof. Unable to place ladders below due to plant overgrowth.

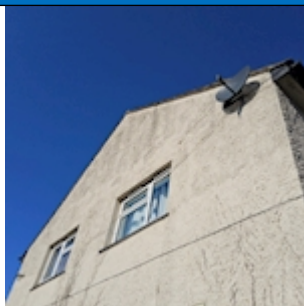
Building	Block 35-37 (A) The Walk			Floor	Ext		
Location Description	001: External			Record Origin Report	W192238		
Item	UNDERCLOAKING

Level of Identification (ID)	Cross Reference (X)	Sample No.	X0002				
Material	Cement Product	Extent	0.5 lm				
Accessibility							
Identification	No Asbestos Detected						
Material Assessment							
Product Type	0	Condition	0	Surface Treatment	0	Asbestos Type	0
Priority Assessment (for more detail see Section 6.0)							
Occupant Activity	0	Disturbance	0	Human Exposure	0	Maintenance Activity	0
Scoring Summary							
Material Score	0	Priority Score	0	Total Risk	0	Risk Priority	N/A
Recommended Action	No Recommendation Required						
Further Information	Cement undercloaking replacent tiles to edges of roofline. Rest of undercloaking consists of clay tiles.
