Leasehold Condition Survey

The Walk, New Inn, Pontypool, NP4 0PU

Prepared for: Bron Afon Community Housing

Ref: 19510_R01

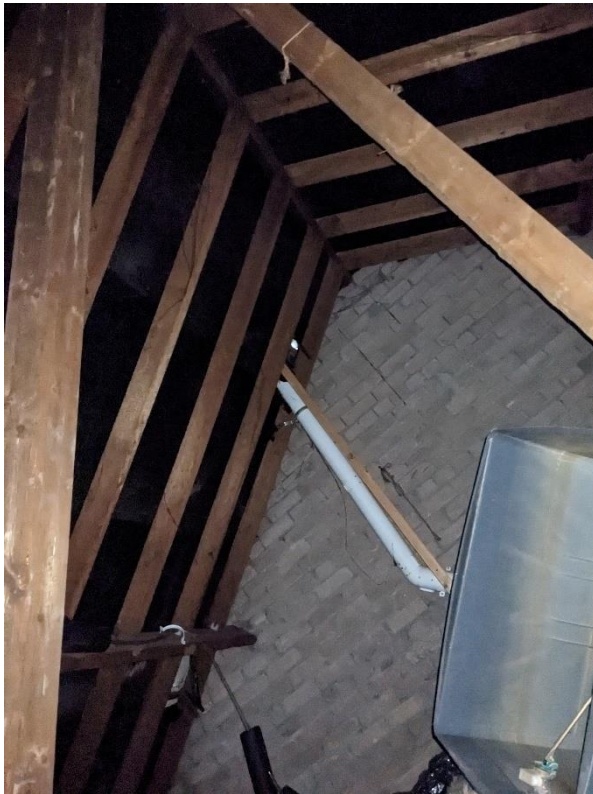
- 4.4. The chimney stacks appear to be in reasonable condition however there is severe moss growth to the flaunching's.
- 4.5. We identified a breach of fire compartmentation to the party wall within the roof space of 35A. The wall should be closed off with masonry to match existing to ensure adequate fire compartmentation is provided.

Photo 1 – 35A roof space

Extend party wall to the underside of the roof for fire compartmentation.	To provide fire compartmentation between the flats.
Remove moss growth, repair render and renew the chimney leadwork. If the chimneys are not in use, consideration could be given to demolish the chimney stack and capping off below roof level.	<p>The render to the chimney should be repaired as a minimum to prevent any further damage as well as potential water ingress.</p> <p>Demolition of the stack during roof replacement would reduce future long term risks of water ingress if the chimneys are redundant.</p>

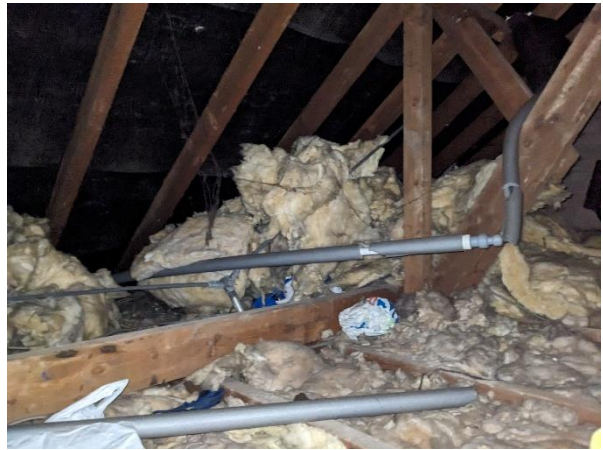
Photo 2 - 35A roof space

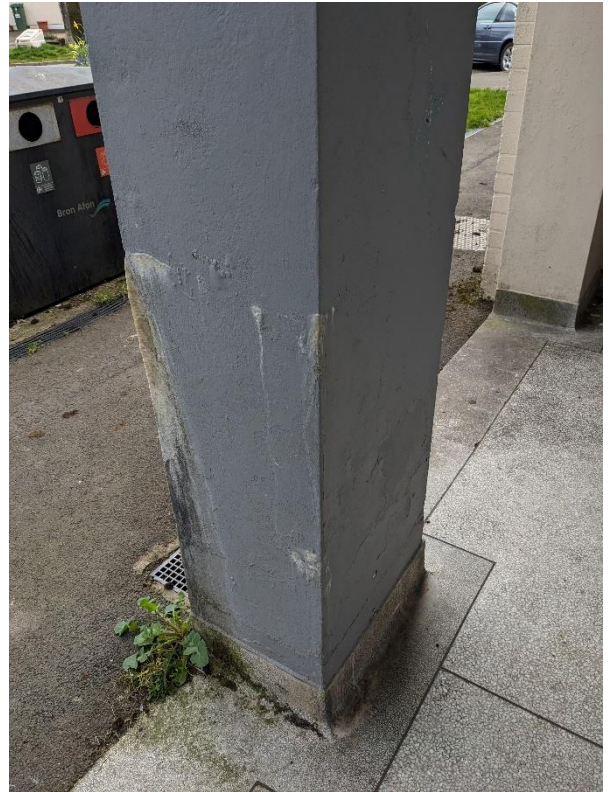
- 4.6. The PVC-u gutters and downpipes are in reasonable condition generally however they do appear aged and are soiled throughout.
- 4.7. There is staining at the gutter joints which indicates they may be leaking.
- 4.8. The downpipes to the front are concealed within the buildings wall at first floor level and within a pillar at ground floor level. There is efflorescence to the masonry pillar at ground floor level. This indicates the downpipes within the walls have deteriorated and are leaking.
- 4.9. A number of gullies appear to be blocked.

Photo 8 – Pillar containing downpipe to front

Recommendation	Reason
Replace gutters and downpipes during roof replacement works.	The gutters and downpipes are showing signs of age and will need to be removed and altered to facilitate the roof replacement work. Typically, PVC-u items tend to be damaged during this type of work, and we anticipate some of the gutters and downpipes would need to be renewed. Given the height of the building and cost of accessing this area we recommend the rainwater goods are replaced in their entirety to minimise future maintenance and repair costs.
Clean out and jet gullies and below ground drainage.	To ensure water is draining from the downpipes correctly and to prevent pooling water against the external walls.

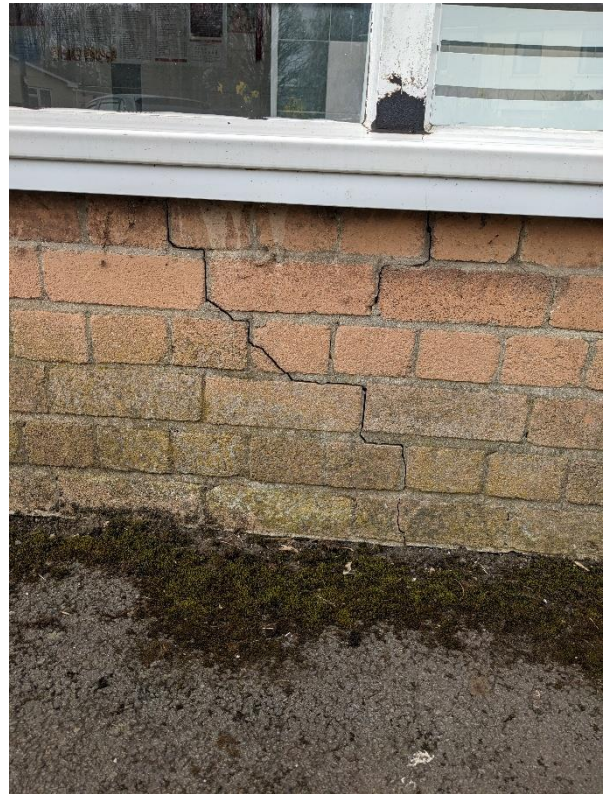
- 4.11. We observed minor cracking to the front and side elevations which is most likely due to thermal expansion and contraction due to lack of movement joints. We recommend that movement joints are installed (in accordance with structural engineer recommendations).

Photo 10 – Cracking below shopfront

Recommendation	Reason
Install vertical movement joints within the external walls utilising a Helifix system as specified by an engineer.	To prevent the reoccurrence of thermal cracking.
Undertake underpinning of the rear external wall as identified by further investigations and engineer design.	To ensure stability of external walls.
Undertake crack stitching to cracking on the rear elevation (in accordance with engineer design).	To reinforce and strengthen external walls.
Repair areas of missing mortar and damaged brickwork.	To prevent any further damage as well as potential water ingress.
Install PVC-u windowsills over the existing tiled sills.	To prevent water ingress.

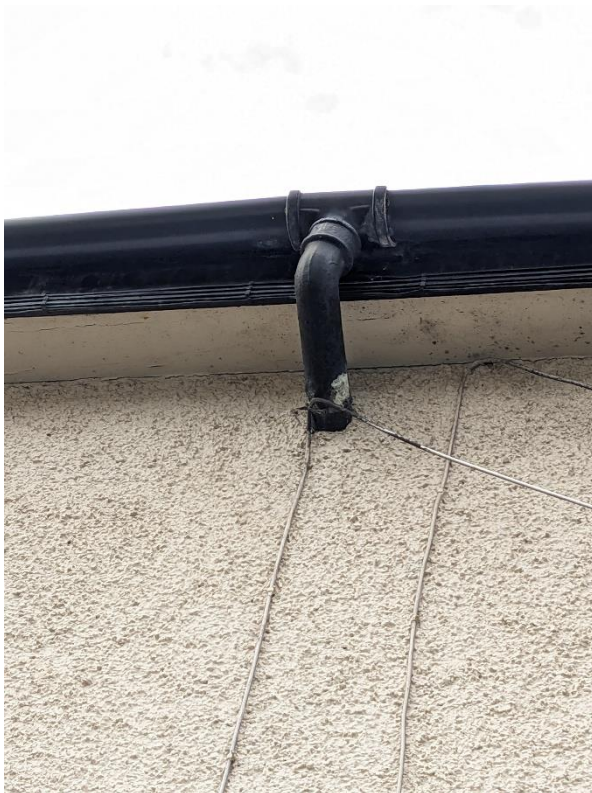
Photo 11 – Downpipe to front

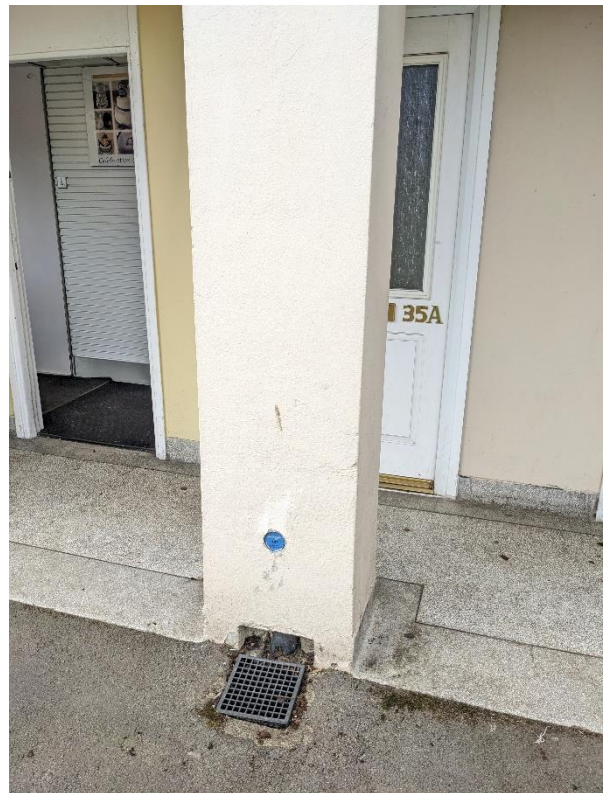
Photo 12 – Pillar containing downpipe to front

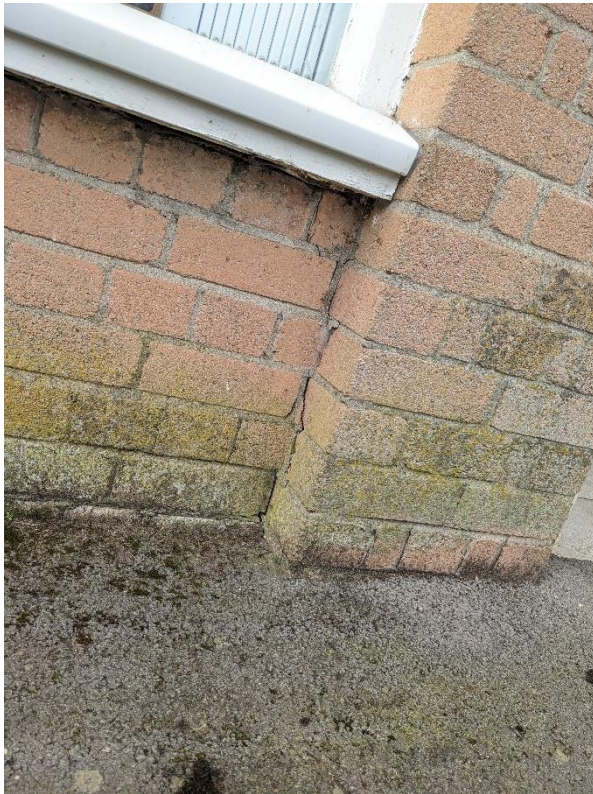
Photo 13 – Cracking below shopfront

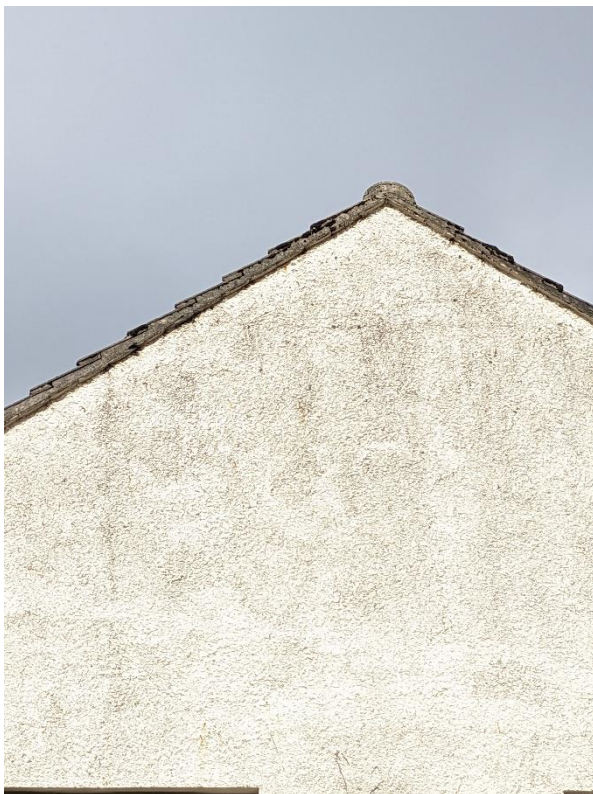
- 4.2. The traditional verge to the side elevations are constructed of an assumed concrete tile under cloak and wet mortar which is cracked throughout. The verge does not extend sufficiently past the external wall and provides minimal protection of the wall below against rainwater.

Photo 15 – Cracking to wet verge to left elevation

Recommendation	Reason
Extend the roof verges.	To provide an overhang to the gable elevations to improve protection of the external walls below.
Replace the fascia's and soffits to the pitched roof areas	The fascia and soffit will need to be removed and altered to facilitate the roof replacement work. Typically, the timber fascia's are beyond economic repair and will be damaged during this type of work, and we anticipate the fascia, and soffit would need to be renewed. Given the height of the building and cost of accessing this area we recommend they are replaced in their entirety to minimise future maintenance and repair costs.
Redistribute the insulation in the roof spaces to achieve required thickness. Upgrade the insulation to meet current building regulations.	Redistributing the existing insulation will reduce thermal bridging in the ceilings below. Building Regulations requires that insulation at ceiling level is improved during roof covering renewals.

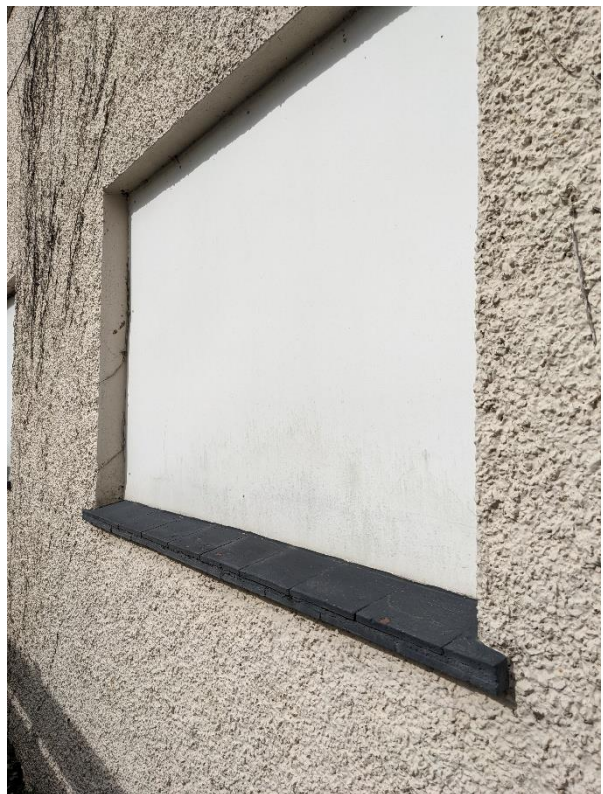
- 4.14. The tile windowsills do not provide a sufficient drip detail and the pointing between tiles is degraded potentially allowing water ingress to the internal areas of the building.

- 4.15. Windows are generally in good condition. The windows to the ground floor side elevations have been blocked up.
- 4.16. There are no caps provided to the soil stacks.

Photo 16 – Blocked up window to left elevation and tiled windowsill

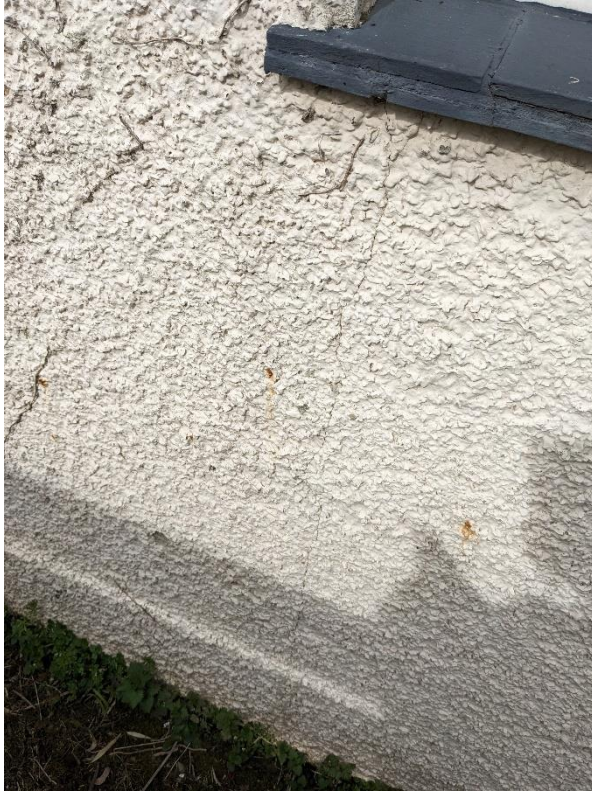
- 4.13. The render is generally in good condition however we observed minor vertical cracking below windows throughout. The render has blown around a vertical crack below a central first-floor window.

Photo 17 – Cracking below window to left elevation

Recommendation	Reason
Hack off existing render finishes and re-render with a approved system.	To ensure a watertight finish is provided to the building. Water can penetrate behind the render through cracks and holes and can become 'trapped'. This can cause potential water ingress into the cavity or cause further deterioration of the render.
Repair of drainage system to rear. Extent of works currently unknown.	To ensure the drainage system is operational and address potential building movement. Full extent of works required is not known at this stage.

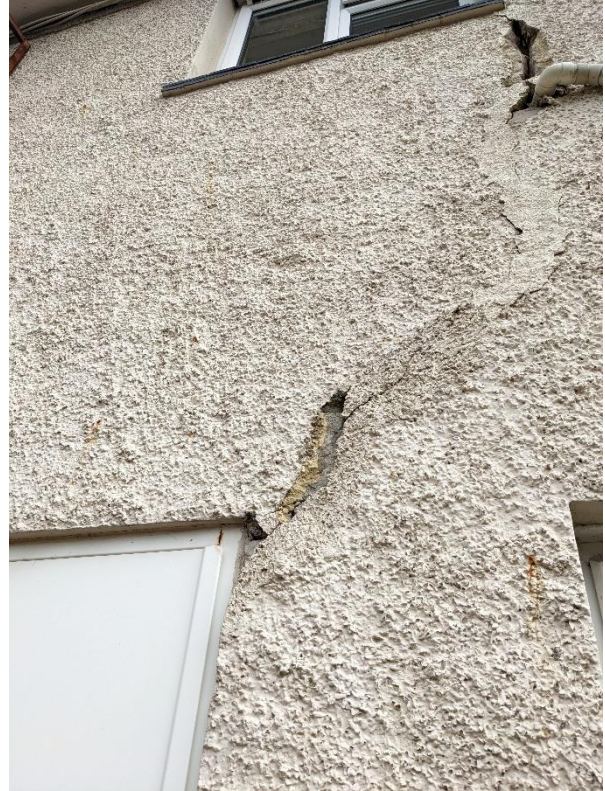
- 4.12. We observed cracking to the rear elevation and this is most likely due to ground movement. We understand a CCTV survey has been undertaken of the drainage in the area and various major defects were identified. Underpinning and crack stitching may be required following repair of the drainage (to be confirmed by structural engineer).

Photo 18 – Blown render around cracking to rear elevation

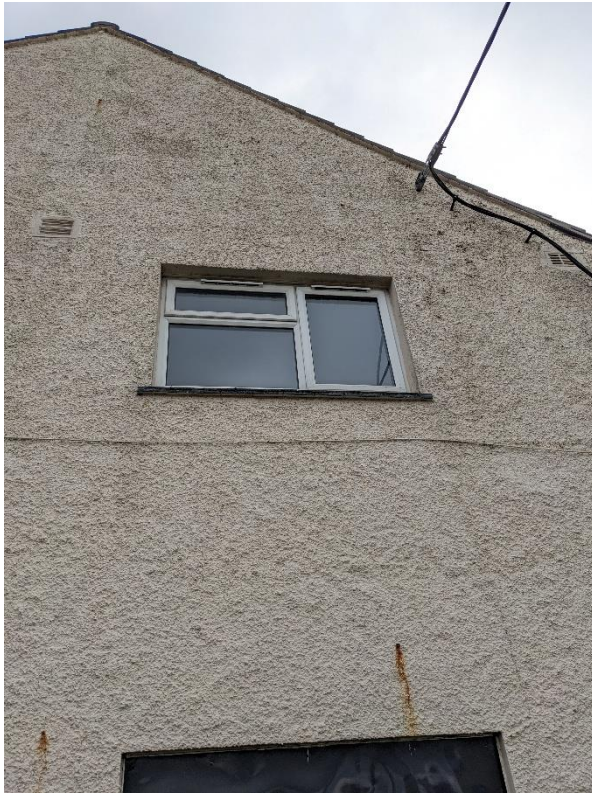
Photo 21 – Cracking below window to right elevation

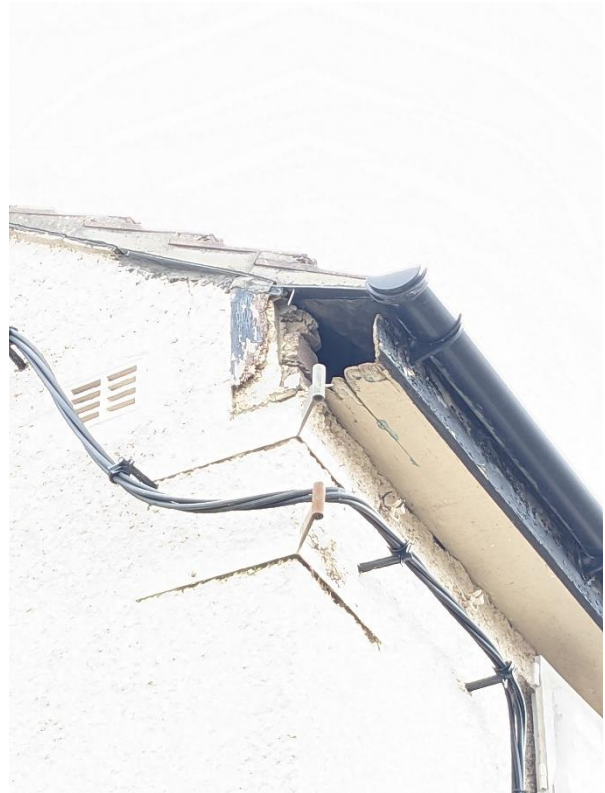
- 4.3. The timber fascia and soffit are generally in reasonable condition however are showing signs of deterioration and are rotten to the left-hand side to the rear allowing birds to nest inside.

Photo 22 – Rotten fascia and soffit to rear

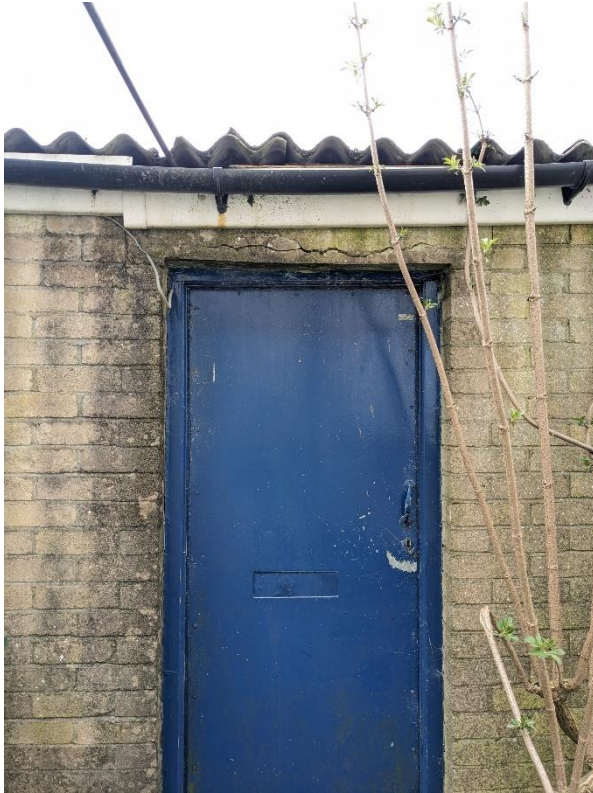
- 4.18. The corrugated roof is in reasonable condition however the ridge and verge details have degraded and been damaged in places.
- 4.19. There are several areas of cracking to the walls to all elevations and the wall to the rear right-hand corner appears to be detaching from the rest of the walls. The building appears to be suffering with subsidence.
- 4.20. The steel doors to the rear have suffered minor damage and the faces are rusting.
- 4.21. The PVCu gutters are in poor condition.
- 4.22. The concrete lintel to the front door has cracked.

Photo 25 – Cracked lintel above front door of outbuilding

Recommendation	Reason
Demolish the outbuilding in its entirety, lay new foundations and install a prefabricated building.	Due to the numerous elements that require renewal and the structural work required to the walls, it may be more cost effective in the long term to demolish the building and supply new. The building is of substandard quality and requires extensive structural repair. Demolition of the building may also be required to facilitate repair of the drainage system.

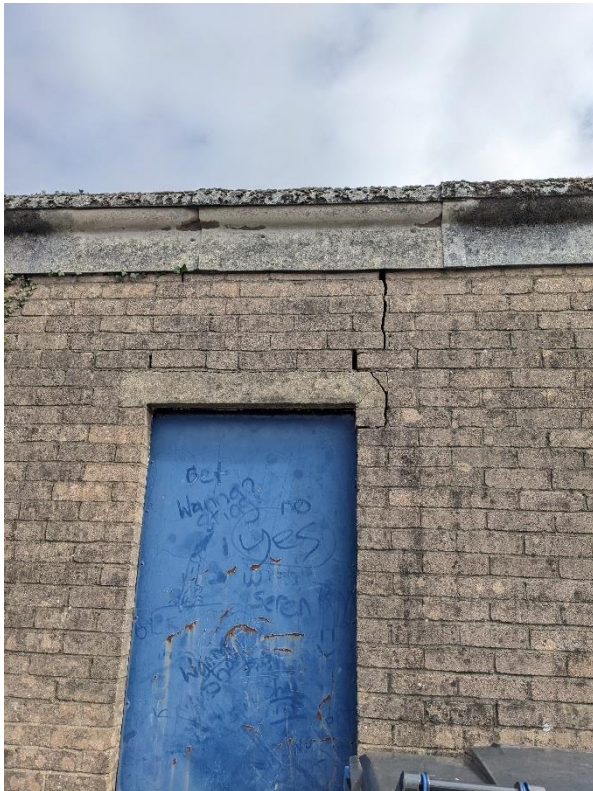
Photo 27 – Cracking to rear of outbuilding

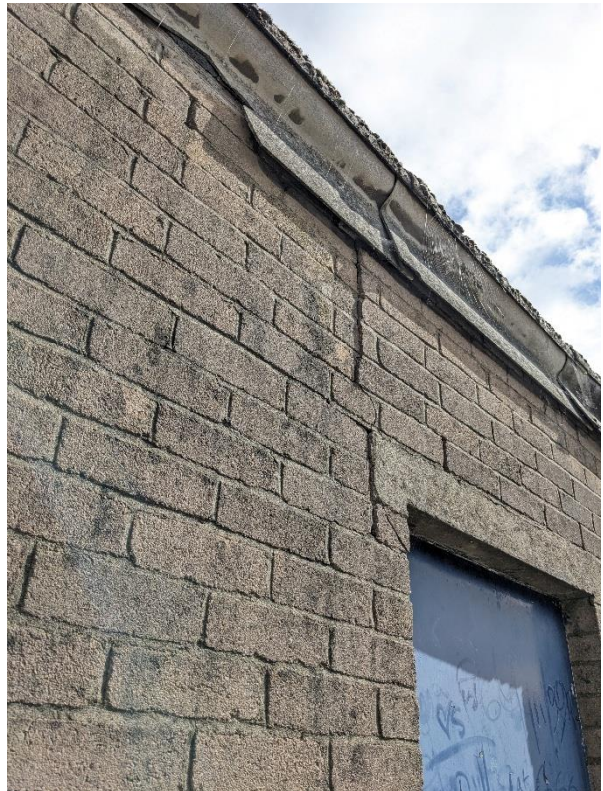
Photo 28 – Cracking to rear of outbuilding
