ASBESTOS DEMOLITION SURVEY
OF
GARAGE 16 YEW CLOSE, GURNOS ESTATE, MERTHYR TYDFIL, CF47 9SD

CLIENT: MERTHYR VALLEYS HOMES LTD
TY BRYCHAN , 22 LANSBURY ROAD, MERTHYR TYDFIL, CF48 1HA

UPRN NO: 0103115
PROJECT NO: J1018483
DATE: APRIL 2025

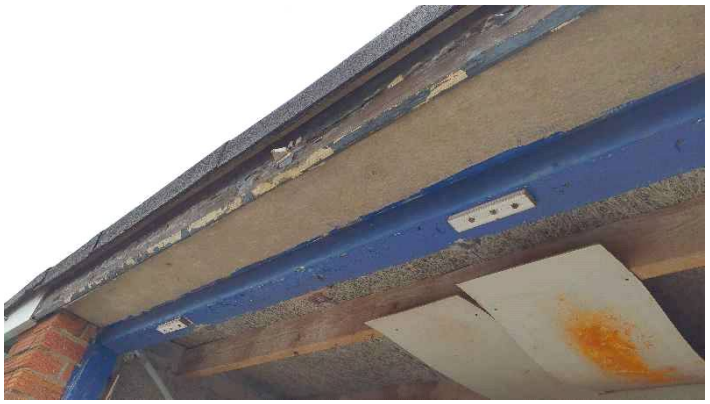
FLOOR/LOCATION:	External

DESCRIPTION:	Cement soffits	
RECOMMENDATIONS:	Remove under controlled conditions	
EXTENT:	<10m² or <10m pipe run	
SAMPLE REF:	ZM005363	
RESULT:	Chrysotile

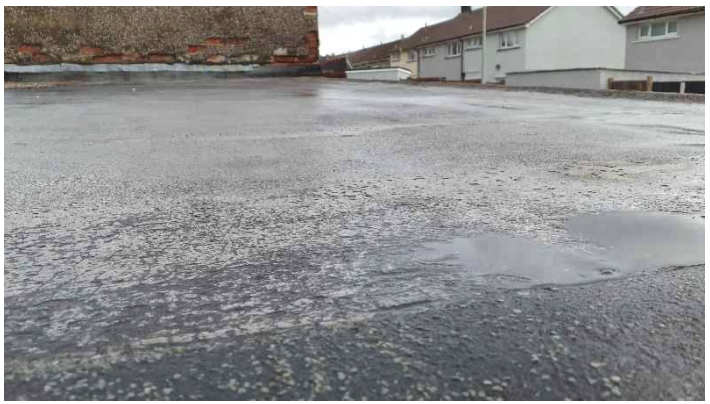
FLOOR/LOCATION:	External

DESCRIPTION:	Felt to garage roof	
RECOMMENDATIONS:	No further action required	
EXTENT:	-	
SAMPLE REF:	ZM005364	
RESULT:	No Asbestos Detected

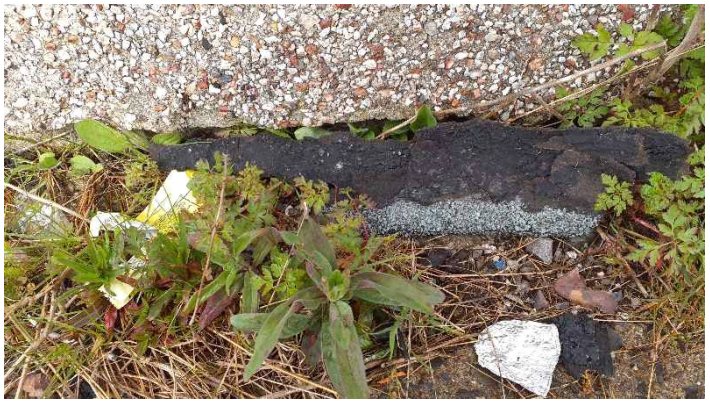
FLOOR/LOCATION:	External

DESCRIPTION:	Garage felt debris	
RECOMMENDATIONS:	No further action required	
EXTENT:	-	
SAMPLE REF:	ZM005365	
RESULT:	No Asbestos Detected

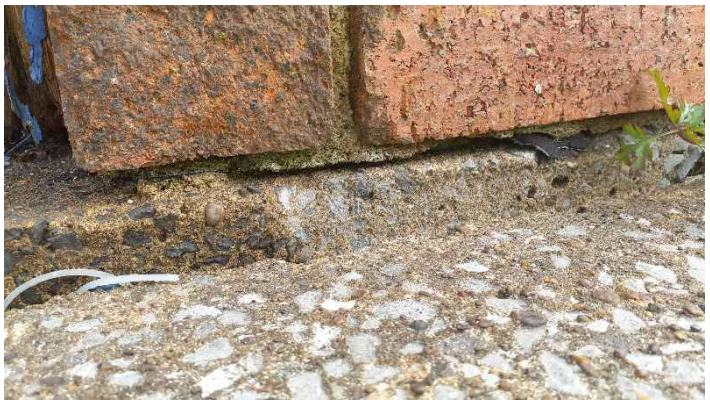
FLOOR/LOCATION:	External

DESCRIPTION:	DPC	
RECOMMENDATIONS:	No further action required	
EXTENT:	-	
SAMPLE REF:	ZM005366	
RESULT:	No Asbestos Detected

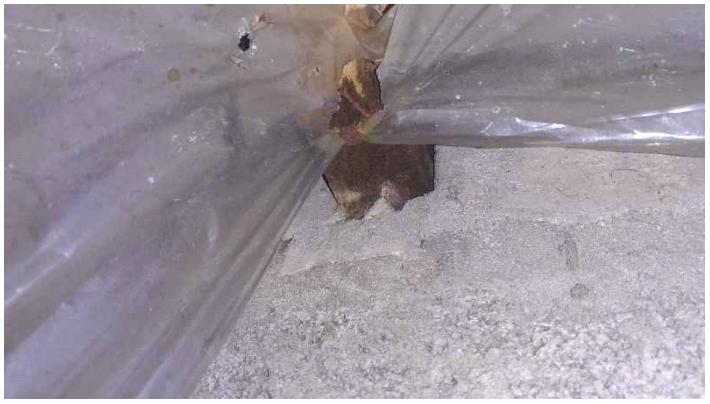
FLOOR/LOCATION:	Ground Floor Storage

DESCRIPTION:	Cement packer within brickwork	
RECOMMENDATIONS:	Remove under controlled conditions	
EXTENT:	<10m² or <10m pipe run	
SAMPLE REF:	ZM005360	
RESULT:	Chrysotile

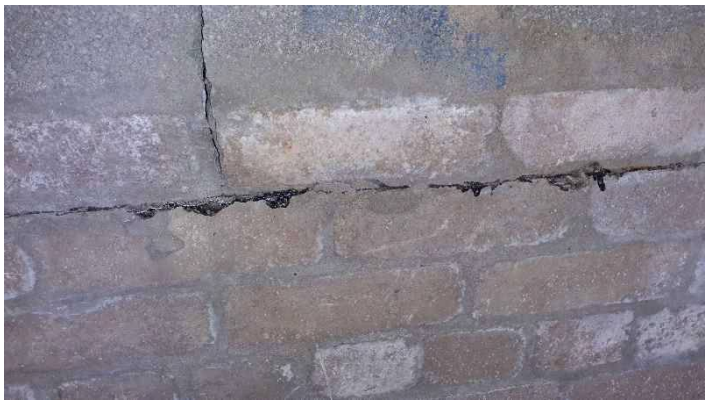
FLOOR/LOCATION:	Ground Floor Storage

DESCRIPTION:	Horizontal DPC to brickwork	
RECOMMENDATIONS:	No further action required	
EXTENT:	-	
SAMPLE REF:	ZM005359	
RESULT:	No Asbestos Detected

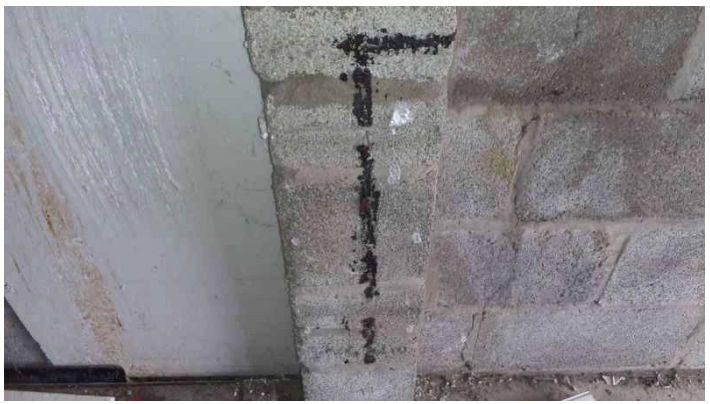
FLOOR/LOCATION:	Ground Floor Storage

DESCRIPTION:	Bitumen adhesive to wall	
RECOMMENDATIONS:	No further action required	
EXTENT:	-	
SAMPLE REF:	ZM005361	
RESULT:	No Asbestos Detected

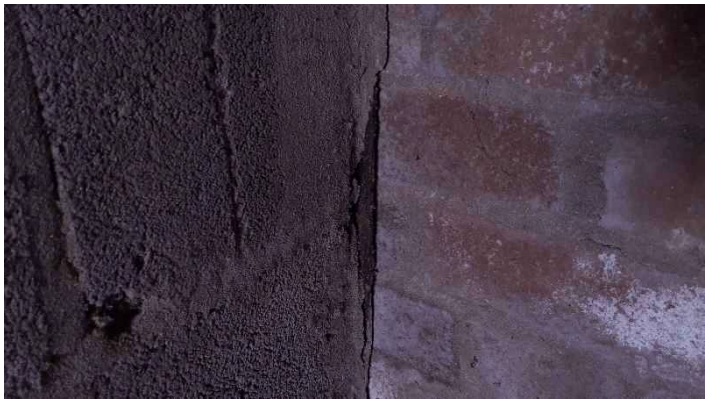
FLOOR/LOCATION:	Ground Floor Storage

DESCRIPTION:	Vertical DPC to brickwork	
RECOMMENDATIONS:	No further action required	
EXTENT:	-	
SAMPLE REF:	ZM005362	
RESULT:	No Asbestos Detected
