ASBESTOS DEMOLITION SURVEY  
OF  
GARAGE 17 YEW CLOSE, GURNOS ESTATE, MERTHYR TYDFIL, CF47 9SD

CLIENT: MERTHYR VALLEYS HOMES LTD  
TY BRYCHAN , 22 LANSBURY ROAD, MERTHYR TYDFIL, CF48 1HA

UPRN NO: 0103124  
PROJECT NO: J1018702  
DATE: APRIL 2025

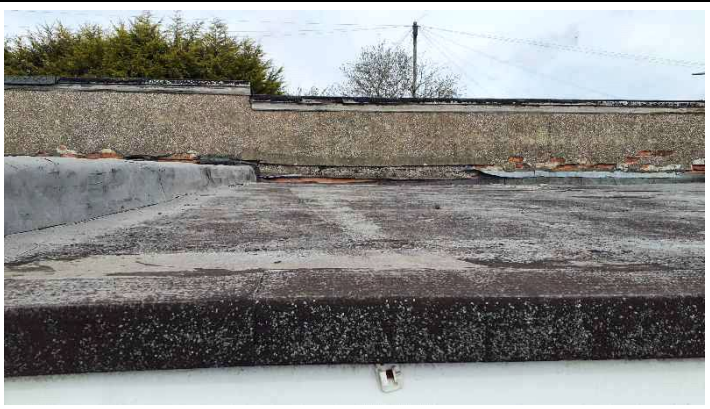
<b>FLOOR/LOCATION:</b>	External

<b>DESCRIPTION:</b>	Felt to garage roof	
<b>RECOMMENDATIONS:</b>	No further action required	
<b>EXTENT:</b>	-	
<b>SAMPLE REF:</b>	ZM005376	
<b>RESULT:</b>	No Asbestos Detected

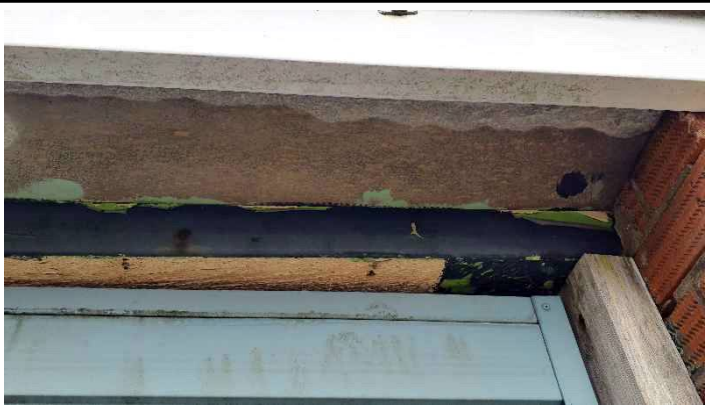
<b>FLOOR/LOCATION:</b>	External

Location	Description	Priority/Risk	Recommendation
Main building / External / External / E0-B1	Cement soffits	Very Low	Remove under controlled conditions

<b>DESCRIPTION:</b>	Cement soffits	
<b>RECOMMENDATIONS:</b>	Remove under controlled conditions	
<b>EXTENT:</b>	<10m² or <10m pipe run	
<b>SAMPLE REF:</b>	ZM005380	
<b>RESULT:</b>	Chrysotile

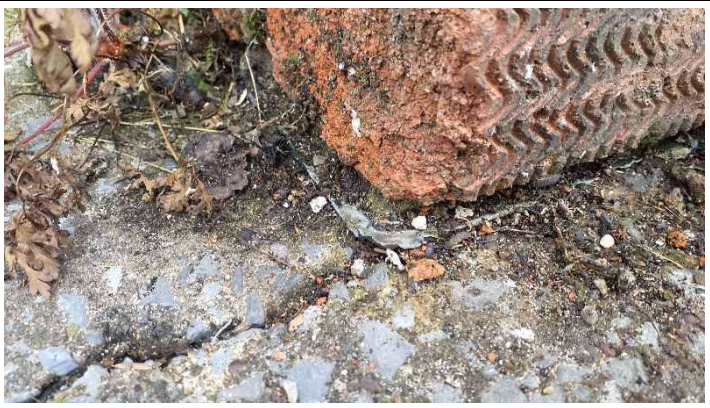
<b>FLOOR/LOCATION:</b>	External

<b>DESCRIPTION:</b>	DPC	
<b>RECOMMENDATIONS:</b>	No further action required	
<b>EXTENT:</b>	-	
<b>SAMPLE REF:</b>	ZM005381	
<b>RESULT:</b>	No Asbestos Detected

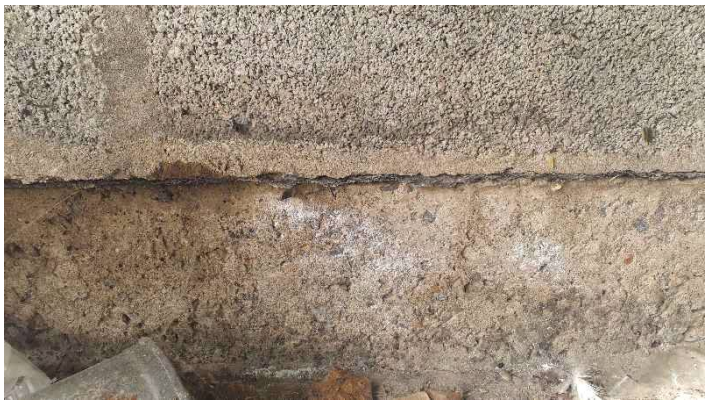
<b>FLOOR/LOCATION:</b>	Ground Floor Storage

<b>DESCRIPTION:</b>	Lower level horizontal DPC to brickwork (left side wall)	
<b>RECOMMENDATIONS:</b>	No further action required	
<b>EXTENT:</b>	-	
<b>SAMPLE REF:</b>	ZM005377	
<b>RESULT:</b>	No Asbestos Detected

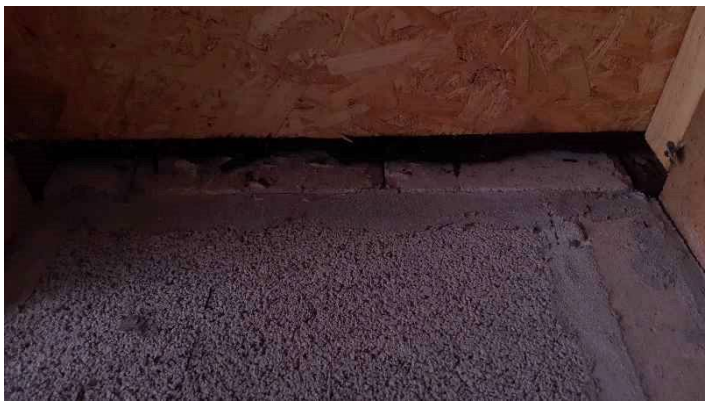
<b>FLOOR/LOCATION:</b>	Ground Floor Storage

<b>DESCRIPTION:</b>	Felt to left side wall	
<b>RECOMMENDATIONS:</b>	No further action required	
<b>EXTENT:</b>	-	
<b>SAMPLE REF:</b>	ZM005378	
<b>RESULT:</b>	No Asbestos Detected

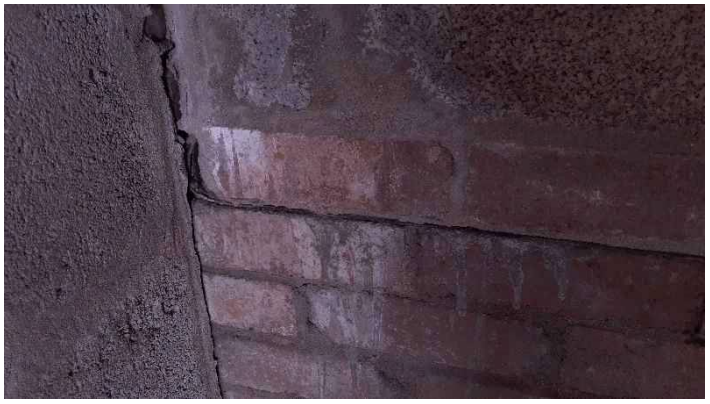
<b>FLOOR/LOCATION:</b>	Ground Floor Storage

<b>DESCRIPTION:</b>	Horizontal DPC to brickwork (back wall)	
<b>RECOMMENDATIONS:</b>	No further action required	
<b>EXTENT:</b>	-	
<b>SAMPLE REF:</b>	ZM005379	
<b>RESULT:</b>	No Asbestos Detected

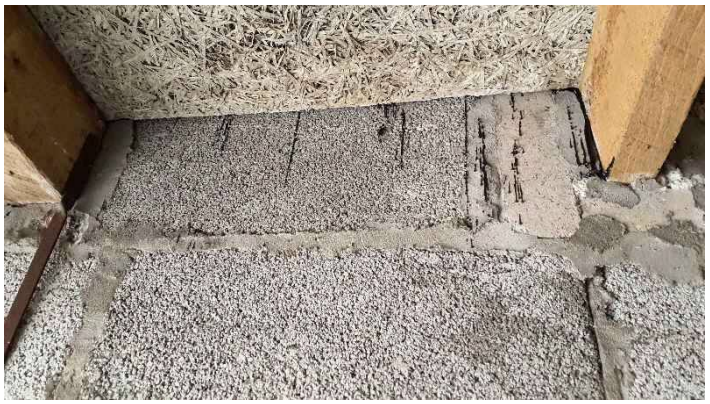
<b>FLOOR/LOCATION:</b>	Ground Floor Storage

<b>DESCRIPTION:</b>	Bitumen residue between stramit board ceiling and wall (left side)	
<b>RECOMMENDATIONS:</b>	No further action required	
<b>EXTENT:</b>	-	
<b>SAMPLE REF:</b>	ZM005382	
<b>RESULT:</b>	No Asbestos Detected
