ASBESTOS DEMOLITION SURVEY  
OF  
GARAGE 18, YEW CLOSE, GURNOS ESTATE, MERTHYR TYDFIL, CF47 9SD

CLIENT: MERTHYR VALLEYS HOMES LTD  
TY BRYCHAN, 22 LANSBURY ROAD, MERTHYR TYDFIL, CF48 1HA

UPRN NO: 2481  
PROJECT NO: J1018705  
DATE: MAY 2025

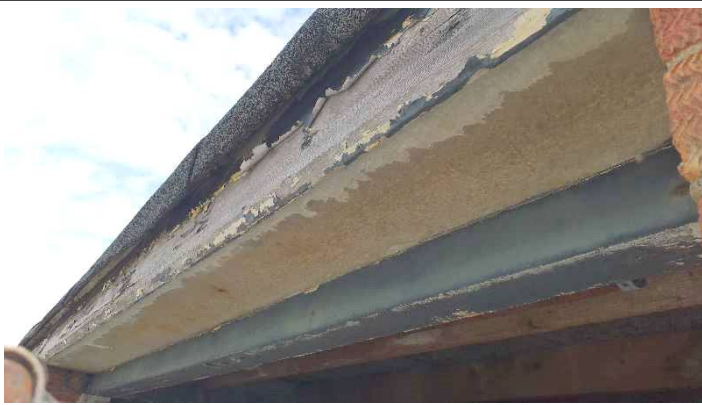
<b>FLOOR/LOCATION:</b>	External

<b>DESCRIPTION:</b>	Cement soffits	
<b>RECOMMENDATIONS:</b>	Remove under controlled conditions	
<b>EXTENT:</b>	<10m² or <10m pipe run	
<b>SAMPLE REF:</b>	ZM005597	
<b>RESULT:</b>	Chrysotile

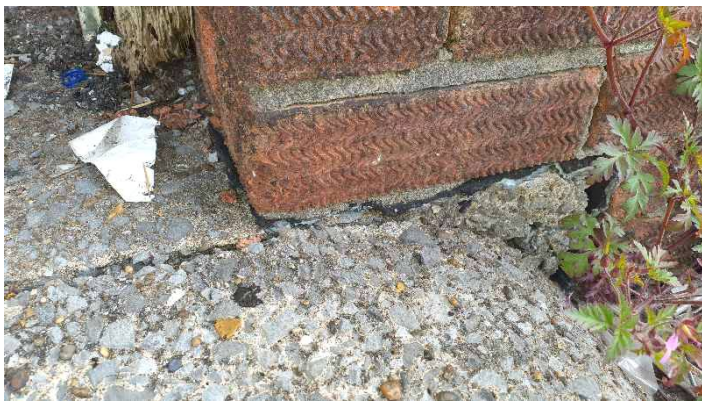
<b>FLOOR/LOCATION:</b>	External

<b>DESCRIPTION:</b>	DPC	
<b>RECOMMENDATIONS:</b>	No further action required	
<b>EXTENT:</b>	-	
<b>SAMPLE REF:</b>	ZM005598	
<b>RESULT:</b>	No Asbestos Detected

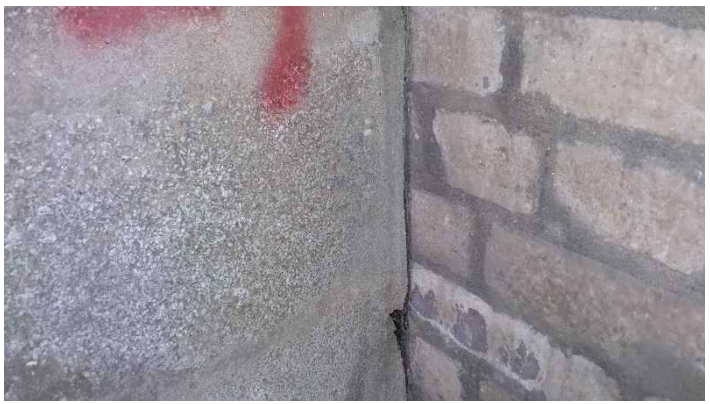
<b>FLOOR/LOCATION:</b>	Ground Floor Storage

<b>DESCRIPTION:</b>	Vertical DPC to brickwork	
<b>RECOMMENDATIONS:</b>	No further action required	
<b>EXTENT:</b>	-	
<b>SAMPLE REF:</b>	ZM005592	
<b>RESULT:</b>	No Asbestos Detected

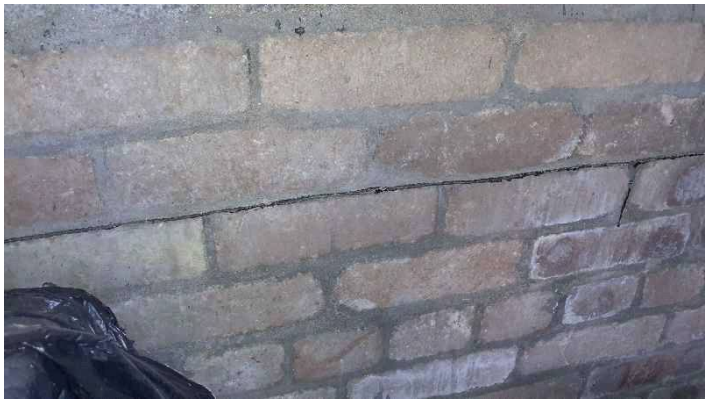
<b>FLOOR/LOCATION:</b>	Ground Floor Storage

<b>DESCRIPTION:</b>	Horizontal DPC to brickwork	
<b>RECOMMENDATIONS:</b>	No further action required	
<b>EXTENT:</b>	-	
<b>SAMPLE REF:</b>	ZM005593	
<b>RESULT:</b>	No Asbestos Detected

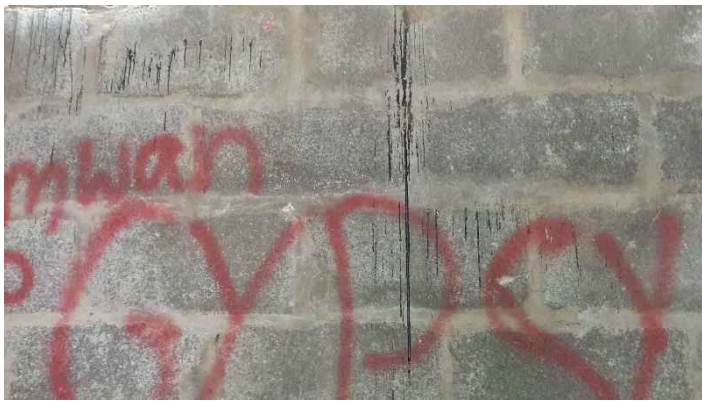
<b>FLOOR/LOCATION:</b>	Ground Floor Storage

<b>DESCRIPTION:</b>	Bitumen residue to walls	
<b>RECOMMENDATIONS:</b>	No further action required	
<b>EXTENT:</b>	-	
<b>SAMPLE REF:</b>	ZM005594	
<b>RESULT:</b>	No Asbestos Detected

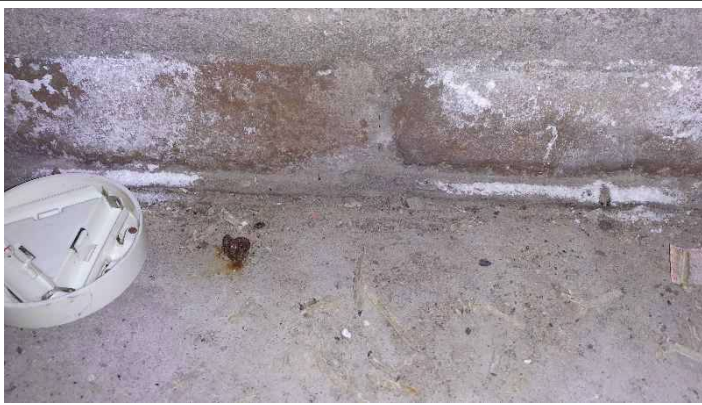
<b>FLOOR/LOCATION:</b>	Ground Floor Storage

<b>DESCRIPTION:</b>	Low level horizontal DPC to brickwork	
<b>RECOMMENDATIONS:</b>	No further action required	
<b>EXTENT:</b>	-	
<b>SAMPLE REF:</b>	ZM005595	
<b>RESULT:</b>	No Asbestos Detected
