ASBESTOS DEMOLITION SURVEY  
OF  
GARAGE 19, YEW CLOSE, GURNOS ESTATE, MERTHYR TYDFIL, CF47 9SD

CLIENT: MERTHYR VALLEYS HOMES LTD  
TY BRYCHAN , 22 LANSBURY ROAD, MERTHYR TYDFIL, CF48 1HA

UPRN NO: 2482  
PROJECT NO: J1018706  
DATE: MAY 2025

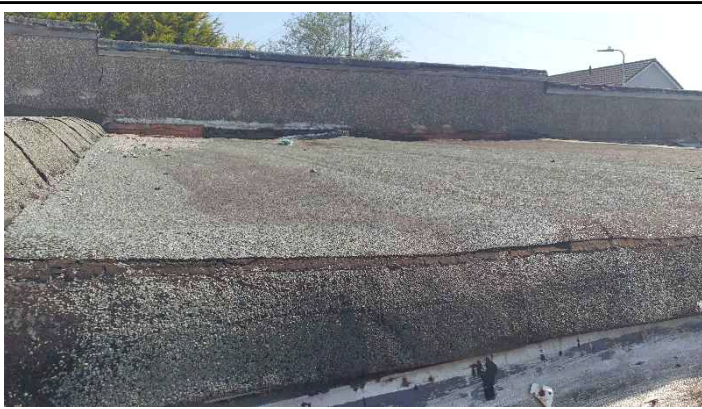
<b>FLOOR/LOCATION:</b>	External

<b>DESCRIPTION:</b>	Felt to roof	
<b>RECOMMENDATIONS:</b>	No further action required	
<b>EXTENT:</b>	-	
<b>SAMPLE REF:</b>	ZM005605	
<b>RESULT:</b>	No Asbestos Detected

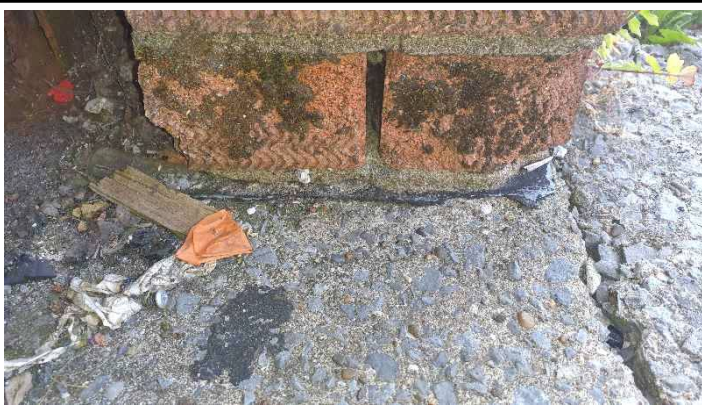
<b>FLOOR/LOCATION:</b>	External

<b>DESCRIPTION:</b>	DPC	
<b>RECOMMENDATIONS:</b>	No further action required	
<b>EXTENT:</b>	-	
<b>SAMPLE REF:</b>	ZM005606	
<b>RESULT:</b>	No Asbestos Detected

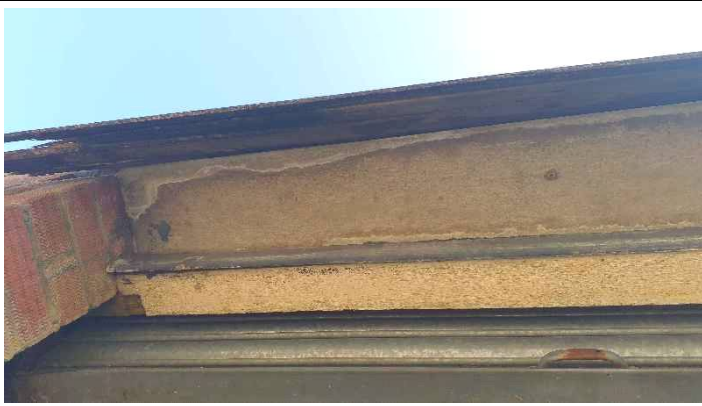
<b>FLOOR/LOCATION:</b>	External

<b>DESCRIPTION:</b>	Cement soffits	
<b>RECOMMENDATIONS:</b>	Remove under controlled conditions	
<b>EXTENT:</b>	<10m <sup>2</sup> or <10m pipe run	
<b>SAMPLE REF:</b>	ZM005607	
<b>RESULT:</b>	Chrysotile

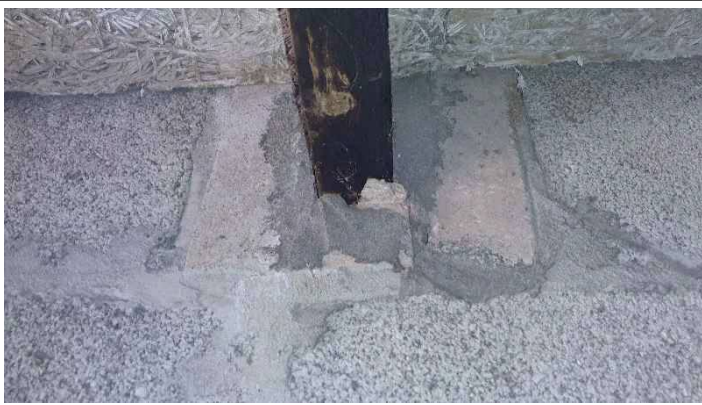
<b>FLOOR/LOCATION:</b>	Ground Floor Storage

<b>DESCRIPTION:</b>	Cement packer between bricks and timber joist	
<b>RECOMMENDATIONS:</b>	Remove under controlled conditions	
<b>EXTENT:</b>	<10m² or <10m pipe run	
<b>SAMPLE REF:</b>	ZM005600	
<b>RESULT:</b>	Chrysotile

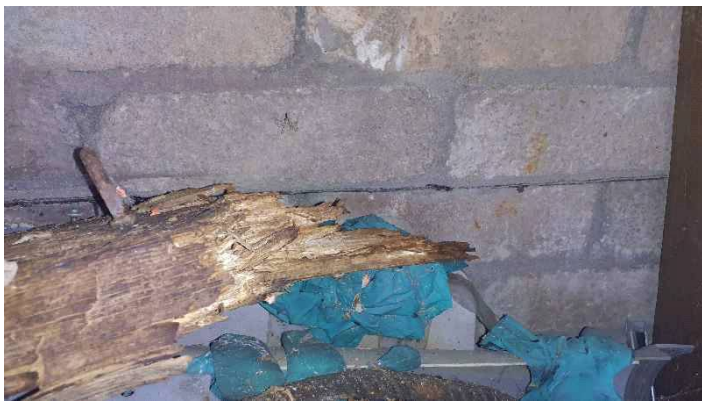
<b>FLOOR/LOCATION:</b>	Ground Floor Storage

<b>DESCRIPTION:</b>	Horizontal DPC to brickwork	
<b>RECOMMENDATIONS:</b>	No further action required	
<b>EXTENT:</b>	-	
<b>SAMPLE REF:</b>	ZM005601	
<b>RESULT:</b>	No Asbestos Detected

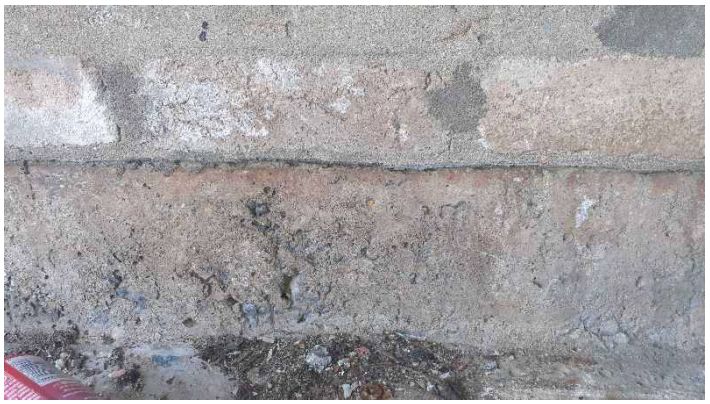
<b>FLOOR/LOCATION:</b>	Ground Floor Storage

<b>DESCRIPTION:</b>	Low level horizontal DPC to brickwork	
<b>RECOMMENDATIONS:</b>	No further action required	
<b>EXTENT:</b>	-	
<b>SAMPLE REF:</b>	ZM005602	
<b>RESULT:</b>	No Asbestos Detected

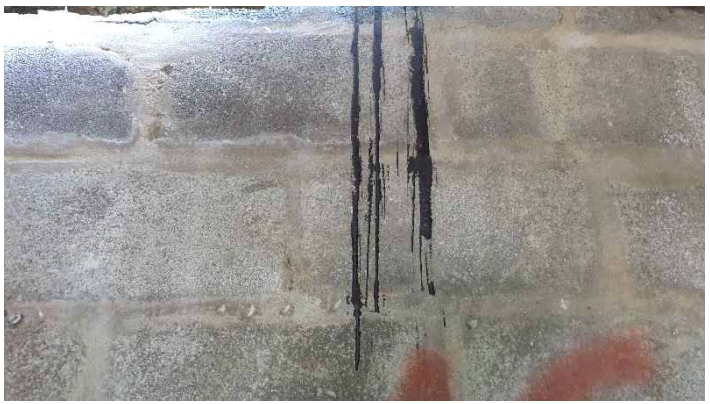
<b>FLOOR/LOCATION:</b>	Ground Floor Storage

<b>DESCRIPTION:</b>	Bitumen residue to walls	
<b>RECOMMENDATIONS:</b>	No further action required	
<b>EXTENT:</b>	-	
<b>SAMPLE REF:</b>	ZM005603	
<b>RESULT:</b>	No Asbestos Detected

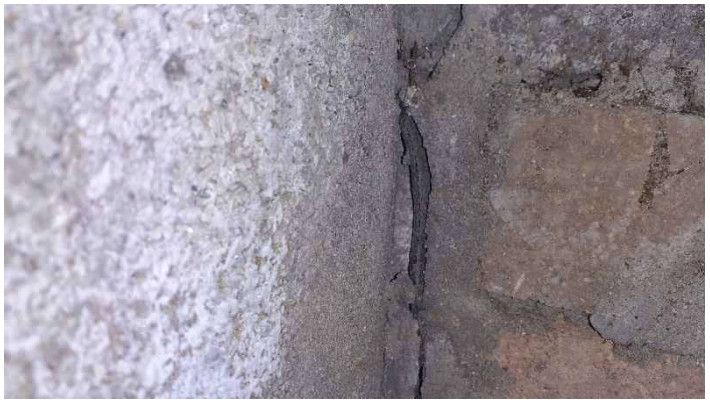
<b>FLOOR/LOCATION:</b>	Ground Floor Storage

<b>DESCRIPTION:</b>	Vertical DPC to brickwork	
<b>RECOMMENDATIONS:</b>	No further action required	
<b>EXTENT:</b>	-	
<b>SAMPLE REF:</b>	ZM005604	
<b>RESULT:</b>	No Asbestos Detected
