ASBESTOS DEMOLITION SURVEY  
OF  
GARAGE 21, YEW CLOSE, GURNOS ESTATE, MERTHYR TYDFIL, CF47 9SD

CLIENT: MERTHYR VALLEYS HOMES LTD  
TY BRYCHAN , 22 LANSBURY ROAD, MERTHYR TYDFIL, CF48 1HA

UPRN NO: 2484  
PROJECT NO: J1018710  
DATE: MAY 2025

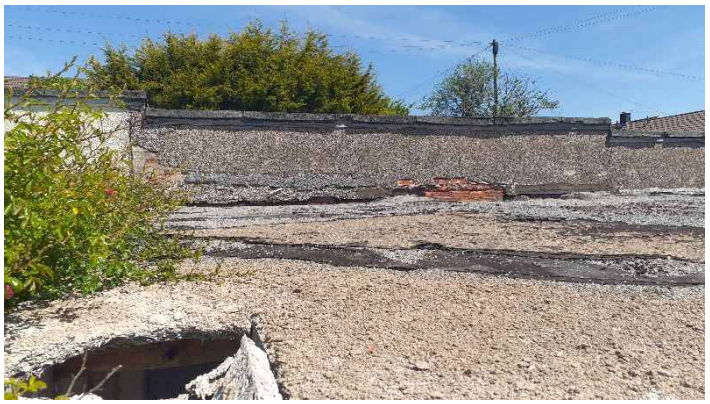
<b>FLOOR/LOCATION:</b>	External

<b>DESCRIPTION:</b>	Partially damaged felt to roof	
<b>RECOMMENDATIONS:</b>	No further action required	
<b>EXTENT:</b>	-	
<b>SAMPLE REF:</b>	ZM005741	
<b>RESULT:</b>	No Asbestos Detected

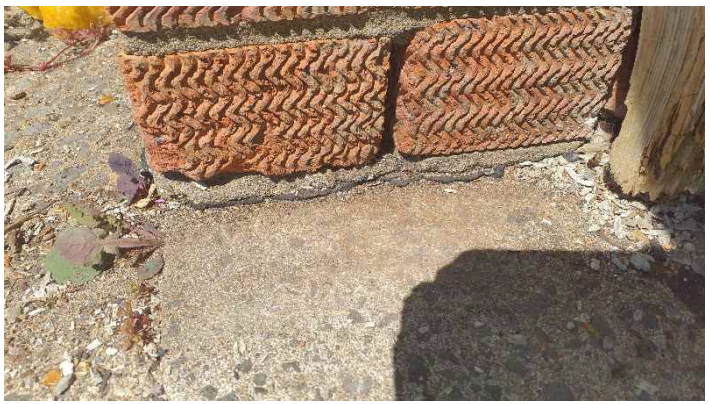
<b>FLOOR/LOCATION:</b>	External

<b>DESCRIPTION:</b>	DPC to side of doorway (left side)	
<b>RECOMMENDATIONS:</b>	No further action required	
<b>EXTENT:</b>	-	
<b>SAMPLE REF:</b>	ZM005743	
<b>RESULT:</b>	No Asbestos Detected

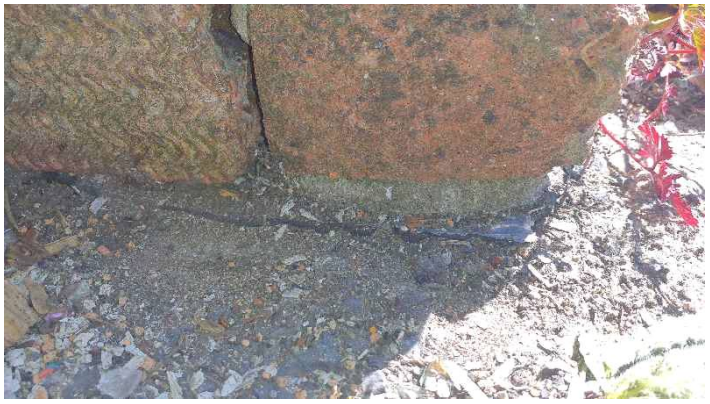
<b>FLOOR/LOCATION:</b>	External

<b>DESCRIPTION:</b>	DPC to side of doorway (right side)	
<b>RECOMMENDATIONS:</b>	No further action required	
<b>EXTENT:</b>	-	
<b>SAMPLE REF:</b>	ZM005742	
<b>RESULT:</b>	No Asbestos Detected

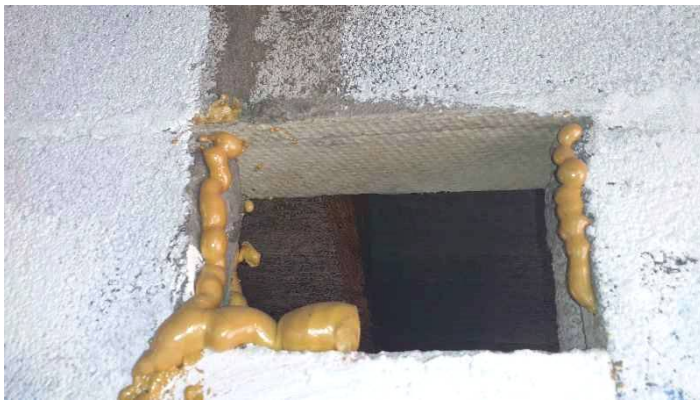
<b>FLOOR/LOCATION:</b>	Ground Floor Storage

Location	Description	Priority/Risk	Recommendation
Main building / Storage / Ground Floor / F00-01	Cement packer within brickwork	Very Low	Remove under controlled conditions

<b>DESCRIPTION:</b>	Cement packer within brickwork	
<b>RECOMMENDATIONS:</b>	Remove under controlled conditions	
<b>EXTENT:</b>	<10m² or <10m pipe run	
<b>SAMPLE REF:</b>	ZM005735	
<b>RESULT:</b>	Chrysotile

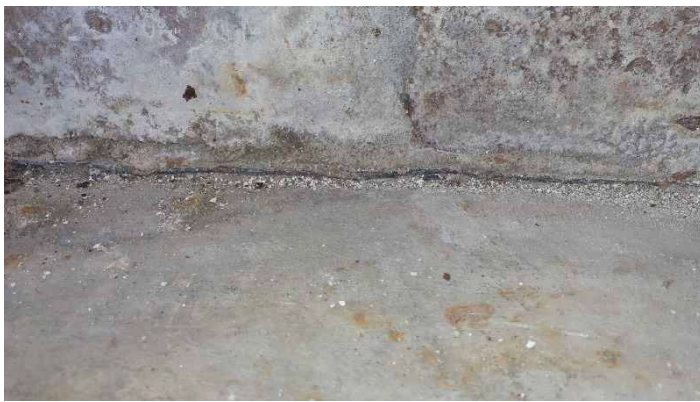
<b>FLOOR/LOCATION:</b>	Ground Floor Storage

<b>DESCRIPTION:</b>	Low level DPC to brickwork (left side)	
<b>RECOMMENDATIONS:</b>	No further action required	
<b>EXTENT:</b>	-	
<b>SAMPLE REF:</b>	ZM005737	
<b>RESULT:</b>	No Asbestos Detected

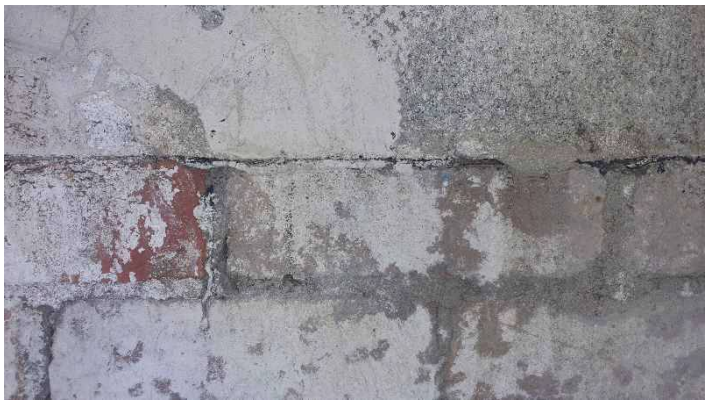
<b>FLOOR/LOCATION:</b>	Ground Floor Storage

<b>DESCRIPTION:</b>	Horizontal DPC to brickwork	
<b>RECOMMENDATIONS:</b>	No further action required	
<b>EXTENT:</b>	-	
<b>SAMPLE REF:</b>	ZM005738	
<b>RESULT:</b>	No Asbestos Detected

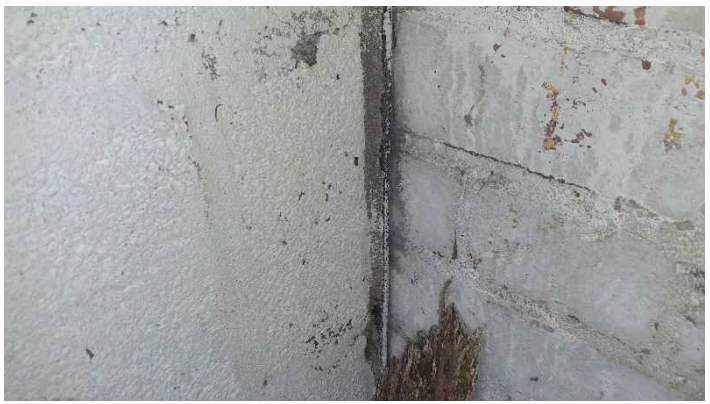
<b>FLOOR/LOCATION:</b>	Ground Floor Storage

<b>DESCRIPTION:</b>	Vertical DPC to brickwork	
<b>RECOMMENDATIONS:</b>	No further action required	
<b>EXTENT:</b>	-	
<b>SAMPLE REF:</b>	ZM005739	
<b>RESULT:</b>	No Asbestos Detected

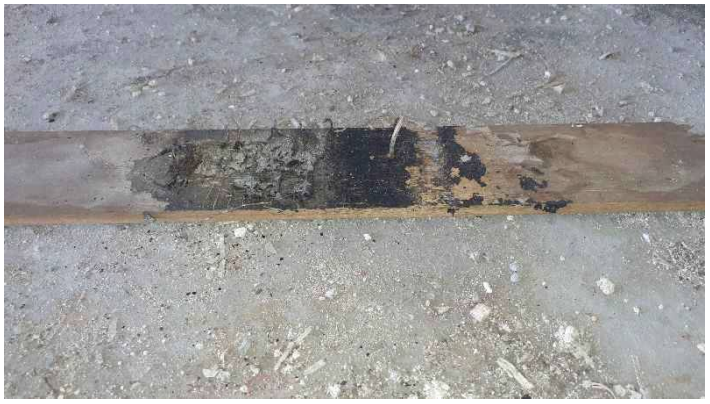
<b>FLOOR/LOCATION:</b>	Ground Floor Storage

<b>DESCRIPTION:</b>	Felt to damaged timber panel to floor	
<b>RECOMMENDATIONS:</b>	No further action required	
<b>EXTENT:</b>	-	
<b>SAMPLE REF:</b>	ZM005740	
<b>RESULT:</b>	No Asbestos Detected
