ASBESTOS DEMOLITION SURVEY
OF
GARAGE 10, YEW CLOSE, GURNOS ESTATE, MERTHYR TYDFIL, CF47 9SD

CLIENT: MERTHYR VALLEYS HOMES LTD
TY BRYCHAN , 22 LANSBURY ROAD, MERTHYR TYDFIL, CF48 1HA

UPRN NO: 2473
PROJECT NO: J1020270
DATE: MAY 2025

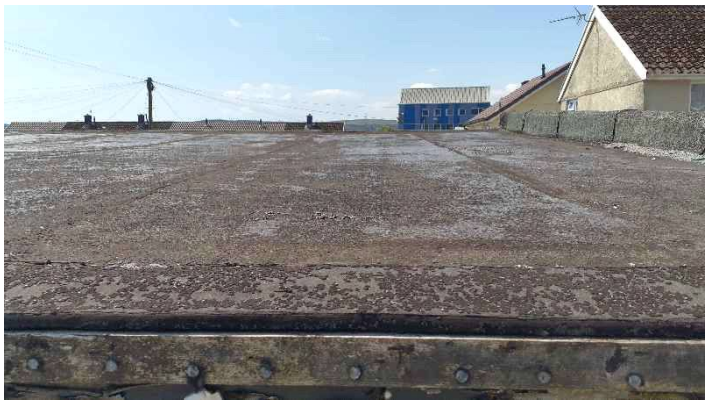
FLOOR/LOCATION:	External

DESCRIPTION:	Felt to roof	
RECOMMENDATIONS:	No further action required	
EXTENT:	-	
SAMPLE REF:	ZM005590	
RESULT:	No Asbestos Detected

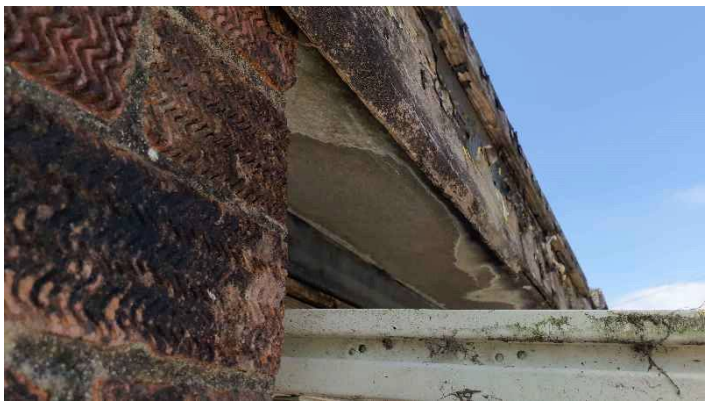
FLOOR/LOCATION:	External

Location	Description	Priority/Risk	Recommendation
Main building / External / External / E0-B1	Cement soffits	Very Low	Remove under controlled conditions

DESCRIPTION:	Cement soffits	
RECOMMENDATIONS:	Remove under controlled conditions	
EXTENT:	<10m² or <10m pipe run	
SAMPLE REF:	ZM005589	
RESULT:	Chrysotile

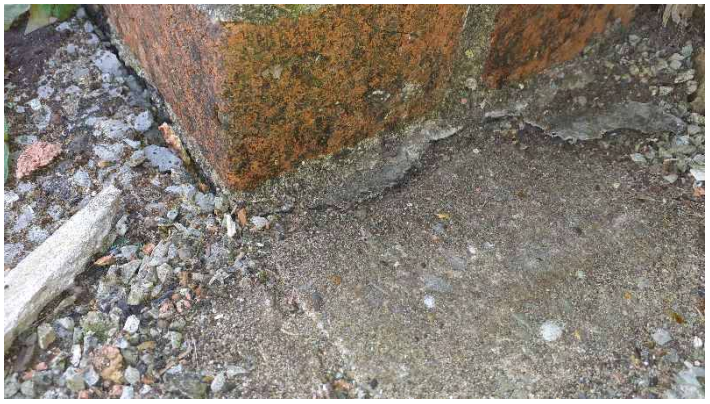
FLOOR/LOCATION:	External

DESCRIPTION:	DPC	
RECOMMENDATIONS:	No further action required	
EXTENT:	-	
SAMPLE REF:	ZM005612	
RESULT:	No Asbestos Detected

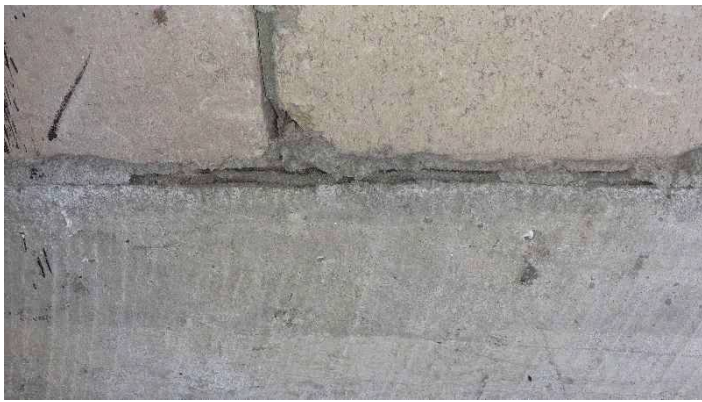
FLOOR/LOCATION:	Ground Floor Storage

DESCRIPTION:	Horizontal DPC to brickwork	
RECOMMENDATIONS:	No further action required	
EXTENT:	-	
SAMPLE REF:	ZM005610	
RESULT:	No Asbestos Detected

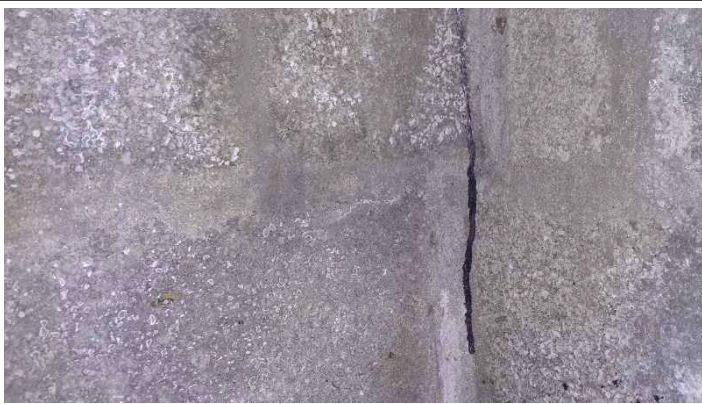
FLOOR/LOCATION:	Ground Floor Storage

DESCRIPTION:	Vertical DPC to brickwork	
RECOMMENDATIONS:	No further action required	
EXTENT:	-	
SAMPLE REF:	ZM005608	
RESULT:	No Asbestos Detected

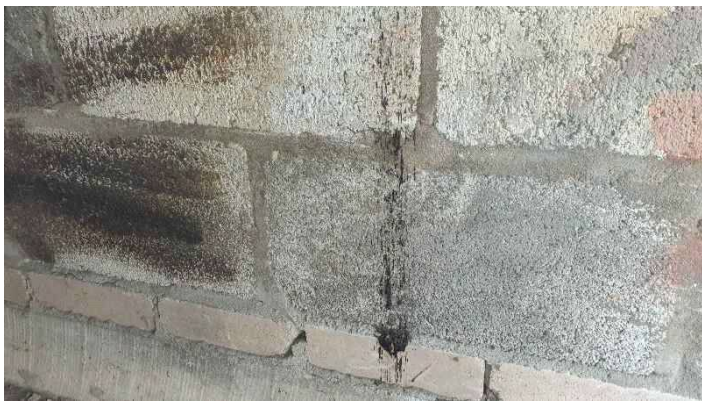
FLOOR/LOCATION:	Ground Floor Storage

DESCRIPTION:	Bitumen residue to walls	
RECOMMENDATIONS:	No further action required	
EXTENT:	-	
SAMPLE REF:	ZM005609	
RESULT:	No Asbestos Detected

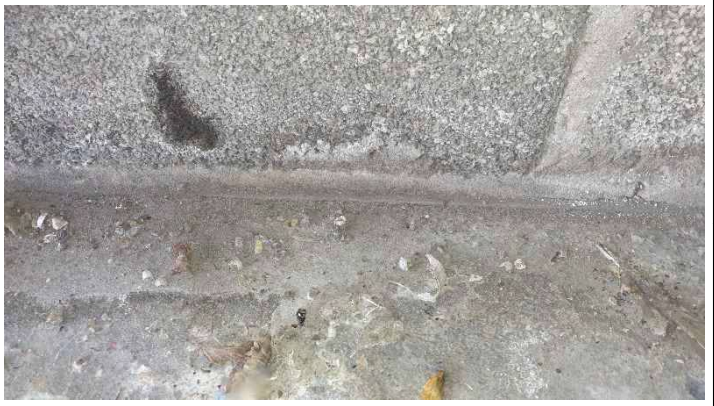
FLOOR/LOCATION:	Ground Floor Storage

DESCRIPTION:	DPC between concrete floor and brickwork	
RECOMMENDATIONS:	No further action required	
EXTENT:	-	
SAMPLE REF:	ZM005611	
RESULT:	No Asbestos Detected
