FRAEW/PAS 9980 report

**St Tydfils Court,
10 Caedraw Road,
Merthyr Tydfil,
CF47 8HP**

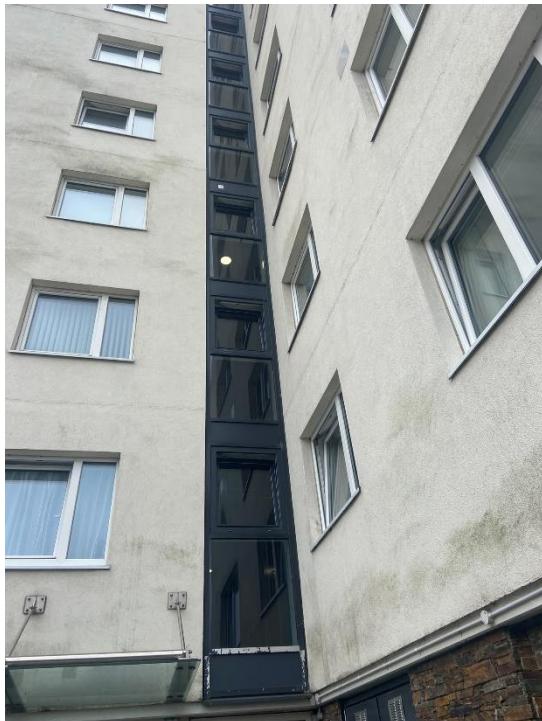
This property has been given a “**Medium/Tolerable**” risk rating. Whilst there are non-compliant wall systems present (ACM spandrel panels), the locations of which are adjacent to communal areas where the risk of ignition is minimal. There are window opening within close proximity of the non-compliant ACM spandrel panels, however, a state of flashover would have to occur in order to propagate enough heat to ignite the spandrel panels by which point, operational fire service crews would have control of the site. There is adequate construction between the communal areas and self-contained residential apartments to instruct a stay put policy unless instructed otherwise by the fire and rescue service.

Spandrel panels run vertically the entire height of building in an isolated location.

- Update Fire Risk Assessment with the findings of this report to ensure it is “Suitable & Sufficient” in accordance with the Regulatory Reform (Fire Safety) Order 2005.
- Consider non-compliant ACM spandrel panels during future refurbishment.
- Install cavity barriers to Chameleon aluminium rain screen system.
- No access was obtained to review fire alarm system within flats. Consideration should be given to upgrading fire warning systems within flats to Grade D1:LD1 systems, if not installed already. Heat detection should be provided in locations adjacent to the spandrel panels or locations that would be subject to false activations. This system should be linked to the communal system so staff can investigate accordingly, in the event of an activation. This allows the local F&RS to be alerted at the earliest opportunity.

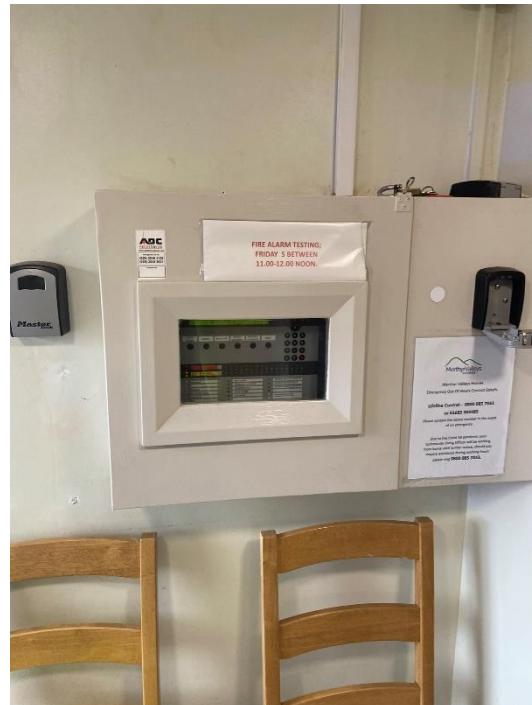
Addressable panel installed which is connected to an alarm receiving centre.

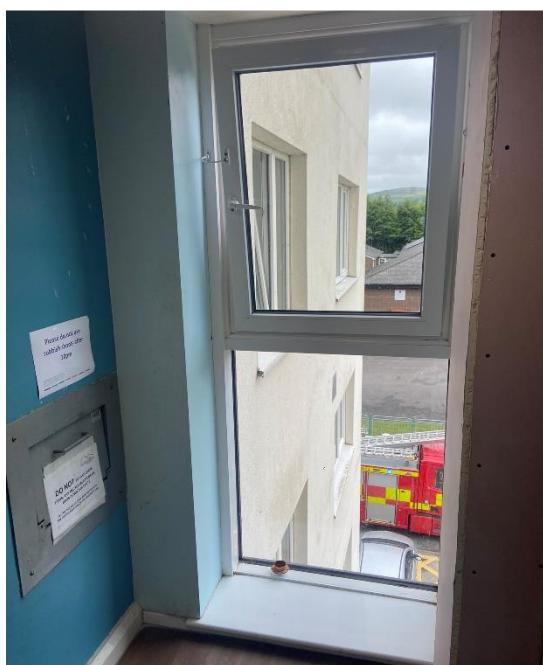
Area adjacent to non-compliant wall system was free from ignition sources and combustible materials during inspection.

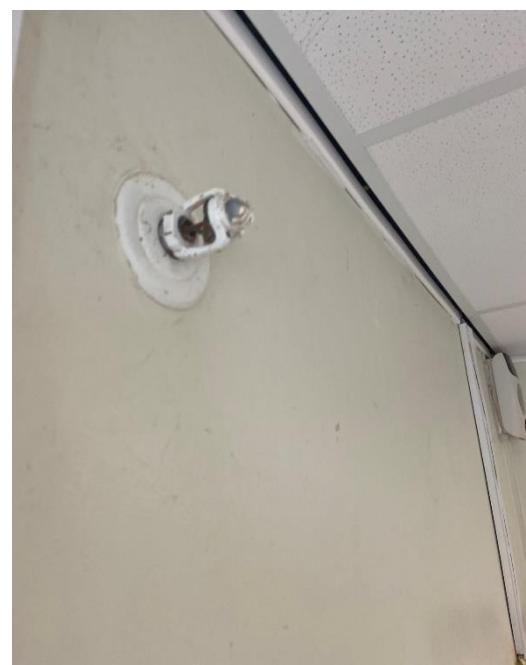
Sprinkler system is installed within communal area and self-contained flats. This is unusual in accordance with the British Standard.
