Grade II Listed Public Conveniences, John St, Porthcawl:

# BUILDING CONDITION SURVEY

PORTHCAWL  
TOWN COUNCIL

Revision	
DRAFT	09.12.2025
P01	10.12.2025

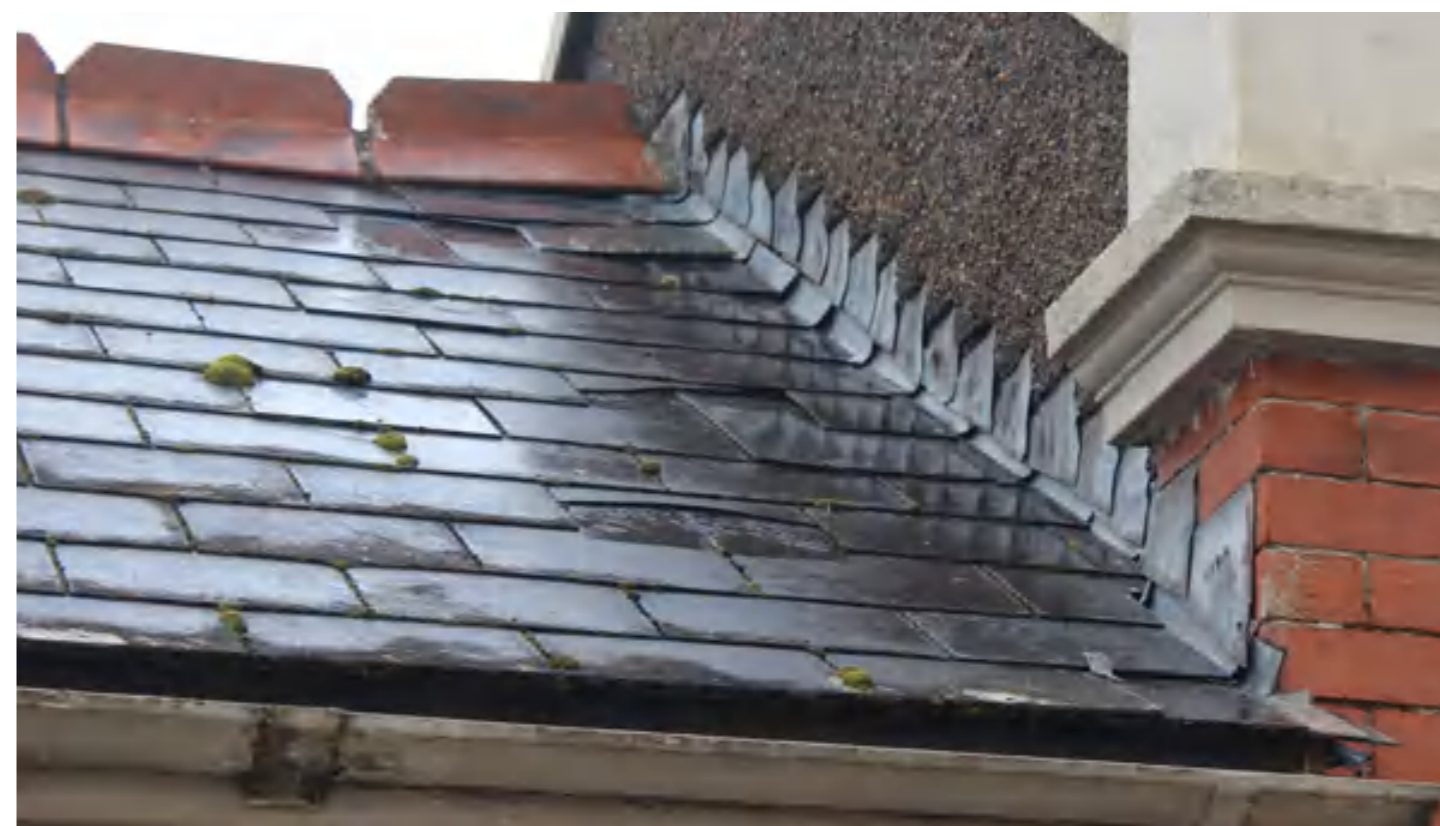
P01

**Condition:** Poor

The existing roof covering is considered to be beyond its expected lifespan (assumed to date from the 1980s and therefore approx. 40 years old) and has failed in numerous areas, with cracked and slipped tiles and consistent deterioration of the artificial slate surface. Evidence of a prolonged pattern of slippage is apparent across the roof, marked by the installation of localised lead straps and replacement slates. Lead flashing details to the eight flush rooflights are insufficiently robust with minimal upstand, creating vulnerable junctions prone to ingress. Lead cover flashings generally do not appear to meet minimum overlaps, particularly at the eastern parapet abutment and have been partially stolen from the abutment between the two roof levels. The red clay ridge tiles are in good condition generally and are considered suitable for careful removal, cleaning and re-use (excluding one cracked tile requiring replacement).

**Recommendation: Replace Artificial Roof Covering with Natural Slate****Priority 1**

1. Carefully remove all red clay plain angled ridge tiles and store for re-instatement;
2. Remove all artificial slates from the full roof area (approx. 107 sqm footprint);

12. Allow for replacing 1 no. cracked ridge tile with like for like.

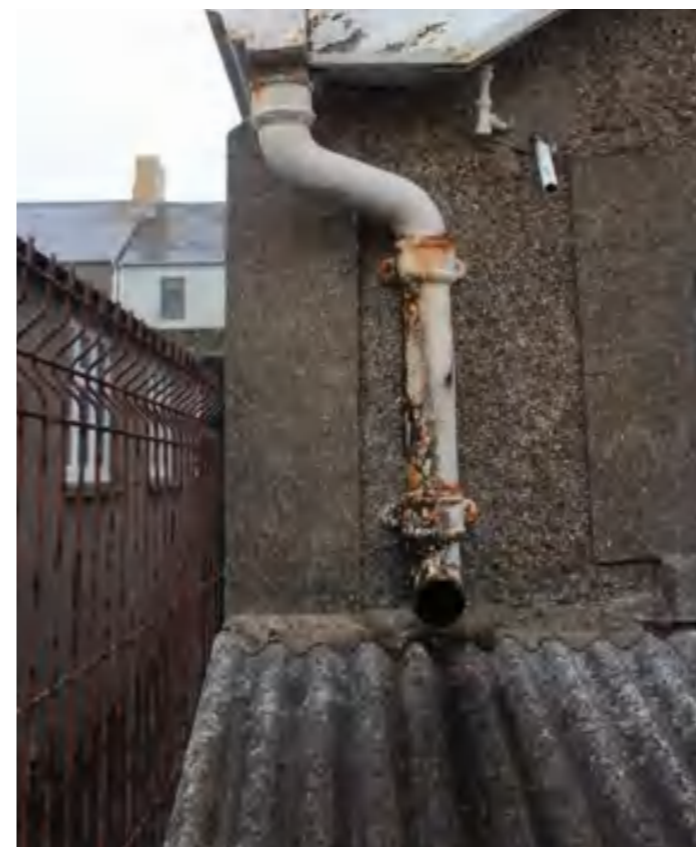
P01

**Condition:** Poor

Cement fillet flashing has generally failed, exhibiting cracking and areas of detachment. The corrugated sheet roof covering is beyond its expected service life, with corrosion evident to fixings. The uPVC guttering is not draining effectively due to inadequate falls and accumulation of debris.

**Recommendation: Replace Corrugated Sheet Roof Covering and Flashing**

1. Remove existing corrugated sheet roof covering, cement haunching and uPVC gutters and downpipes (*presence of asbestos to be confirmed prior to any works*)
2. Install new black polyester powder coated corrugated aluminium roof covering (black)
3. Install new lead flashing at abutment junction between and outside of concrete cills, coordinated with render replacement recommended later in this report.

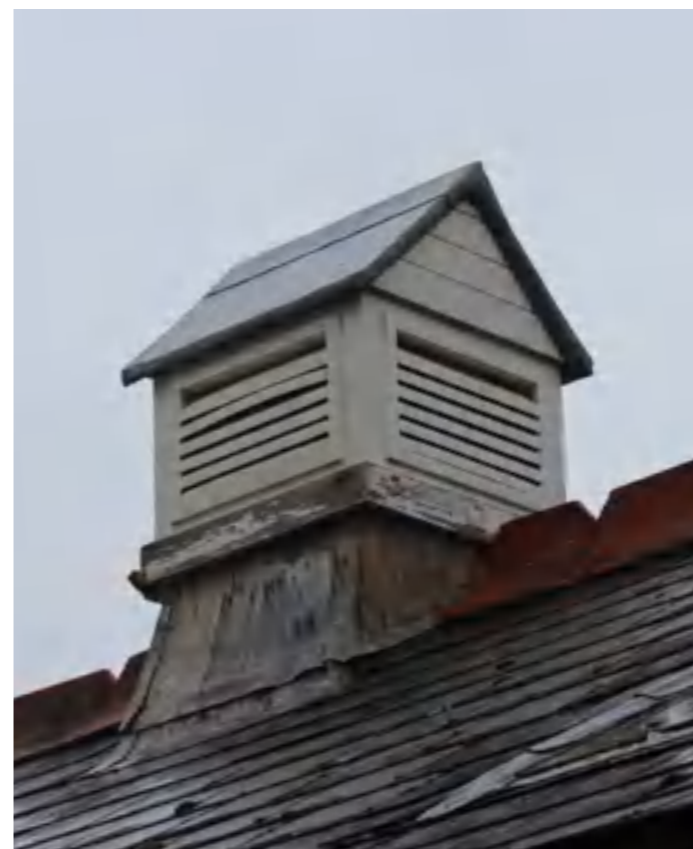
P01

**Condition:** Fair

The existing cupolas are in fair condition and do not appear to be contributing to active rainwater ingress. However, the lead apron flashing is showing deterioration and, as part of the principal roof re-covering, should be renewed. The painted timber rails covering the apron flashings are deteriorating on both cupolas. Furthermore, stainless steel fixings have not been used, and fixings are corroding to the base rails and to the ventilation louvres generally.

#### Recommendation: Repairs to Cupolas

1. Renew deteriorating lead upstand and cover flashings to cupola skirts with Code 5 lead, treated with patination oil, to LSTA guidance;
2. Renew deteriorating timber baserails with painted hardwood to matching profiles, fixed with stainless steel fixings;
3. Remove timber ventilation louvres and frame profile to remove corroding fixings;
4. Replace warped timber ventilation louvres in painted hardwood, fixed with stainless steel fixings;
5. Rub down cupola timber structure and prepare for redecoration;
6. Treat all timber with preservative primer (as per Dulux Weathershield, TBA with Conservation Officer);
7. Redecorate the cupolas (as per Dulux Weathershield, spec and colour TBA with Conservation Officer)

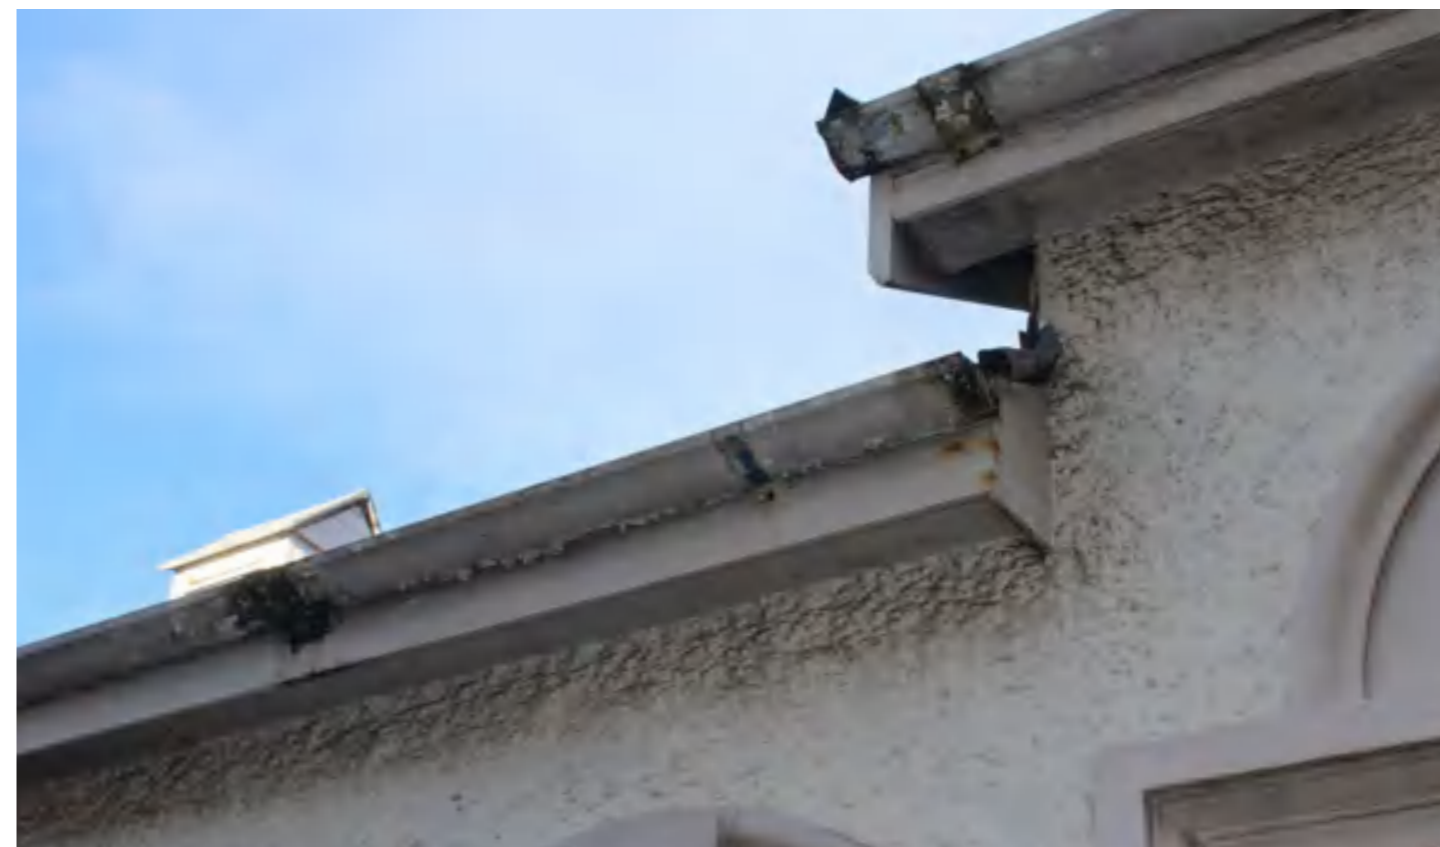
P01

The cast iron gutters generally exhibit consistent paint failure and surface corrosion. Heavy staining and surface corrosion is visible around the exposed cast iron support brackets to the south.

The cast iron downpipe to the southern elevation is undersized and shows localised surface corrosion at its socket joints and at connection to the ground, but is otherwise in fair condition. In contrast, the short cast iron downpipe to the western elevation, serving the northern gutter, displays significant corrosion.

**Recommendation: Repairs to Rainwater Goods****Priority 1**

1. Remove all cast iron rainwater goods and allow for temporary rainwater goods for duration required to undertake repairs / replacement.
2. Remove aluminium downpipe from western gable end (P05)

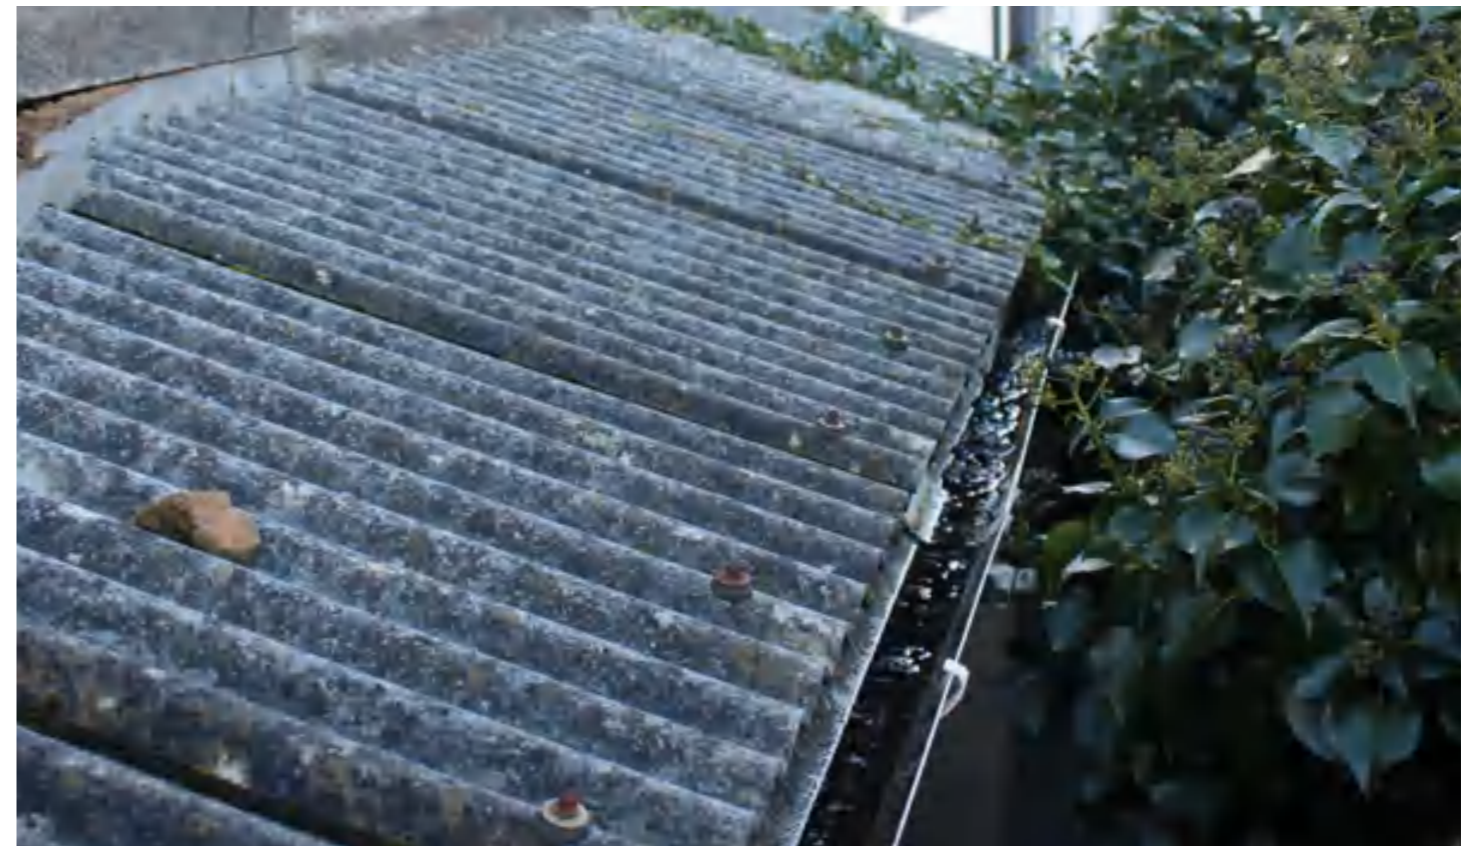
P07

To the west elevation, an inappropriate aluminium downpipe is installed to receive discharge from the southern gutter. This replacement is visually and materially out of character with the historic building and the family of rainwater goods. Similarly, the uPVC gutter to the lean-to roof over external urinals is materially inappropriate and failing to drain adequately to falls.

3. Remove uPVC gutter and downpipe from external urinal lean-to roof (P06/7)
4. Allow for complete replacement of short cast iron downpipe section to western elevation (P04/10)

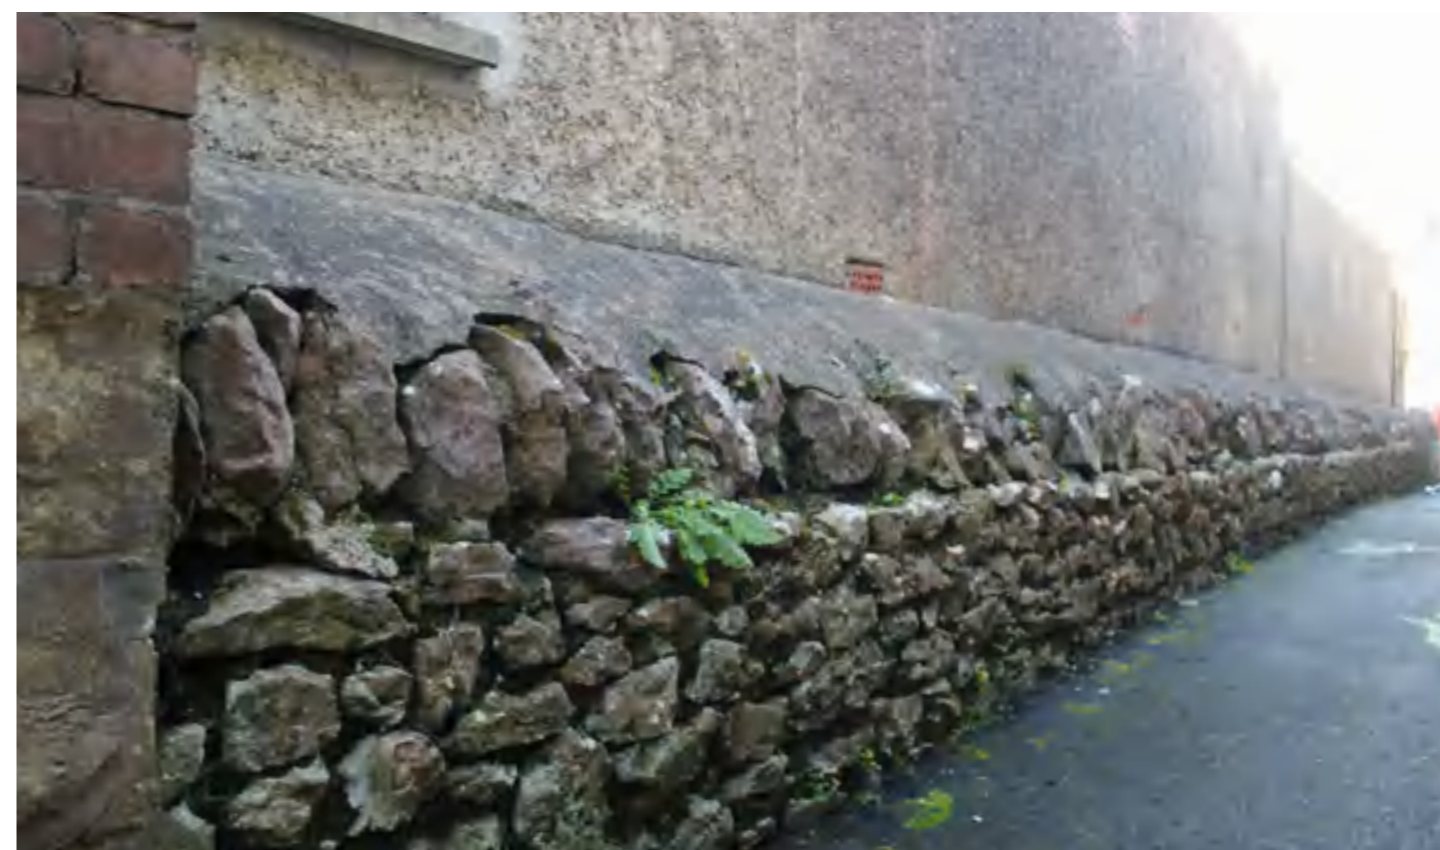
P01

The upper rendered wall finish exhibits widespread hairline cracking considered to be largely superficial. Three more pronounced vertical cracks are evident to the eastern end, at the stepped roof junction and to the lower wall, with previous repair attempts and crack infilling.

**Recommendation: Repairs to North Elevation External Walls**

1. Conduct localised render repairs to 3 no. areas of vertical cracking and prior repair.
2. Remove all cement haunching from the stone boundary wall and replace with lime mortar haunching (mix ratio TBA with Architect)
3. Remove all vegetation from mortar joints of stone boundary wall and allow for full re-pointing in lime mortar (approx 19 metres long, 600mm high)

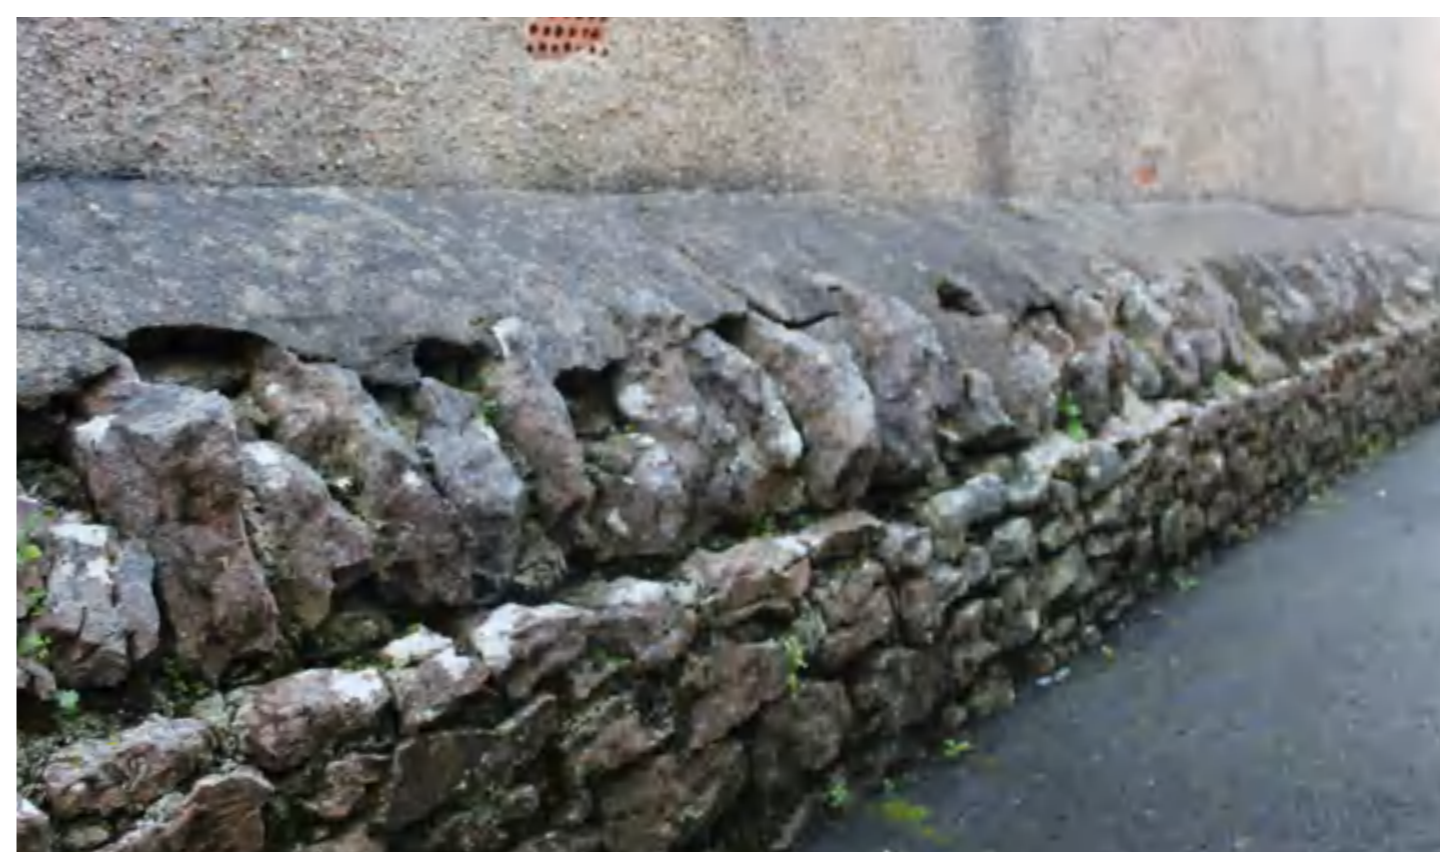
P02

The stone boundary wall is generally in poor condition, with lime mortar joints visibly weathered and vegetation growth contributing to ongoing deterioration. The cement haunchings to the wall head are eroded and, in places, have contributed to damage and decay of the underlying cock-and-hen stones.

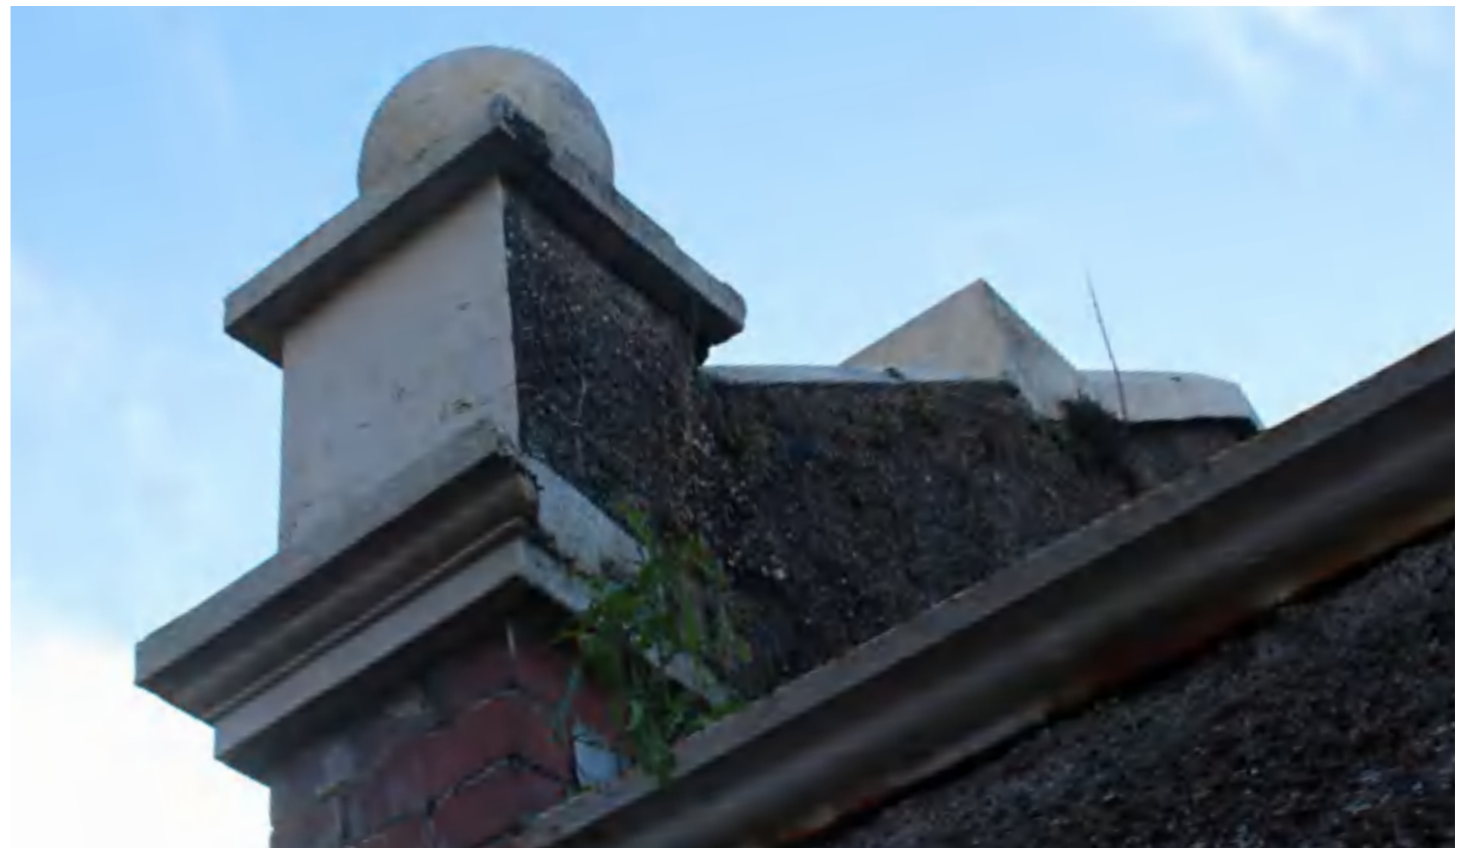
P08

The southern brick pier is observed to be moving outward leaving notably wide vertical joints between the pilaster and the elevation proper on the south and east sides. In 2023 Ferrier Hart Thomas produced a structural assessment on behalf of Porthcawl Town Council, recommending the need for intervention by Specialists as a short-term priority, employing grouted sock structural anchors to restrain the pier.

The rear face of the parapet wall is in poor condition with saturated render which is cracking and failing generally, along with vegetation growth. Poor weather resistance at this junction has led to ingress and damage to ceiling finishes within the Accessible WC and entrance lobby beneath.

**Recommendation: Structural Repairs to East Elevation External Walls****Priority 1**

1. Adopt recommendations in Ferrier Hart Thomas Structural Assessment (2023), requiring the appointment of a specialist to install structural grouted sock anchors (or similar, specified by specialist) to restrain the pilaster (P03). Re-point open joints with lime mortar.

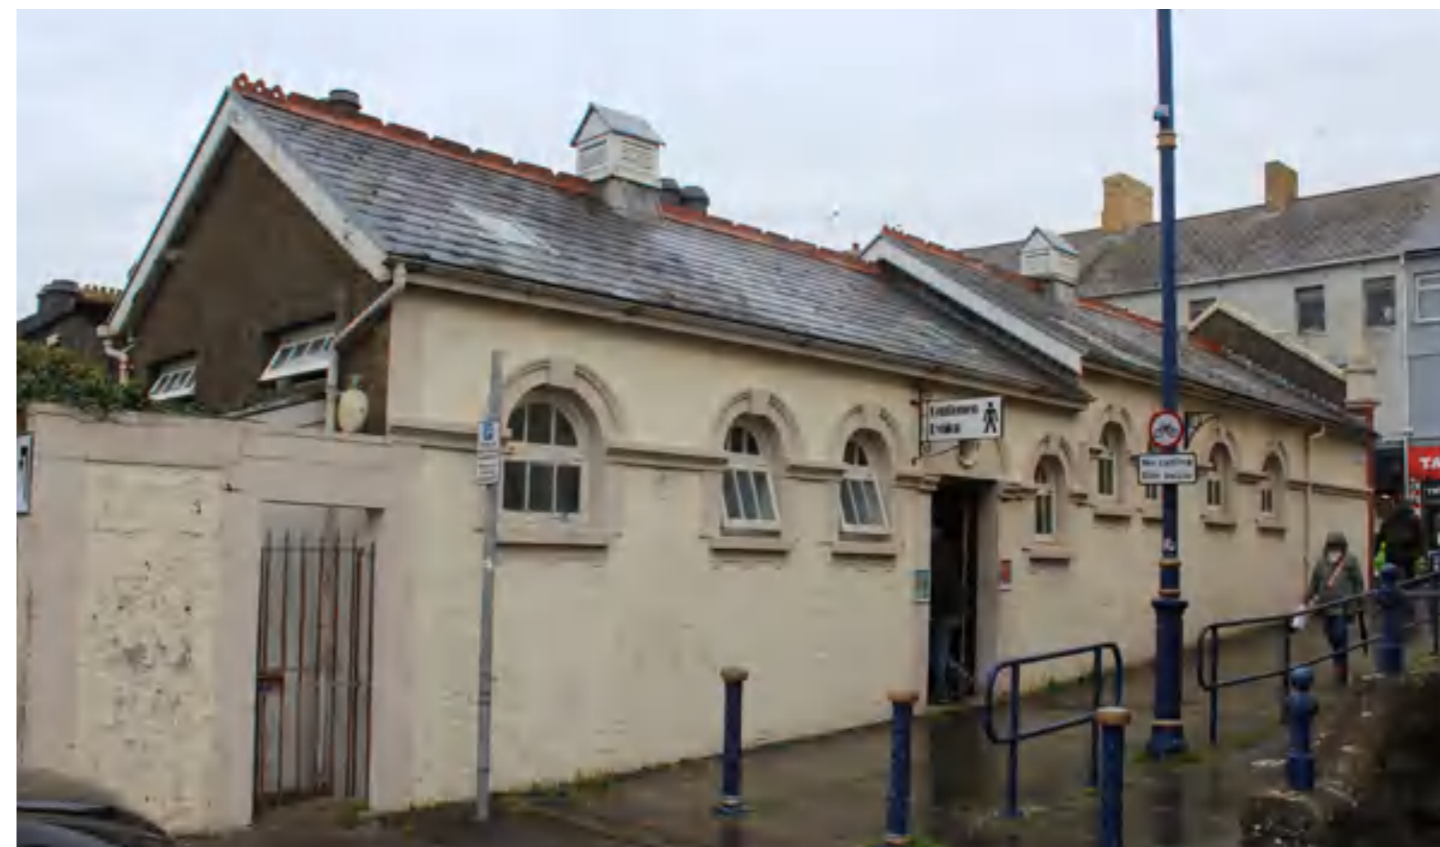
P01

Vegetation growth is accumulating at the junction between the paving and the rendered wall, and within perimeter drainage channels. This requires regular routine maintenance to prevent moisture retention at the base of the walls and further deterioration of the render.

**Recommendation: Repairs to South Elevation External Walls****Priority 1**

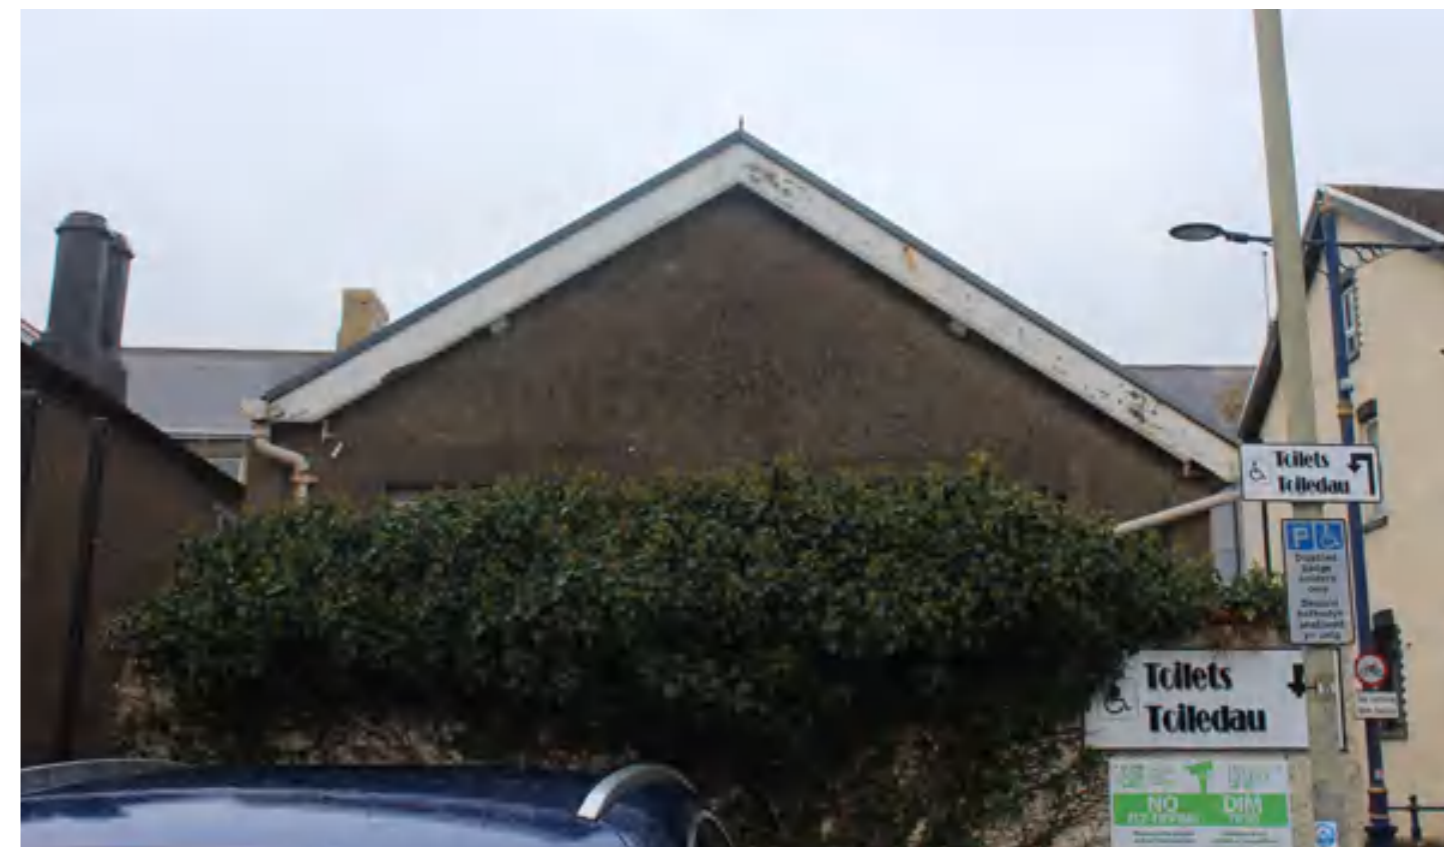
P01

**Condition:** Poor

The wall surfaces located beneath the lean-to roof could only be inspected from above due to restricted access. The rusticated smooth cement render in these areas shows evidence of cracking and spalling and will require localised repair along with full redecoration. Invasive vegetation has established itself along the external urinal wall and has grown into the window opening of the male WCs. The wall surface concealed behind this vegetation could not be viewed directly, but the render is considered likely to be compromised as a result of the plant growth.

**Recommendation: Repairs to West Elevation**

1. Remove cracked roughcast cement render from wall area above lean-to roof and allow for re-rendering with matching smooth window surrounds.
2. Remove all climbing vegetation from external wall to outdoor urinals (P01)
3. Allow for fluted coping stones to cap outdoor urinal walls and line through with impost band (as per Humber Cast Stone Fluted Wall Coping FWC900x300, sample TBC). Wall length approx. 5500mm. Allow for decoration.
4. Allow for localised making good and redecoration of west face of external wall to outdoor urinals once uncovered from vegetation removal.

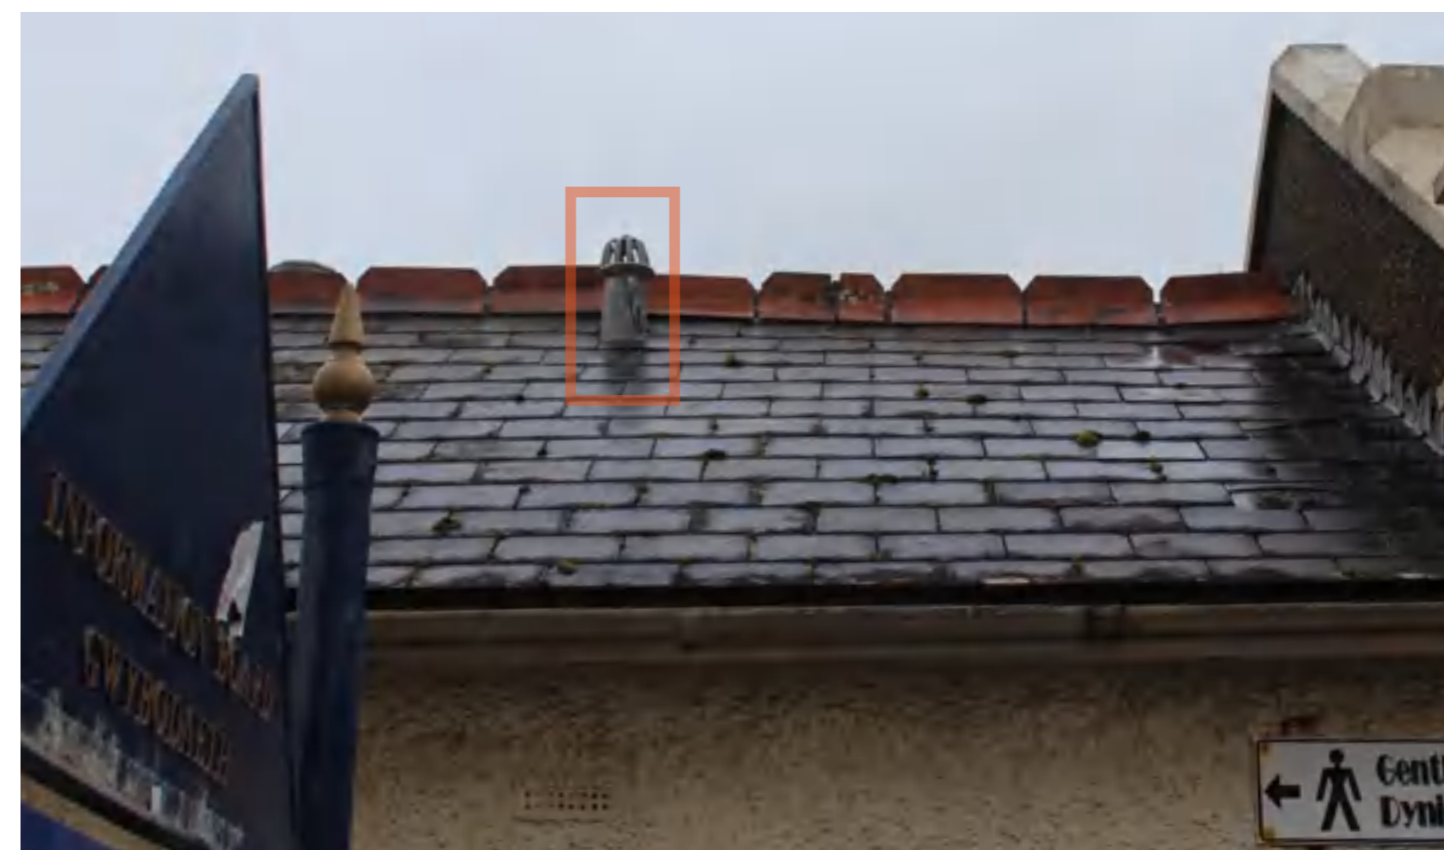
P01

The cast iron pipe is weatherproofed with a lead collar detail at roof level which is showing signs of deterioration although still functional. A presumed plastic cowl is mounted atop in good condition although not the most aesthetically appropriate for the building.

#### Recommendation: Repairs to Above Ground Drainage Systems

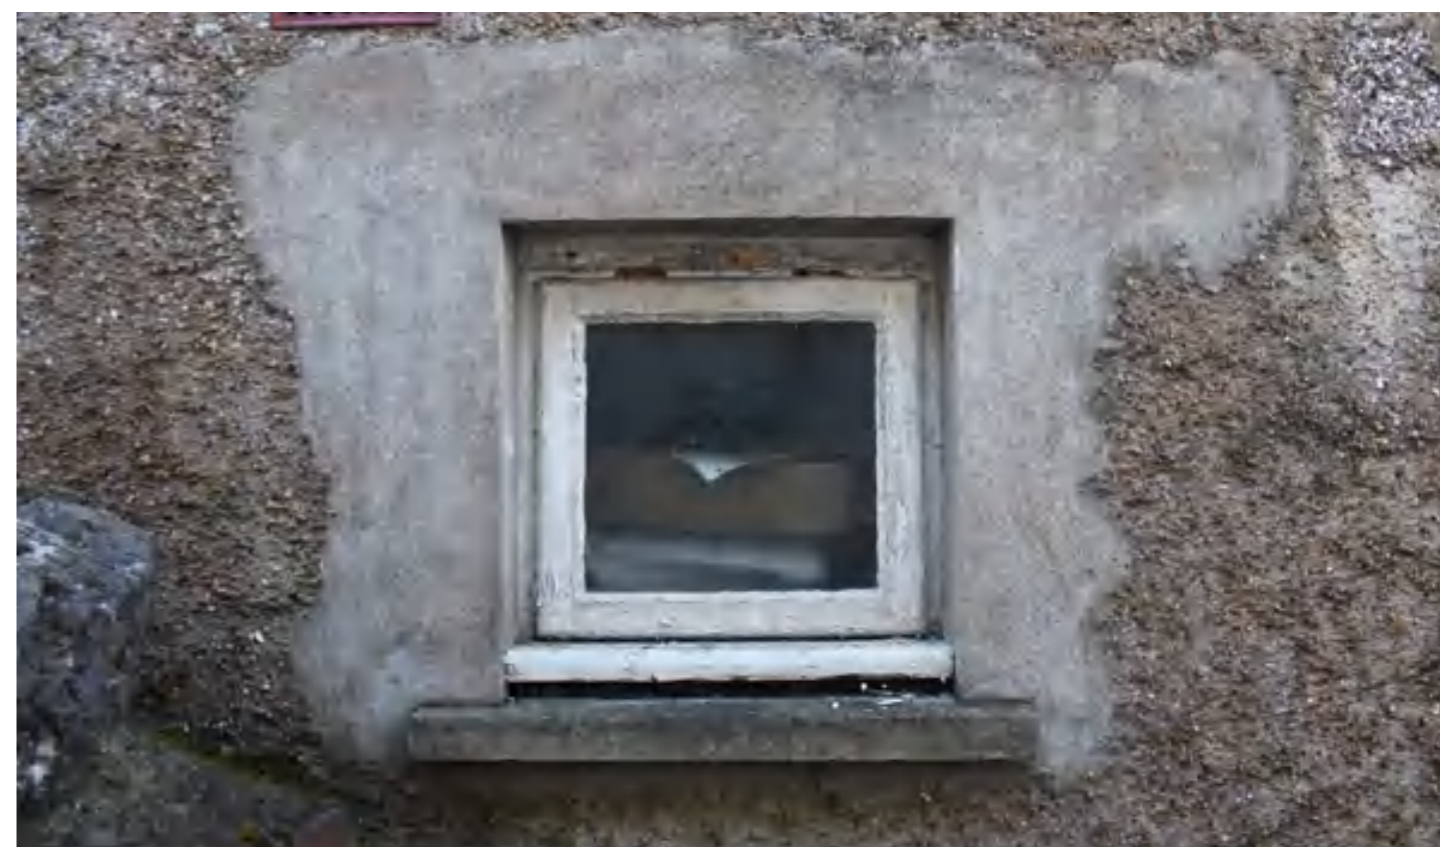
Extensive paint failure to all joinery, with the timber cill suffering from decay. Top hung butt hinges showing surface corrosion along with embedded fixings to the frame.

#### Recommendation: Repairs to Window 01

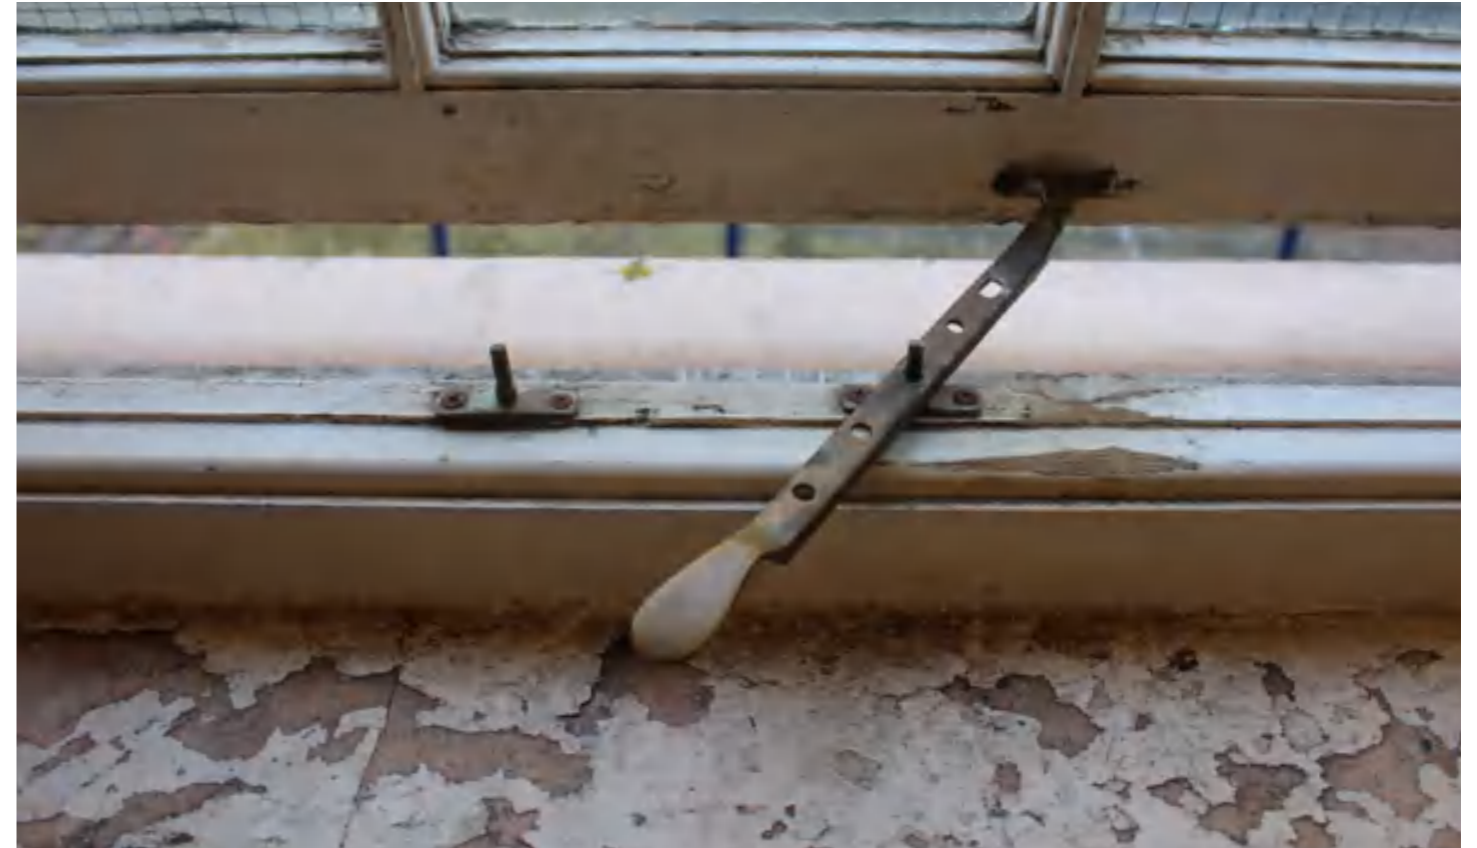
Window 06 - Typical Brass Stay and Localised Scarf Repairs to Stool

1. Typical existing brass casement window stays to remain and to be cleaned and polished.
2. Replace all screw fixings with stainless steel.
3. Allow for localised scarf repairs to all base rails of all windows in locations shown on photographs to the right, where damage has occurred from fastener operation
4. Allow for replacing weather seals.
5. Allow for new sealant between window frames and reveals.

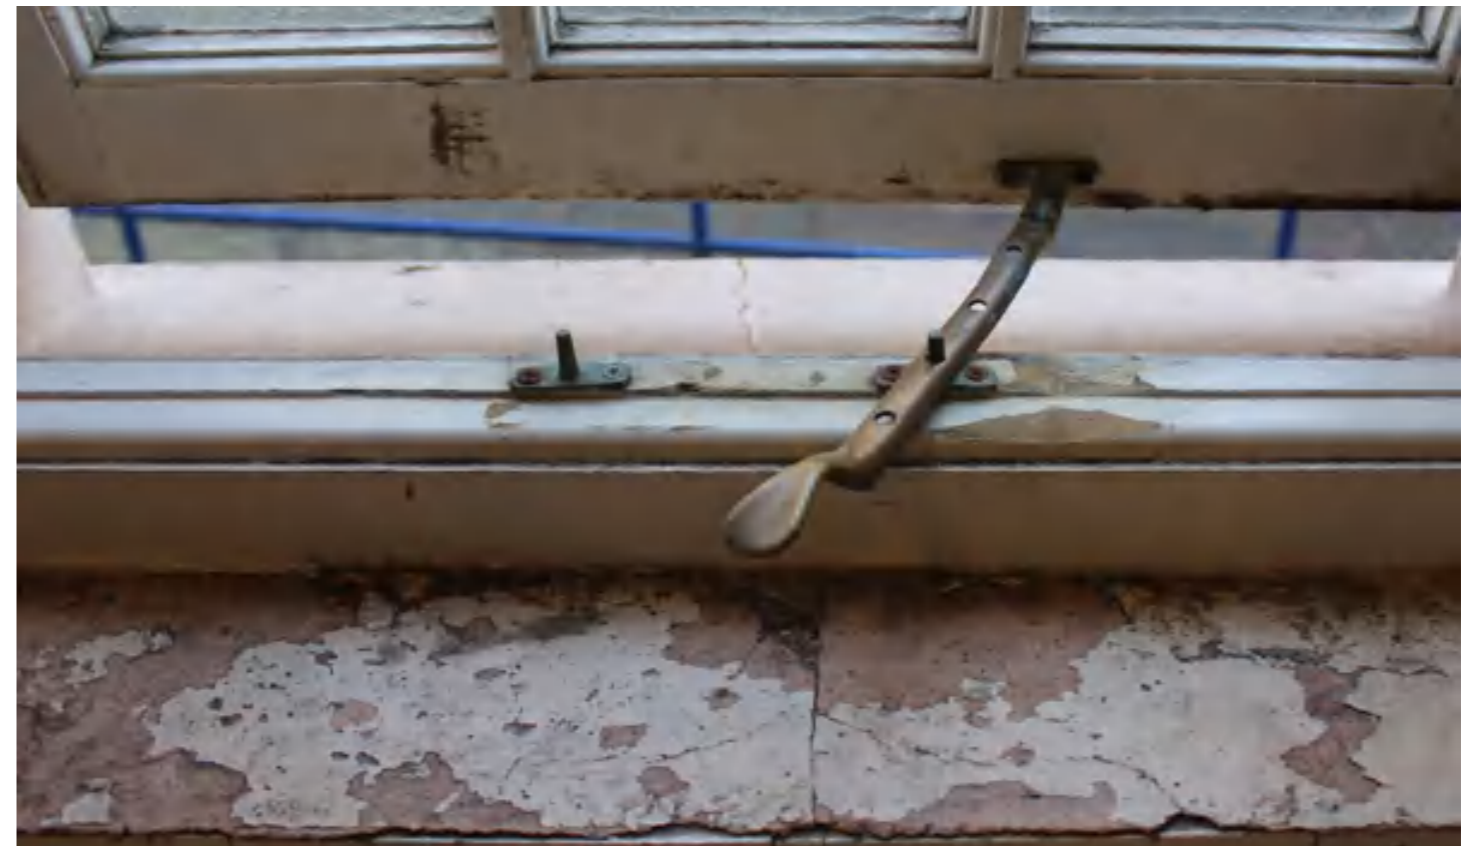
Window 07 - Typical Brass Stay and Localised Scarf Repairs to Stool

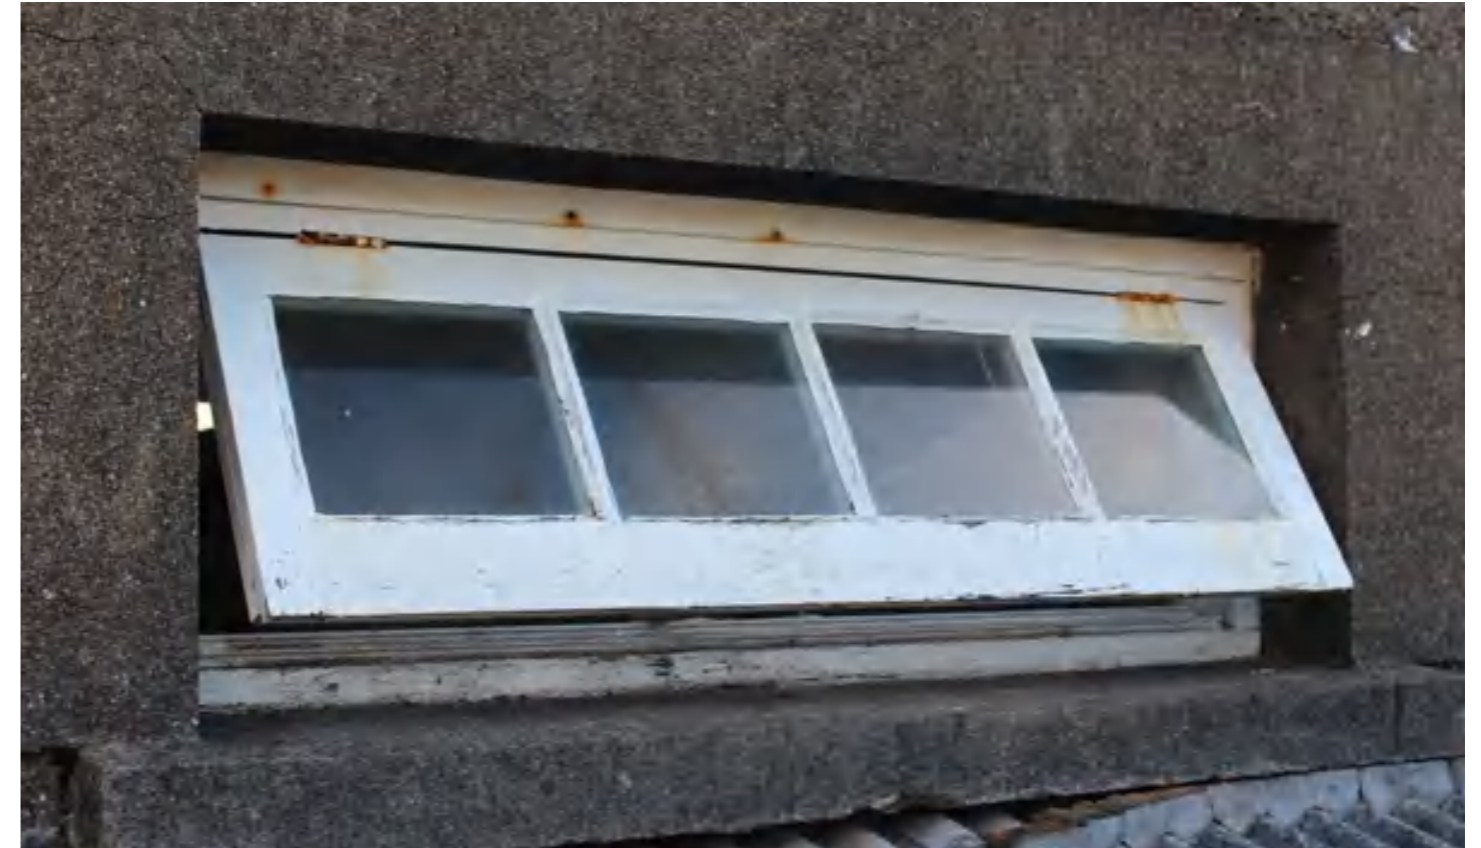
Window 12

Windows remain in operable condition, although exhibit age related weathering of decorative finishes and corrosion of both hinges and screw/nail fixings to frames.

**Recommendation: Repairs to Windows 012/13****Priority 2**

1. Rub down and remove all defective paint from the timber surfaces.
2. Remove operable light and hinges, allowing for new stainless steel top hung casement hinges.
3. Ease opening lights where tight or rubbing.
4. Retain all brass casement window stays and polish.
5. Investigate areas of corrosion to window frame and remove any embedded metal fixings. Allow for making good from any removal with timber scarfing if necessary.
6. Remove deteriorating glazing putty and provide new.
7. Provide new sealant between window linings and reveals.
8. Allow for full external and internal redecoration with Dulux Weathershield System, inclusive of preservative primer and top coat (Colour TBA)

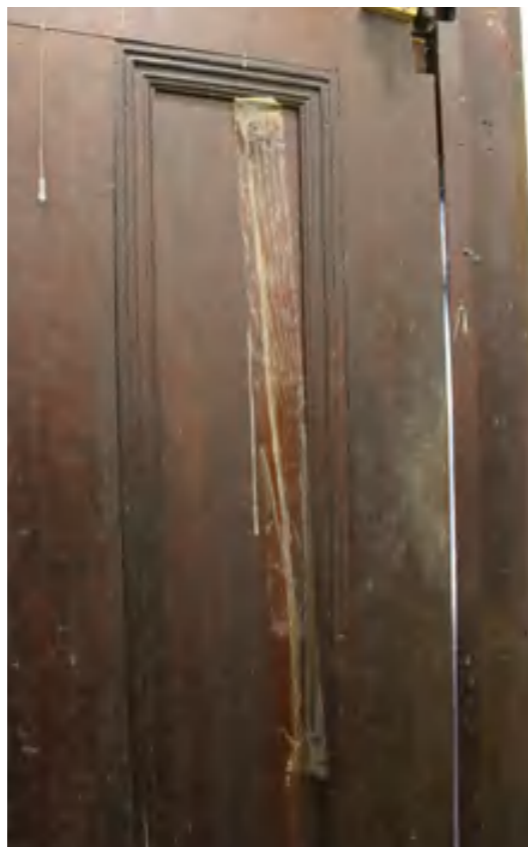
Door 13 Crack

**Recommendation: Refurbishment of Doors & Joinery to Male WCs**

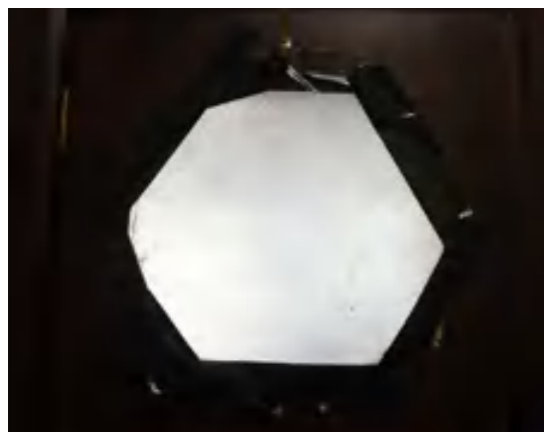
Door 13 Damaged Glazing

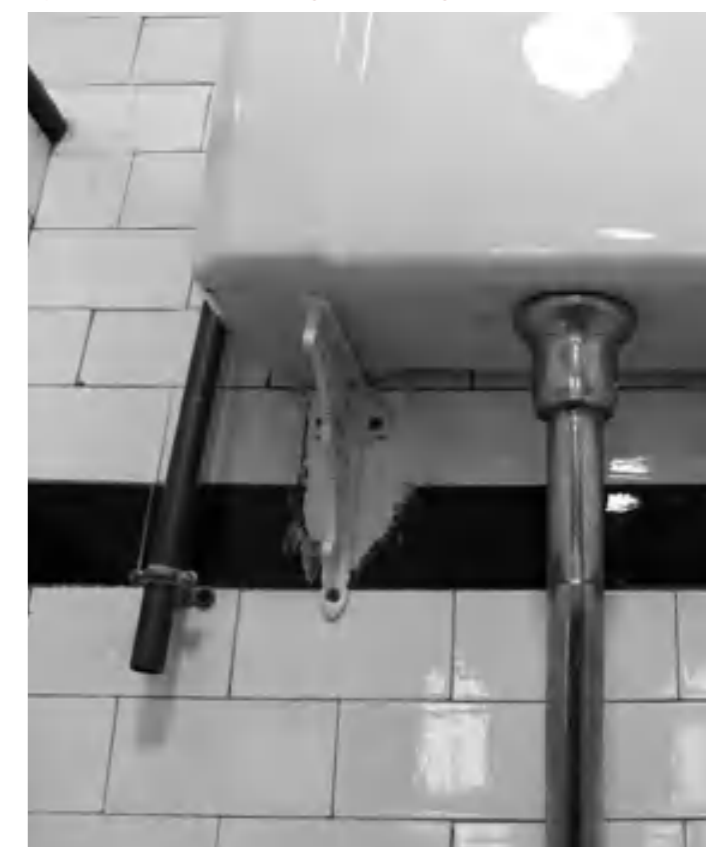
Typical Cistern Fixing / Damage
