Project Name: Porthcawl Public Conveniences
Project Description: Survey of existing drainage
Project Number: CLS/0609
Project Date: 30/10/2025
Inspection Standard: MSCC5 Sewers & Drainage GB (SRM5 Scoring)

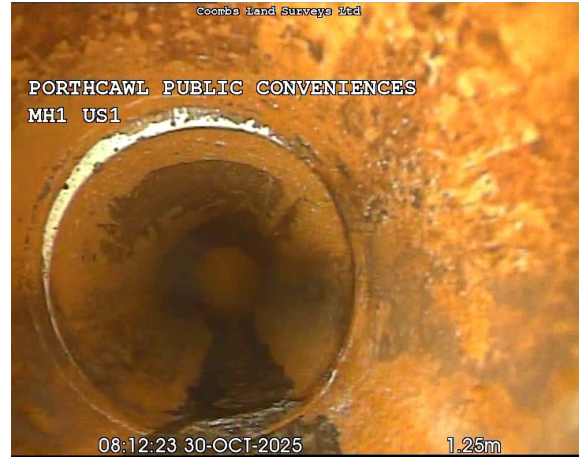
<table><tr> <td style="text-align: center;">0.00</td> <td style="text-align: center;">MH</td> <td>Start node, manhole, reference: MH1</td> <td style="text-align: center;">00:00:00</td> <td></td> <td></td> </tr><tr> <td style="text-align: center;">1.25</td> <td style="text-align: center;">CCJ</td> <td>Crack, circumferential at joint from 4 o'clock to 1 o'clock</td> <td style="text-align: center;">00:00:19</td> <td>MH1US1X_bb479cf7-1870-473</td> <td style="text-align: center;">2 / 2</td> </tr></table>

MH1US1X_bb479cf7-1870-4736-a41d-ca543cdf48cf_20251030_135346_717.jpg, 00:00:19, 1.25 m
 Crack, circumferential at joint from 4 o'clock to 1 o'clock

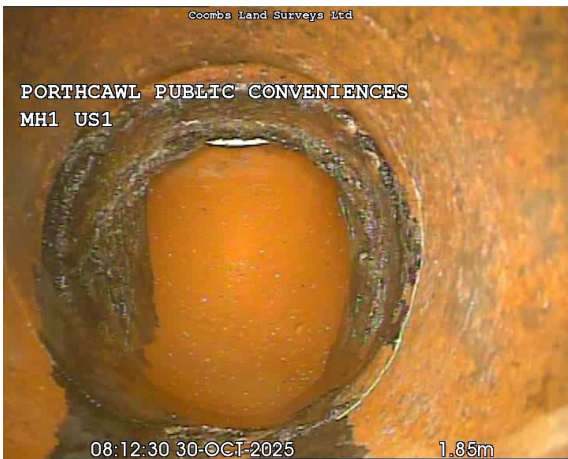
<table><tr> <td style="text-align: center;">0.00</td> <td style="text-align: center;">MH</td> <td>Start node, manhole, reference: MH1</td> <td style="text-align: center;">00:00:00</td> <td></td> <td></td> </tr><tr> <td style="text-align: center;">1.85</td> <td style="text-align: center;">CCJ</td> <td>Crack, circumferential at joint from 2 o'clock to 9 o'clock</td> <td style="text-align: center;">00:00:26</td> <td>MH1US1X_35d39d28-a6a5-42</td> <td style="text-align: center;">2 / 2</td> </tr></table>

MH1US1X_35d39d28-a6a5-4248-b4f1-657a1669a3c3_20251030_135424_152.jpg, 00:00:26, 1.85 m
 Crack, circumferential at joint from 2 o'clock to 9 o'clock

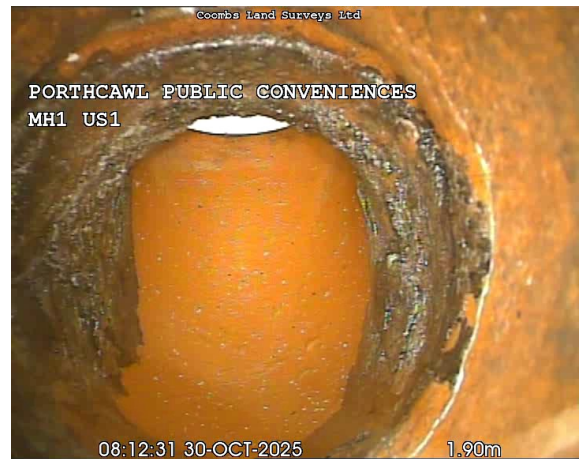
MH1US1X_39bca0f4-511e-4277-969b-f1764c5d47cf_20251030_140113_004.jpg, 00:00:28, 1.90 m
 Attached deposits, fouling from 12 o'clock to 12 o'clock, 5% cross-sectional area loss

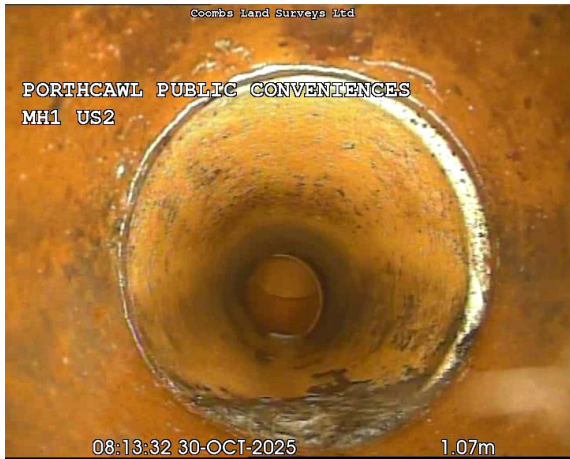
MH1US2X_ab9f18e7-a0e0-4689-b1db-4f3869930562_20251030_141103_704.jpg, 00:00:26, 1.07 m
 Crack, circumferential at joint from 7 o'clock to 2 o'clock

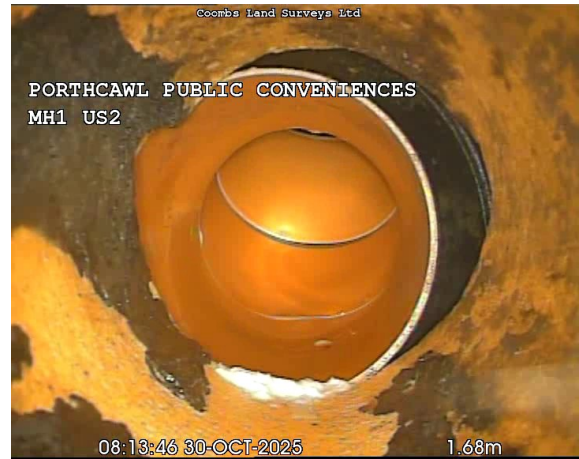
MH1US2X_0ad361e2-f698-4d57-a495-2d819d79bd3d_20251030_141315_944.jpg, 00:00:39, 1.68 m
 Point repair, pipe replaced from 12 o'clock to 12 o'clock, New pipe displaced but not open

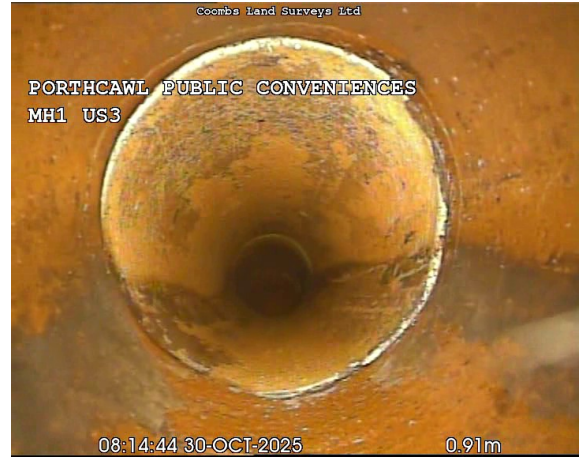
<table><tr> <td style="text-align: right;">0.00</td> <td>MH</td> <td>Start node, manhole, reference: MH1</td> <td>00:00:00</td> <td></td> <td></td> <td></td> </tr><tr> <td style="text-align: right;">0.90</td> <td>CCJ</td> <td>Crack, circumferential at joint from 9 o'clock to 3 o'clock</td> <td>00:00:17</td> <td>MH1US3X_7055dc70-6695-46</td> <td>2 / 2</td> <td></td> </tr></table>

MH1US3X_7055dc70-6695-46ab-b64e-ebad8ac8fc5d_20251030_141848_545.jpg, 00:00:17, 0.90 m
 Crack, circumferential at joint from 9 o'clock to 3 o'clock

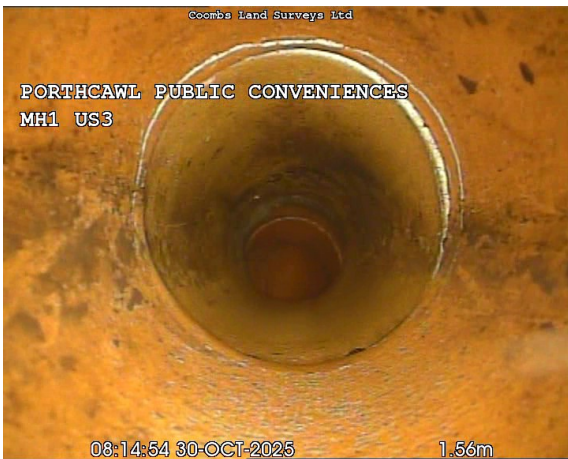
<table><tr> <td style="text-align: right;">0.00</td> <td>MH</td> <td>Start node, manhole, reference: MH1</td> <td>00:00:00</td> <td></td> <td></td> <td></td> </tr><tr> <td style="text-align: right;">1.56</td> <td>CCJ</td> <td>Crack, circumferential at joint from 9 o'clock to 4 o'clock</td> <td>00:00:27</td> <td>MH1US3X_18aac77-7de4-4c</td> <td>2 / 2</td> <td></td> </tr></table>

MH1US3X_18aabc77-7de4-4c1f-af0f-1b07af7aeefc_20251030_141937_026.jpg, 00:00:27, 1.56 m
 Crack, circumferential at joint from 9 o'clock to 4 o'clock

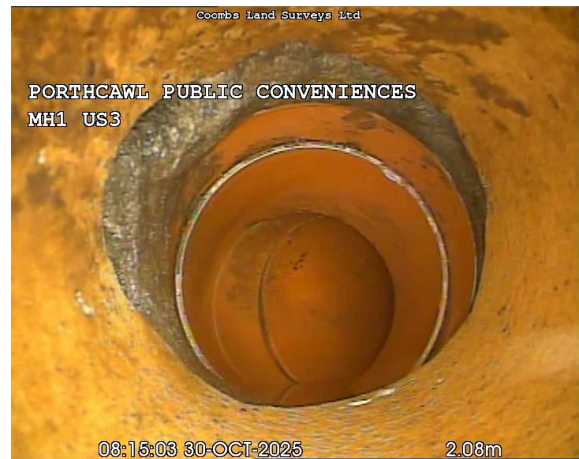
<table><tr> <td style="text-align: right;">0.00</td> <td>MH</td> <td>Start node, manhole, reference: MH1</td> <td>00:00:00</td> <td></td> <td></td> <td></td> </tr><tr> <td style="text-align: right;">2.08</td> <td>RPR</td> <td>Point repair, pipe replaced from 12 o'clock to 12 o'clock: New pipe displaced but not open</td> <td>00:00:36</td> <td>MH1US3X_f84c4ec4-59da-4a2</td> <td></td> <td></td> </tr></table>

MH1US3X_f84c4ec4-59da-4a26-b49e-df870da98231_20251030_142026_593.jpg, 00:00:36, 2.08 m
 Point repair, pipe replaced from 12 o'clock to 12 o'clock, New pipe displaced but not open

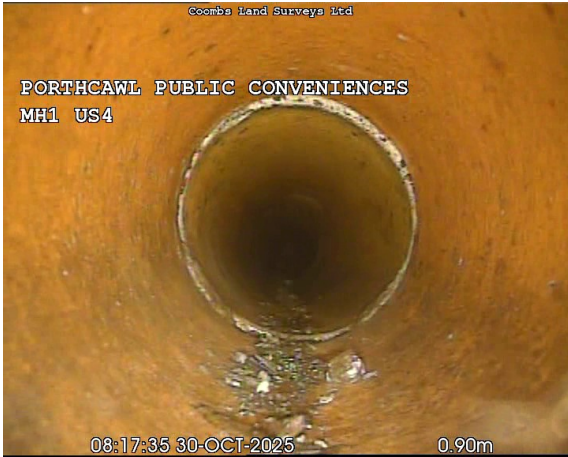
MH1US4X_a373b7c8-df1f-44d8-8cdb-fbb5e3582b5e_20251030_142704_142.jpg, 00:00:28, 0.90 m
Settled deposits, coarse, 5% cross-sectional area loss, start

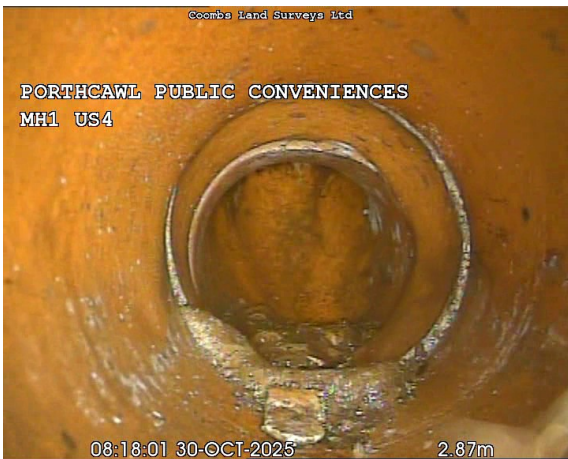
MH1US4X_1e7e6131-fb4d-4a00-9db6-0230afe08020_20251030_142839_440.jpg, 00:00:55, 2.87 m
Attached deposits, fouling at joint from 5 o'clock to 8 o'clock, 10% cross-sectional area loss

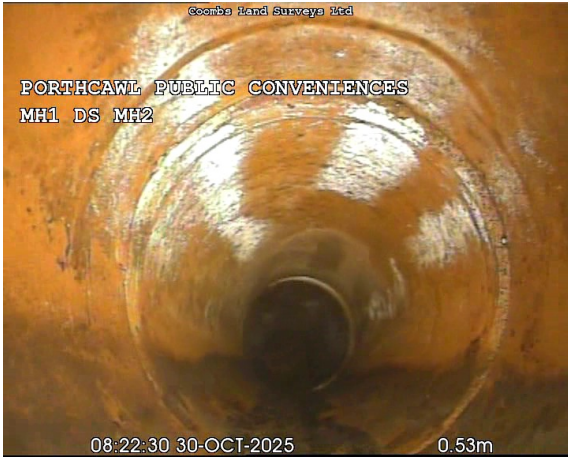
MH1X_64b42b8e-8778-4ea4-a00d-7cb4edd1c734_20251030_143350_153.jpg, 00:00:08, 0.53 m
Crack, circumferential at joint from 9 o'clock to 3 o'clock

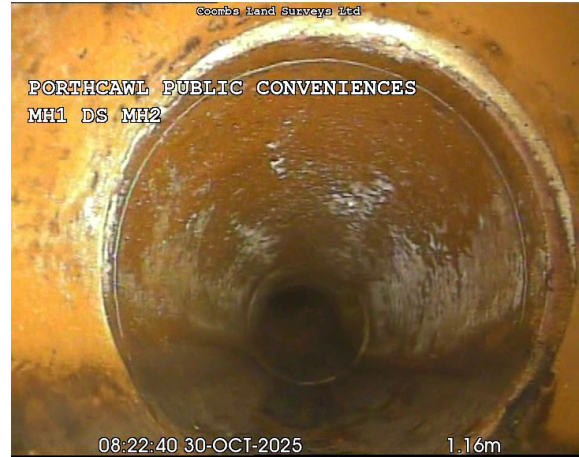
MH1X_d6316030-9abc-430a-a546-3e3af8964508_20251030_143422_601.jpg, 00:00:18, 1.16 m
Crack, circumferential at joint from 9 o'clock to 3 o'clock

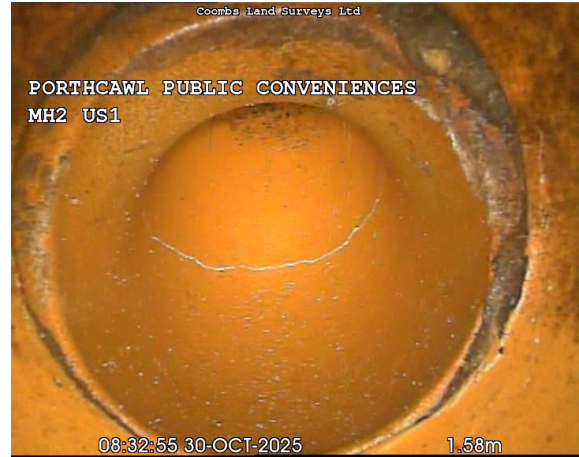
MH2US1X_f1b127c7-808b-45a2-bdb2-fd78384adb0e_20251030_144000_851.jpg, 00:00:40, 2.00 m
Crack, circumferential from 3 o'clock to 9 o'clock, Crack in soil pipe bend

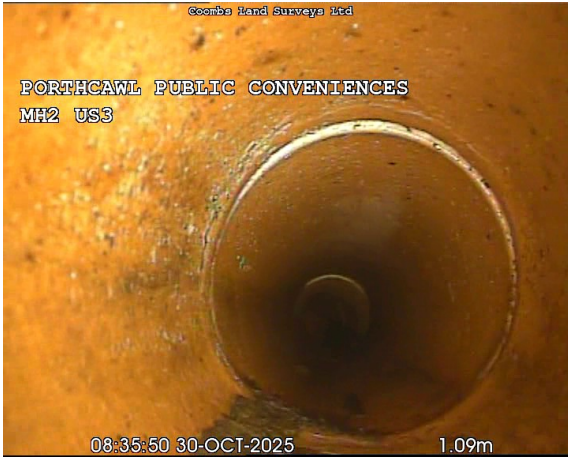
MH2US3X_89e84666-b551-404f-8aa7-d303a931c3de_20251030_150435_681.jpg, 00:00:08, 1.09 m
Crack, circumferential at joint from 9 o'clock to 2 o'clock

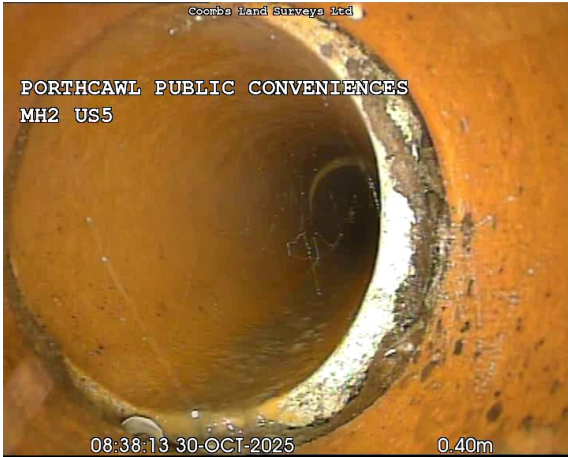
MH2US5X_044a7ba0-7c0d-473e-b719-53afab3cb3c7_20251
030_151028_344.jpg, 00:00:11, 0.40 m
Joint displaced, medium

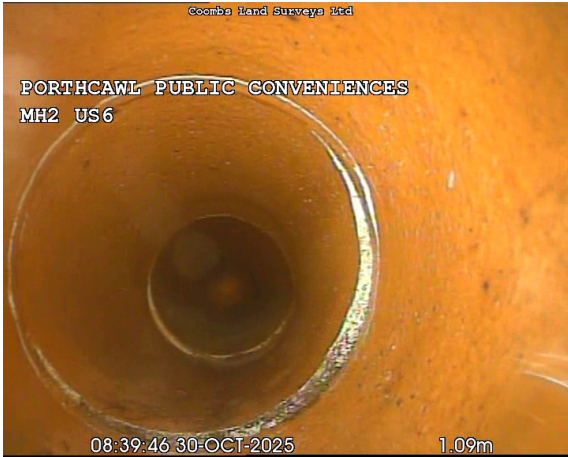
MH2US6X_b112e3bf-49e3-4884-bfa3-28048fc7a24f_20251030_151446_794.jpg, 00:00:14, 1.09 m
Crack, circumferential at joint from 12 o'clock to 12 o'clock

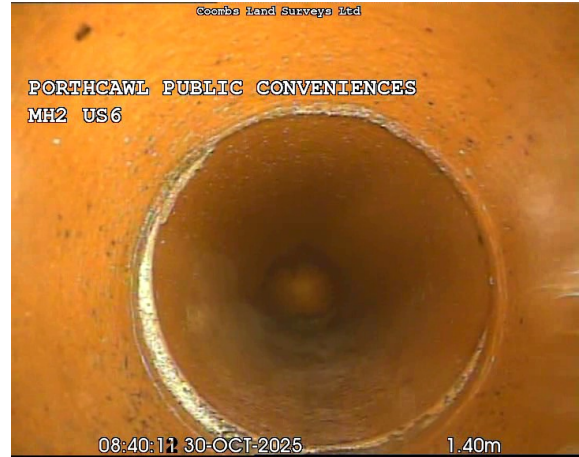
MH2US6X_da967db4-977d-42e5-b4fc-c4efc44c95ee_20251030_151539_701.jpg, 00:00:40, 1.40 m
Crack, circumferential at joint from 2 o'clock to 11 o'clock

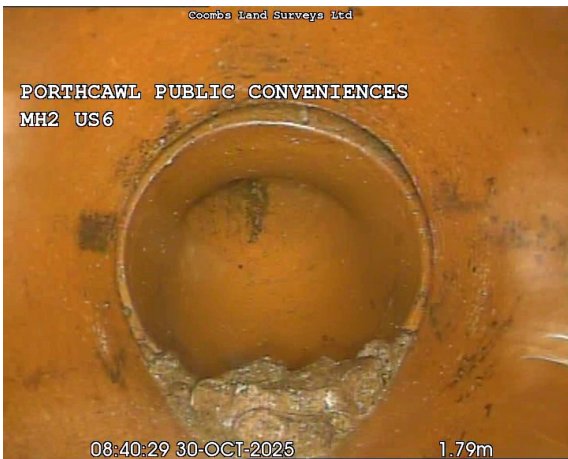
MH2US6X_23205f73-e479-4c4f-8782-7ee589f2acb6_20251030_151621_022.jpg, 00:00:58, 1.80 m
Attached deposits, fouling at joint from 5 o'clock to 7 o'clock, 15% cross-sectional area loss

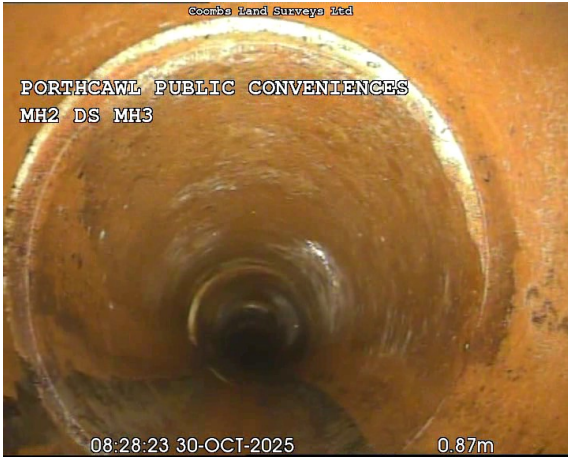
MH2X_fbfb30b6-0317-43e1-89d0-3bdf7efc708d_20251030_152116_464.jpg, 00:00:34, 0.87 m
 Crack, circumferential at joint from 3 o'clock to 1 o'clock

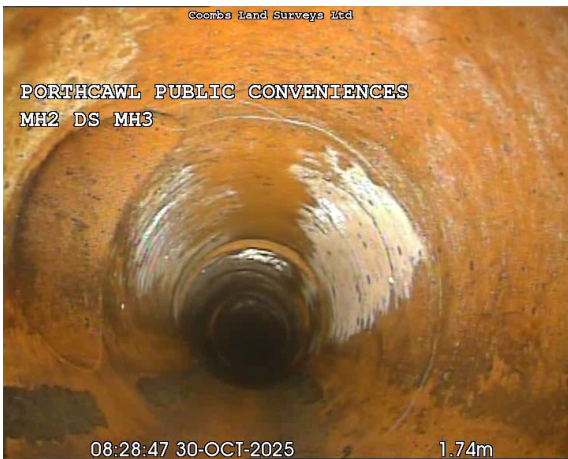
MH2X_b2e7adbb-e48d-4bf4-a58c-0502e74da5db_20251030_152841_927.jpg, 00:00:58, 1.74 m
 Crack, circumferential from 11 o'clock to 5 o'clock

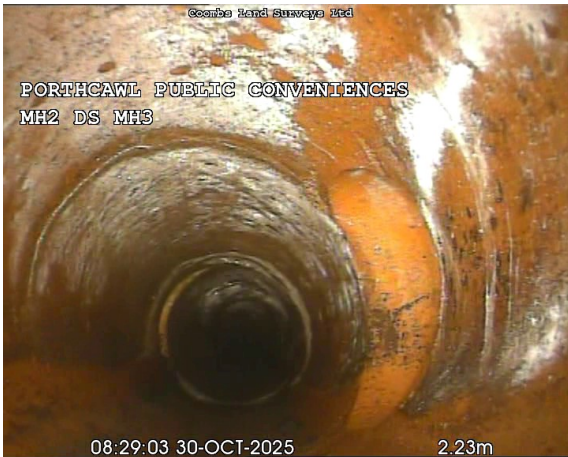
MH2X_dba9821f-c952-4f46-9e11-0361ac2a3d84_20251030_153017_552.jpg, 00:01:14, 2.23 m
Crack, circumferential from 9 o'clock to 2 o'clock

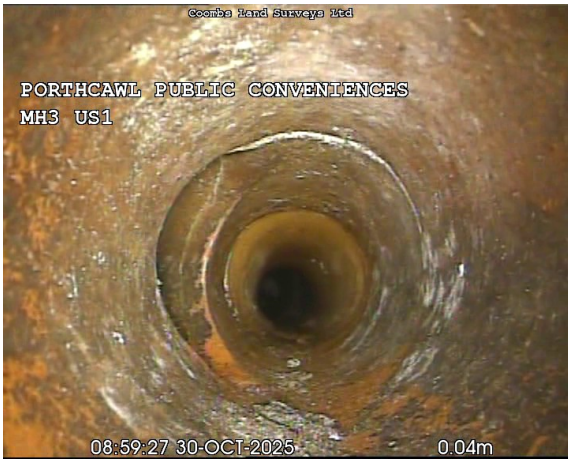
Section	PLR	Grade	Description
12	MH3US1X	3	Fracture, circumferential from 11 o'clock to 3 o'clock
17	MH4US2X	4	Hole in drain or sewer at 1 o'clock

<table><tr> <td style="width: 10%;">0.00</td> <td style="width: 10%;">MH</td> <td style="width: 40%;">Start node, manhole, reference: MH3</td> <td style="width: 10%;">00:00:00</td> <td></td> <td></td> </tr><tr> <td style="color: red;">0.20</td> <td style="color: red;">FC</td> <td style="color: red;">Fracture, circumferential from 11 o'clock to 3 o'clock</td> <td style="color: red;">00:00:04</td> <td style="color: red;">MH3US1X_74de2e3a-2ff8-42c</td> <td style="color: red;">3 / 2</td> </tr></table>

MH3US1X_74de2e3a-2ff8-42c5-b4c9-5148ae7bae50_20251030_154937_906.jpg, 00:00:04, 0.20 m
Fracture, circumferential from 11 o'clock to 3 o'clock

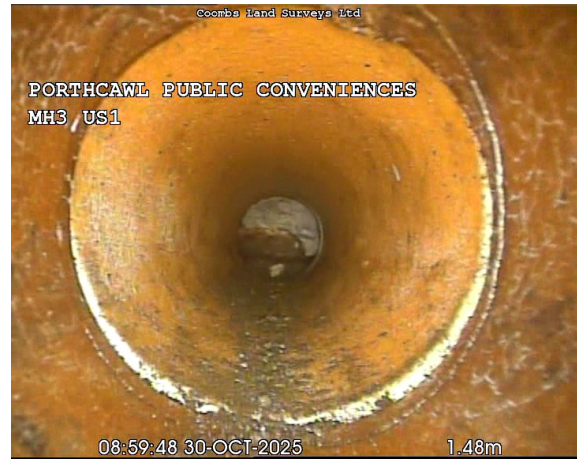
<table><tr> <td style="width: 10%;">0.00</td> <td style="width: 10%;">MH</td> <td style="width: 40%;">Start node, manhole, reference: MH3</td> <td style="width: 10%;">00:00:00</td> <td></td> <td></td> </tr><tr> <td style="color: red;">1.48</td> <td style="color: red;">CCJ</td> <td style="color: red;">Crack, circumferential at joint from 12 o'clock to 8 o'clock</td> <td style="color: red;">00:00:25</td> <td style="color: red;">MH3US1X_bfcb32a5-432b-453</td> <td style="color: red;">2 / 2</td> </tr></table>

MH3US1X_bfcb32a5-432b-4533-b03e-1a2966a8b1a5_20251030_155128_573.jpg, 00:00:25, 1.48 m
Crack, circumferential at joint from 12 o'clock to 8 o'clock

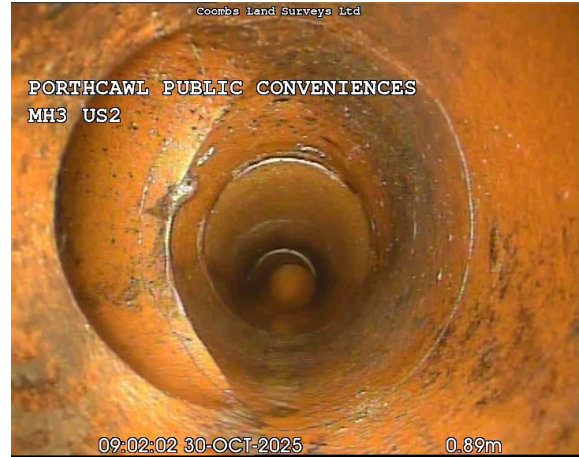
MH3US2X_6fcf7c1a-bb80-43db-8e49-3b5e8115a976_20251030_155627_672.jpg, 00:00:14, 0.89 m
 Crack, circumferential from 11 o'clock to 6 o'clock

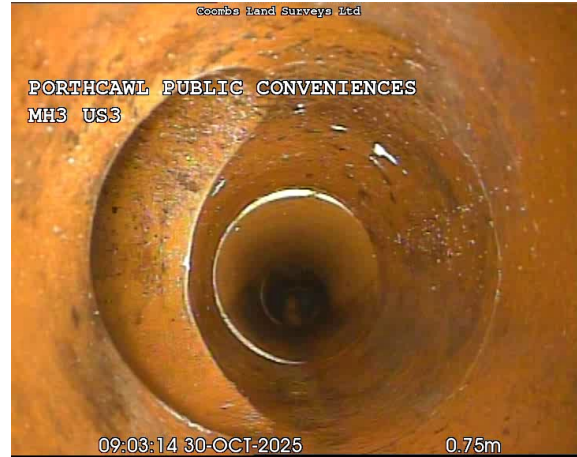
MH3US3X_e4f246da-fd53-46d9-bf61-c72d68cffbd9_20251030_160012_152.jpg, 00:00:07, 0.75 m
Crack, circumferential from 11 o'clock to 6 o'clock

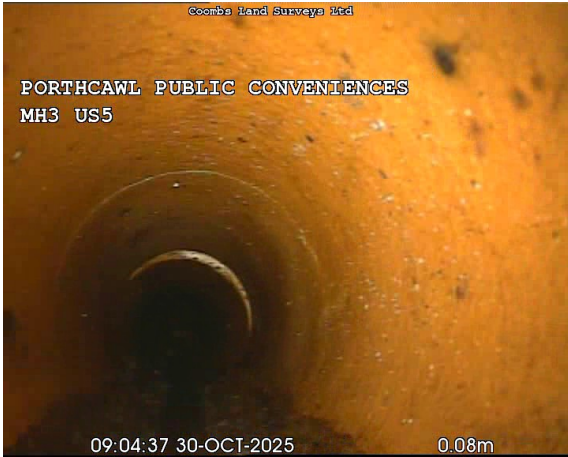
MH3US5X_462c77bc-30c1-4a98-b1bd-36cdeedc973d_20251
030_160336_884.jpg, 00:00:03, 0.20 m
Crack, circumferential from 9 o'clock to 3 o'clock

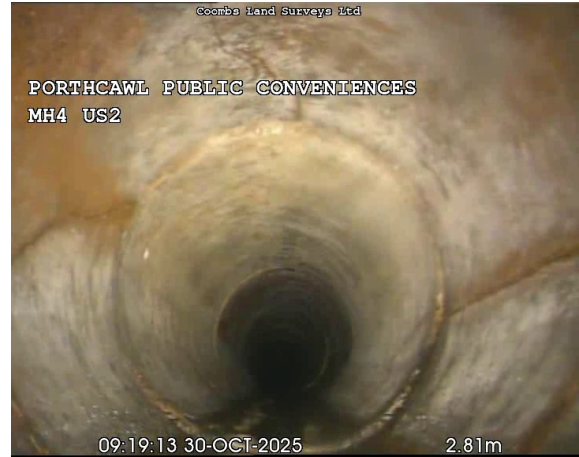
MH4US2X_76ce77ee-adeb-47fb-8121-9e37b45ba4fd_20251031_090701_052.jpg, 00:00:24, 2.81 m
 Crack, longitudinal at joint at 9 o'clock

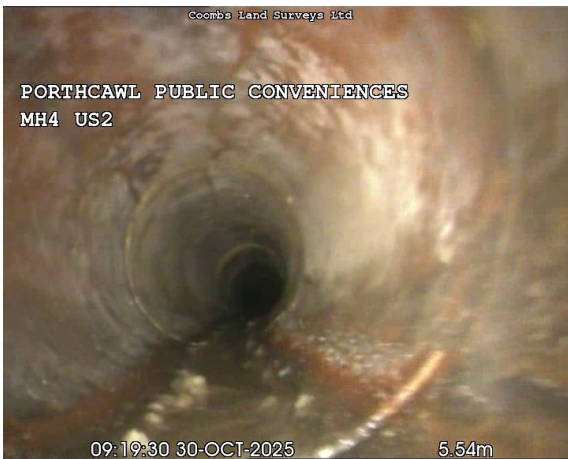
MH4US2X_31183ad8-1d3a-4356-8b02-1c927edcfb64_20251031_091614_018.jpg, 00:00:41, 5.54 m
 Crack, longitudinal at joint at 12 o'clock

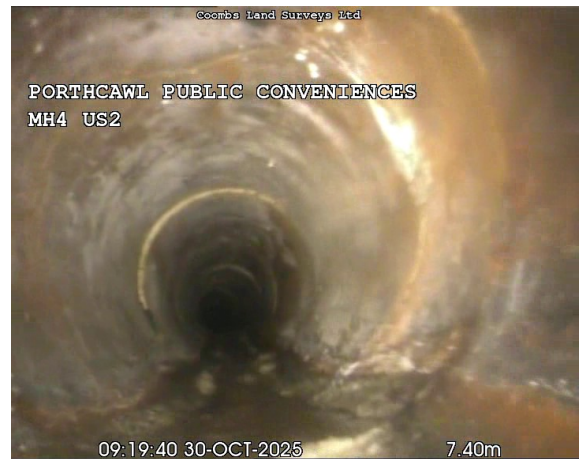
MH4US2X_a3898dd6-da3d-4d50-812a-dec2928405b5_20251031_091650_360.jpg, 00:00:52, 7.40 m
 Crack, circumferential from 7 o'clock to 5 o'clock

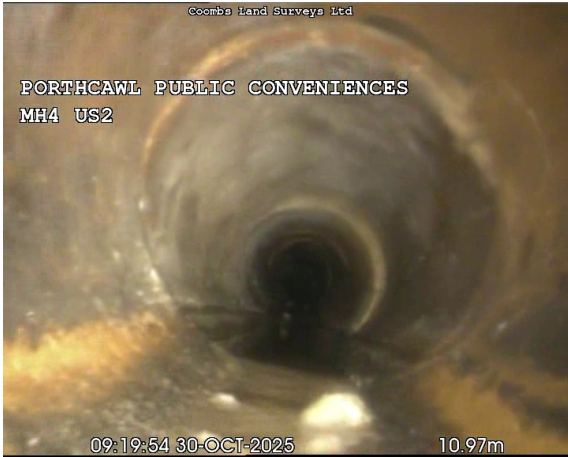
MH4US2X_ee0d96a3-61f4-4664-8a7f-cfd22c26969d_20251031_091751_040.jpg, 00:01:06, 10.97 m
 Hole in drain or sewer at 1 o'clock

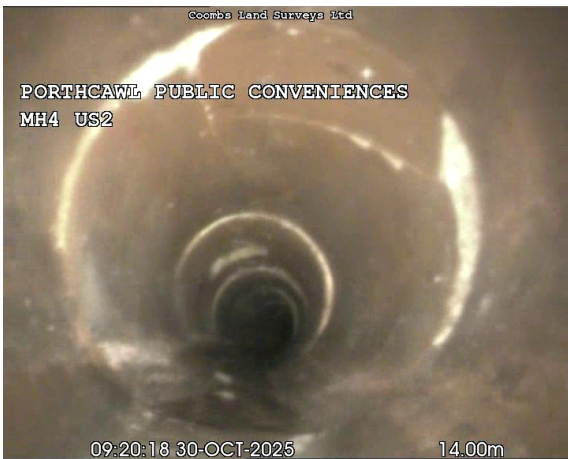
MH4US2X_5001f75c-b014-46ec-9a17-83cf11271024_20251031_091920_851.jpg, 00:01:30, 14.00 m
 Cracks, multiple at joint from 11 o'clock to 3 o'clock

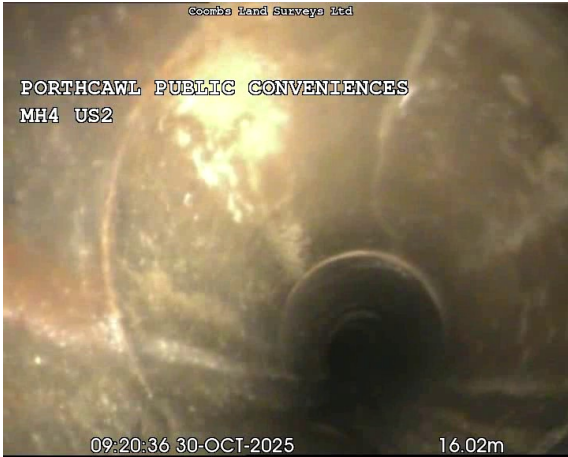
MH4US2X_8f7ae233-c6f9-4b44-b1de-da72e3b17c72_20251031_092104_735.jpg, 00:01:47, 16.02 m
Crack, longitudinal at 12 o'clock
