Roof Condition Report

Project:
Llwynderw Flats

Project ID: SP157083
Date of issue: 20/05/2026

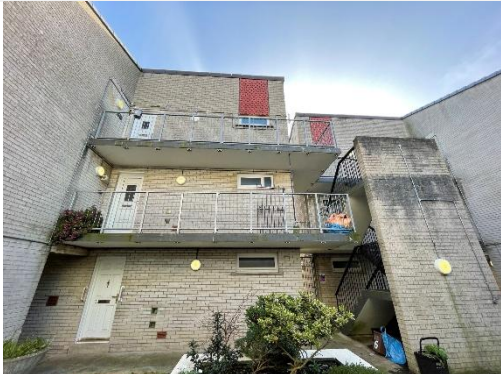
Overview of the balcony area. The system is no longer providing adequate protection.

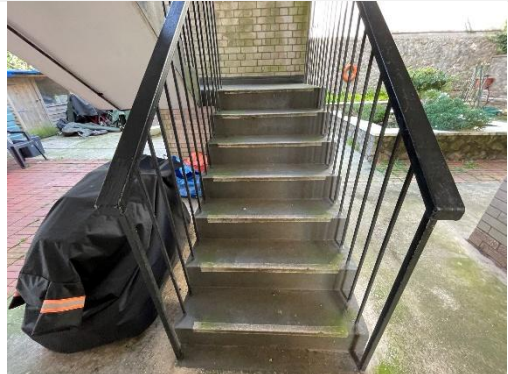
Overview of the staircase. The edge of the stairs shall be coated in yellow.

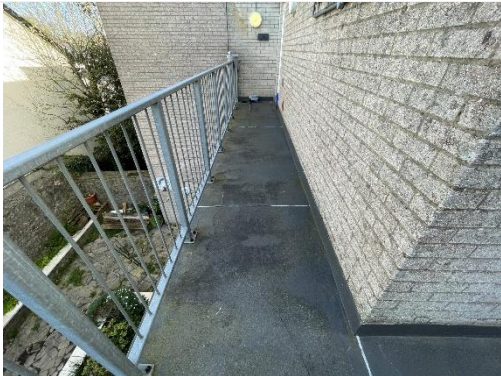
Further overview of the balcony area. The waterproofing system has reached the end of its serviceable life.

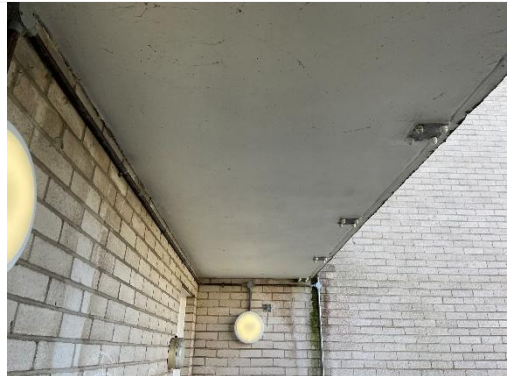
Overview of the concrete deck below the balcony areas.

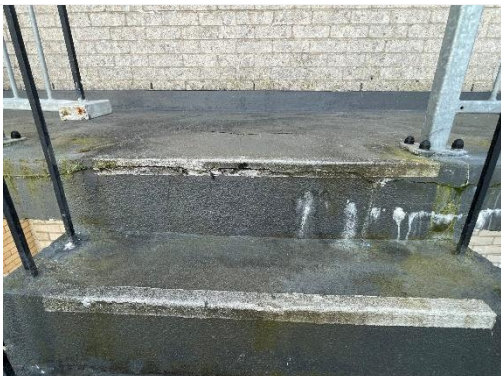
The damaged sections of concrete will need to be repaired.

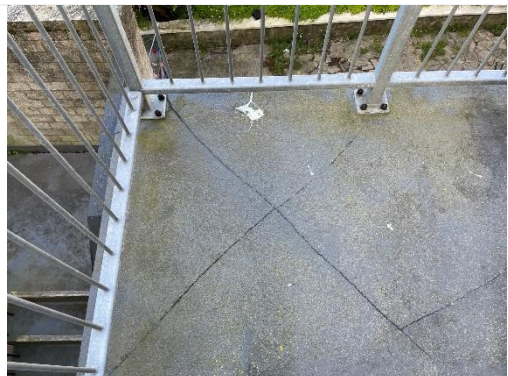
We identified large cracks, throughout the system. These sections will need to be stripped back to the concrete deck and repaired.

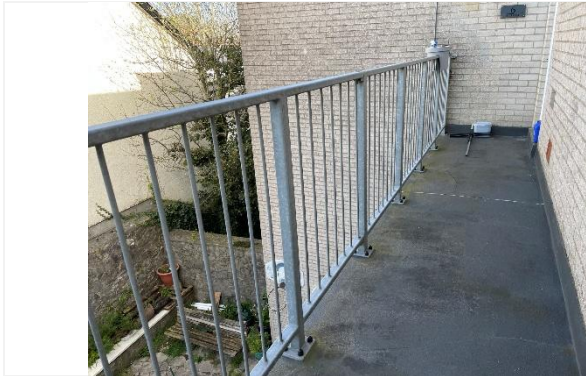
Handrail has been fixed through the concrete balcony; therefore, it shall remain in situ. The handrail is 1.1m which complies with current regulations.

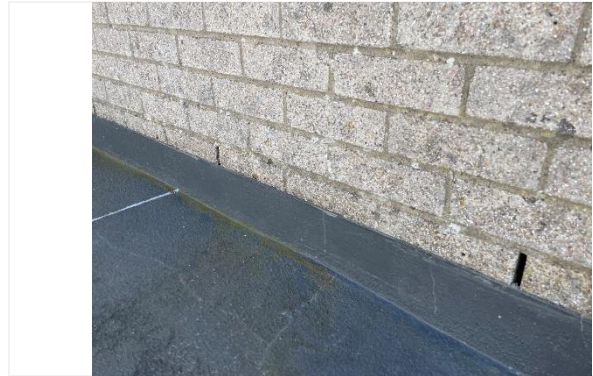
Cavity trays will not be affected by the installation of the new waterproofing system. They shall be reformed and cleaned as part of the scope of works.
