Management Asbestos Survey

Ysgol Maes Owen
Morfa Avenue
Towyn
Abergele
LL18 5LE

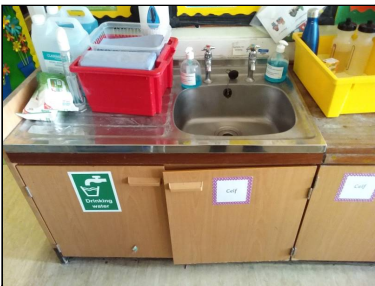
Inspection No. 1

Survey Date:	Lead Surveyor	Survey Type	Floor	Analysis
	08 Mar 2022	James Doherty, Shaun Doherty	Management Survey	Ground Floor	No Asbestos Detected
	Building	Room	Item	Quantity	
	Ysgol Maes Owen	Class B006	Sink pad to underside of sink.	<1m ²	
	Sample No (S,SP,P,As)	Product Type	Surface Treatment	Condition	Accessibility
	NE002635 (S)	N/A	N/A	N/A	N/A
	Material Risk Score				
Recommended action		No further action required			
Surveyor comments		N/A

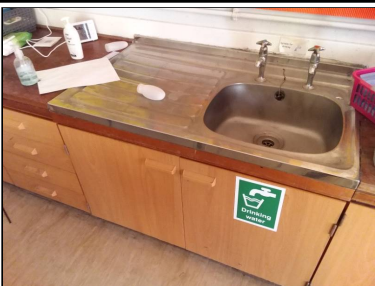
Inspection No. 2

Survey Date:	Lead Surveyor	Survey Type	Floor	Analysis
	08 Mar 2022	James Doherty, Shaun Doherty	Management Survey	Ground Floor	No Asbestos Detected
	Building	Room	Item	Quantity	
	Ysgol Maes Owen	Class B010	Sink pad to underside of sink.	<1m ²	
	Sample No (S,SP,P,As)	Product Type	Surface Treatment	Condition	Accessibility
	As NE002635 (SP)	N/A	N/A	N/A	N/A
	Material Risk Score				
Recommended action		No further action required			
Surveyor comments		N/A

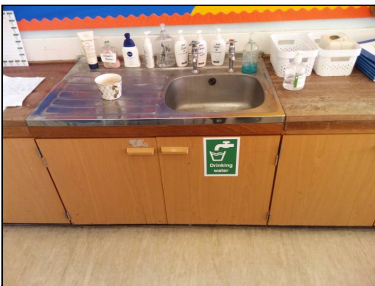
Survey Date:	Lead Surveyor	Survey Type	Floor	Analysis
	08 Mar 2022	James Doherty, Shaun Doherty	Management Survey	Ground Floor	No Asbestos Detected
	Building	Room	Item	Quantity	
	Ysgol Maes Owen	Class B012	Sink pad to underside of sink.	<1m ²	
	Sample No (S,SP,P,As)	Product Type	Surface Treatment	Condition	Accessibility
	As NE002635 (SP)	N/A	N/A	N/A	N/A
	Material Risk Score				
Recommended action		No further action required			
Surveyor comments		N/A

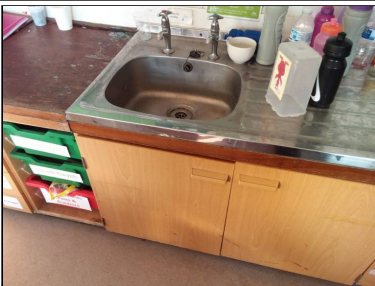
Survey Date:	Lead Surveyor	Survey Type	Floor	Analysis
	08 Mar 2022	James Doherty, Shaun Doherty	Management Survey	Ground Floor	No Asbestos Detected
	Building	Room	Item	Quantity	
	Ysgol Maes Owen	Class B015	Sink pad to underside of sink.	<1m ²	
	Sample No (S,SP,P,As)	Product Type	Surface Treatment	Condition	Accessibility
	As NE002635 (SP)	N/A	N/A	N/A	N/A
	Material Risk Score				
Recommended action		No further action required			
Surveyor comments		N/A

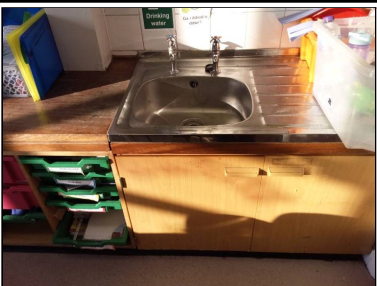
Survey Date:	Lead Surveyor	Survey Type	Floor	Analysis
	08 Mar 2022	James Doherty, Shaun Doherty	Management Survey	Ground Floor	No Asbestos Detected
	Building	Room	Item	Quantity	
	Ysgol Maes Owen	Class B017	Sink pad to underside of sink.	<1m ²	Accessibility
	Sample No (S,SP,P,As)	Product Type	Surface Treatment	Condition	
	As NE002635 (SP)	N/A	N/A	N/A	N/A
	Material Risk Score				
Recommended action		No further action required			
Surveyor comments		N/A

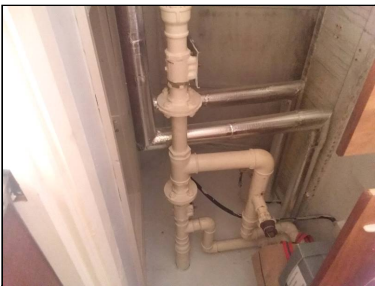
Survey Date:	Lead Surveyor	Survey Type	Floor	Analysis
	08 Mar 2022	James Doherty, Shaun Doherty	Management Survey	Ground Floor	Chrysotile (1)
	Building	Room	Item	Quantity	
	Ysgol Maes Owen	Store B019	Gaskets to pipework.	<1m ²	
	Sample No (S,SP,P,As)	Product Type	Surface Treatment	Condition	Accessibility
	Visual (P)	Gasket (2)	Surface Sealed (1)	Low Damage (1)	Usually inaccessible or unlikely to be disturbed
	Material Risk Score				
5					
Recommended action		Manage			
Surveyor comments		No safe access from ladders to sample.

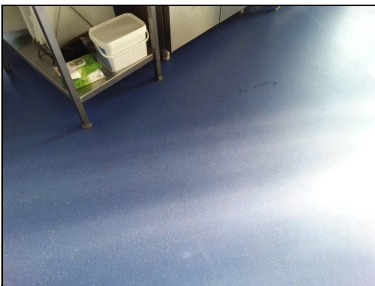
Survey Date:	Lead Surveyor	Survey Type	Floor	Analysis
	08 Mar 2022	James Doherty, Shaun Doherty	Management Survey	Ground Floor	N/A
	Building	Room	Item	Quantity	
	Ysgol Maes Owen	Kitchen B064	Fitted modern altro flooring not accessed below to prevent damage.	N/A	
	Sample No (S,SP,P,As)	Product Type	Surface Treatment	Condition	Accessibility
	Visual (P)	N/A	N/A	N/A	N/A
	Material Risk Score				
Recommended action		Inspection Required			
Surveyor comments		N/A

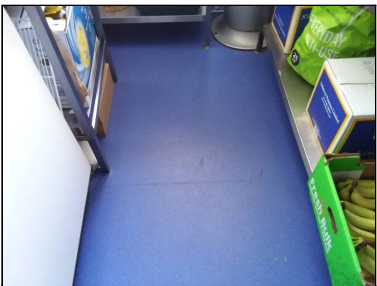
Survey Date:	Lead Surveyor	Survey Type	Floor	Analysis
	08 Mar 2022	James Doherty, Shaun Doherty	Management Survey	Ground Floor	N/A
	Building	Room	Item	Quantity	
	Ysgol Maes Owen	Store B065	Fitted modern altro flooring not accessed below to prevent damage.	N/A	
	Sample No (S,SP,P,As)	Product Type	Surface Treatment	Condition	Accessibility
	Visual (P)	N/A	N/A	N/A	N/A
	Material Risk Score				
Recommended action		Inspection Required			
Surveyor comments		N/A

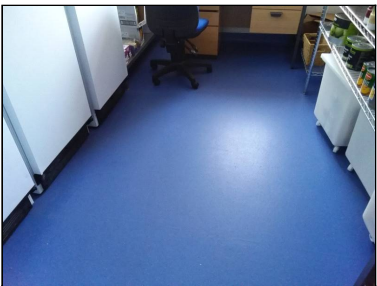
Survey Date:	Lead Surveyor	Survey Type	Floor	Analysis
	08 Mar 2022	James Doherty, Shaun Doherty	Management Survey	Ground Floor	N/A
	Building	Room	Item	Quantity	
	Ysgol Maes Owen	Store B069	Fitted modern altro flooring not accessed below to prevent damage.	N/A	
	Sample No (S,SP,P,As)	Product Type	Surface Treatment	Condition	Accessibility
	Visual (P)	N/A	N/A	N/A	N/A
	Material Risk Score				
Recommended action		Inspection Required			
Surveyor comments		N/A

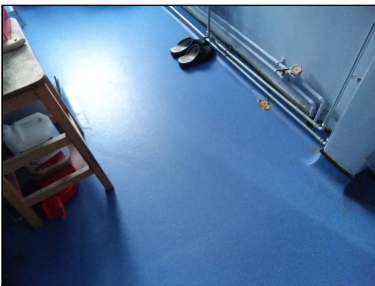
Survey Date:	Lead Surveyor	Survey Type	Floor	Analysis
	08 Mar 2022	James Doherty, Shaun Doherty	Management Survey	Ground Floor	N/A
	Building	Room	Item	Quantity	
	Ysgol Maes Owen	Toilet B068	Fitted modern altro flooring not accessed below to prevent damage.	N/A	
	Sample No (S,SP,P,As)	Product Type	Surface Treatment	Condition	Accessibility
	Visual (P)	N/A	N/A	N/A	N/A
	Material Risk Score				
Recommended action		Inspection Required			
Surveyor comments		N/A

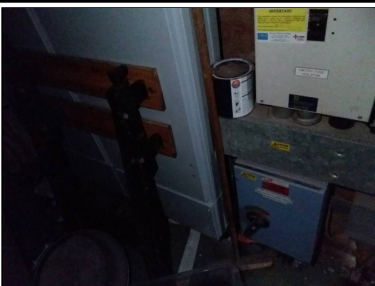
Survey Date:	Lead Surveyor	Survey Type	Floor	Analysis
	08 Mar 2022	James Doherty, Shaun Doherty	Management Survey	Ground Floor	N/A
	Building	Room	Item	Quantity	
	Ysgol Maes Owen	Mains Cupboard B066	Electrics not accessed within as services remain live.	N/A	
	Sample No (S,SP,P,As)	Product Type	Surface Treatment	Condition	Accessibility
	Visual (P)	N/A	N/A	N/A	N/A
	Material Risk Score				
Recommended action		Inspection Required			
Surveyor comments		N/A

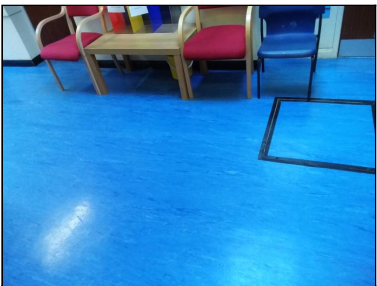
Survey Date:	Lead Surveyor	Survey Type	Floor	Analysis
	08 Mar 2022	James Doherty, Shaun Doherty	Management Survey	Ground Floor	N/A
	Building	Room	Item	Quantity	
	Ysgol Maes Owen	Corridor B002	Fitted modern altro flooring not accessed below to prevent damage.	N/A	
	Sample No (S,SP,P,As)	Product Type	Surface Treatment	Condition	Accessibility
	Visual (P)	N/A	N/A	N/A	N/A
	Material Risk Score				
Recommended action		Inspection Required			
Surveyor comments		N/A

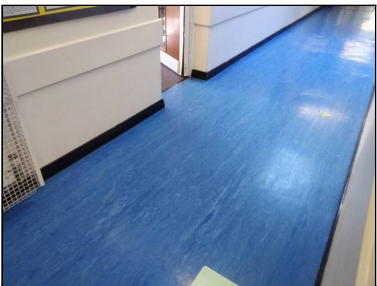
Survey Date:	Lead Surveyor	Survey Type	Floor	Analysis
	08 Mar 2022	James Doherty, Shaun Doherty	Management Survey	Ground Floor	N/A
	Building	Room	Item	Quantity	
	Ysgol Maes Owen	Corridor B005	Fitted modern altro flooring not accessed below to prevent damage.	N/A	
	Sample No (S,SP,P,As)	Product Type	Surface Treatment	Condition	Accessibility
	Visual (P)	N/A	N/A	N/A	N/A
	Material Risk Score				
Recommended action		Inspection Required			
Surveyor comments		N/A

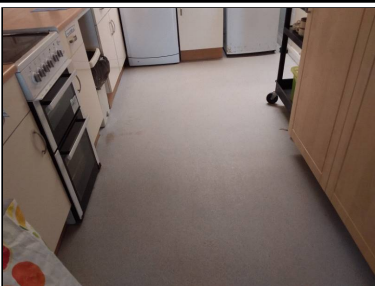
Survey Date:	Lead Surveyor	Survey Type	Floor	Analysis
	08 Mar 2022	James Doherty, Shaun Doherty	Management Survey	Ground Floor	N/A
	Building	Room	Item	Quantity	
	Ysgol Maes Owen	Kitchen B051	Fitted modern altro flooring not accessed below to prevent damage.	N/A	
	Sample No (S,SP,P,As)	Product Type	Surface Treatment	Condition	Accessibility
	Visual (P)	N/A	N/A	N/A	N/A
	Material Risk Score				
Recommended action		Inspection Required			
Surveyor comments		N/A

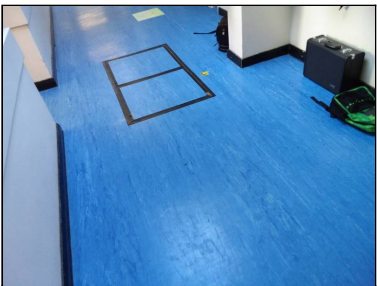
Survey Date:	Lead Surveyor	Survey Type	Floor	Analysis
	08 Mar 2022	James Doherty, Shaun Doherty	Management Survey	Ground Floor	N/A
	Building	Room	Item	Quantity	
	Ysgol Maes Owen	Corridor B072	Fitted modern altro flooring not accessed below to prevent damage.	N/A	
	Sample No (S,SP,P,As)	Product Type	Surface Treatment	Condition	Accessibility
	Visual (P)	N/A	N/A	N/A	N/A
	Material Risk Score				
Recommended action		Inspection Required			
Surveyor comments		N/A

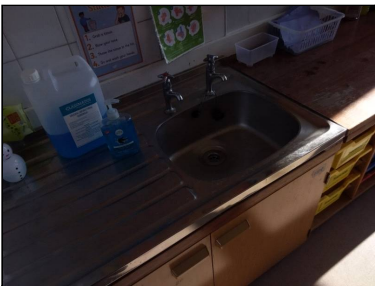
Survey Date:	Lead Surveyor	Survey Type	Floor	Analysis
	08 Mar 2022	James Doherty, Shaun Doherty	Management Survey	Ground Floor	No Asbestos Detected
	Building	Room	Item	Quantity	
	Ysgol Maes Owen	Class B020	Sink pad to underside of sink.	<1m ²	
	Sample No (S,SP,P,As)	Product Type	Surface Treatment	Condition	Accessibility
	As NE002635 (SP)	N/A	N/A	N/A	N/A
	Material Risk Score				
Recommended action		No further action required			
Surveyor comments		N/A

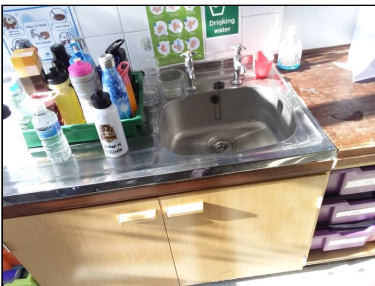
Survey Date:	Lead Surveyor	Survey Type	Floor	Analysis
	08 Mar 2022	James Doherty, Shaun Doherty	Management Survey	Ground Floor	No Asbestos Detected
	Building	Room	Item	Quantity	
	Ysgol Maes Owen	Class B021	Sink pad to underside of sink.	<1m ²	
	Sample No (S,SP,P,As)	Product Type	Surface Treatment	Condition	Accessibility
	As NE002635 (SP)	N/A	N/A	N/A	N/A
	Material Risk Score				
Recommended action		No further action required			
Surveyor comments		N/A

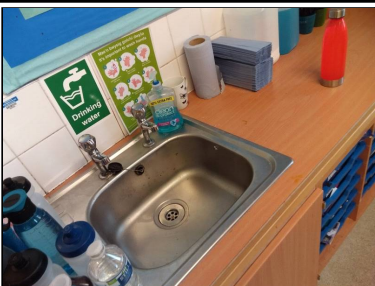
Survey Date:	Lead Surveyor	Survey Type	Floor	Analysis
	08 Mar 2022	James Doherty, Shaun Doherty	Management Survey	Ground Floor	No Asbestos Detected
	Building	Room	Item	Quantity	
	Ysgol Maes Owen	Class B025	Sink pad to underside of sink.	<1m ²	
	Sample No (S,SP,P,As)	Product Type	Surface Treatment	Condition	Accessibility
	As NE002635 (SP)	N/A	N/A	N/A	N/A
	Material Risk Score				
Recommended action		No further action required			
Surveyor comments		N/A

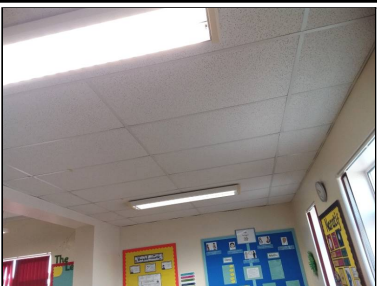
Survey Date:	Lead Surveyor	Survey Type	Floor	Analysis
	08 Mar 2022	James Doherty, Shaun Doherty	Management Survey	Ground Floor	N/A
	Building	Room	Item	Quantity	
	Ysgol Maes Owen	Class B025	Suspended ceiling not accessed above to prevent damage.	N/A	
	Sample No (S,SP,P,As)	Product Type	Surface Treatment	Condition	Accessibility
	Visual (P)	N/A	N/A	N/A	N/A
	Material Risk Score				
Recommended action		Inspection Required			
Surveyor comments		N/A

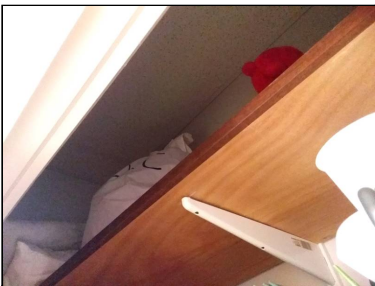
Survey Date:	Lead Surveyor	Survey Type	Floor	Analysis
	08 Mar 2022	James Doherty, Shaun Doherty	Management Survey	Ground Floor	N/A
	Building	Room	Item	Quantity	
	Ysgol Maes Owen	Store B070	Suspended ceiling tiles not accessed above to prevent damage.	N/A	
	Sample No (S,SP,P,As)	Product Type	Surface Treatment	Condition	Accessibility
	Visual (P)	N/A	N/A	N/A	N/A
	Material Risk Score				
Recommended action		Inspection Required			
Surveyor comments		N/A

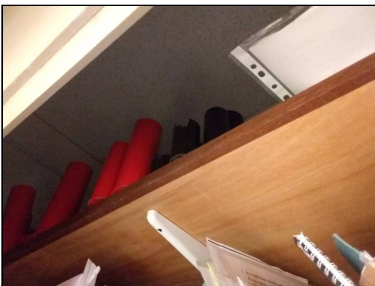
Survey Date:	Lead Surveyor	Survey Type	Floor	Analysis
	08 Mar 2022	James Doherty, Shaun Doherty	Management Survey	Ground Floor	N/A
	Building	Room	Item	Quantity	
	Ysgol Maes Owen	Store B071	Suspended ceiling tiles not accessed above to prevent damage.	N/A	
	Sample No (S,SP,P,As)	Product Type	Surface Treatment	Condition	Accessibility
	Visual (P)	N/A	N/A	N/A	N/A
	Material Risk Score				
Recommended action		Inspection Required			
Surveyor comments		N/A

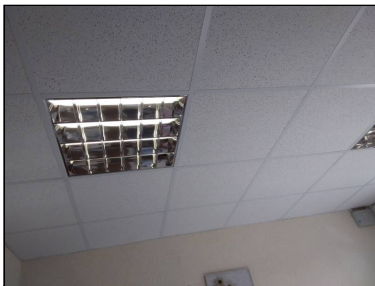
Survey Date:	Lead Surveyor	Survey Type	Floor	Analysis
	08 Mar 2022	James Doherty, Shaun Doherty	Management Survey	Ground Floor	N/A
	Building	Room	Item	Quantity	
	Ysgol Maes Owen	Office B004	Suspended ceiling panels not accessed above to prevent damage as room is occupied.	N/A	
	Sample No (S,SP,P,As)	Product Type	Surface Treatment	Condition	Accessibility
	Visual (P)	N/A	N/A	N/A	N/A
	Material Risk Score				
	N/A				
	Recommended action	Inspection Required			
Surveyor comments	N/A

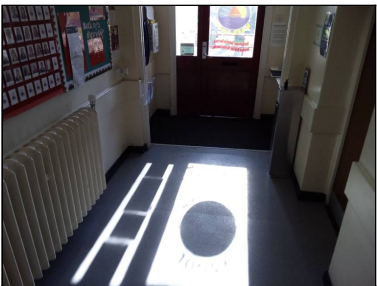
Survey Date:	Lead Surveyor	Survey Type	Floor	Analysis
	08 Mar 2022	James Doherty, Shaun Doherty	Management Survey	Ground Floor	N/A
	Building	Room	Item	Quantity	
	Ysgol Maes Owen	Lobby B001	Fitted flooring not accessed below to prevent damage.	N/A	
	Sample No (S,SP,P,As)	Product Type	Surface Treatment	Condition	Accessibility
	Visual (P)	N/A	N/A	N/A	N/A
	Material Risk Score				
Recommended action		Inspection Required			
Surveyor comments		N/A

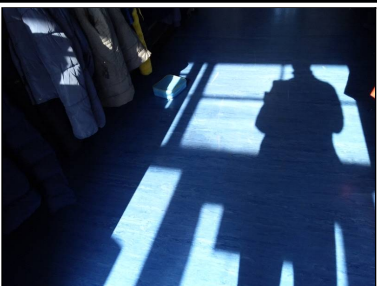
Survey Date:	Lead Surveyor	Survey Type	Floor	Analysis
	08 Mar 2022	James Doherty, Shaun Doherty	Management Survey	Ground Floor	N/A
	Building	Room	Item	Quantity	
	Ysgol Maes Owen	Corridor B008	Fitted modern altro flooring not accessed below to prevent damage.	N/A	
	Sample No (S,SP,P,As)	Product Type	Surface Treatment	Condition	Accessibility
	Visual (P)	N/A	N/A	N/A	N/A
	Material Risk Score				
Recommended action		Inspection Required			
Surveyor comments		N/A
