**Asbestos Survey Report  
Refurbishment Survey  
(with Priority Assessments)  
Block 1-20 (A-D) The Tower  
Southville, Cwmbran Torfaen, NP44 3QY  
648838  
Anthony Davies**

Job Number: W105286/1

Issue Date: 06/07/2023

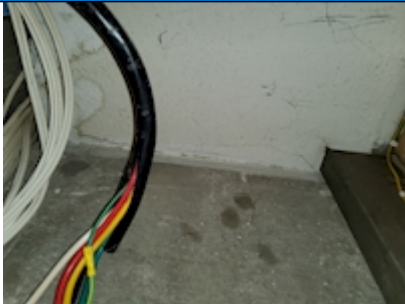
| <b>Location Description</b> | 081: Meter Cupboard | | | <b>Record Origin Report</b> | W105286 | | |

| <b>Item</b> | Ceiling | | | | | | |
| <b>Level of Identification (ID)</b> | Sample (S) | <b>Sample No.</b> | S0029 | | | | |
| <b>Product Type</b> | 1 | <b>Condition</b> | 1 | <b>Surface Treatment</b> | 0 | <b>Asbestos Type</b> | 1 |

| <b>Recommended Action</b> | Manage / Remove if Affected by Scope of Works | | | | | | |

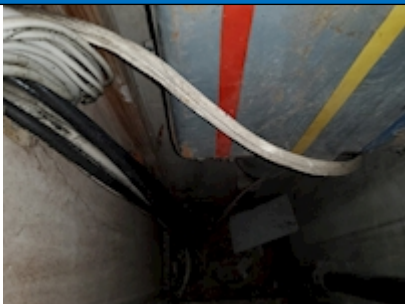
| <b>Location Description</b> | 081: Meter Cupboard | | | <b>Record Origin Report</b> | W105286 | | |

| <b>Item</b> | Panel | | | | | | |
| <b>Level of Identification (ID)</b> | Sample (S) | <b>Sample No.</b> | S0030 | | | | |
| <b>Product Type</b> | 0 | <b>Condition</b> | 0 | <b>Surface Treatment</b> | 0 | <b>Asbestos Type</b> | 0 |

| <b>Recommended Action</b> | No Recommendation Required | | | | | | |

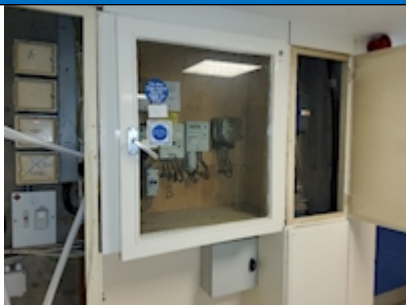
| <b>Location Description</b> | 081: Meter Cupboard | | | <b>Record Origin Report</b> | W105286 | | |

| <b>Item</b> | Within electrics | | | | | | |
| <b>Level of Identification (ID)</b> | Strongly Presumed (SP) | <b>Sample No.</b> | | | | | |
| <b>Product Type</b> | 2 | <b>Condition</b> | 1 | <b>Surface Treatment</b> | 2 | <b>Asbestos Type</b> | 1 |

| <b>Recommended Action</b> | Manage / Remove if Affected by Scope of Works | | | | | | |

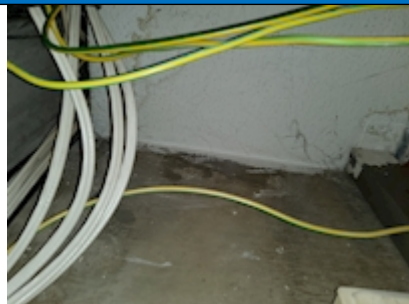
| <b>Item</b> | Ceiling | | | | | | |
| <b>Level of Identification (ID)</b> | Sample (S) | <b>Sample No.</b> | S0027 | | | | |

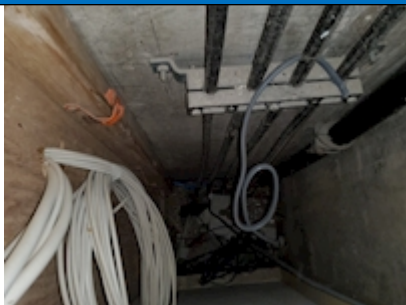
| <b>Location Description</b> | 080: Meter Cupboard | | | <b>Record Origin Report</b> | W105286 | | |

| <b>Item</b> | Panel | | | | | | |
| <b>Level of Identification (ID)</b> | Sample (S) | <b>Sample No.</b> | S0028 | | | | |

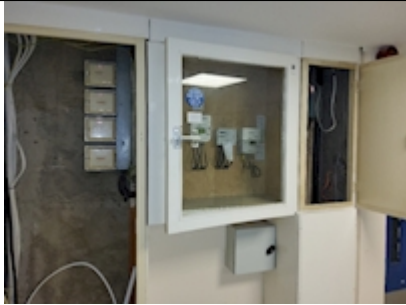
| <b>Location Description</b> | 080: Meter Cupboard | | | <b>Record Origin Report</b> | W105286 | | |

| <b>Item</b> | Within electrics | | | | | | |
| <b>Level of Identification (ID)</b> | Strongly Presumed (SP) | <b>Sample No.</b> | | | | | |

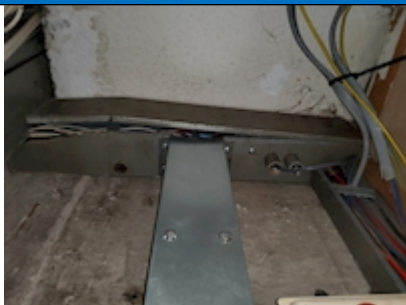
| <b>Location Description</b> | 079: Meter Cupboard | | | <b>Record Origin Report</b> | W105286 | | |

| <b>Item</b> | Ceiling | | | | | | |
| <b>Level of Identification (ID)</b> | Sample (S) | <b>Sample No.</b> | S0025 | | | | |

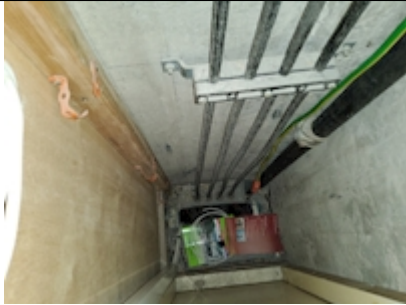
| <b>Location Description</b> | 079: Meter Cupboard | | | <b>Record Origin Report</b> | W105286 | | |

| <b>Item</b> | Panel | | | | | | |
| <b>Level of Identification (ID)</b> | Sample (S) | <b>Sample No.</b> | S0026 | | | | |

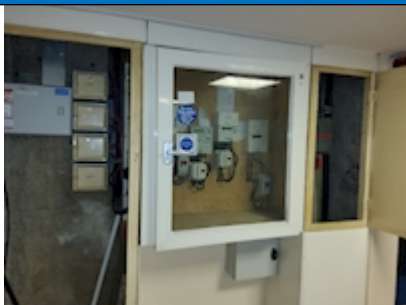
| <b>Location Description</b> | 079: Meter Cupboard | | | <b>Record Origin Report</b> | W105286 | | |

| <b>Item</b> | Within electrics | | | | | | |
| <b>Level of Identification (ID)</b> | Strongly Presumed (SP) | <b>Sample No.</b> | | | | | |

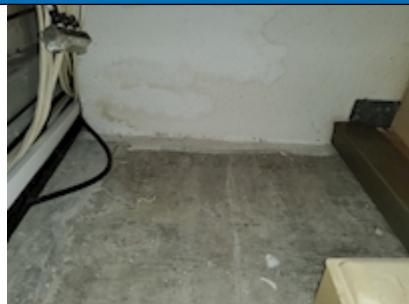
| <b>Item</b> | Ceiling | | | | | | |
| <b>Level of Identification (ID)</b> | Sample (S) | <b>Sample No.</b> | S0023 | | | | |

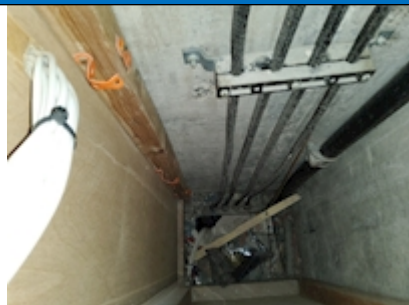
| <b>Location Description</b> | 078: Meter Cupboard | | | <b>Record Origin Report</b> | W105286 | | |

| <b>Item</b> | Panel | | | | | | |
| <b>Level of Identification (ID)</b> | Sample (S) | <b>Sample No.</b> | S0024 | | | | |

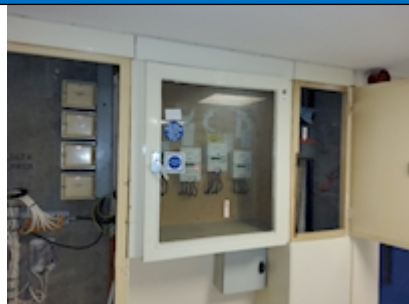
| <b>Location Description</b> | 078: Meter Cupboard | | | <b>Record Origin Report</b> | W105286 | | |

| <b>Item</b> | Within electrics | | | | | | |
| <b>Level of Identification (ID)</b> | Strongly Presumed (SP) | <b>Sample No.</b> | | | | | |

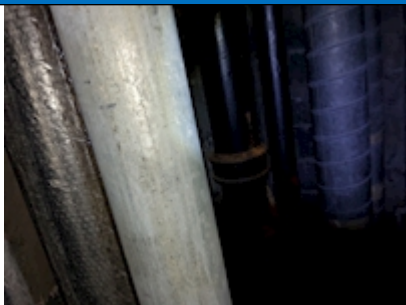
| <b>Location Description</b> | 047: Cupboard | | | <b>Record Origin Report</b> | W105286 | | |

| <b>Item</b> | Putty | | | | | | |
| <b>Level of Identification (ID)</b> | Sample (S) | <b>Sample No.</b> | S0022 | | | | |

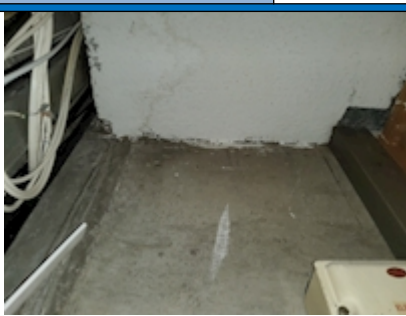
| <b>Location Description</b> | 077: Meter Cupboard | | | <b>Record Origin Report</b> | W105286 | | |

| <b>Item</b> | Ceiling | | | | | | |
| <b>Level of Identification (ID)</b> | Sample (S) | <b>Sample No.</b> | S0020 | | | | |

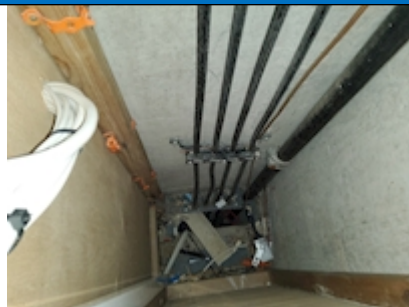
| <b>Location Description</b> | 077: Meter Cupboard | | | <b>Record Origin Report</b> | W105286 | | |

| <b>Item</b> | Panel | | | | | | |
| <b>Level of Identification (ID)</b> | Sample (S) | <b>Sample No.</b> | S0021 | | | | |

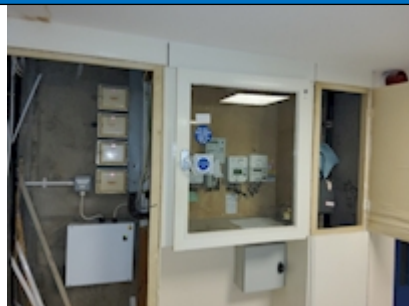
| <b>Location Description</b> | 077: Meter Cupboard | | | <b>Record Origin Report</b> | W105286 | | |

| <b>Item</b> | Within electrics | | | | | | |
| <b>Level of Identification (ID)</b> | Strongly Presumed (SP) | <b>Sample No.</b> | | | | | |

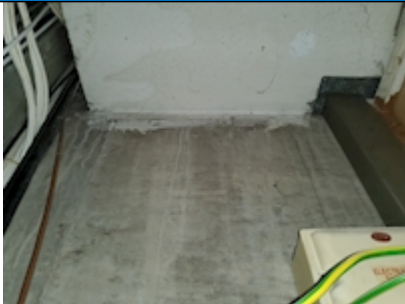
| <b>Location Description</b> | 076: Meter Cupboard | | | <b>Record Origin Report</b> | W105286 | | |

| <b>Item</b> | Ceiling | | | | | | |
| <b>Level of Identification (ID)</b> | Sample (S) | <b>Sample No.</b> | S0018 | | | | |

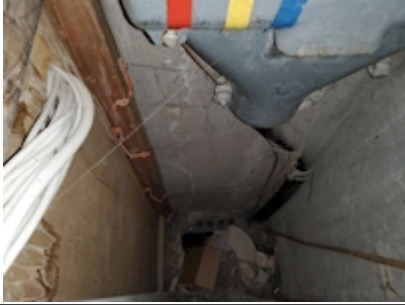
| <b>Location Description</b> | 076: Meter Cupboard | | | <b>Record Origin Report</b> | W105286 | | |

| <b>Item</b> | Panel | | | | | | |
| <b>Level of Identification (ID)</b> | Sample (S) | <b>Sample No.</b> | S0019 | | | | |

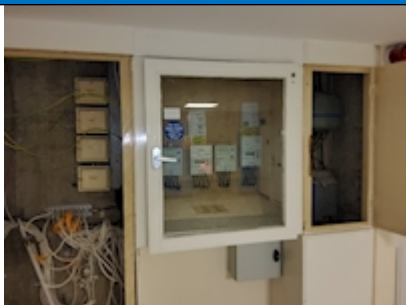
| <b>Location Description</b> | 076: Meter Cupboard | | | <b>Record Origin Report</b> | W105286 | | |

| <b>Item</b> | Within electrics | | | | | | |
| <b>Level of Identification (ID)</b> | Strongly Presumed (SP) | <b>Sample No.</b> | | | | | |

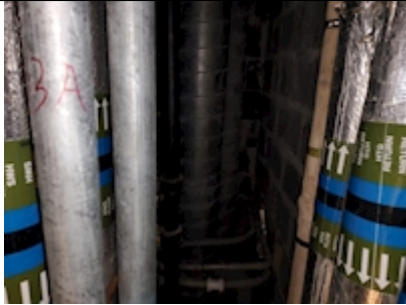
| <b>Location Description</b> | 056: Cupboard | | | <b>Record Origin Report</b> | W105286 | | |

| <b>Item</b> | Mastic | | | | | | |
| <b>Level of Identification (ID)</b> | Sample (S) | <b>Sample No.</b> | S0017 | | | | |

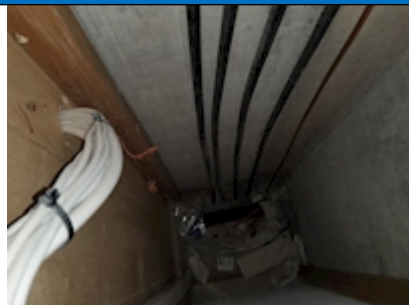
| <b>Location Description</b> | 075: Meter Cupboard | | | <b>Record Origin Report</b> | W105286 | | |

| <b>Item</b> | Panel | | | | | | |
| <b>Level of Identification (ID)</b> | Sample (S) | <b>Sample No.</b> | S0016 | | | | |

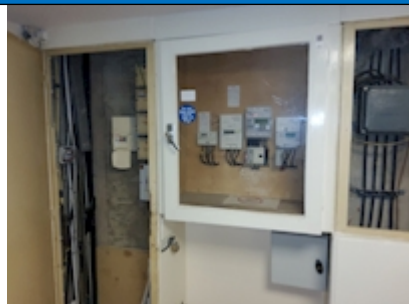
| <b>Location Description</b> | 075: Meter Cupboard | | | <b>Record Origin Report</b> | W105286 | | |

| <b>Item</b> | Within electrics | | | | | | |
| <b>Level of Identification (ID)</b> | Strongly Presumed (SP) | <b>Sample No.</b> | | | | | |

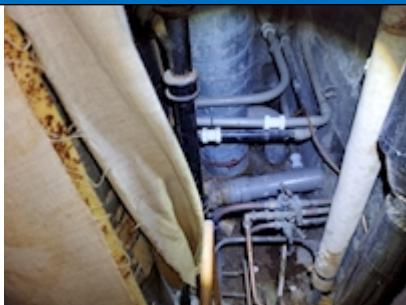
| <b>Location Description</b> | 060: Cupboard | | | <b>Record Origin Report</b> | W105286 | | |

| <b>Item</b> | Mastic | | | | | | |
| <b>Level of Identification (ID)</b> | Sample (S) | <b>Sample No.</b> | S0015 | | | | |

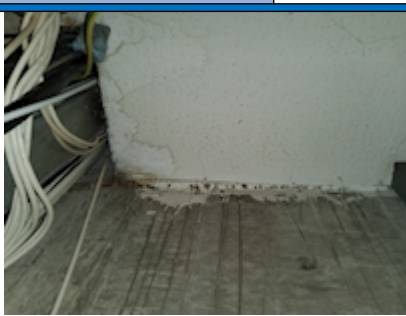
| <b>Location Description</b> | 074: Meter Cupboard | | | <b>Record Origin Report</b> | W105286 | | |

| <b>Item</b> | Ceiling | | | | | | |
| <b>Level of Identification (ID)</b> | Sample (S) | <b>Sample No.</b> | S0011 | | | | |

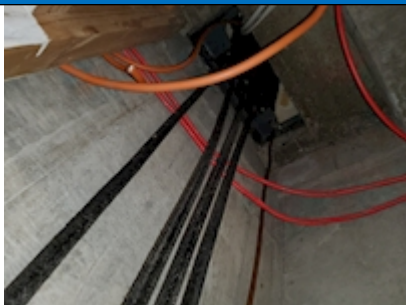
| <b>Location Description</b> | 074: Meter Cupboard | | | <b>Record Origin Report</b> | W105286 | | |

| <b>Item</b> | Panel | | | | | | |
| <b>Level of Identification (ID)</b> | Sample (S) | <b>Sample No.</b> | S0012 | | | | |

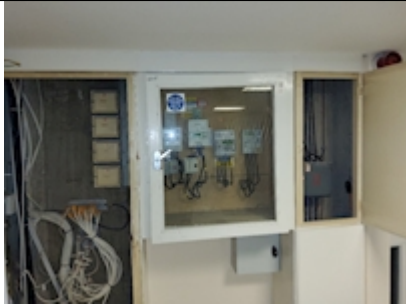
| <b>Location Description</b> | 074: Meter Cupboard | | | <b>Record Origin Report</b> | W105286 | | |

| <b>Item</b> | Within electrics | | | | | | |
| <b>Level of Identification (ID)</b> | Strongly Presumed (SP) | <b>Sample No.</b> | | | | | |

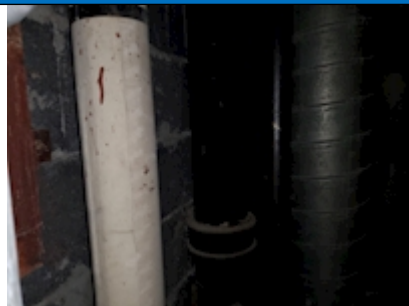
| <b>Item</b> | Putty | | | | | | |
| <b>Level of Identification (ID)</b> | Sample (S) | <b>Sample No.</b> | S0009 | | | | |

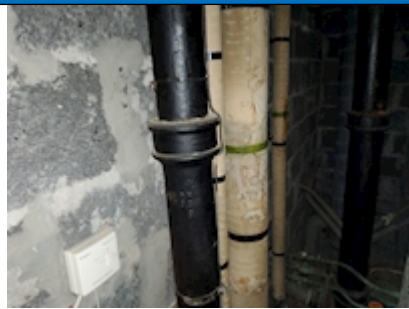
| <b>Item</b> | Putty | | | | | | |
| <b>Level of Identification (ID)</b> | Sample (S) | <b>Sample No.</b> | S0010 | | | | |

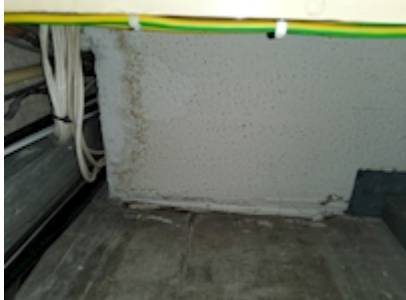
| <b>Item</b> | Ceiling | | | | | | |
| <b>Level of Identification (ID)</b> | Sample (S) | <b>Sample No.</b> | S0008 | | | | |

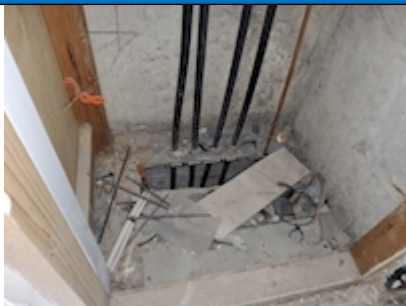
| <b>Item</b> | Panel | | | | | | |
| <b>Level of Identification (ID)</b> | Sample (S) | <b>Sample No.</b> | S0013 | | | | |

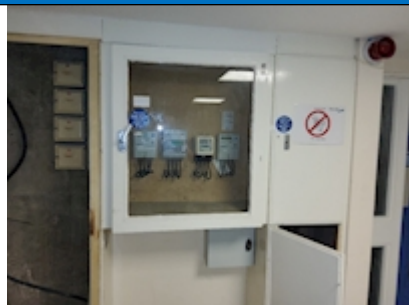
| <b>Item</b> | Within electrics | | | | | | |
| <b>Level of Identification (ID)</b> | Strongly Presumed (SP) | <b>Sample No.</b> | | | | | |

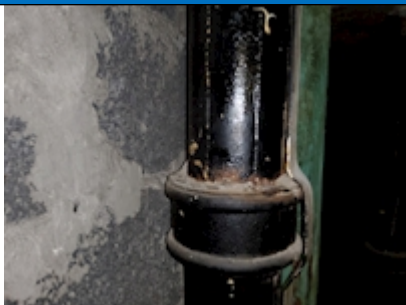
| <b>Item</b> | Putty | | | | | | |
| <b>Level of Identification (ID)</b> | Sample (S) | <b>Sample No.</b> | S0007 | | | | |

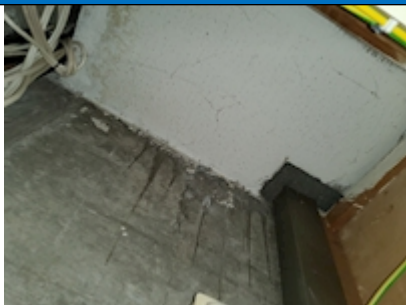
| <b>Item</b> | Ceiling | | | | | | |
| <b>Level of Identification (ID)</b> | Sample (S) | <b>Sample No.</b> | S0006 | | | | |

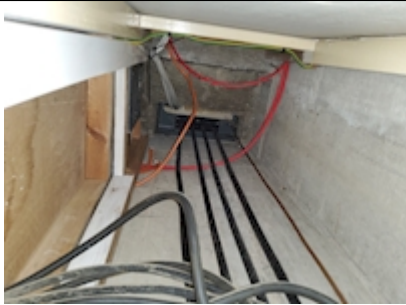
| <b>Item</b> | Panel | | | | | | |
| <b>Level of Identification (ID)</b> | Sample (S) | <b>Sample No.</b> | S0014 | | | | |

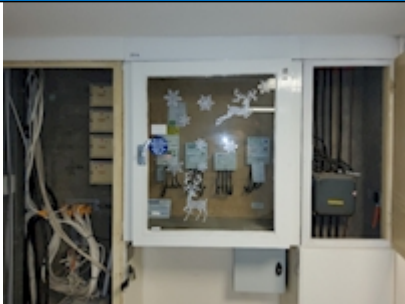
| <b>Item</b> | Within electrics | | | | | | |
| <b>Level of Identification (ID)</b> | Strongly Presumed (SP) | <b>Sample No.</b> | | | | | |
