# Asbestos Re-inspection Report (with Priority Assessments)

**Block 1-20 (A-D) The Tower**  
**Southville, Cwmbran Torfaen, NP44 3QY**  
**648838**  
**Lois Hobbs**

Job Number: W96459/1  
Issue Date: 04/05/2023  
Issue No: 1

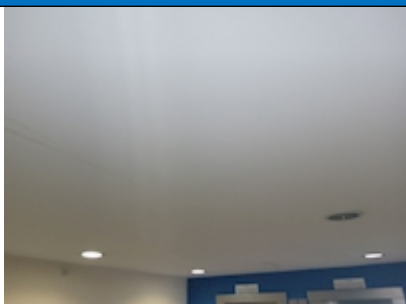
| <b>Item</b> | Ceiling | | | | | | |
| <b>Material</b> | Textured Coating | <b>Extent</b> | 30 m <sup>2</sup> | | | | |
| <b>Product Type</b> | 1 | <b>Condition</b> | 1 | <b>Surface Treatment</b> | 0 | <b>Asbestos Type</b> | 1 |

| <b>Recommended Action</b> | <b>Manage and Re-inspect</b> | | | | | | |

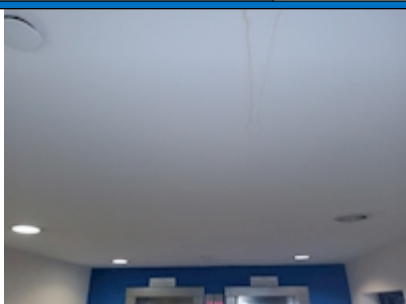
| <b>Item</b> | Ceiling | | | | | | |
| <b>Material</b> | Textured Coating | <b>Extent</b> | 24 m <sup>2</sup> | | | | |
| <b>Product Type</b> | 1 | <b>Condition</b> | 1 | <b>Surface Treatment</b> | 0 | <b>Asbestos Type</b> | 1 |

| <b>Recommended Action</b> | <b>Manage and Re-inspect</b> | | | | | | |

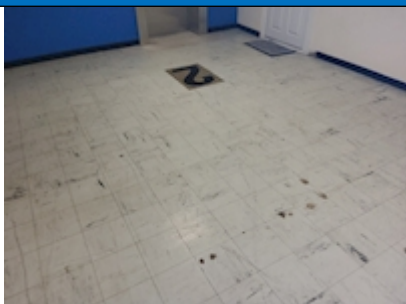
| <b>Item</b> | Floor | | | | | | |
| <b>Material</b> | Floor Tiles (Thermoplastic) | <b>Extent</b> | 24 m <sup>2</sup> | | | | |
| <b>Product Type</b> | 1 | <b>Condition</b> | 1 | <b>Surface Treatment</b> | 0 | <b>Asbestos Type</b> | 1 |

| <b>Recommended Action</b> | <b>Manage and Re-inspect</b> | | | | | | |

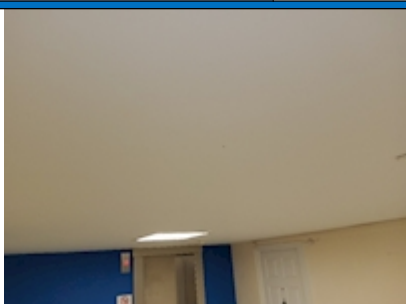
| <b>Item</b> | Ceiling | | | | | | |
| <b>Material</b> | Textured Coating | <b>Extent</b> | 24 m <sup>2</sup> | | | | |
| <b>Product Type</b> | 1 | <b>Condition</b> | 1 | <b>Surface Treatment</b> | 0 | <b>Asbestos Type</b> | 1 |

| <b>Recommended Action</b> | <b>Manage and Re-inspect</b> | | | | | | |

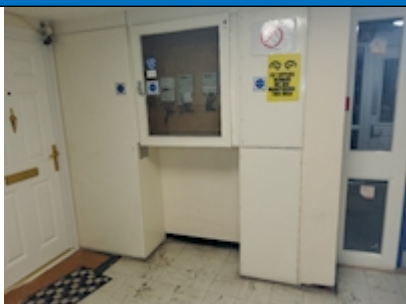
| Building | Floor | Location | Level of ID | Item | Extent | Material Assessment (MA) | | | | | Item Accessibility | Priority Assess't (PA) Score | Recommendation |
|---|---|---|---|---|---|---|---|---|---|---|---|---|---|
| Block 1-20 (A-D) The Tower | 2 | 021: Lobby | SP | Wall | 2 lm | Lagging / Loose Insulation | 1 | 2 | Amosite | 8 | Occasionally likely to be disturbed | 4 | Manage and Re-inspect |

| <b>Item</b> | Wall | | | | | | |
| <b>Material</b> | Lagging / Loose Insulation | <b>Extent</b> | 2 lm | | | | |
| <b>Product Type</b> | 3 | <b>Condition</b> | 1 | <b>Surface Treatment</b> | 2 | <b>Asbestos Type</b> | 2 |

| <b>Recommended Action</b> | <b>Manage and Re-inspect</b> | | | | | | |

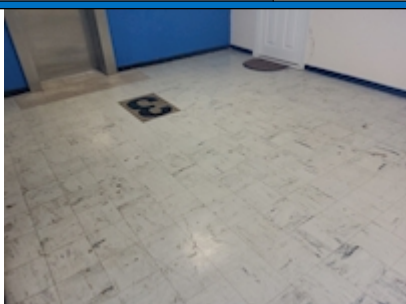
| <b>Item</b> | Floor | | | | | | |
| <b>Product Type</b> | 1 | <b>Condition</b> | 1 | <b>Surface Treatment</b> | 0 | <b>Asbestos Type</b> | 1 |

| <b>Recommended Action</b> | <b>Manage and Re-inspect</b> | | | | | | |

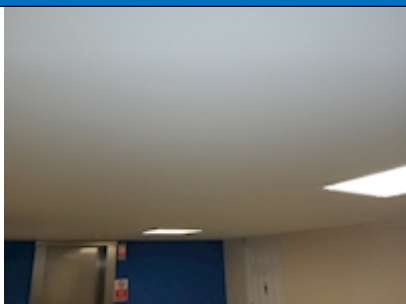
| <b>Item</b> | Ceiling | | | | | | |
| <b>Product Type</b> | 1 | <b>Condition</b> | 1 | <b>Surface Treatment</b> | 0 | <b>Asbestos Type</b> | 1 |

| <b>Recommended Action</b> | <b>Manage and Re-inspect</b> | | | | | | |

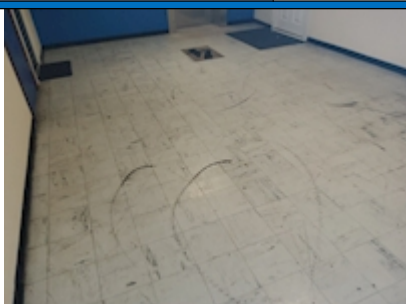
| <b>Item</b> | Floor | | | | | | |
| <b>Product Type</b> | 1 | <b>Condition</b> | 1 | <b>Surface Treatment</b> | 0 | <b>Asbestos Type</b> | 1 |

| <b>Recommended Action</b> | <b>Manage and Re-inspect</b> | | | | | | |

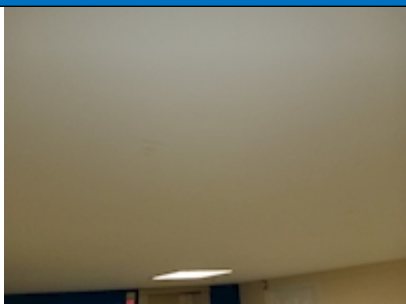
| <b>Item</b> | Ceiling | | | | | | |
| <b>Product Type</b> | 1 | <b>Condition</b> | 1 | <b>Surface Treatment</b> | 0 | <b>Asbestos Type</b> | 1 |

| <b>Recommended Action</b> | <b>Manage and Re-inspect</b> | | | | | | |

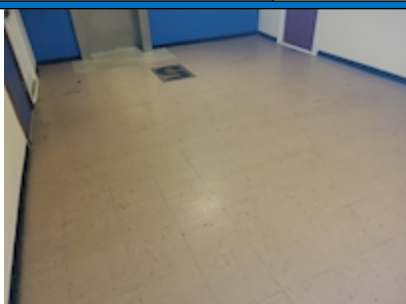
| <b>Item</b> | Floor | | | | | | |
| <b>Product Type</b> | 1 | <b>Condition</b> | 1 | <b>Surface Treatment</b> | 0 | <b>Asbestos Type</b> | 1 |

| <b>Recommended Action</b> | <b>Manage and Re-inspect</b> | | | | | | |

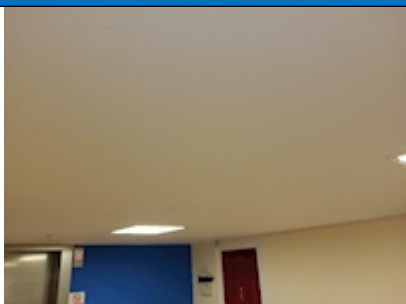
| <b>Item</b> | Ceiling | | | | | | |
| <b>Product Type</b> | 1 | <b>Condition</b> | 1 | <b>Surface Treatment</b> | 0 | <b>Asbestos Type</b> | 1 |

| <b>Recommended Action</b> | <b>Manage and Re-inspect</b> | | | | | | |

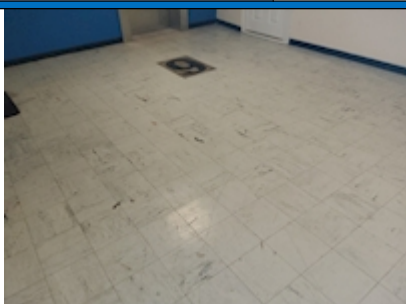
| <b>Item</b> | Floor | | | | | | |
| <b>Product Type</b> | 1 | <b>Condition</b> | 1 | <b>Surface Treatment</b> | 0 | <b>Asbestos Type</b> | 1 |

| <b>Recommended Action</b> | <b>Manage and Re-inspect</b> | | | | | | |

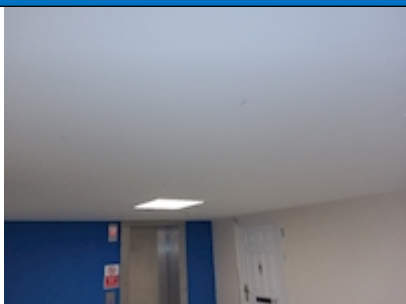
| <b>Item</b> | Ceiling | | | | | | |
| <b>Product Type</b> | 1 | <b>Condition</b> | 1 | <b>Surface Treatment</b> | 0 | <b>Asbestos Type</b> | 1 |

| <b>Recommended Action</b> | <b>Manage and Re-inspect</b> | | | | | | |

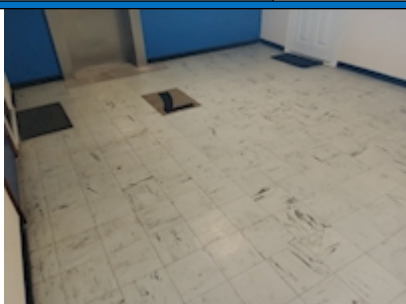
| <b>Item</b> | Floor | | | | | | |
| <b>Product Type</b> | 1 | <b>Condition</b> | 1 | <b>Surface Treatment</b> | 0 | <b>Asbestos Type</b> | 1 |

| <b>Recommended Action</b> | <b>Manage and Re-inspect</b> | | | | | | |

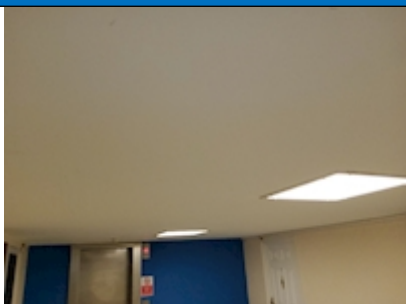
| <b>Item</b> | Ceiling | | | | | | |
| <b>Product Type</b> | 1 | <b>Condition</b> | 1 | <b>Surface Treatment</b> | 0 | <b>Asbestos Type</b> | 1 |

| <b>Recommended Action</b> | <b>Manage and Re-inspect</b> | | | | | | |

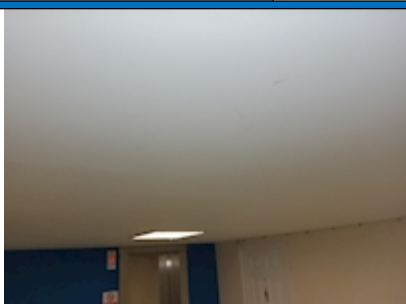
| <b>Item</b> | Ceiling | | | | | | |
| <b>Product Type</b> | 1 | <b>Condition</b> | 1 | <b>Surface Treatment</b> | 0 | <b>Asbestos Type</b> | 1 |

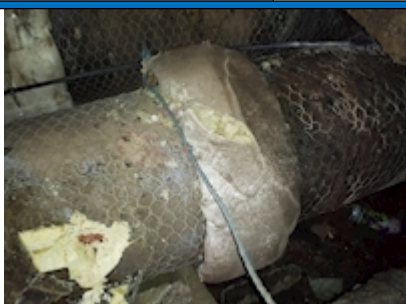
| <b>Location Description</b> | 069: External | | | <b>Record Origin Report</b> | W20930 | | |

| <b>Item</b> | Pipework | | | | | | |
| <b>Level of Identification (ID)</b> | Sample (S) | <b>Sample No.</b> | S0001 | | | | |

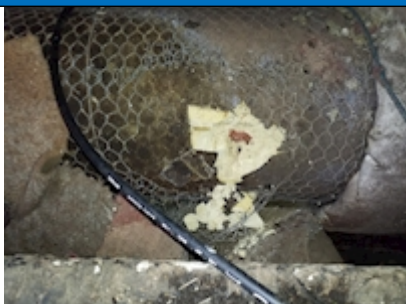
| <b>Location Description</b> | 069: External | | | <b>Record Origin Report</b> | W20930 | | |

| <b>Item</b> | Pipework | | | | | | |
| <b>Level of Identification (ID)</b> | Sample (S) | <b>Sample No.</b> | S0002 | | | | |

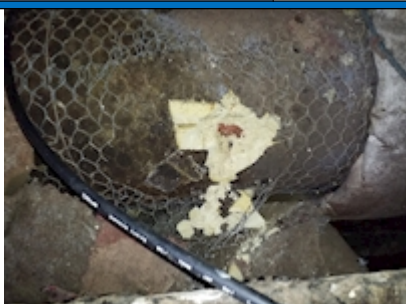
| <b>Location Description</b> | 069: External | | | <b>Record Origin Report</b> | W20930 | | |

| <b>Item</b> | Pipework | | | | | | |
| <b>Level of Identification (ID)</b> | Sample (S) | <b>Sample No.</b> | S0003 | | | | |

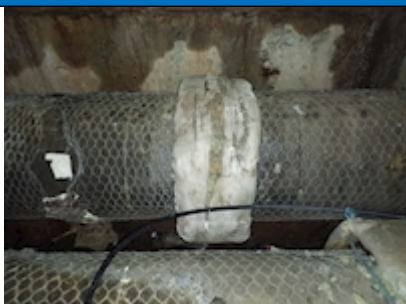
| <b>Location Description</b> | 069: External | | | <b>Record Origin Report</b> | W20930 | | |

| <b>Item</b> | Pipework | | | | | | |
| <b>Level of Identification (ID)</b> | Sample (S) | <b>Sample No.</b> | S0004 | | | | |

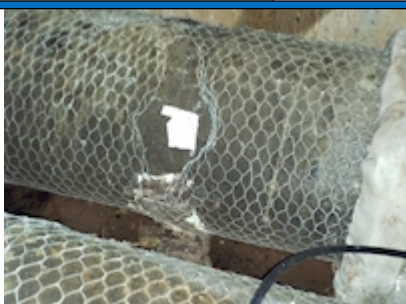
| <b>Location Description</b> | 069: External | | | <b>Record Origin Report</b> | W20930 | | |

| <b>Item</b> | Pipework | | | | | | |
| <b>Level of Identification (ID)</b> | Sample (S) | <b>Sample No.</b> | S0005 | | | | |
