ASBESTOS MANAGEMENT SURVEY WITH A  
REFURBISHMENT TO SPECIFIED AREAS OF  
3 TAN Y CASTELL, LLWYNYGROES, TREGARON, CEREDIGION, SY25 6QB

CLIENT: BARCUD  
TY CANOL HOUSE, FFORDD CROESAWDY, NEWTOWN,, SY16 1AL

UPRN NO: 103454  
PROJECT NO: J1105644  
DATE: June 2026

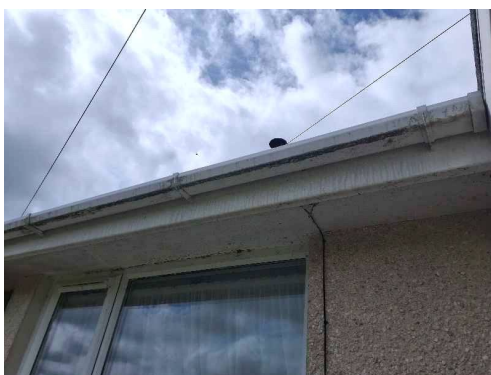
| <b>FLOOR/LOCATION:</b> | External | |

| SITE ADDRESS: 3 TAN Y CASTELL, LLWYNYGROES, TREGARON, CEREDIGION, SY25 6QB | | | | | | | | | | DATE: 04/06/2026 | |
|---|---|---|---|---|---|---|---|---|---|---|---|
| Man | External / External (0) | None (0) | Insulating board soffits (2) | 30m <sup>L</sup> (2) | Partially Sealed (2) | Good Condition (0) | Rare (0) | GK004792 / <b>Amosite</b> (2) | 6 + 2 = 8 | Very Low | Manage, monitor and inform maintenance personnel prior to relevant works |

| <b>DESCRIPTION:</b> | Insulating board soffits | |
| <b>RESULT:</b> | Amosite | |

| <b>RECOMMENDATIONS:</b> | Manage, monitor and inform maintenance personnel prior to relevant works | |

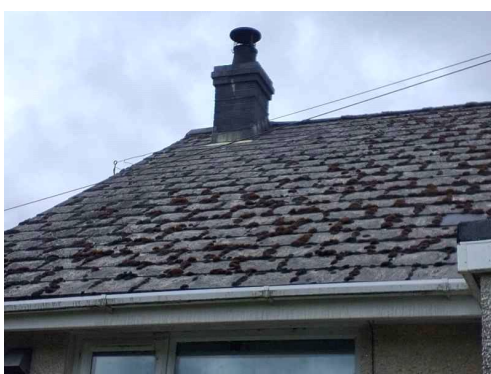
| <b>FLOOR/LOCATION:</b> | External | |

| SITE ADDRESS: 3 TAN Y CASTELL, LLWYNYGROES, TREGARON, CEREDIGION, SY25 6QB | | | | | | | | | | DATE: 04/06/2026 | |
|---|---|---|---|---|---|---|---|---|---|---|---|
| Man | External / External (0) | None (0) | Cement roof tiles (1) | 40m <sup>2</sup> (2) | Unsealed (1) | Good Condition (0) | Rare (0) | GK004793 / <b>Chrysotile</b> (1) | 3 + 2 = 5 | Very Low | Manage, monitor and inform maintenance personnel prior to relevant works |

| <b>DESCRIPTION:</b> | Cement roof tiles | |
| <b>RESULT:</b> | Chrysotile | |

| <b>RECOMMENDATIONS:</b> | Manage, monitor and inform maintenance personnel prior to relevant works | |

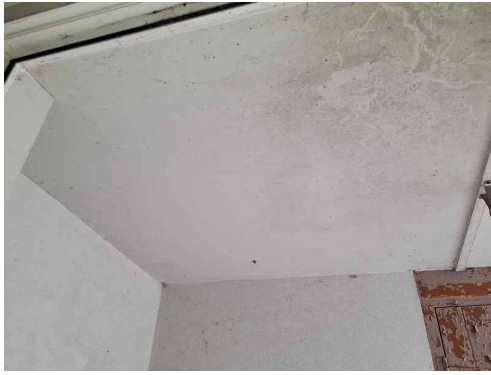
| <b>FLOOR/LOCATION:</b> | External | |

| SITE ADDRESS: 3 TAN Y CASTELL, LLWYNYGROES, TREGARON, CEREDIGION, SY25 6QB | | | | | | | | | | DATE: 04/06/2026 | |
|---|---|---|---|---|---|---|---|---|---|---|---|
| Man | External / External (0) | None (0) | Exterior canopy ceiling (2) | 2m <sup>2</sup> (1) | Partially Sealed (2) | Good Condition (0) | Low (1) | Strongly presumed similar to GK004792 / <b>Amosite</b> (2) | 6 + 2 = 8 | Very Low | Manage, monitor and inform maintenance personnel prior to relevant works |

| <b>DESCRIPTION:</b> | Exterior canopy ceiling | |
| <b>RESULT:</b> | Amosite | |

| <b>RECOMMENDATIONS:</b> | Manage, monitor and inform maintenance personnel prior to relevant works | |

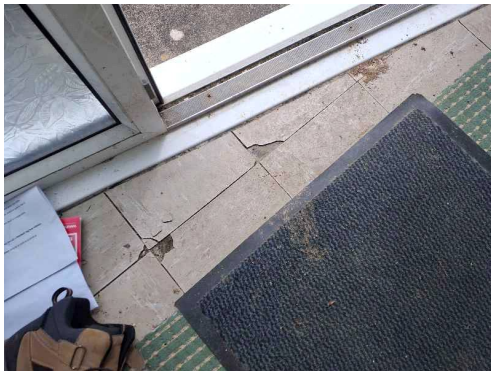
| <b>FLOOR/LOCATION:</b> | Ground Floor Hall | |

| SITE ADDRESS: 3 TAN Y CASTELL, LLWYNYGROES, TREGARON, CEREDIGION, SY25 6QB | | | | | | | | | DATE: 04/06/2026 | | |
|---|---|---|---|---|---|---|---|---|---|---|---|
| Man | Ground Floor / Hall (1) | 1 - 3 (1) | Cream Vinyl floor tiles (1) | 2m <sup>2</sup> (1) | Composite Material (0) | Low Damage (1) | High (3) | GK004787 / <b>Chrysotile</b> (1)<br>(In Tile Only) | 3 + 6 = 9 | Very Low | Remove under controlled conditions |

| <b>DESCRIPTION:</b> | Cream Vinyl floor tiles | |
| <b>RESULT:</b> | Chrysotile (In Tile Only) | |

| <b>RECOMMENDATIONS:</b> | Remove under controlled conditions | |

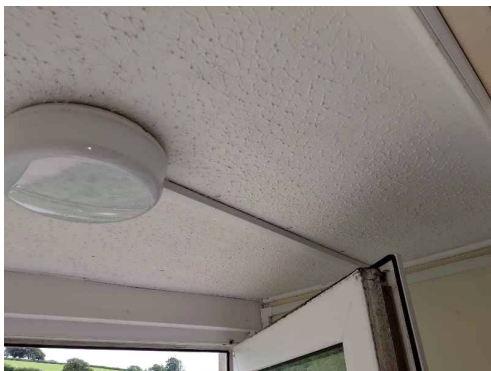
| <b>FLOOR/LOCATION:</b> | Ground Floor Hall | |

| SITE ADDRESS: 3 TAN Y CASTELL, LLWYNYGROES, TREGARON, CEREDIGION, SY25 6QB | | | | | | | | | DATE: 04/06/2026 | | |
|---|---|---|---|---|---|---|---|---|---|---|---|
| Man | Ground Floor / Hall (1) | 1 - 3 (1) | Textured coating to ceiling (1) | 2m <sup>2</sup> (1) | Sealed (0) | Low Damage (1) | Low (1) | GK004788 / <b>Chrysotile</b> (1) | 3 + 4 = 7 | Very Low | Manage, monitor and inform maintenance personnel prior to relevant works |

| <b>DESCRIPTION:</b> | Textured coating to ceiling | |
| <b>RESULT:</b> | Chrysotile | |

| <b>RECOMMENDATIONS:</b> | Manage, monitor and inform maintenance personnel prior to relevant works | |

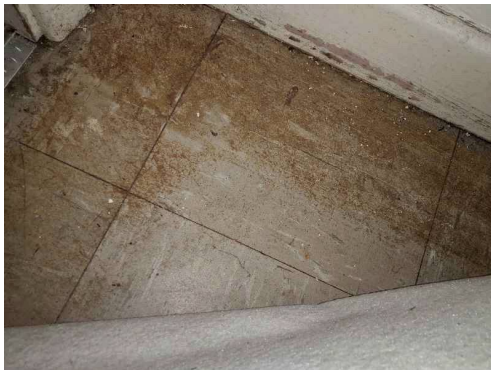
| <b>FLOOR/LOCATION:</b> | Ground Floor Lounge | |

| SITE ADDRESS: 3 TAN Y CASTELL, LLWYNYGROES, TREGARON, CEREDIGION, SY25 6QB | | | | | | | | | DATE: 04/06/2026 | | |
|---|---|---|---|---|---|---|---|---|---|---|---|
| RFD | Ground Floor / Lounge (1) | 1 - 3 (1) | Cream Vinyl floor tile beneath carpet (1) | 16m <sup>2</sup> (2) | Composite Material (0) | Low Damage (1) | Low (1) | Strongly presumed similar to GK004787 / <b>Chrysotile</b> (1)<br>(In Tile Only) | 3 + 5 = 8 | Very Low | Remove under controlled conditions |

| <b>DESCRIPTION:</b> | Cream Vinyl floor tile beneath carpet | |
| <b>RESULT:</b> | Chrysotile (In Tile Only) | |

| <b>RECOMMENDATIONS:</b> | Remove under controlled conditions | |

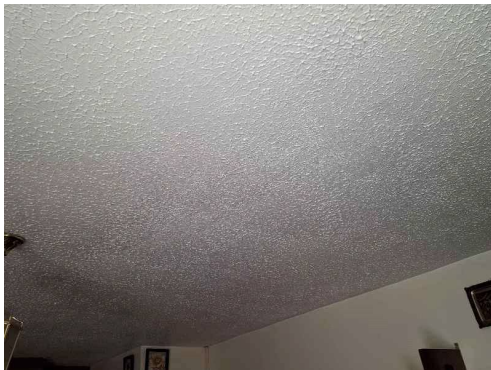
| <b>FLOOR/LOCATION:</b> | Ground Floor Lounge | |

| SITE ADDRESS: 3 TAN Y CASTELL, LLWYNYGROES, TREGARON, CEREDIGION, SY25 6QB | | | | | | | | | DATE: 04/06/2026 | | |
|---|---|---|---|---|---|---|---|---|---|---|---|
| Man | Ground Floor / Lounge (1) | 1 - 3 (1) | Textured coating to ceiling (1) | 16m <sup>2</sup> (2) | Sealed (0) | Low Damage (1) | Low (1) | Strongly presumed similar to GK004788 / <b>Chrysotile</b> (1) | 3 + 5 = 8 | Very Low | Manage, monitor and inform maintenance personnel prior to relevant works |

| <b>DESCRIPTION:</b> | Textured coating to ceiling | |
| <b>RESULT:</b> | Chrysotile | |

| <b>RECOMMENDATIONS:</b> | Manage, monitor and inform maintenance personnel prior to relevant works | |

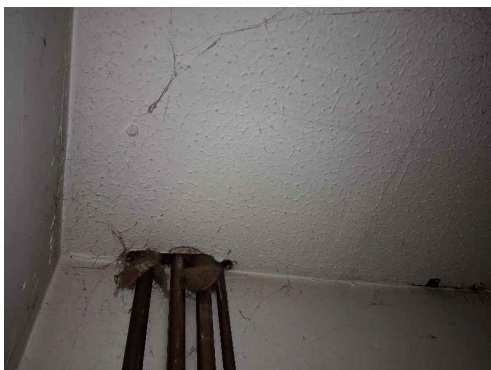
| <b>FLOOR/LOCATION:</b> | Ground Floor Kitchen cupboard | |

| SITE ADDRESS: 3 TAN Y CASTELL, LLWYNYGROES, TREGARON, CEREDIGION, SY25 6QB | | | | | | | | | | DATE: 04/06/2026 | | |
|---|---|---|---|---|---|---|---|---|---|---|---|--|
| Man | Ground Floor / Kitchen cupboard (1) | 1 - 3 (1) | Textured coating to ceiling (1) | 1m² (1) | Sealed (0) | Low Damage (1) | Low (1) | Strongly presumed similar to GK004788 / <b>Chrysotile (1)</b> | 3 + 4 = 7 | Very Low | Manage, monitor and inform maintenance personnel prior to relevant works | |

| <b>DESCRIPTION:</b> | Textured coating to ceiling | |
| <b>RESULT:</b> | Chrysotile | |

| <b>RECOMMENDATIONS:</b> | Manage, monitor and inform maintenance personnel prior to relevant works | |

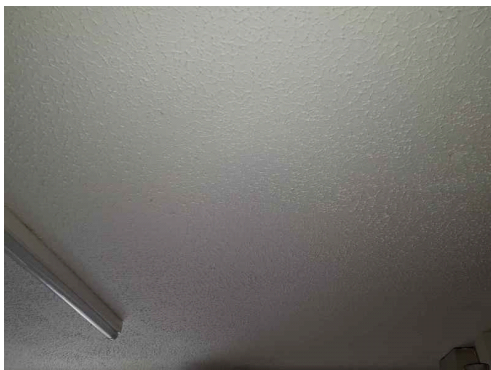
| <b>FLOOR/LOCATION:</b> | Ground Floor Kitchen | |

| SITE ADDRESS: 3 TAN Y CASTELL, LLWYNYGROES, TREGARON, CEREDIGION, SY25 6QB | | | | | | | | | | DATE: 04/06/2026 | | |
|---|---|---|---|---|---|---|---|---|---|---|---|--|
| Man | Ground Floor / Kitchen (1) | 1 - 3 (1) | Textured coating to ceiling (1) | 12m² (2) | Sealed (0) | Low Damage (1) | Low (1) | Strongly presumed similar to GK004789 / <b>Chrysotile (1)</b> | 3 + 5 = 8 | Very Low | Manage, monitor and inform maintenance personnel prior to relevant works | |

| <b>DESCRIPTION:</b> | Textured coating to ceiling | |
| <b>RESULT:</b> | Chrysotile | |

| <b>RECOMMENDATIONS:</b> | Manage, monitor and inform maintenance personnel prior to relevant works | |

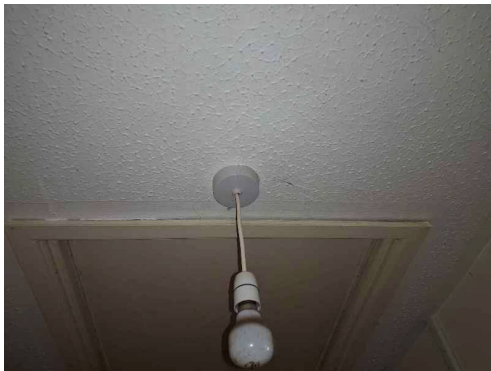
| <b>FLOOR/LOCATION:</b> | Ground Floor Hallway | |

| SITE ADDRESS: 3 TAN Y CASTELL, LLWYNYGROES, TREGARON, CEREDIGION, SY25 6QB | | | | | | | | | | DATE: 04/06/2026 | |
|---|---|---|---|---|---|---|---|---|---|---|---|
| Man | Ground Floor / Hallway (1) | 1 - 3 (1) | Textured coating to ceiling (1) | 2m² (1) | Sealed (0) | Low Damage (1) | Low (1) | GK004789 / <b>Chrysotile (1)</b> | 3 + 4 = 7 | Very Low | Manage, monitor and inform maintenance personnel prior to relevant works |

| <b>DESCRIPTION:</b> | Textured coating to ceiling | |
| <b>RESULT:</b> | Chrysotile | |

| <b>RECOMMENDATIONS:</b> | Manage, monitor and inform maintenance personnel prior to relevant works | |

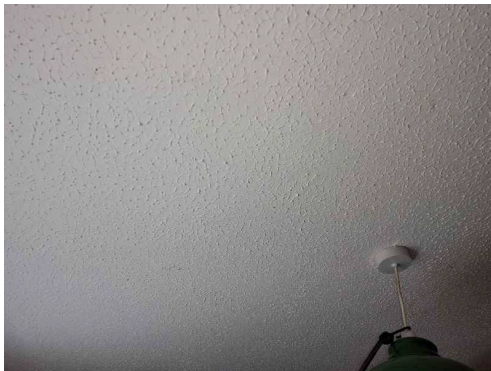
| <b>FLOOR/LOCATION:</b> | Ground Floor Store room | |

| SITE ADDRESS: 3 TAN Y CASTELL, LLWYNYGROES, TREGARON, CEREDIGION, SY25 6QB | | | | | | | | | | DATE: 04/06/2026 | |
|---|---|---|---|---|---|---|---|---|---|---|---|
| Man | Ground Floor / Store room (1) | 1 - 3 (1) | Textured coating to ceiling (1) | 6m² (1) | Sealed (0) | Low Damage (1) | Low (1) | GK004791 / <b>Chrysotile (1)</b> | 3 + 4 = 7 | Very Low | Manage, monitor and inform maintenance personnel prior to relevant works |

| <b>DESCRIPTION:</b> | Textured coating to ceiling | |
| <b>RESULT:</b> | Chrysotile | |

| <b>RECOMMENDATIONS:</b> | Manage, monitor and inform maintenance personnel prior to relevant works | |

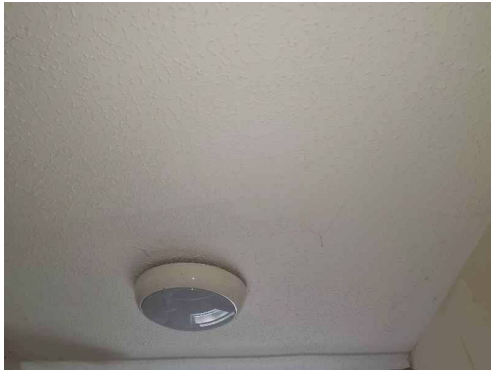
| <b>FLOOR/LOCATION:</b> | Ground Floor Bathroom | |

| SITE ADDRESS: 3 TAN Y CASTELL, LLWYNYGROES, TREGARON, CEREDIGION, SY25 6QB | | | | | | | | | | DATE: 04/06/2026 | | |
|---|---|---|---|---|---|---|---|---|---|---|---|--|
| Man | Ground Floor / Bathroom (1) | 1 - 3 (1) | Textured coating to ceiling (1) | 6m <sup>2</sup> (1) | Sealed (0) | Low Damage (1) | Low (1) | Strongly presumed similar to GK004789 / <b>Chrysotile (1)</b> | 3 + 4 = 7 | Very Low | Manage, monitor and inform maintenance personnel prior to relevant works | |

| <b>DESCRIPTION:</b> | Textured coating to ceiling | |
| <b>RESULT:</b> | Chrysotile | |

| <b>RECOMMENDATIONS:</b> | Manage, monitor and inform maintenance personnel prior to relevant works | |

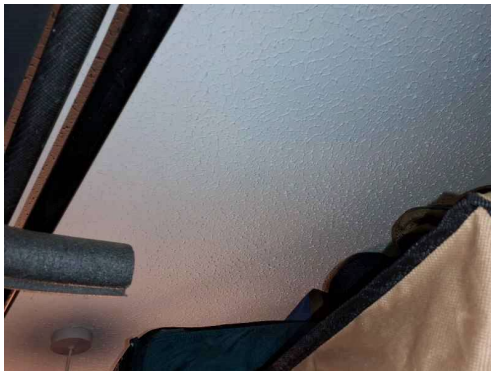
| <b>FLOOR/LOCATION:</b> | Ground Floor Cupboard | |

| SITE ADDRESS: 3 TAN Y CASTELL, LLWYNYGROES, TREGARON, CEREDIGION, SY25 6QB | | | | | | | | | | DATE: 04/06/2026 | | |
|---|---|---|---|---|---|---|---|---|---|---|---|--|
| Man | Ground Floor / Cupboard (1) | 1 - 3 (1) | Textured coating to ceiling (1) | 4m <sup>2</sup> (1) | Sealed (0) | Low Damage (1) | Low (1) | Strongly presumed similar to GK004789 / <b>Chrysotile (1)</b> | 3 + 4 = 7 | Very Low | Manage, monitor and inform maintenance personnel prior to relevant works | |

| <b>DESCRIPTION:</b> | Textured coating to ceiling | |
| <b>RESULT:</b> | Chrysotile | |

| <b>RECOMMENDATIONS:</b> | Manage, monitor and inform maintenance personnel prior to relevant works | |

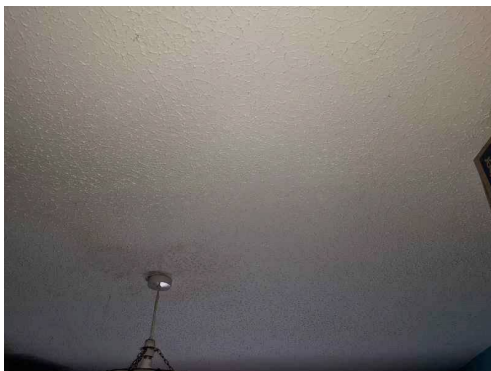
| <b>FLOOR/LOCATION:</b> | Ground Floor Bedroom | |

| SITE ADDRESS: 3 TAN Y CASTELL, LLWYNYGROES, TREGARON, CEREDIGION, SY25 6QB | | | | | | | | | | DATE: 04/06/2026 | |
|---|---|---|---|---|---|---|---|---|---|---|---|
| Man | Ground Floor / Bedroom (1) | 1 - 3 (1) | Textured coating to ceiling (1) | 14m <sup>2</sup> (2) | Sealed (0) | Low Damage (1) | Low (1) | Strongly presumed similar to GK004791 / <b>Chrysotile</b> (1) | 3 + 5 = 8 | Very Low | Manage, monitor and inform maintenance personnel prior to relevant works |

| <b>DESCRIPTION:</b> | Textured coating to ceiling | |

| <b>RECOMMENDATIONS:</b> | Manage, monitor and inform maintenance personnel prior to relevant works | |
