## **Asbestos Register based upon a Management Survey of**

**3 Tan Y Castell, Llwynygroes, Tregaron. SY25 6QB  
for  
Tai Ceredigion**

**Lead Surveyor:** Dale Hedges  
**Junior Surveyor:** N A  
**Report No.** WES 017596  
**Authorised By:** Lead Surveyor  
**Technical Manager:** Andre Hedges BSc(Hons) MRICS

**Issue Date:** 27/10/2010  
**Copy No:** 1

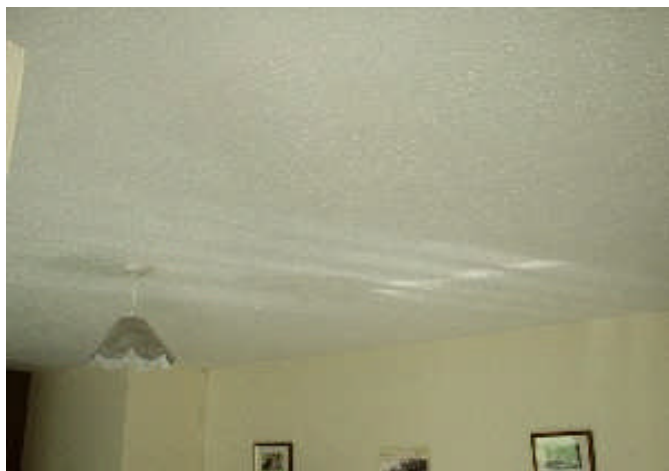
Ref. No. 017596/001

DESCRIPTION: Artex. G1, G2 and G3 ceilings.

| <b>Asbestos Present?</b> | Yes |
| <b>Lab Detail:</b> | Chrysotile - White |

| | <b>Material Assessment:</b> | 4 |

This material was found at more than one location but has the same material assessment score.

The Asbestos Management Plan will need to be updated to include the above material. This plan should state the means of managing the acm, eg: the frequency of a periodic inspection regime and whether or not labelling is required etc. Also a risk assessment will need to be undertaken if this acm is likely to be disturbed by maintenance or refurbishment works. This may confirm that the acm can be removed by a **competent contractor** under the control of Asbestos Regulations 2006 Approved Code of Practice L143 and disposed of as hazardous waste

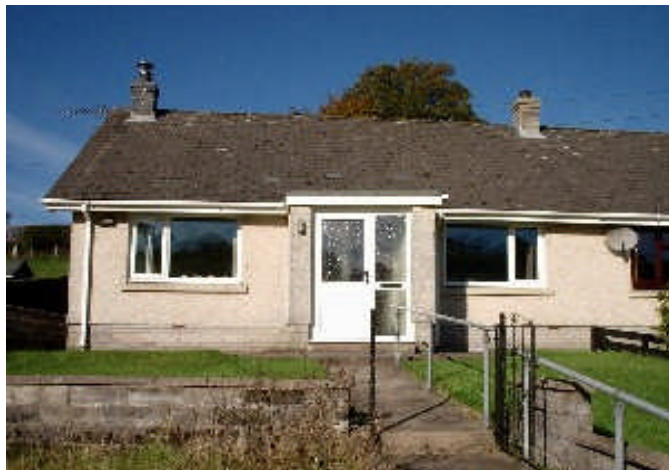
Ref. No. 017596/001P

DESCRIPTION: No access. Cavities, voids and hidden materials.

| Asbestos Present? | Presumed asbestos present |

This Management survey inspected readily available materials only. All hidden materials below other securely fixed materials or inaccessible cavities and voids have not been inspected. This is because this survey does not destructively and intrusively inspect the deeper fabric of the building. If intrusive maintenance, refurbishment or demolition is being planned, then you will need to requisition a Refurbishment and Demolition survey. While some potentially hidden asbestos containing materials have been highlighted within this report, they do not form an exhaustive list.

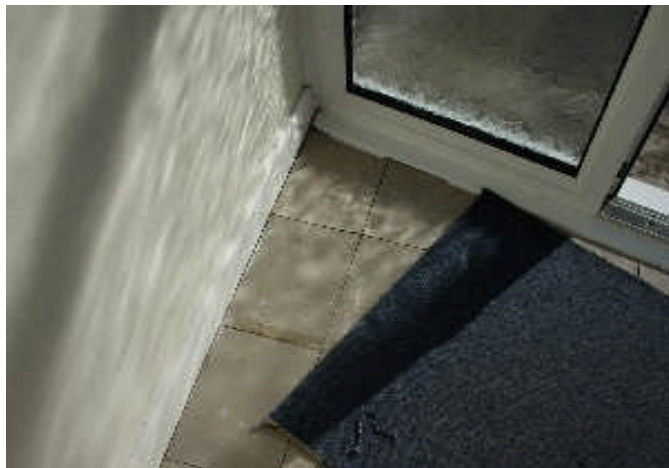
Ref. No. 017596/002

DESCRIPTION: Grey tiles and adhesive. G1 and G2 floors.

| <b>Asbestos Present?</b> | Yes |
| <b>Lab Detail:</b> | Chrysotile - White |

| | <b>Material Assessment:</b> | <b>3</b> |

This material was found at more than one location but has the same material assessment score.

The Asbestos Management Plan will need to be updated to include the above material. This plan should state the means of managing the acm, eg: the frequency of a periodic inspection regime and whether or not labelling is required etc. Also a risk assessment will need to be undertaken if this acm is likely to be disturbed by maintenance or refurbishment works. This may confirm that the acm can be removed by a **competent contractor** under the control of Asbestos Regulations 2006 Approved Code of Practice L143 and disposed of as hazardous waste

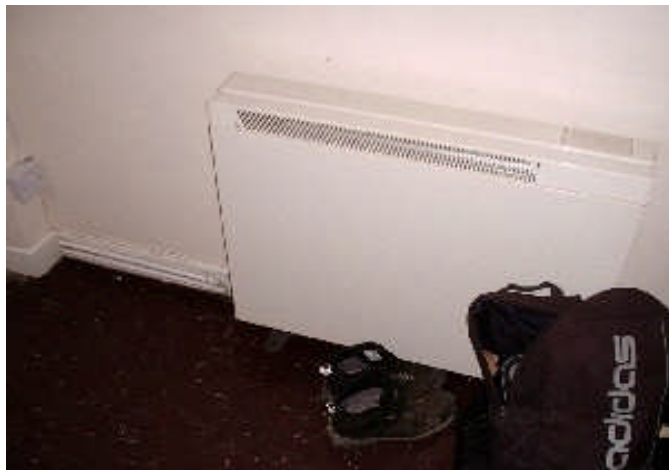
Ref. No. 017596/002P

DESCRIPTION: No access. G2 fire and G4, G7 and G8 storage radiators.

Asbestos Present? Presumed asbestos present  
Lab Detail:

It is possible for all types of plant and equipment to contain asbestos. This could be in the form of rope seals, paper lining, insulating board, gaiters, and lagging etc. Sometimes an item can be disposed of without needing to open the casing. This can be done by a **competent contractor**. The product may also be a type which even though it might need to be disturbed can again be done by a **competent contractor** eg: Gaskets, gaiters, rope seals etc. However, some products such as insulating board and lagging need to be removed by a **HSE licensed contractor**.

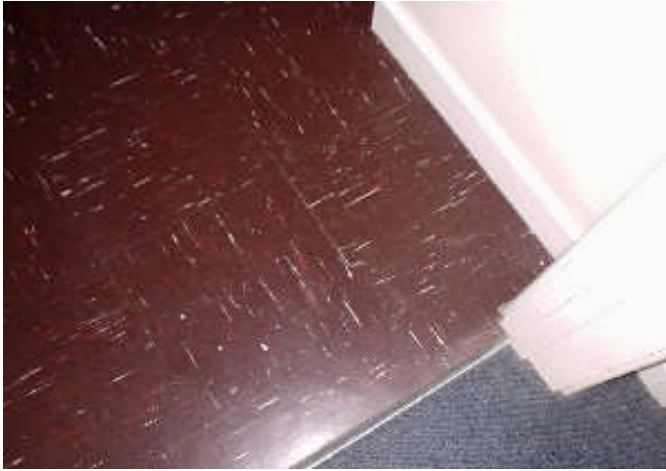
Ref. No. 017596/003

DESCRIPTION: Brown tiles and adhesive. G3, G4, G5, G6, G8 and G9 floors.

| <b>Asbestos Present?</b> | None detected |

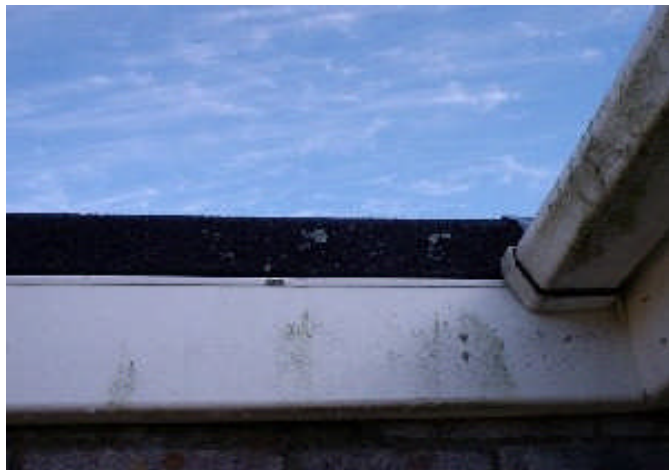
Ref. No. 017596/003P

DESCRIPTION: Flat felt. External porch and rear flat roof.

| <b>Asbestos Present?</b> | Presumed asbestos present |

| | <b>Material Assessment:</b> | 5 |

The Asbestos Management Plan will need to be updated to include the above material. This plan should state the means of managing the acm, eg: the frequency of a periodic inspection regime and whether or not labelling is required etc. Also a risk assessment will need to be undertaken if this acm is likely to be disturbed by maintenance or refurbishment works. This may confirm that the acm can be removed by a **competent contractor** under the control of Asbestos Regulations 2006 Approved Code of Practice L143 and disposed of as hazardous waste

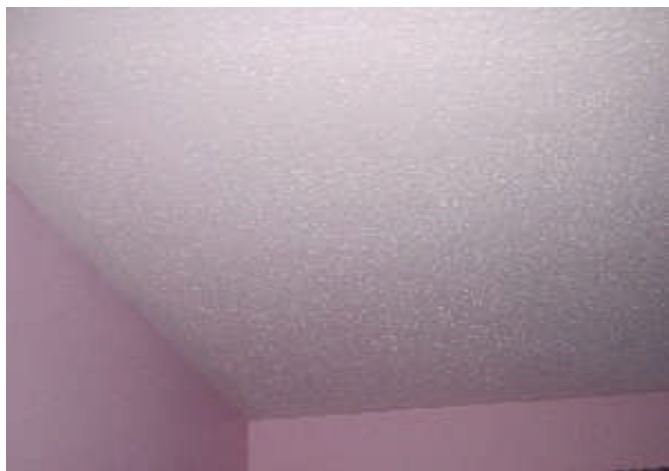
Ref. No. 017596/004

DESCRIPTION: Artex. G4, G5, G6 and G7 ceilings.

| <b>Asbestos Present?</b> | Yes |
| <b>Lab Detail:</b> | Chrysotile - White |

| | <b>Material Assessment:</b> | <b>4</b> |

This material was found at more than one location but has the same material assessment score.

The Asbestos Management Plan will need to be updated to include the above material. This plan should state the means of managing the acm, eg: the frequency of a periodic inspection regime and whether or not labelling is required etc. Also a risk assessment will need to be undertaken if this acm is likely to be disturbed by maintenance or refurbishment works. This may confirm that the acm can be removed by a **competent contractor** under the control of Asbestos Regulations 2006 Approved Code of Practice L143 and disposed of as hazardous waste

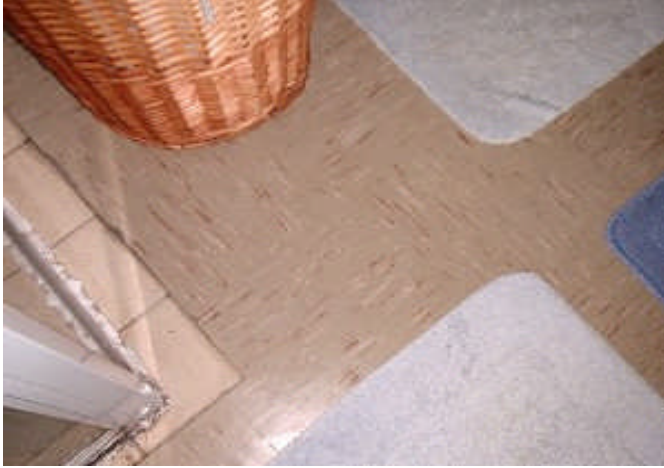
Ref. No. 017596/005

DESCRIPTION: Grey flex tiles and adhesive. G7 floor.

| <b>Asbestos Present?</b> | None detected |

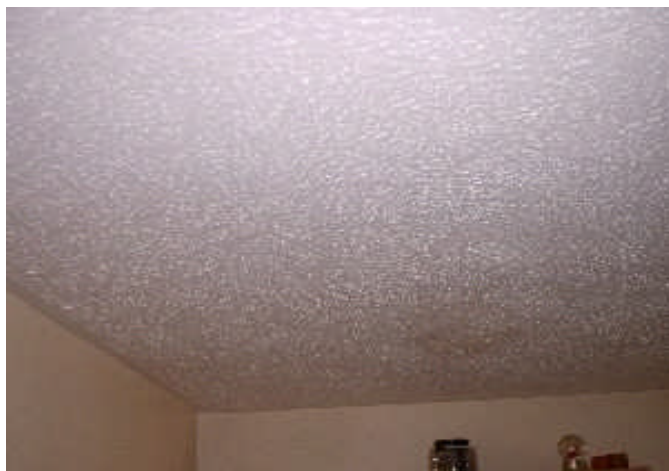
Ref. No. 017596/006

DESCRIPTION: Artex. G8 and G9 ceilings.

| <b>Asbestos Present?</b> | Yes |
| <b>Lab Detail:</b> | Chrysotile - White |

| | <b>Material Assessment:</b> | 4 |

This material was found at more than one location but has the same material assessment score.

The Asbestos Management Plan will need to be updated to include the above material. This plan should state the means of managing the acm, eg: the frequency of a periodic inspection regime and whether or not labelling is required etc. Also a risk assessment will need to be undertaken if this acm is likely to be disturbed by maintenance or refurbishment works. This may confirm that the acm can be removed by a **competent contractor** under the control of Asbestos Regulations 2006 Approved Code of Practice L143 and disposed of as hazardous waste

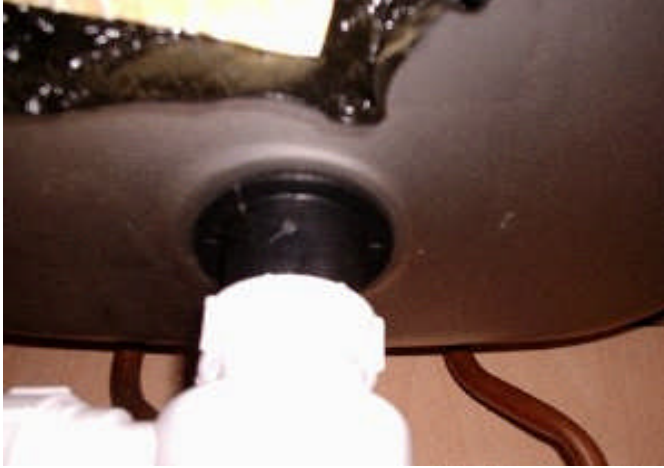
Ref. No. 017596/007

DESCRIPTION: Baffle. G8 sink unit.

Asbestos Present? None detected  
Lab Detail:

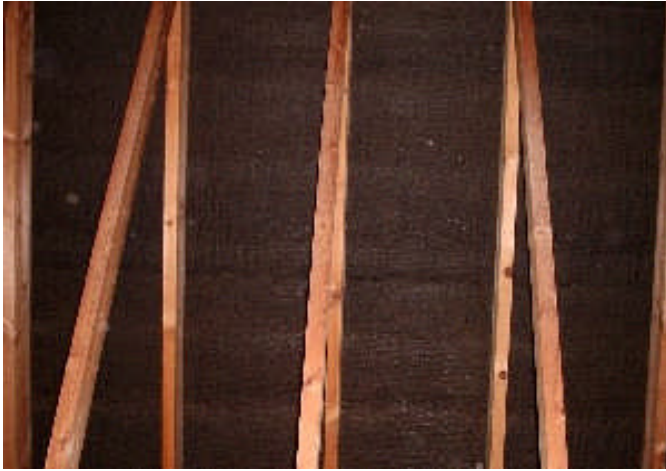
Ref. No. 017596/008

DESCRIPTION: Pitched felt. RV1 main roof void.

**Asbestos Present?** None detected  
**Lab Detail:**

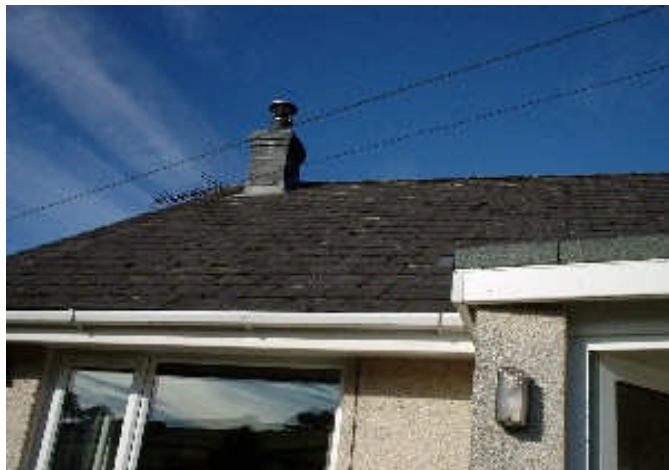
Ref. No. 017596/009

DESCRIPTION: Composite slate. External roof.

| <b>Asbestos Present?</b> | Yes | | |
| <b>Lab Detail:</b> | Chrysotile - White | | |

| | <b>Material Assessment:</b> | <b>4</b> |

The Asbestos Management Plan will need to be updated to include the above material. This plan should state the means of managing the acm, eg: the frequency of a periodic inspection regime and whether or not labelling is required etc. Also a risk assessment will need to be undertaken if this acm is likely to be disturbed by maintenance or refurbishment works. This may confirm that the acm can be removed by a **competent contractor** under the control of Asbestos Regulations 2006 Approved Code of Practice L143 and disposed of as hazardous waste

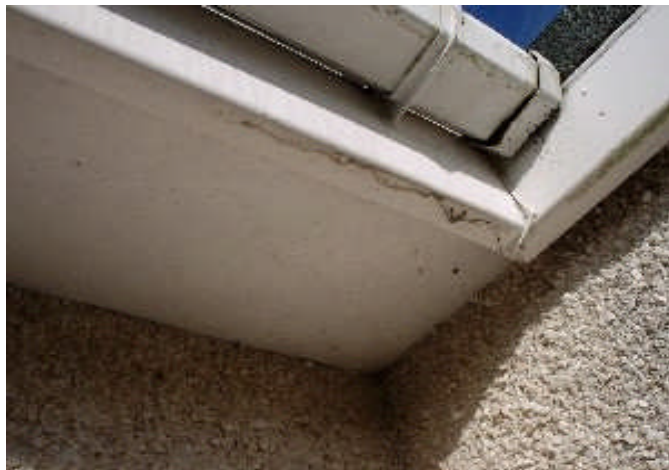
Ref. No. 017596/010

DESCRIPTION: Insulating board. External soffit.

| <b>Asbestos Present?</b> | Yes |
| <b>Lab Detail:</b> | Amosite - Brown |

| | <b>Material Assessment:</b> | 7 |

The Asbestos Management Plan will need to be updated to include the above material. This plan should state the means of managing the acm, eg: the frequency of a periodic inspection regime and whether or not labelling is required etc. Also a risk assessment will need to be undertaken if this acm is likely to be disturbed by maintenance or refurbishment works. This may confirm that the acm can be removed by a **HSE Licensed contractor** under the control of Asbestos Regulations 2006 Approved Code of Practice L143 and disposed of as hazardous waste
