## **Asbestos Refurbishment Survey External Garages**

**Barcud Tai Ceridigion**

**Beeches Garages  
Llandysul  
Ceredigion  
SA44 4HS**

**Project Reference: P-443744**

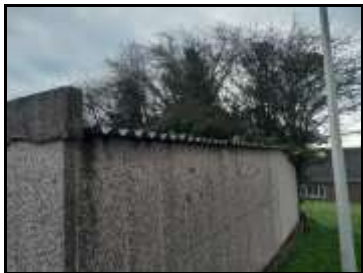
| | Item description: | Corrugated roof sheets | | | | | |
| | Quantity / Extent: | 16 m² | | | | | |
| Product Type: | 1 | Condition: | 0 | Surface Treatment: | 1 | Asbestos Type: | 1 |

| Recommended action: | Remove if likely to be disturbed by the refurbishment, otherwise monitor condition. | | | | | | |

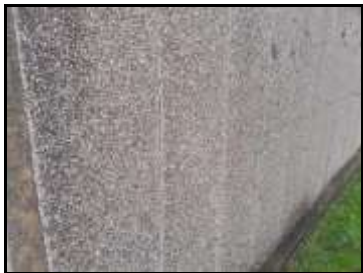
| | Item description: | Mastic to wall/s | | | | | |
| | Quantity / Extent: | 16 m linear | | | | | |
| Product Type: | 1 | Condition: | 0 | Surface Treatment: | 0 | Asbestos Type: | 1 |

| Recommended action: | Remove if likely to be disturbed by the refurbishment, otherwise monitor condition. | | | | | | |

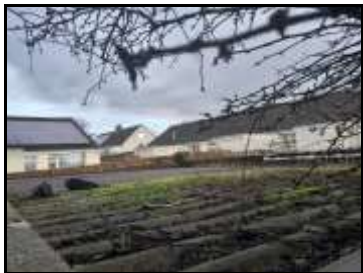
| | Item description: | Corrugated roof sheets | | | | | |
| | Quantity / Extent: | 16 m² | | | | | |
| Product Type: | 1 | Condition: | 0 | Surface Treatment: | 1 | Asbestos Type: | 1 |

| Recommended action: | Remove if likely to be disturbed by the refurbishment, otherwise monitor condition. | | | | | | |

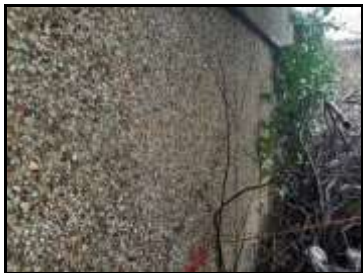
| | Item description: | Mastic to wall/s | | | | | |
| | Quantity / Extent: | 16 m linear | | | | | |
| Product Type: | 1 | Condition: | 0 | Surface Treatment: | 0 | Asbestos Type: | 1 |

| Recommended action: | Remove if likely to be disturbed by the refurbishment, otherwise monitor condition. | | | | | | |

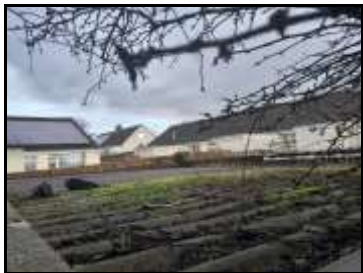
| | Item description: | Corrugated roof sheets | | | | | |
| | Quantity / Extent: | 6 m² | | | | | |

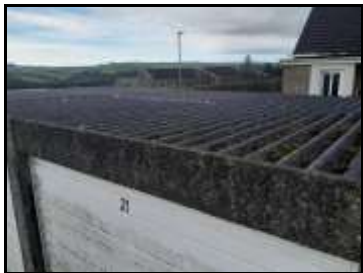
| | Item description: | Corrugated roof sheets | | | | | |
| | Quantity / Extent: | 6 m² | | | | | |
| Product Type: | 1 | Condition: | 0 | Surface Treatment: | 1 | Asbestos Type: | 1 |

| Recommended action: | Remove if likely to be disturbed by the refurbishment, otherwise monitor condition. | | | | | | |

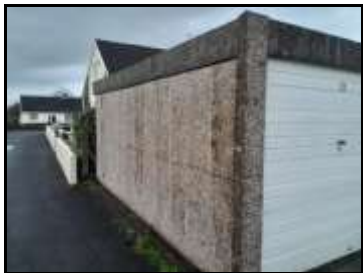
| | Item description: | Mastic to wall/s | | | | | |
| | Quantity / Extent: | 16 m linear | | | | | |
| Product Type: | 1 | Condition: | 0 | Surface Treatment: | 0 | Asbestos Type: | 1 |

| Recommended action: | Remove if likely to be disturbed by the refurbishment, otherwise monitor condition. | | | | | | |

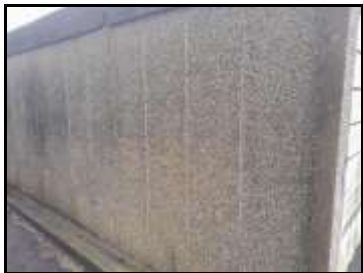
| | Item description: | Mastic to wall/s | | | | | |
| | Quantity / Extent: | 16 m linear | | | | | |
| Product Type: | 1 | Condition: | 0 | Surface Treatment: | 0 | Asbestos Type: | 1 |

| Recommended action: | Remove if likely to be disturbed by the refurbishment, otherwise monitor condition. | | | | | | |

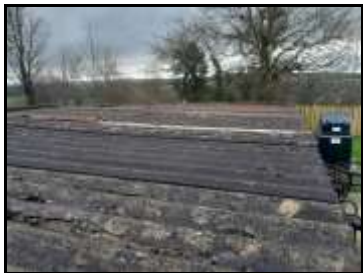
| | Item description: | Corrugated roof sheets | | | | | |
| | Quantity / Extent: | 20 m² | | | | | |
| Product Type: | 1 | Condition: | 0 | Surface Treatment: | 1 | Asbestos Type: | 1 |

| Recommended action: | Remove if likely to be disturbed by the refurbishment, otherwise monitor condition. | | | | | | |

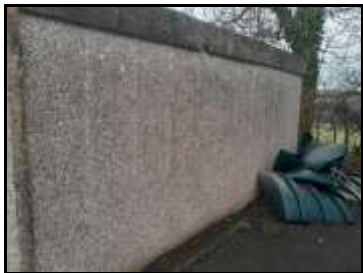
| | Item description: | Mastic to wall/s | | | | | |
| | Quantity / Extent: | 20 m linear | | | | | |
| Product Type: | 1 | Condition: | 0 | Surface Treatment: | 0 | Asbestos Type: | 1 |

| Recommended action: | Remove if likely to be disturbed by the refurbishment, otherwise monitor condition. | | | | | | |

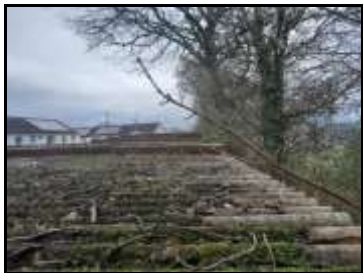
| | Item description: | Corrugated roof sheets | | | | | |
| | Quantity / Extent: | 30 m² | | | | | |
| Product Type: | 1 | Condition: | 0 | Surface Treatment: | 1 | Asbestos Type: | 1 |

| Recommended action: | Remove if likely to be disturbed by the refurbishment, otherwise monitor condition. | | | | | | |

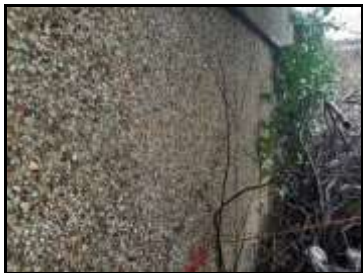
| | Item description: | Mastic to wall/s | | | | | |
| | Quantity / Extent: | 16 m linear | | | | | |
| Product Type: | 1 | Condition: | 0 | Surface Treatment: | 0 | Asbestos Type: | 1 |

| Recommended action: | Remove if likely to be disturbed by the refurbishment, otherwise monitor condition. | | | | | | |

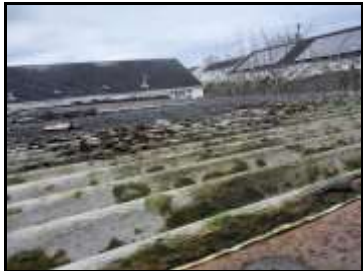
| | Item description: | Corrugated roof sheets | | | | | |
| | Quantity / Extent: | 16 m² | | | | | |
| Product Type: | 1 | Condition: | 0 | Surface Treatment: | 1 | Asbestos Type: | 1 |

| Recommended action: | Remove if likely to be disturbed by the refurbishment, otherwise monitor condition. | | | | | | |

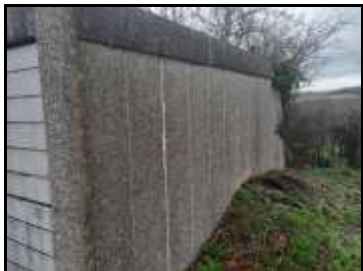
| | Item description: | Mastic to wall/s | | | | | |
| | Quantity / Extent: | 8 m linear | | | | | |
| Product Type: | 1 | Condition: | 0 | Surface Treatment: | 0 | Asbestos Type: | 1 |

| Recommended action: | Remove if likely to be disturbed by the refurbishment, otherwise monitor condition. | | | | | | |

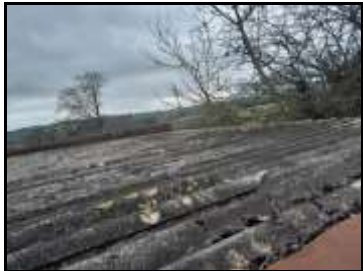
| | Item description: | Corrugated roof sheets | | | | | |
| | Quantity / Extent: | 8 m² | | | | | |
| Product Type: | 1 | Condition: | 0 | Surface Treatment: | 1 | Asbestos Type: | 1 |

| Recommended action: | Remove if likely to be disturbed by the refurbishment, otherwise monitor condition. | | | | | | |
