Project:  
37 THE WALK, NEW INN, PONTYPOOL

Title:  
SURVEY PHOTO ID

Date: 25.07.25 Job No. P0560 Drawing No. SK06s Revision: - Suitability: -

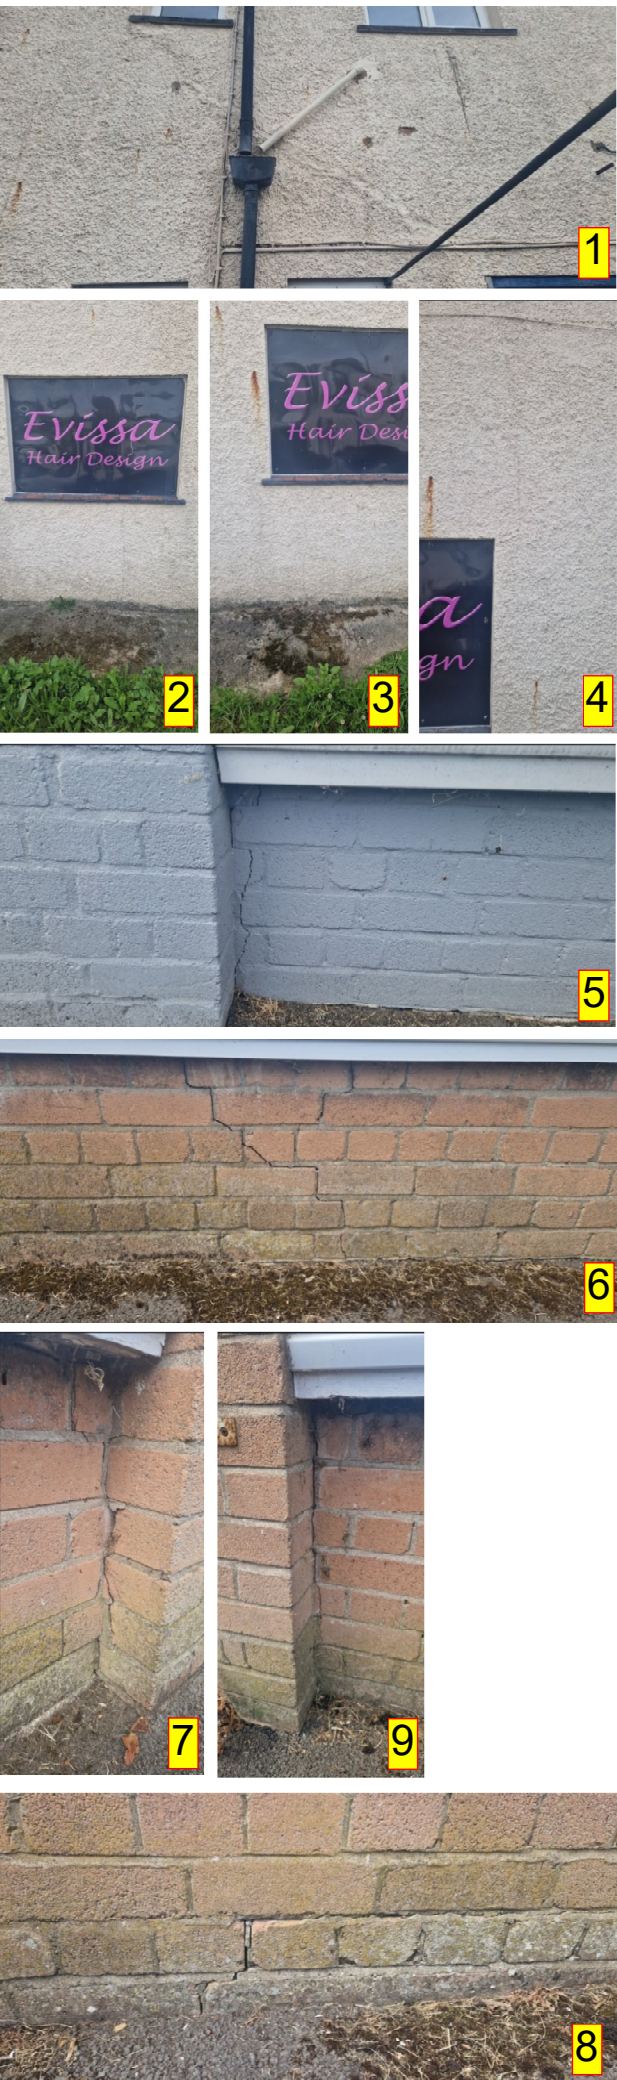
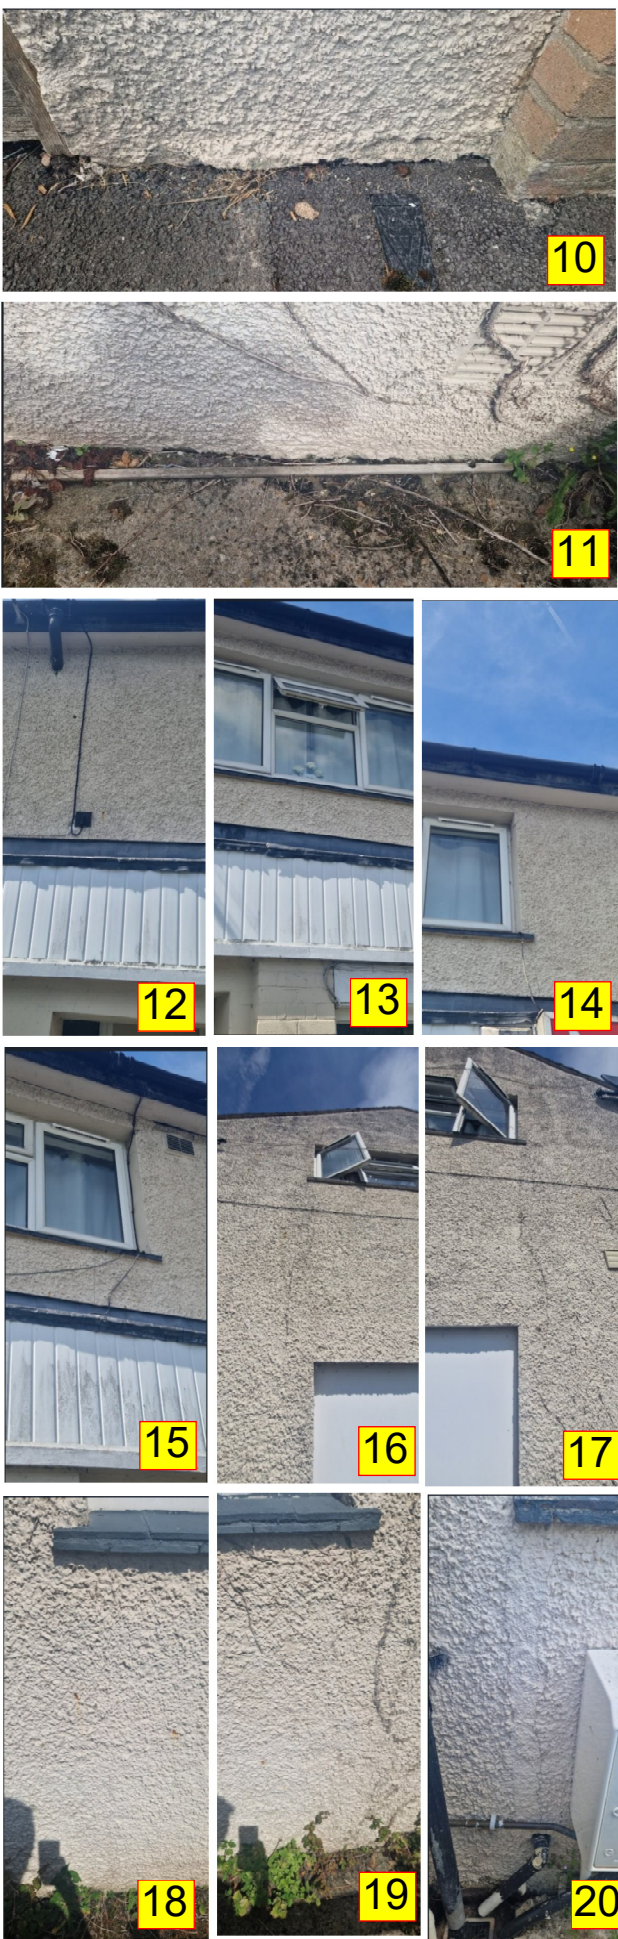
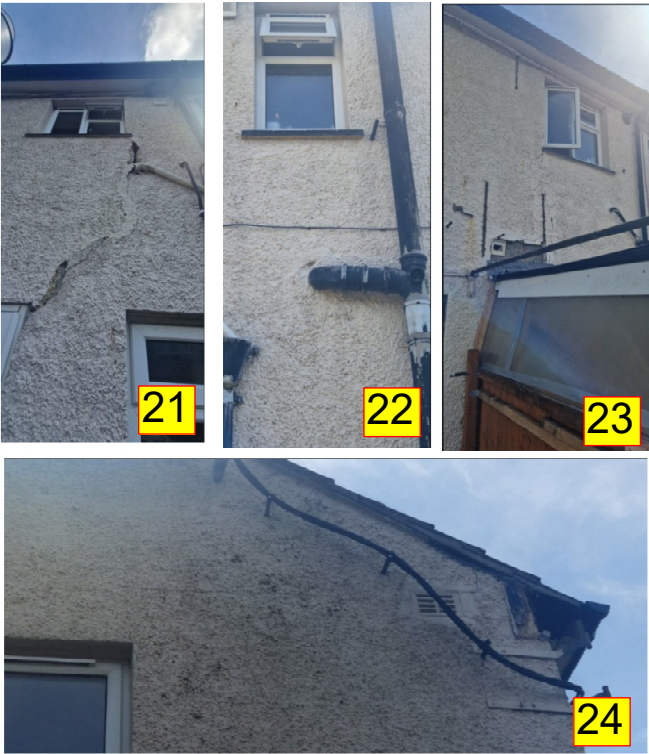
1. Diagonal crack - REM 1
2. Vertical crack - REM 2
3. Vertical crack - REM 2
4. Diagonal crack - REM 1
5. Vertical crack - REM 2
6. Diag/Vert crack - REM 2
7. Vertical crack - REM 2
8. Horizontal crack - REM 2
9. Vertical crack - REM 2
10. Horizontal gap/crack - REM 2
11. Horizontal gap - REM 2
12. Vertical crack - REM 2
13. Vertical crack - REM 2
14. Vertical crack - REM 2
15. Vertical crack - REM 2
16. Vertical crack - REM 2
17. Vertical crack - REM 2
18. Vertical crack - REM 2
19. Vertical crack - REM 2
20. Vertical crack - REM 2
21. Diagonal crack - REM 1
22. Vertical crack - REM 2
23. Vertical crack - REM 2
24. Horizontal gap - REM 2
