MERTHYR VALLEY HOMES

YEW CLOSE GARAGES,  
MERTHYR TYDFIL

BUILDING INSPECTION  
REPORT

Document Ref: E25132001/DOC 01 – JUNE 2025

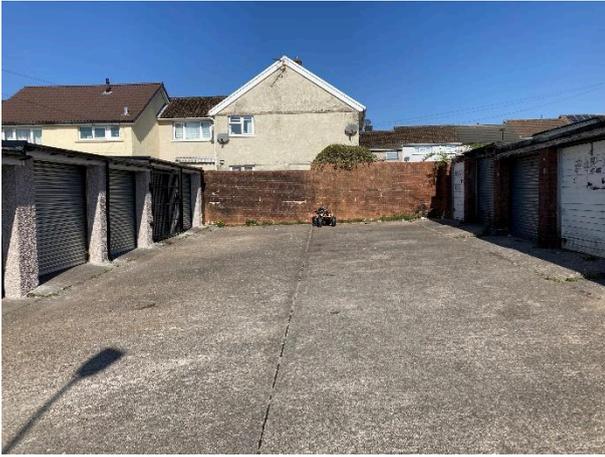
- 3.6 The survey only identified minor potential roost features (PRFs) associated with the external elevations. This included gaps associated with rotten wood around the door frames of units 8 and 9, and missing pebble dash and mortar on unit 16, which provide small access points into the internal garage space (see Figures 2 & 3). There were also a small gap between the door frames associated with unit 19. No other PRFs were identified during the survey.

***Figure 2 – Missing/rotten wooden frame (units 8 & 9)***

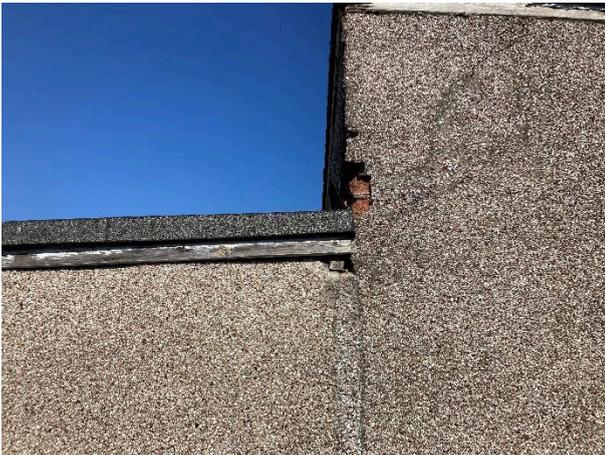
**Figure 3 – Missing pebble dash on unit 16**

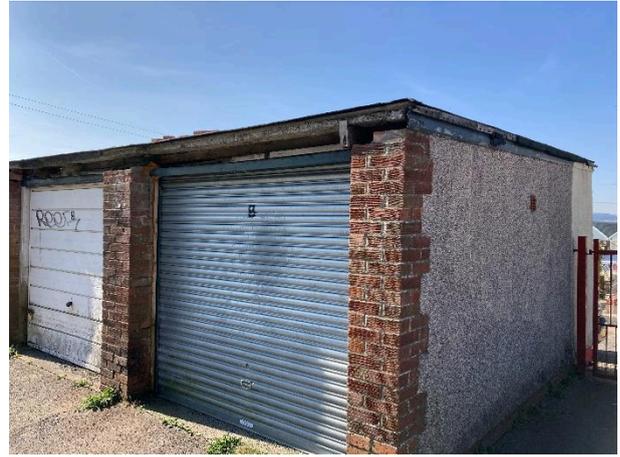
- 3.7 An internal inspection of garage units 9, 10, 11, 12, 14, 15, 16, 17, 20 and 21 was undertaken during the current survey. As discussed in paragraph 2.7, units 8, 13, 18 and 19 were not inspected internally due to health and safety concerns or seized locks. Internally the garages do not support a cavity wall, with the walls consisting of brick and breezeblock (Figure 4). Inside the garage roof comprises of stramit board (wood wool board), bitumen felt and timber beams. The only PRF associated with the internal aspect of the garage units is a small gap (3-4cm) to the rear of units 9-15 between the timber beam and wall (Figure 5). Other gaps have been filled in with spray/foam insulation. Apart from the external gaps to units 8, 9, 16 and 19 there are no other access points for bats. In addition, those with collapsed or partly collapsed roofs (Figure 6) were considered unsuitable to support roosting bats as they are likely open, well-lit and exposed to weather conditions.

**Figure 4 – Internal garage space**

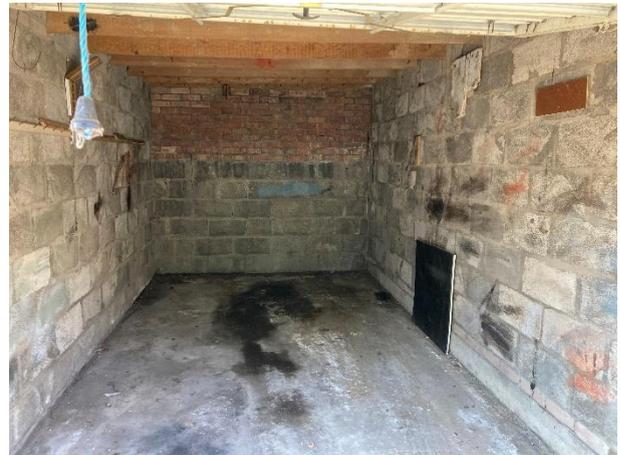
**Figure 5 – Gap to rear of garage units**

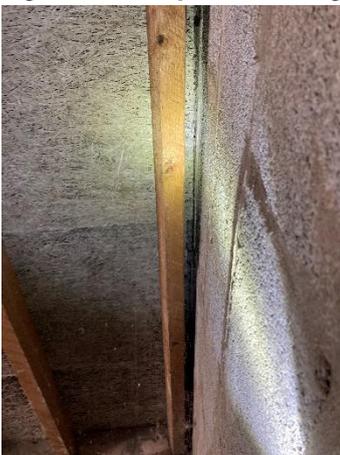
containing garage units 8-21, comprise of brick, pebble dash, metal doors, a combination of wooden and metal frames and felt roofing. The garage units are in a poor condition and in a general state of disrepair. For example, many of the wooden door frames are rotten, doors damaged and the roof to the rear of units 21-18 has collapsed.

**Figure 6 – Collapsed roof (unit 20)**

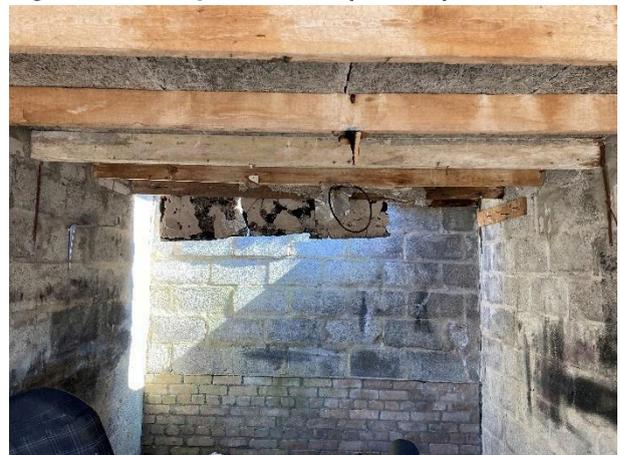
- 3.8 No evidence of roosting bats (or nesting birds) was found during the internal inspection e.g., droppings or feeding remains. Rat droppings were noted within units 9 and 10 (Figure 7). In combination with the lack of ecological features at the site, well-lit environment and lack of ecological connectivity (built-up residential area), the garage units were assessed to be of Negligible potential to support roosting bats.

**Figure 7 – Rat droppings**
