ASBESTOS DEMOLITION SURVEY
OF
GARAGE 15, YEW CLOSE, GURNOS ESTATE, MERTHYR TYDFIL, CF47 9SD

UPRN NO: 2478
PROJECT NO: J1020282
DATE: MAY 2025

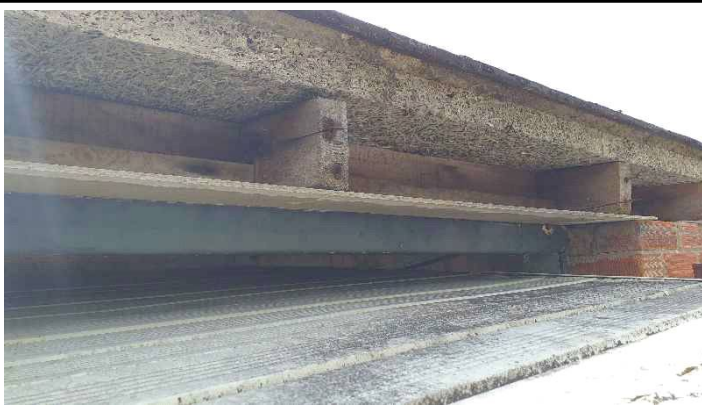
FLOOR/LOCATION:	External

DESCRIPTION:	Cement soffits	
RECOMMENDATIONS:	Remove under controlled conditions	
EXTENT:	<10m² or <10m pipe run	
SAMPLE REF:	ZM005671	
RESULT:	Chrysotile

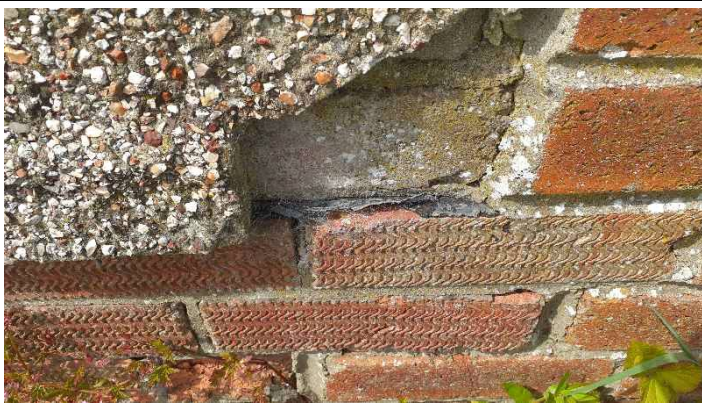
FLOOR/LOCATION:	External

DESCRIPTION:	DPC	
RECOMMENDATIONS:	No further action required	
EXTENT:	-	
SAMPLE REF:	ZM005672	
RESULT:	No Asbestos Detected

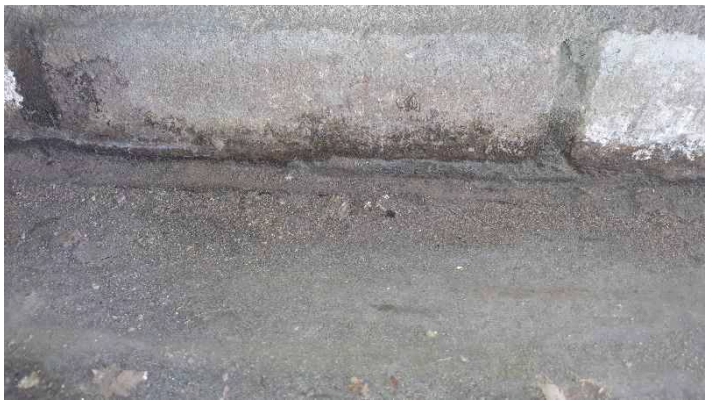
FLOOR/LOCATION:	Ground Floor Storage

DESCRIPTION:	Low level DPC between brickwork and concrete floor	
RECOMMENDATIONS:	No further action required	
EXTENT:	-	
SAMPLE REF:	ZM005668	
RESULT:	No Asbestos Detected

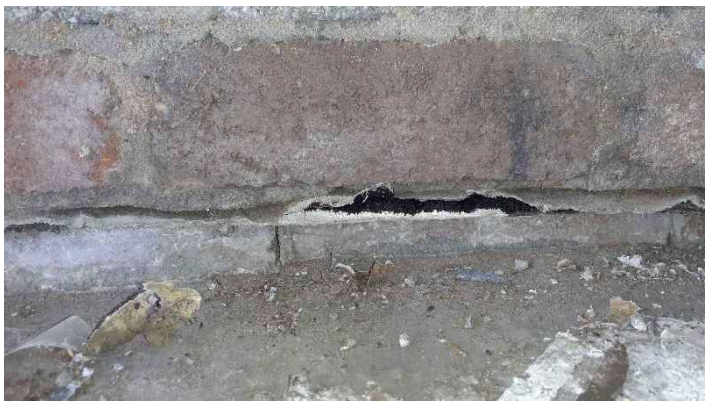
FLOOR/LOCATION:	Ground Floor Storage

DESCRIPTION:	Low level DPC to brickwork	
RECOMMENDATIONS:	No further action required	
EXTENT:	-	
SAMPLE REF:	ZM005669	
RESULT:	No Asbestos Detected
