ASBESTOS DEMOLITION SURVEY
OF
GARAGE 20 YEW CLOSE, GURNOS ESTATE, MERTHYR TYDFIL, CF47 9SD

CLIENT: MERTHYR VALLEYS HOMES LTD
TY BRYCHAN , 22 LANSBURY ROAD, MERTHYR TYDFIL, CF48 1HA

UPRN NO: 0103151
PROJECT NO: J1018708
DATE: APRIL 2025

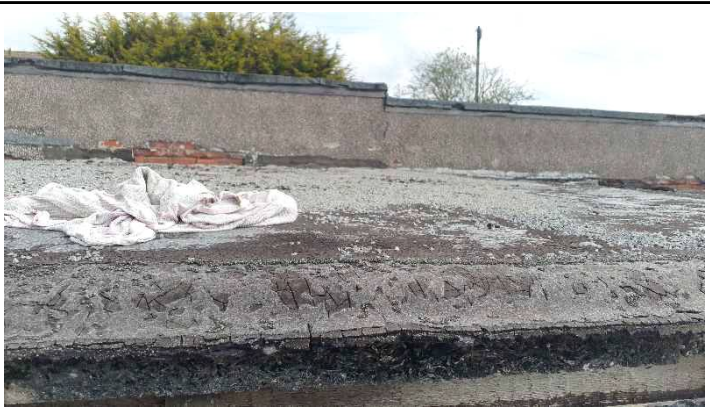
FLOOR/LOCATION:	External

DESCRIPTION:	Felt to roof	
RECOMMENDATIONS:	No further action required	
EXTENT:	-	
SAMPLE REF:	ZM005484	
RESULT:	No Asbestos Detected

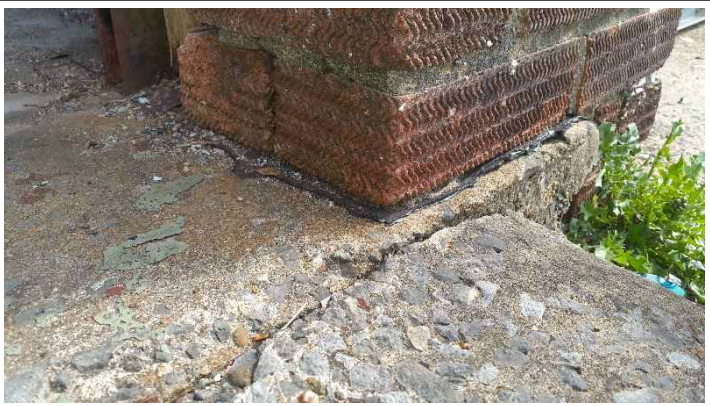
FLOOR/LOCATION:	External

DESCRIPTION:	DPC	
RECOMMENDATIONS:	No further action required	
EXTENT:	-	
SAMPLE REF:	ZM005485	
RESULT:	No Asbestos Detected

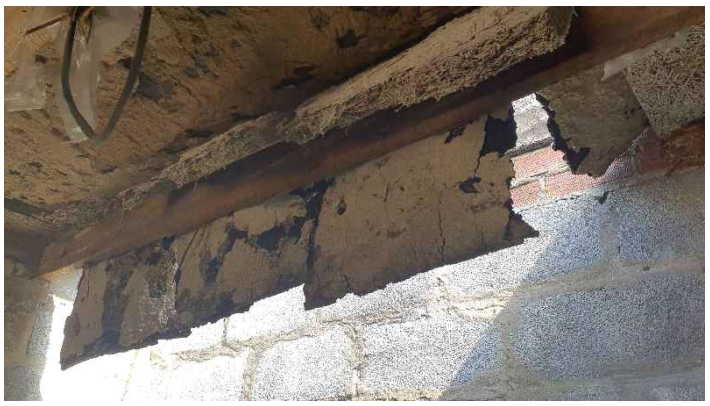
FLOOR/LOCATION:	Ground Floor Storage

DESCRIPTION:	Felt to partially damaged roof	
RECOMMENDATIONS:	No further action required	
EXTENT:	-	
SAMPLE REF:	ZM005480	
RESULT:	No Asbestos Detected

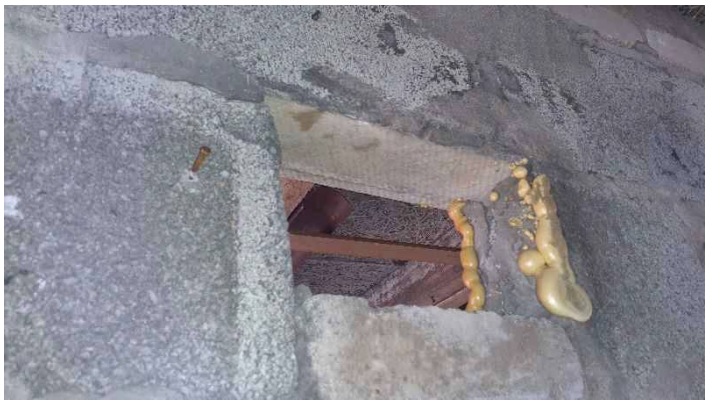
FLOOR/LOCATION:	Ground Floor Storage

Location	Description	Priority/Risk	Recommendation
Main building / Storage / Ground Floor / F00-01	Cement packer within wall	Very Low	Remove under controlled conditions

DESCRIPTION:	Cement packer within wall	
RECOMMENDATIONS:	Remove under controlled conditions	
EXTENT:	<10m² or <10m pipe run	
SAMPLE REF:	ZM005481	
RESULT:	Chrysotile

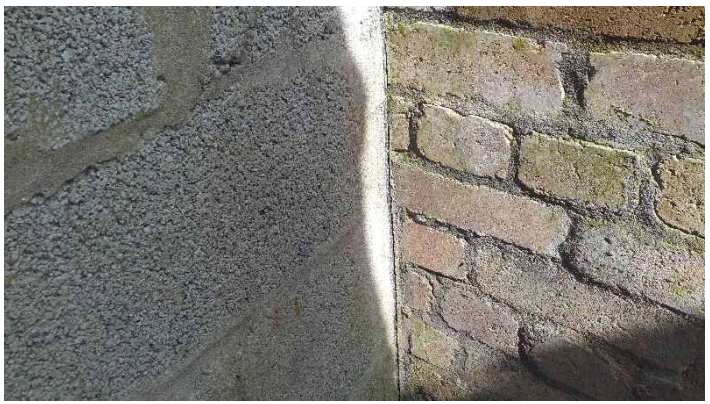
FLOOR/LOCATION:	Ground Floor Storage

DESCRIPTION:	Vertical DPC to brickwork	
RECOMMENDATIONS:	No further action required	
EXTENT:	-	
SAMPLE REF:	ZM005482	
RESULT:	No Asbestos Detected

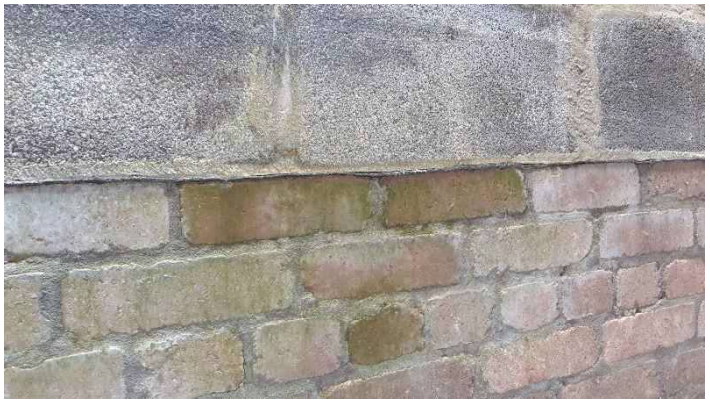
FLOOR/LOCATION:	Ground Floor Storage

DESCRIPTION:	Horizontal DPC to brickwork	
RECOMMENDATIONS:	No further action required	
EXTENT:	-	
SAMPLE REF:	ZM005483	
RESULT:	No Asbestos Detected
