ASBESTOS DEMOLITION SURVEY  
OF  
GARAGE 11 YEW CLOSE, GURNOS ESTATE, MERTHYR TYDFIL, CF47 9SD

CLIENT: MERTHYR VALLEYS HOMES LTD  
TY BRYCHAN , 22 LANSBURY ROAD, MERTHYR TYDFIL, CF48 1HA

UPRN NO: 010362  
PROJECT NO: J1020276  
DATE: MAY 2025

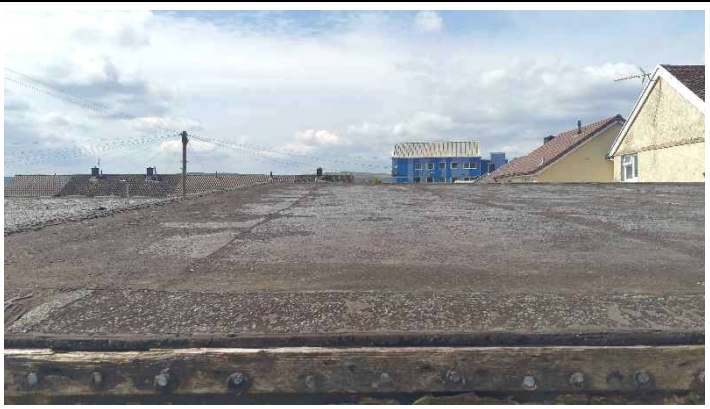
<b>FLOOR/LOCATION:</b>	External

<b>DESCRIPTION:</b>	Felt to roof	
<b>RECOMMENDATIONS:</b>	No further action required	
<b>EXTENT:</b>	-	
<b>SAMPLE REF:</b>	ZM005650	
<b>RESULT:</b>	No Asbestos Detected

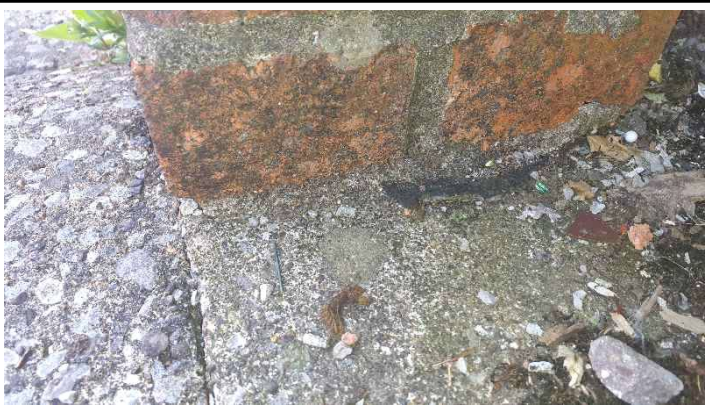
<b>FLOOR/LOCATION:</b>	External

<b>DESCRIPTION:</b>	DPC	
<b>RECOMMENDATIONS:</b>	No further action required	
<b>EXTENT:</b>	-	
<b>SAMPLE REF:</b>	ZM005651	
<b>RESULT:</b>	No Asbestos Detected

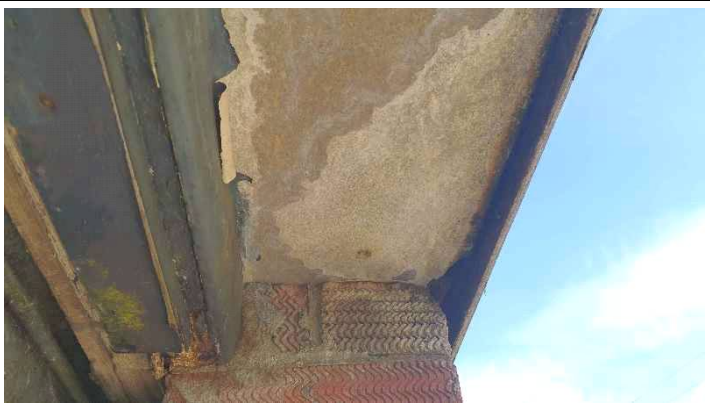
<b>FLOOR/LOCATION:</b>	External

Location	Description	Priority/Risk	Recommendation
Main building / External / External / E0-B1	Cement soffits	Very Low	Remove under controlled conditions

<b>DESCRIPTION:</b>	Cement soffits	
<b>RECOMMENDATIONS:</b>	Remove under controlled conditions	
<b>EXTENT:</b>	<10m <sup>2</sup> or <10m pipe run	
<b>SAMPLE REF:</b>	ZM005652	
<b>RESULT:</b>	Chrysotile

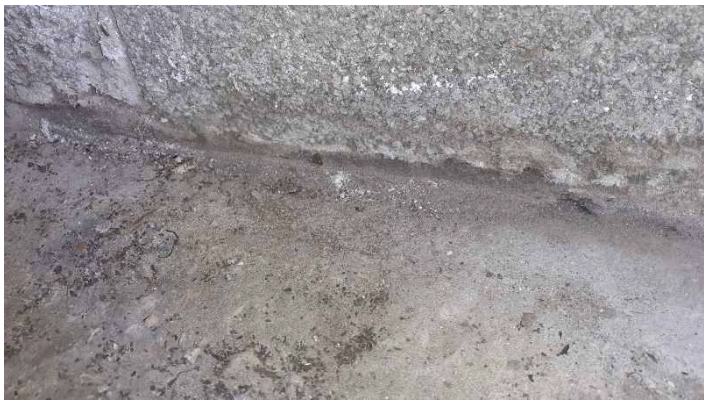
<b>FLOOR/LOCATION:</b>	Ground Floor Storage

<b>DESCRIPTION:</b>	Low level DPC to brickwork	
<b>RECOMMENDATIONS:</b>	No further action required	
<b>EXTENT:</b>	-	
<b>SAMPLE REF:</b>	ZM005649	
<b>RESULT:</b>	No Asbestos Detected
