ASBESTOS DEMOLITION SURVEY
OF
GARAGE 13 YEW CLOSE, GURNOS ESTATE, MERTHYR TYDFIL, CF47 9SD

CLIENT: MERTHYR VALLEYS HOMES LTD
TY BRYCHAN , 22 LANSBURY ROAD, MERTHYR TYDFIL, CF48 1HA

UPRN NO: 010380
PROJECT NO: J1020279
DATE: MAY 2025

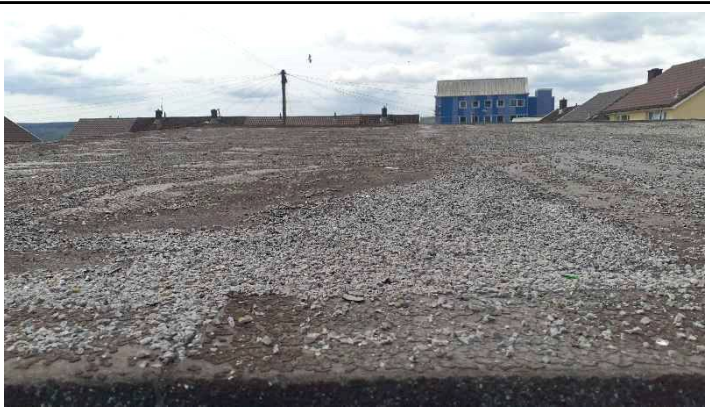
FLOOR/LOCATION:	External

DESCRIPTION:	Felt to roof	
RECOMMENDATIONS:	No further action required	
EXTENT:	-	
SAMPLE REF:	ZM005659	
RESULT:	No Asbestos Detected

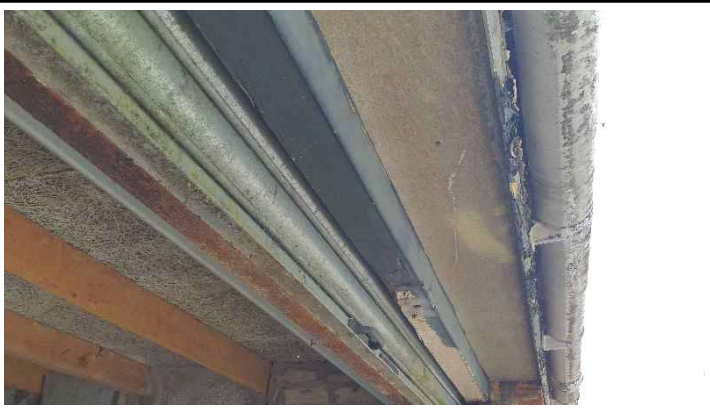
FLOOR/LOCATION:	External

Location	Description	Priority/Risk	Recommendation
Main building / External / External / E0-B1	Cement soffits	Very Low	Remove under controlled conditions

DESCRIPTION:	Cement soffits	
RECOMMENDATIONS:	Remove under controlled conditions	
EXTENT:	<10m² or <10m pipe run	
SAMPLE REF:	ZM005660	
RESULT:	Chrysotile

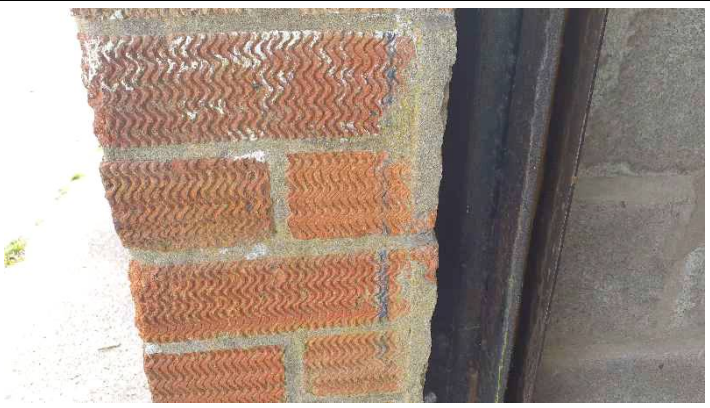
FLOOR/LOCATION:	External

DESCRIPTION:	Vertical DPC to brickwork	
RECOMMENDATIONS:	No further action required	
EXTENT:	-	
SAMPLE REF:	ZM005661	
RESULT:	No Asbestos Detected

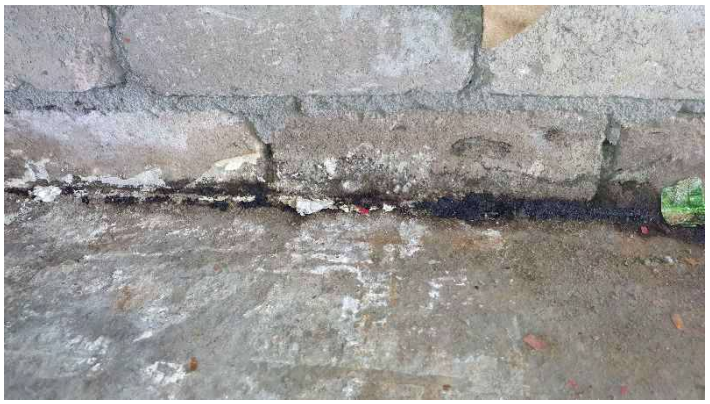
FLOOR/LOCATION:	Ground Floor Storage

DESCRIPTION:	Low level DPC between brickwork and concrete floor	
RECOMMENDATIONS:	No further action required	
EXTENT:	-	
SAMPLE REF:	ZM005658	
RESULT:	No Asbestos Detected
