ASBESTOS DEMOLITION SURVEY
OF
GARAGE 14 YEW CLOSE, GURNOS ESTATE, MERTHYR TYDFIL, CF47 9SD

CLIENT: MERTHYR VALLEYS HOMES LTD
TY BRYCHAN , 22 LANSBURY ROAD, MERTHYR TYDFIL, CF48 1HA

UPRN NO: 010390
PROJECT NO: J1020281
DATE: MAY 2025

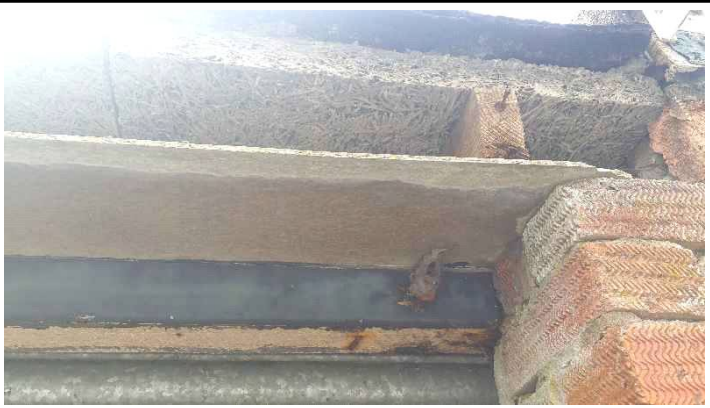
FLOOR/LOCATION:	External

DESCRIPTION:	Cement soffits	
RECOMMENDATIONS:	Remove under controlled conditions	
EXTENT:	<10m² or <10m pipe run	
SAMPLE REF:	ZM005663	
RESULT:	Chrysotile

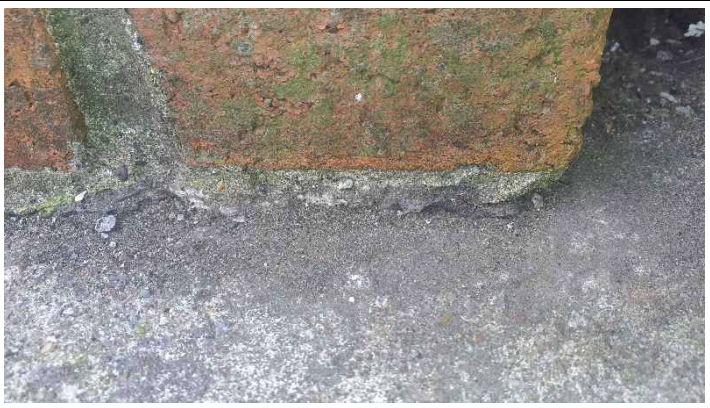
FLOOR/LOCATION:	External

DESCRIPTION:	DPC	
RECOMMENDATIONS:	No further action required	
EXTENT:	-	
SAMPLE REF:	ZM005664	
RESULT:	No Asbestos Detected

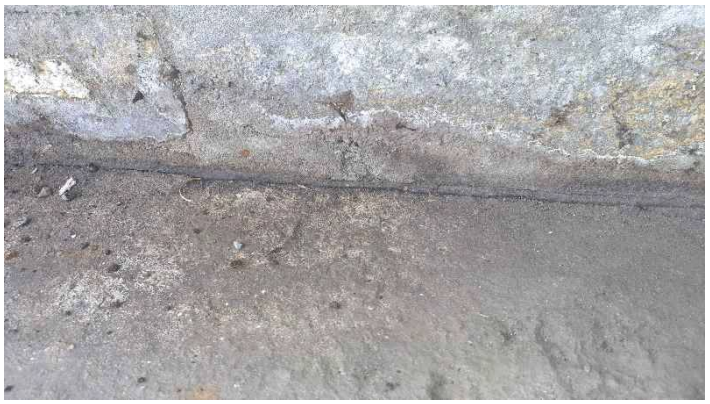
FLOOR/LOCATION:	Ground Floor Storage

DESCRIPTION:	Low level DPC between brickwork and concrete floor	
RECOMMENDATIONS:	No further action required	
EXTENT:	-	
SAMPLE REF:	ZM005665	
RESULT:	No Asbestos Detected

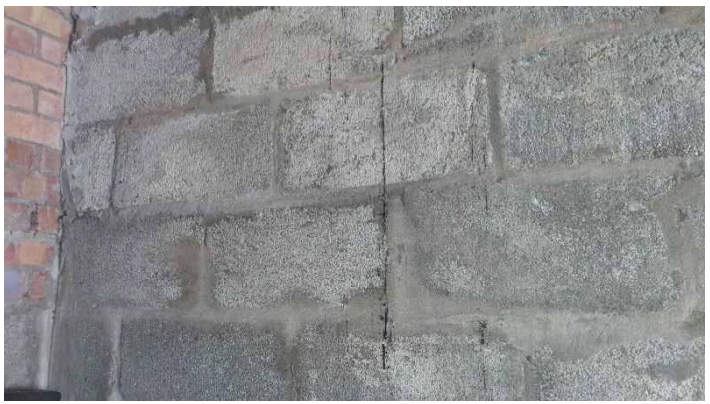
FLOOR/LOCATION:	Ground Floor Storage

DESCRIPTION:	Bitumen residue to wall	
RECOMMENDATIONS:	No further action required	
EXTENT:	-	
SAMPLE REF:	ZM005666	
RESULT:	No Asbestos Detected

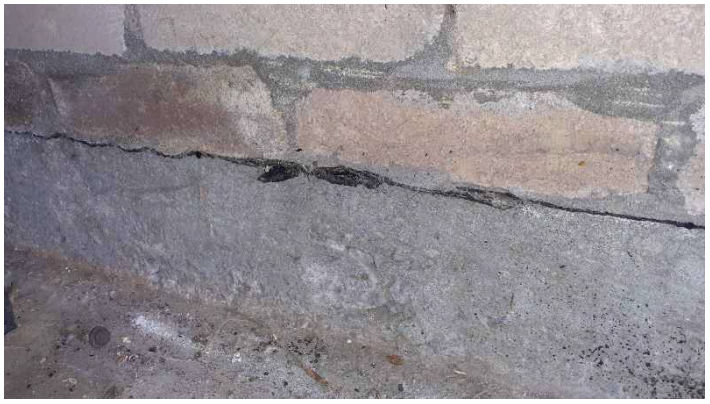
FLOOR/LOCATION:	Ground Floor Storage

DESCRIPTION:	Horizontal DPC to brickwork	
RECOMMENDATIONS:	No further action required	
EXTENT:	-	
SAMPLE REF:	ZM005667	
RESULT:	No Asbestos Detected
