ASBESTOS DEMOLITION SURVEY
OF
GARAGE 8, YEW CLOSE, MERTHYR TYDFIL, MID GLAMORGAN, CF47 9SD

CLIENT: MERTHYR VALLEYS HOMES LTD
TY BRYCHAN , 22 LANSBURY ROAD, MERTHYR TYDFIL, CF48 1HA

UPRN NO: 0103035
PROJECT NO: J1020269
DATE: MAY 2025

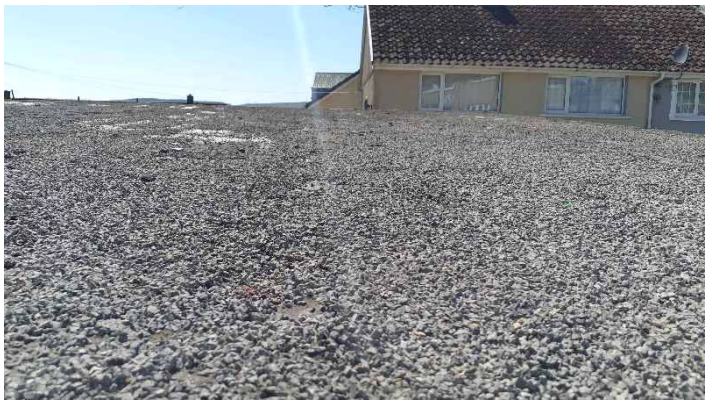
FLOOR/LOCATION:	External

DESCRIPTION:	Felt to roof	
RECOMMENDATIONS:	No further action required	
EXTENT:	-	
SAMPLE REF:	ZM005725	
RESULT:	No Asbestos Detected

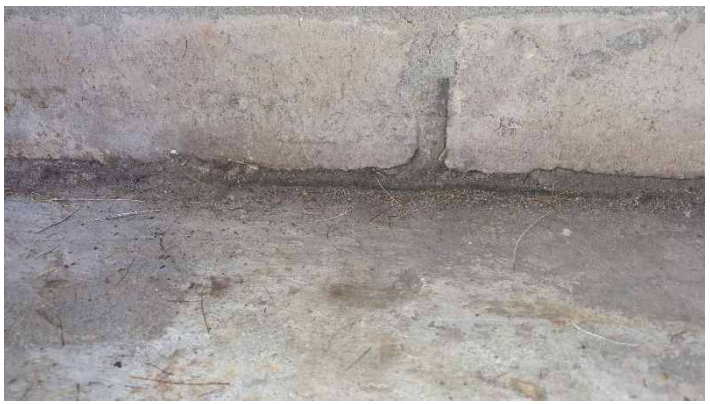
FLOOR/LOCATION:	Ground Floor Storage

DESCRIPTION:	Low level DPC between brickwork and concrete floor	
RECOMMENDATIONS:	No further action required	
EXTENT:	-	
SAMPLE REF:	ZM005745	
RESULT:	No Asbestos Detected

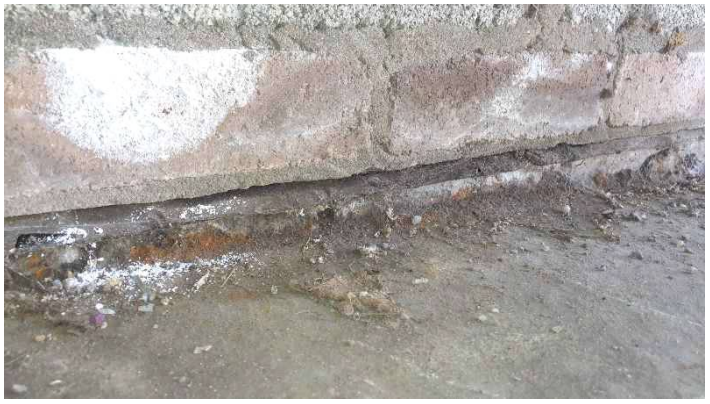
FLOOR/LOCATION:	Ground Floor Storage

DESCRIPTION:	Low level DPC to brickwork	
RECOMMENDATIONS:	No further action required	
EXTENT:	-	
SAMPLE REF:	ZM005746	
RESULT:	No Asbestos Detected
