ASBESTOS DEMOLITION SURVEY  
OF  
GARAGE 9, YEW CLOSE, MERTHYR TYDFIL, MID GLAMORGAN, CF47 9SD

CLIENT: MERTHYR VALLEYS HOMES LTD  
TY BRYCHAN , 22 LANSBURY ROAD, MERTHYR TYDFIL, CF48 1HA

UPRN NO: 0103044  
PROJECT NO: J1023295  
DATE: MAY 2025

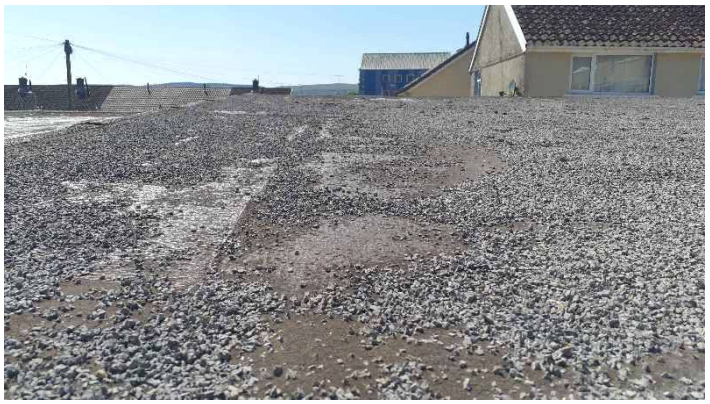
<b>FLOOR/LOCATION:</b>	External

<b>DESCRIPTION:</b>	Felt to roof	
<b>RECOMMENDATIONS:</b>	No further action required	
<b>EXTENT:</b>	-	
<b>SAMPLE REF:</b>	ZM005726	
<b>RESULT:</b>	No Asbestos Detected

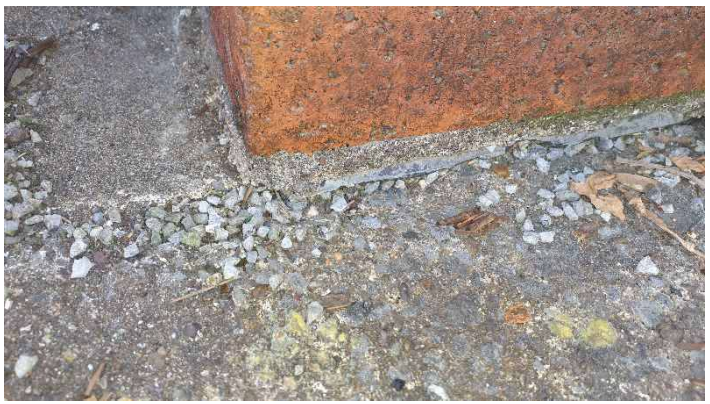
<b>FLOOR/LOCATION:</b>	External

<b>DESCRIPTION:</b>	DPC	
<b>RECOMMENDATIONS:</b>	No further action required	
<b>EXTENT:</b>	-	
<b>SAMPLE REF:</b>	ZM005728	
<b>RESULT:</b>	No Asbestos Detected

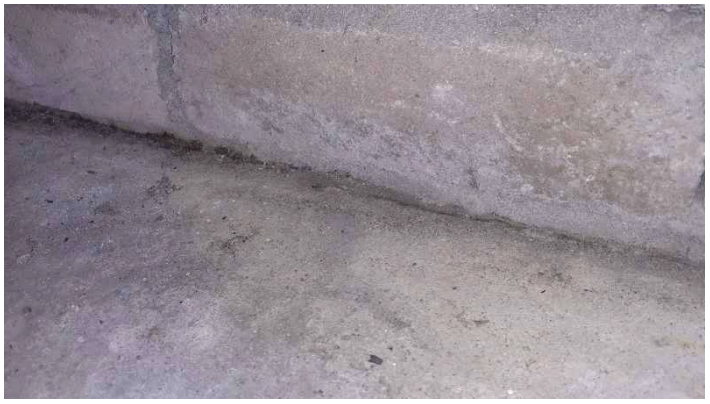
<b>FLOOR/LOCATION:</b>	Ground Floor Storage

<b>DESCRIPTION:</b>	Low level DPC between brickwork and concrete floor	
<b>RECOMMENDATIONS:</b>	No further action required	
<b>EXTENT:</b>	-	
<b>SAMPLE REF:</b>	ZM005744	
<b>RESULT:</b>	No Asbestos Detected
