Leasehold Condition Survey

The Walk, New Inn, Pontypool, NP4 0PU

Prepared for: Bron Afon Community Housing

Ref: 19510_R01

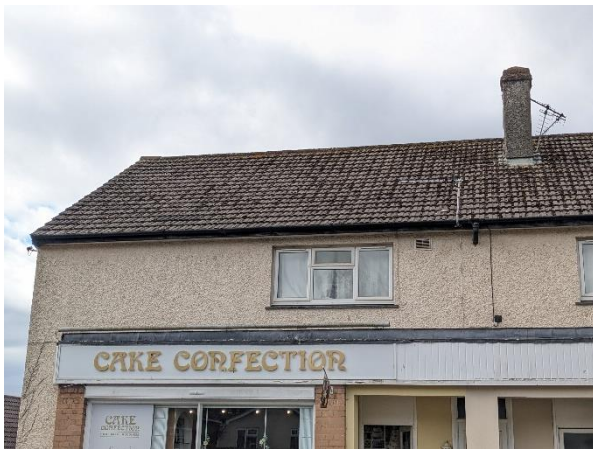
Photo 4 – Front elevation

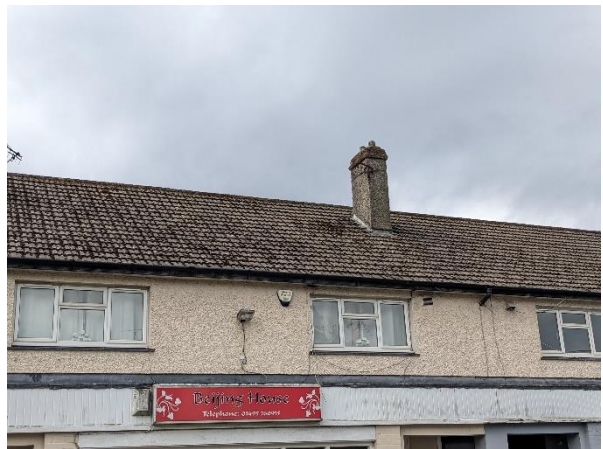
Photo 5 – Front elevation

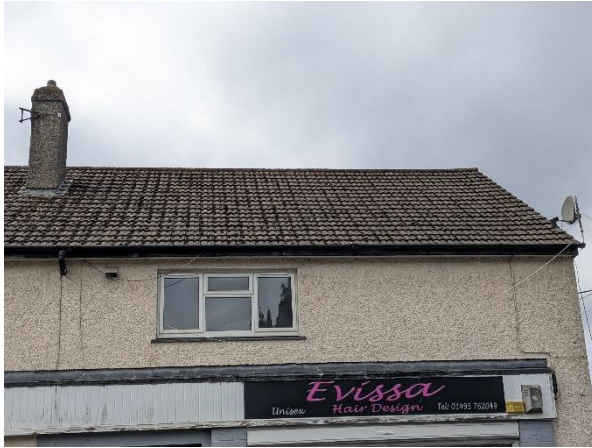
- 4.4. The chimney stacks appear to be in reasonable condition however there is severe moss growth to the flaunching's.
- 4.5. We identified a breach of fire compartmentation to the party wall within the roof space of 35A. The wall should be closed off with masonry to match existing to ensure adequate fire compartmentation is provided.

Photo 6 – Chimney to front right

Extend party wall to the underside of the roof for fire compartmentation.	To provide fire compartmentation between the flats.
Remove moss growth, repair render and renew the chimney leadwork. If the chimneys are not in use, consideration could be given to demolish the chimney stack and capping off below roof level.	<p>The render to the chimney should be repaired as a minimum to prevent any further damage as well as potential water ingress.</p> <p>Demolition of the stack during roof replacement would reduce future long term risks of water ingress if the chimneys are redundant.</p>

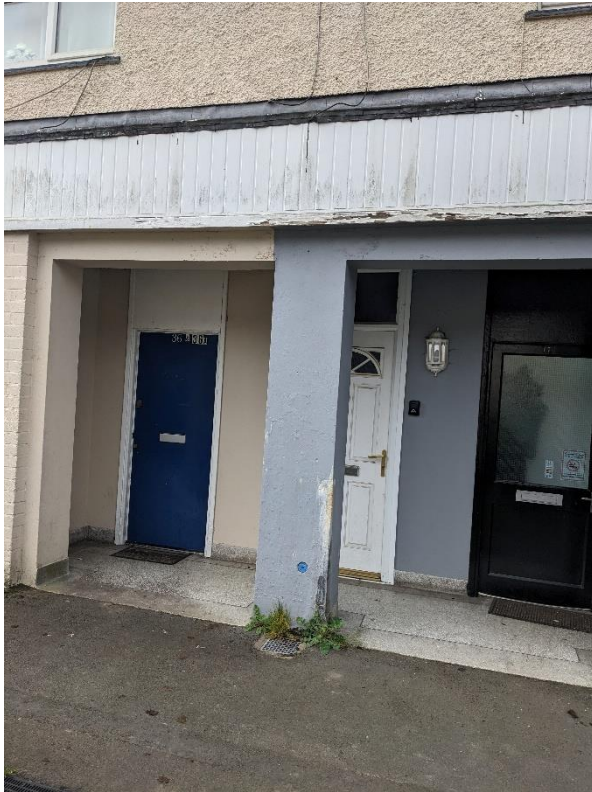
- 4.6. The PVC-u gutters and downpipes are in reasonable condition generally however they do appear aged and are soiled throughout.
- 4.7. There is staining at the gutter joints which indicates they may be leaking.
- 4.8. The downpipes to the front are concealed within the buildings wall at first floor level and within a pillar at ground floor level. There is efflorescence to the masonry pillar at ground floor level. This indicates the downpipes within the walls have deteriorated and are leaking.
- 4.9. A number of gullies appear to be blocked.

Photo 8 – Pillar containing downpipe to front

Recommendation	Reason
Replace gutters and downpipes during roof replacement works.	The gutters and downpipes are showing signs of age and will need to be removed and altered to facilitate the roof replacement work. Typically, PVC-u items tend to be damaged during this type of work, and we anticipate some of the gutters and downpipes would need to be renewed. Given the height of the building and cost of accessing this area we recommend the rainwater goods are replaced in their entirety to minimise future maintenance and repair costs.
Clean out and jet gullies and below ground drainage.	To ensure water is draining from the downpipes correctly and to prevent pooling water against the external walls.

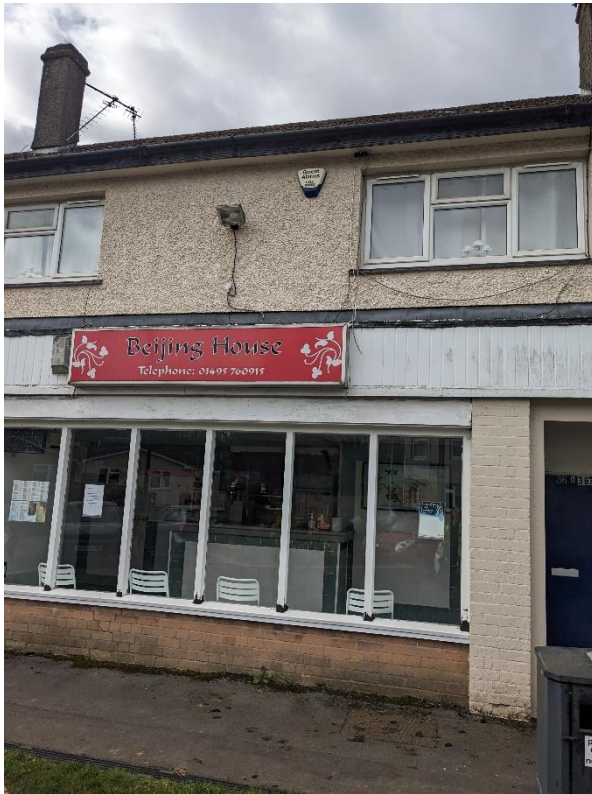
- 4.11. We observed minor cracking to the front and side elevations which is most likely due to thermal expansion and contraction due to lack of movement joints. We recommend that movement joints are installed (in accordance with structural engineer recommendations).

Photo 10 – Cracking below shopfront

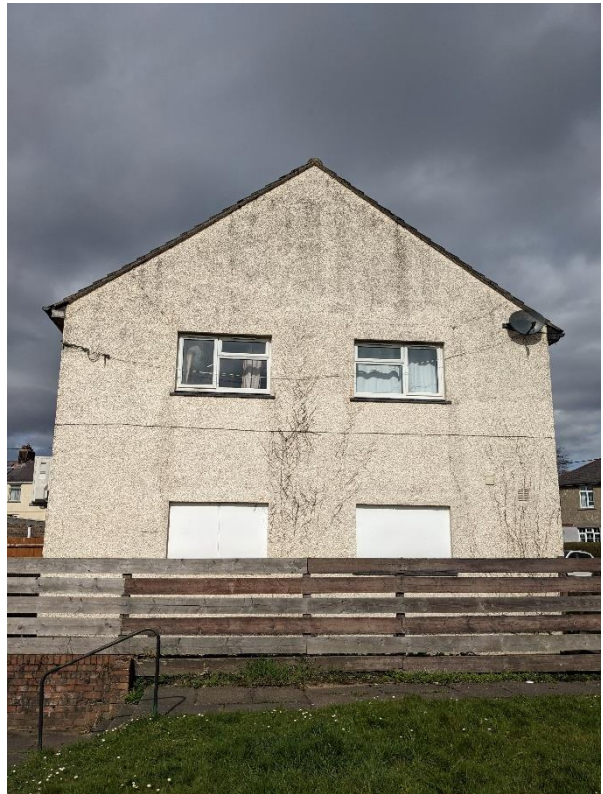
- 4.2. The traditional verge to the side elevations are constructed of an assumed concrete tile under cloak and wet mortar which is cracked throughout. The verge does not extend sufficiently past the external wall and provides minimal protection of the wall below against rainwater.

Photo 15 – Cracking to wet verge to left elevation

Recommendation	Reason
Extend the roof verges.	To provide an overhang to the gable elevations to improve protection of the external walls below.
Replace the fascia's and soffits to the pitched roof areas	The fascia and soffit will need to be removed and altered to facilitate the roof replacement work. Typically, the timber fascia's are beyond economic repair and will be damaged during this type of work, and we anticipate the fascia, and soffit would need to be renewed. Given the height of the building and cost of accessing this area we recommend they are replaced in their entirety to minimise future maintenance and repair costs.
Redistribute the insulation in the roof spaces to achieve required thickness. Upgrade the insulation to meet current building regulations.	Redistributing the existing insulation will reduce thermal bridging in the ceilings below. Building Regulations requires that insulation at ceiling level is improved during roof covering renewals.

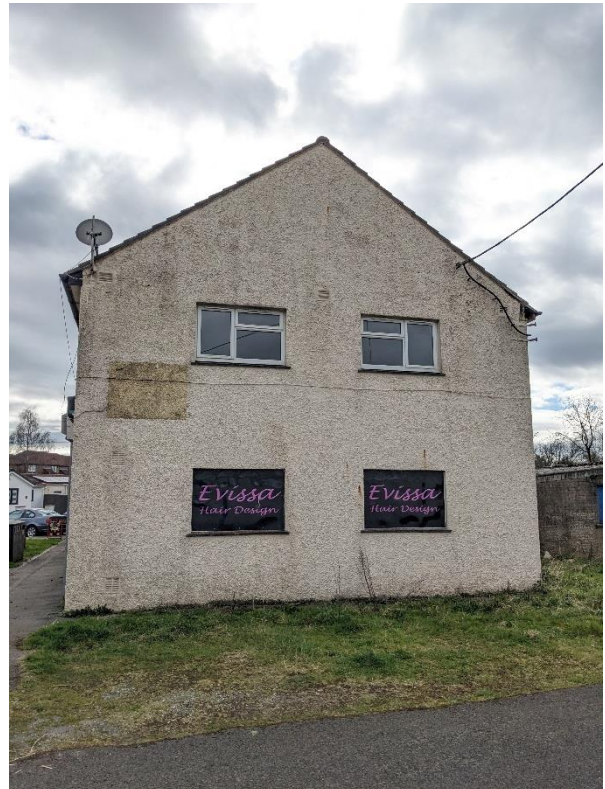
Photo 21 – Cracking below window to right elevation

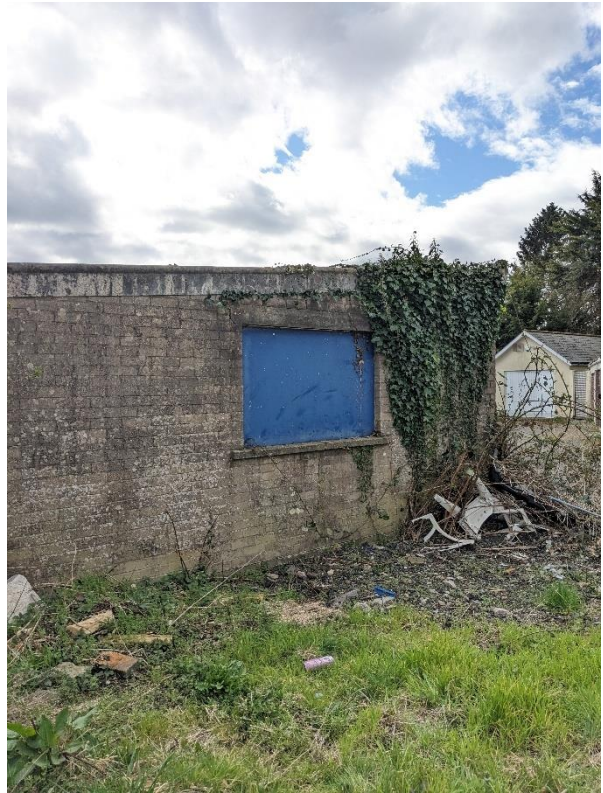
- 4.18. The corrugated roof is in reasonable condition however the ridge and verge details have degraded and been damaged in places.
- 4.19. There are several areas of cracking to the walls to all elevations and the wall to the rear right-hand corner appears to be detaching from the rest of the walls. The building appears to be suffering with subsidence.
- 4.20. The steel doors to the rear have suffered minor damage and the faces are rusting.
- 4.21. The PVCu gutters are in poor condition.
- 4.22. The concrete lintel to the front door has cracked.

Photo 27 – Cracking to rear of outbuilding

Recommendation	Reason
Demolish the outbuilding in its entirety, lay new foundations and install a prefabricated building.	Due to the numerous elements that require renewal and the structural work required to the walls, it may be more cost effective in the long term to demolish the building and supply new. The building is of substandard quality and requires extensive structural repair. Demolition of the building may also be required to facilitate repair of the drainage system.

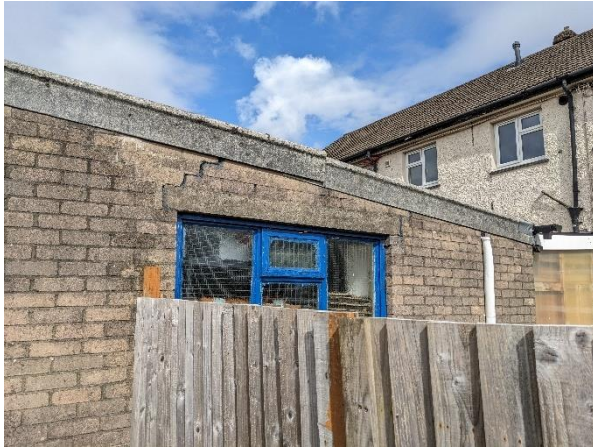
Photo 30 – Rear corner of outbuilding
