Grade II Listed Public Conveniences, John St, Porthcawl:

# BUILDING CONDITION SURVEY

PORTHCAWL  
TOWN COUNCIL

Revision	
DRAFT	09.12.2025
P01	10.12.2025

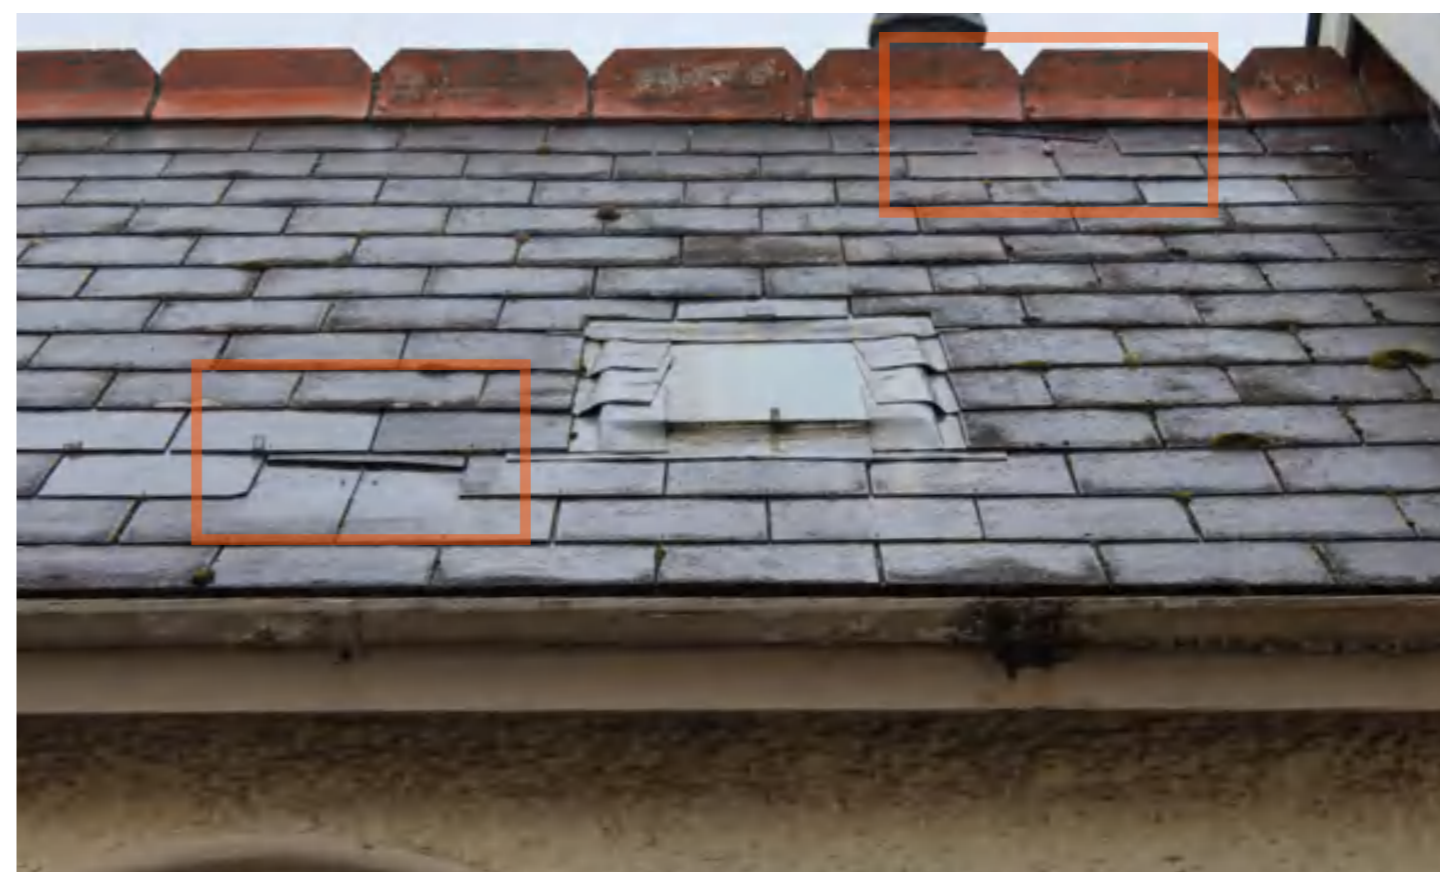
P03

**Condition:** Poor

The existing roof covering is considered to be beyond its expected lifespan (assumed to date from the 1980s and therefore approx. 40 years old) and has failed in numerous areas, with cracked and slipped tiles and consistent deterioration of the artificial slate surface. Evidence of a prolonged pattern of slippage is apparent across the roof, marked by the installation of localised lead straps and replacement slates. Lead flashing details to the eight flush rooflights are insufficiently robust with minimal upstand, creating vulnerable junctions prone to ingress. Lead cover flashings generally do not appear to meet minimum overlaps, particularly at the eastern parapet abutment and have been partially stolen from the abutment between the two roof levels. The red clay ridge tiles are in good condition generally and are considered suitable for careful removal, cleaning and re-use (excluding one cracked tile requiring replacement).

**Recommendation: Replace Artificial Roof Covering with Natural Slate****Priority 1**

12. Allow for replacing 1 no. cracked ridge tile with like for like.

*Note: Porthcawl falls within the 'Severe' category on the BS 5534 Driving Rain Index. The roof pitch is approximately 30 degrees. Minimum head lap for fixing slates with nails to comply with BS 5534:2014 + A2:2018.*

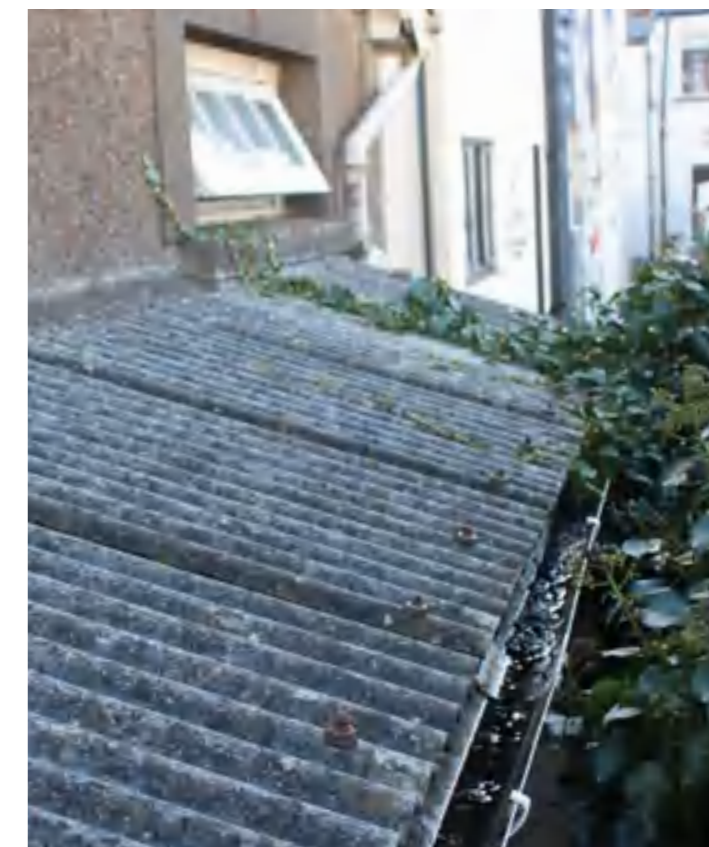
P03

**Condition:** Poor

Cement fillet flashing has generally failed, exhibiting cracking and areas of detachment. The corrugated sheet roof covering is beyond its expected service life, with corrosion evident to fixings. The uPVC guttering is not draining effectively due to inadequate falls and accumulation of debris.

**Recommendation: Replace Corrugated Sheet Roof Covering and Flashing**

1. Remove existing corrugated sheet roof covering, cement haunching and uPVC gutters and downpipes (*presence of asbestos to be confirmed prior to any works*)
2. Install new black polyester powder coated corrugated aluminium roof covering (black)
3. Install new lead flashing at abutment junction between and outside of concrete cills, coordinated with render replacement recommended later in this report.

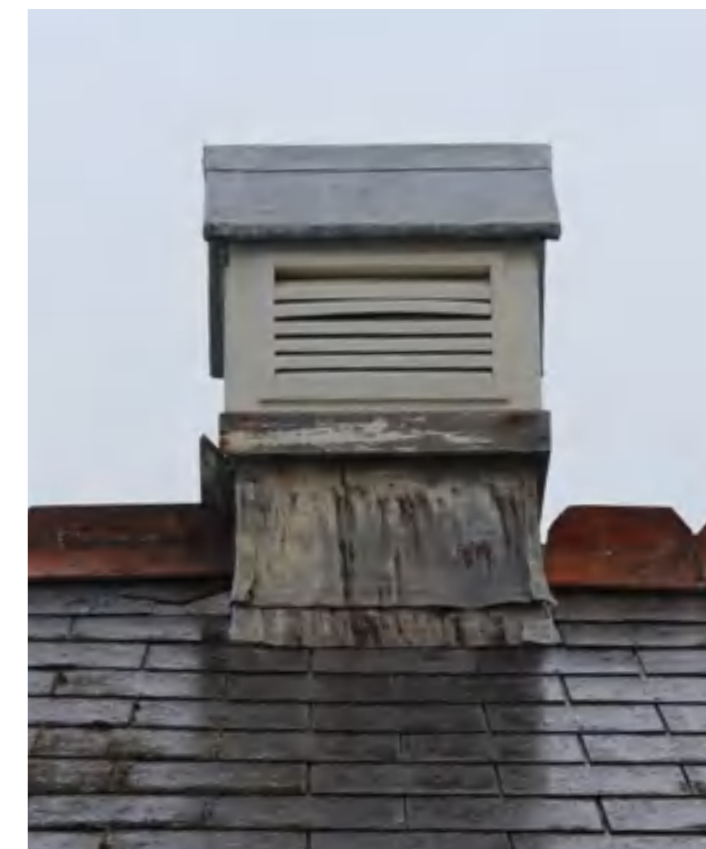
P03

**Condition:** Fair

The existing cupolas are in fair condition and do not appear to be contributing to active rainwater ingress. However, the lead apron flashing is showing deterioration and, as part of the principal roof re-covering, should be renewed. The painted timber rails covering the apron flashings are deteriorating on both cupolas. Furthermore, stainless steel fixings have not been used, and fixings are corroding to the base rails and to the ventilation louvres generally.

#### Recommendation: Repairs to Cupolas

1. Renew deteriorating lead upstand and cover flashings to cupola skirts with Code 5 lead, treated with patination oil, to LSTA guidance;
2. Renew deteriorating timber baserails with painted hardwood to matching profiles, fixed with stainless steel fixings;
3. Remove timber ventilation louvres and frame profile to remove corroding fixings;
4. Replace warped timber ventilation louvres in painted hardwood, fixed with stainless steel fixings;
5. Rub down cupola timber structure and prepare for redecoration;
6. Treat all timber with preservative primer (as per Dulux Weathershield, TBA with Conservation Officer);
7. Redecorate the cupolas (as per Dulux Weathershield, spec and colour TBA with Conservation Officer)

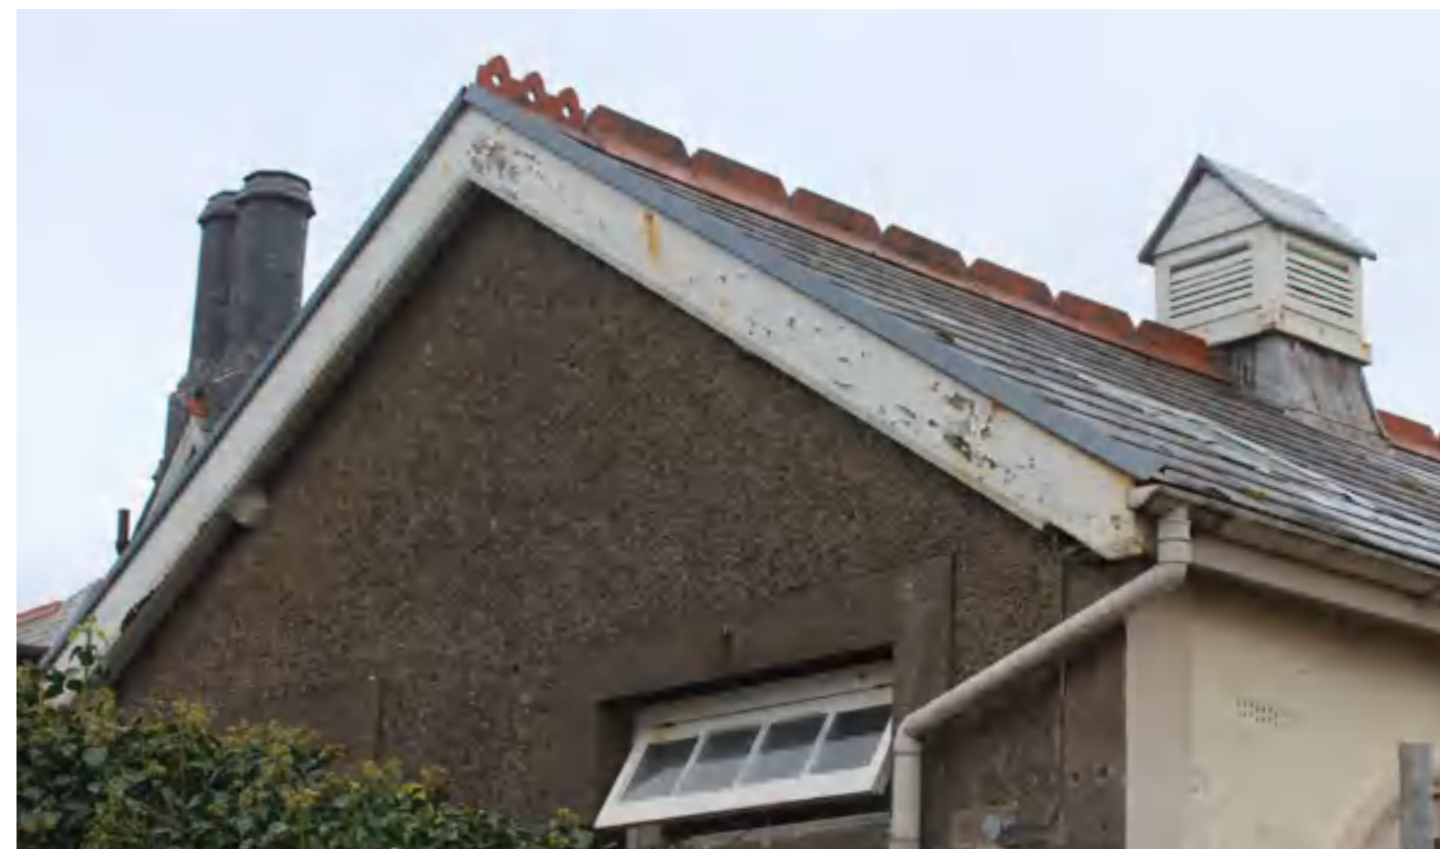
P02

**Condition:** Fair to Poor

The softwood barge board to the lower level has been cut and modified at eaves level and sees paint failure and decay generally. Corroding fixings are observed generally to all weatherboards across the building.

#### Recommendation: Repairs to Weatherboards

1. Remove plastic dry verge profiles to 2 no. west facing gable ends
2. Carefully remove all weatherboards
3. Allow for replacing barge boards to 2 no. west facing gable ends with painted hardwood, profiles to match those of lower-level barge board (P01)
4. Allow for replacing fascia boards with painted hardwood to southern elevation only (profiles to match existing)
5. Allow for replacing all soffit boards with painted hardwood to southern elevation only (allowing for integrated eaves level ventilation)
6. Allow for wet verge detail using Cornerstone Performance Roofline Lime Mortar or equal

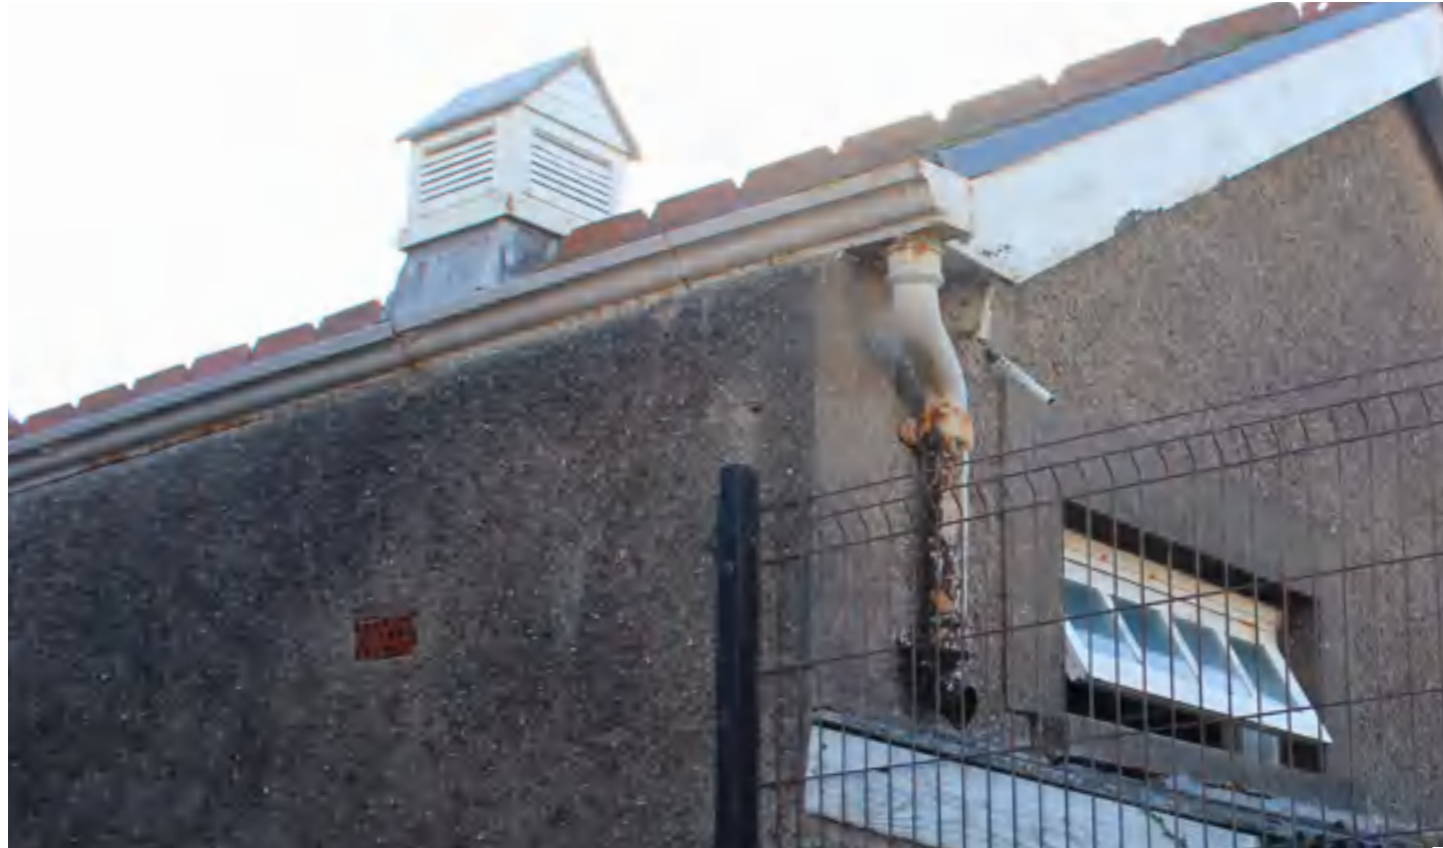
P04

The cast iron downpipe to the southern elevation is undersized and shows localised surface corrosion at its socket joints and at connection to the ground, but is otherwise in fair condition. In contrast, the short cast iron downpipe to the western elevation, serving the northern gutter, displays significant corrosion.

3. Remove uPVC gutter and downpipe from external urinal lean-to roof (P06/7)
4. Allow for complete replacement of short cast iron downpipe section to western elevation (P04/10)

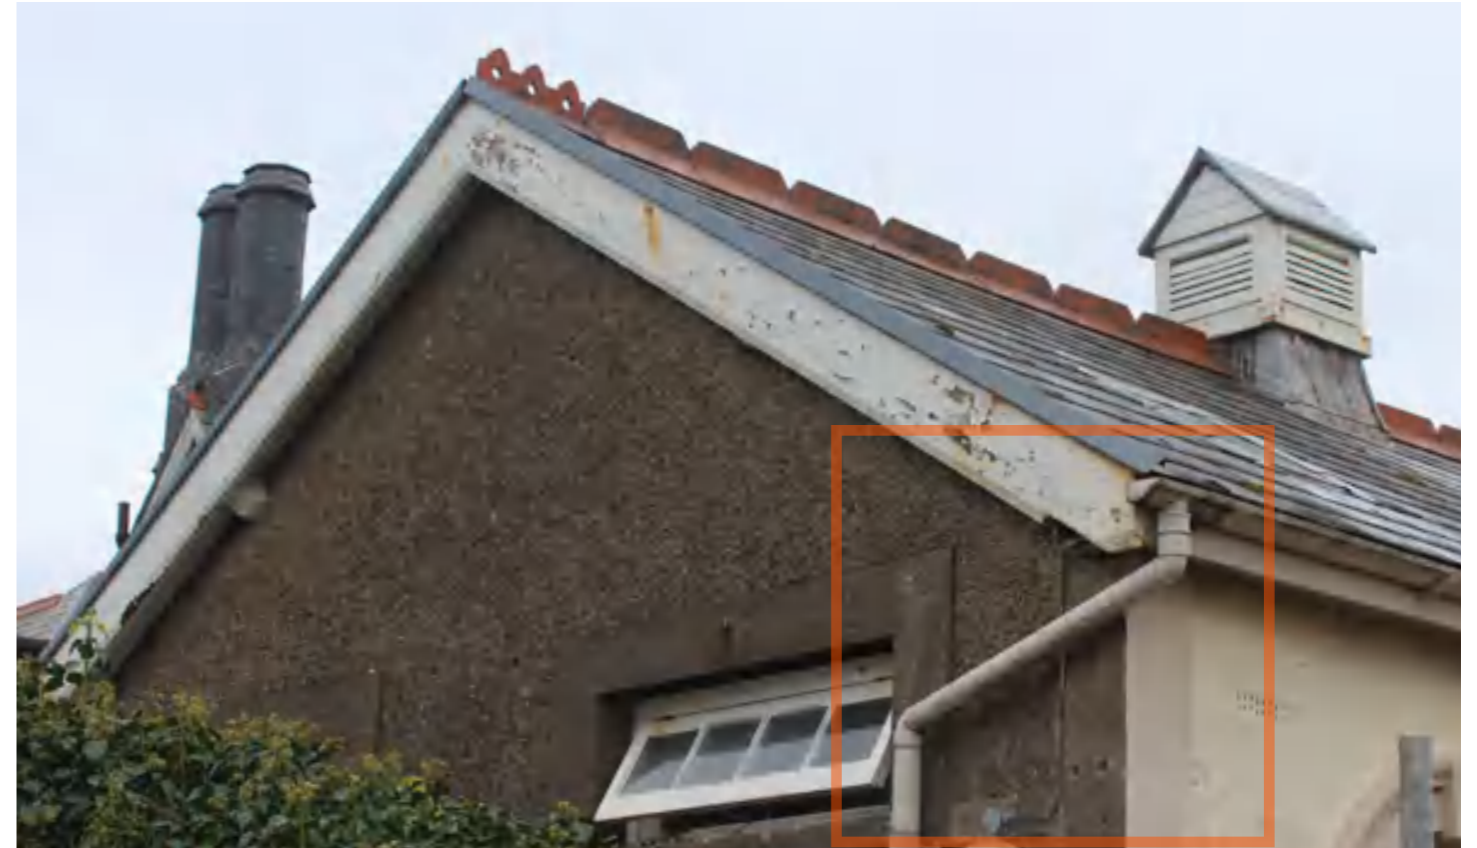
P05

To the west elevation, an inappropriate aluminium downpipe is installed to receive discharge from the southern gutter. This replacement is visually and materially out of character with the historic building and the family of rainwater goods. Similarly, the uPVC gutter to the lean-to roof over external urinals is materially inappropriate and failing to drain adequately to falls.

1. Remove all cast iron rainwater goods and allow for temporary rainwater goods for duration required to undertake repairs / replacement.
2. Remove aluminium downpipe from western gable end (P05)

5. Allow for complete replacement of existing inappropriate aluminium downpipe to west elevation with a new round cast iron downpipe and associated sockets, swan necks and shoes.

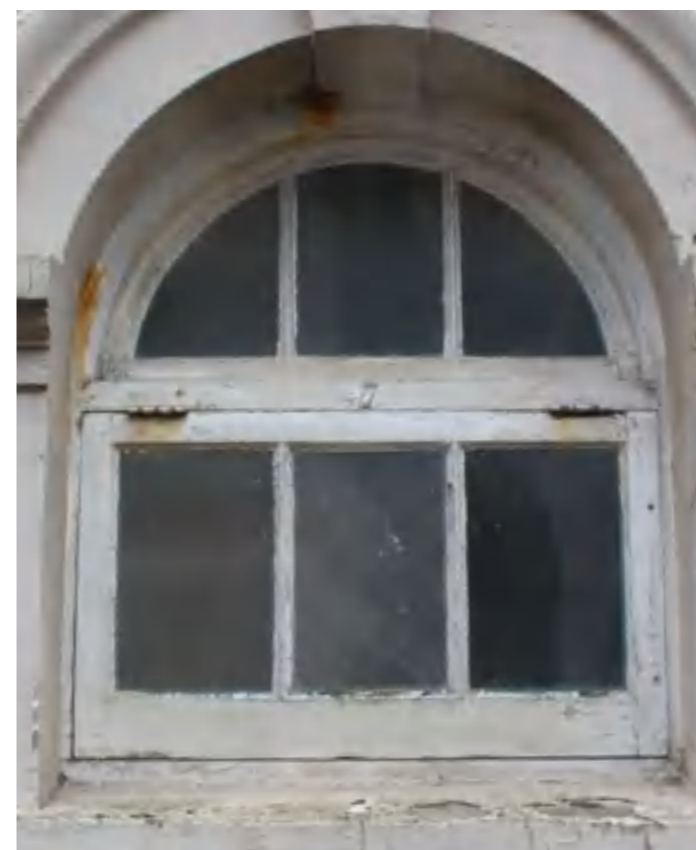
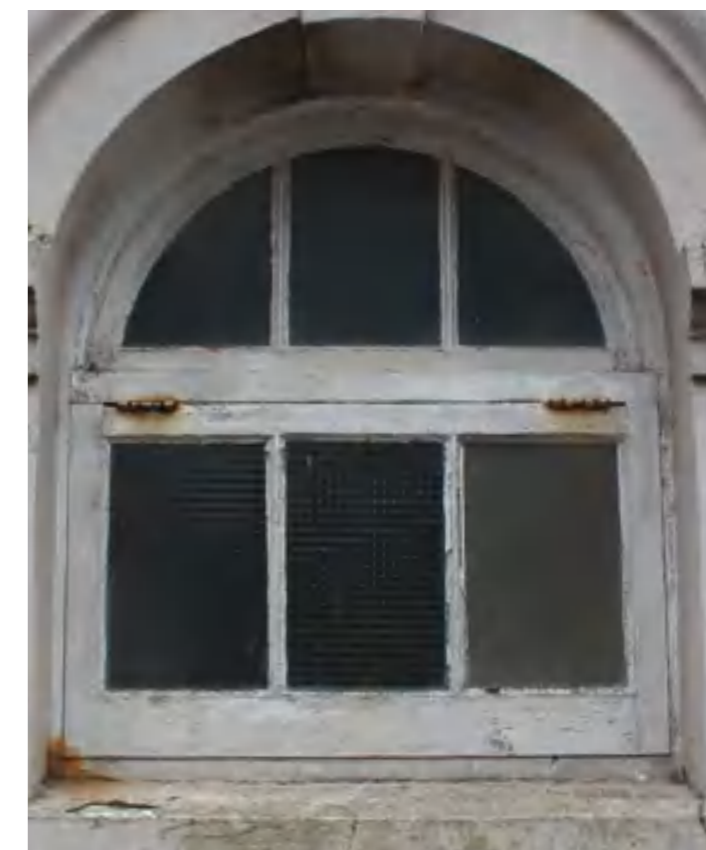
**Condition:** Fair

The timber lining, rails, styles and glazing bars appear in a fair and intact condition subject to general paint deterioration across the windows. The 2 no. hinges to the top-hung casements are showing surface corrosion, in addition to embedded metal fixings at localised locations to the corners and arched heads. The glazing is a mix of single glazed obscure glass and security wired glass. Linseed glazing putty has failed generally.

1. Rub down and remove all defective paint from the timber surfaces.
2. Remove the lower casement and hinges, allowing for new stainless steel top hung casement hinges.

3. Ease opening lights where tight or rubbing.
4. Retain 1 no. brass casement window stay to Window 03 and polish.
5. Replace metal window stay to Window 02 with like-for-like brass stay to match adjacent, as per Altro Cast Victorian Casement Window Stay Antique Brass.

6. Investigate areas of corrosion to window frame and remove any embedded metal fixings. Allow for making good from any removal with timber scarfing if necessary.

7. Remove all failed glazing putty and glazing beads.
8. Replace Georgian wire mesh glazing and later glazing panes with obscure toughened single glazing to match original within fanlights (2 no. panes to W02, 3 no. pane to W03)

9. Install new hardwood glazing beads with linseed glazing putty.
10. Provide new sealant between window linings and reveals.
11. Allow for full external and internal redecoration with Dulux Weathershield System, inclusive of preservative primer and top coat (Colour and specification TBA)

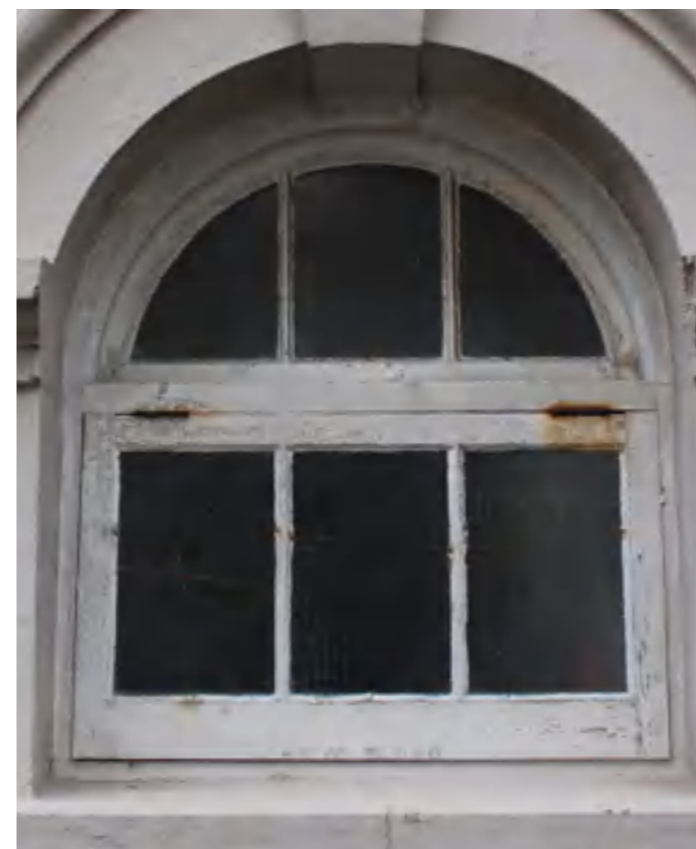
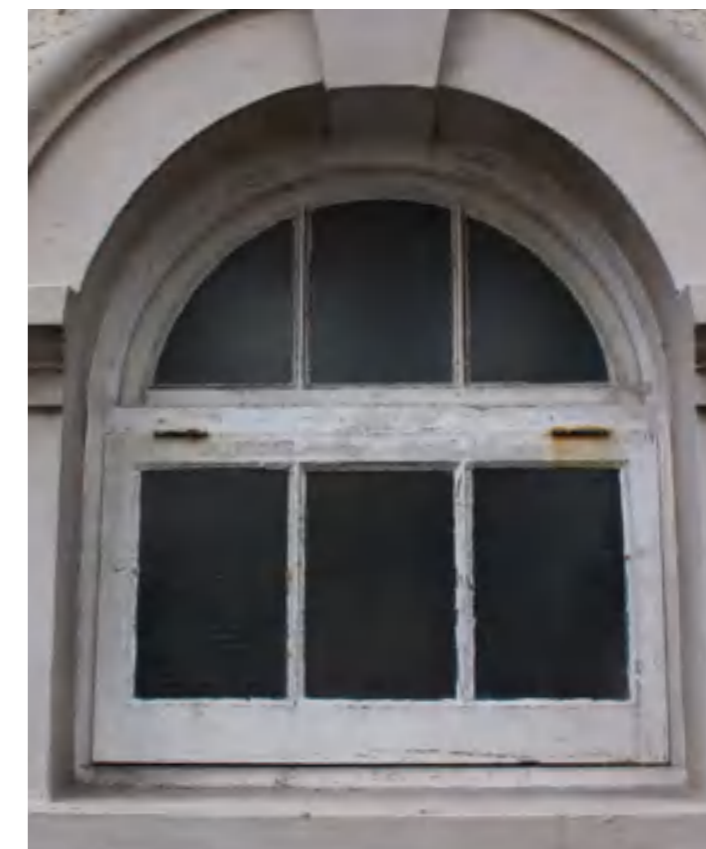
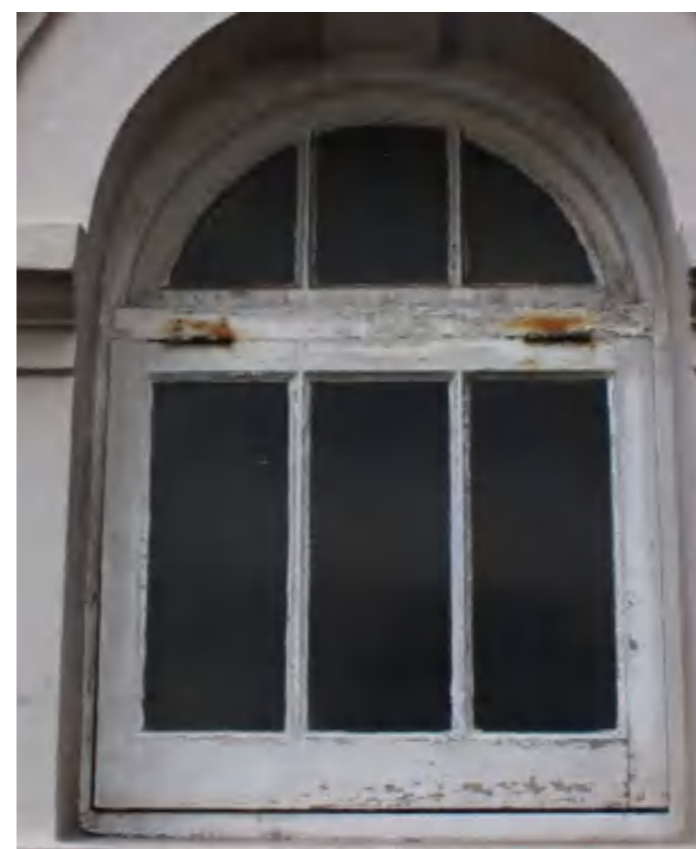
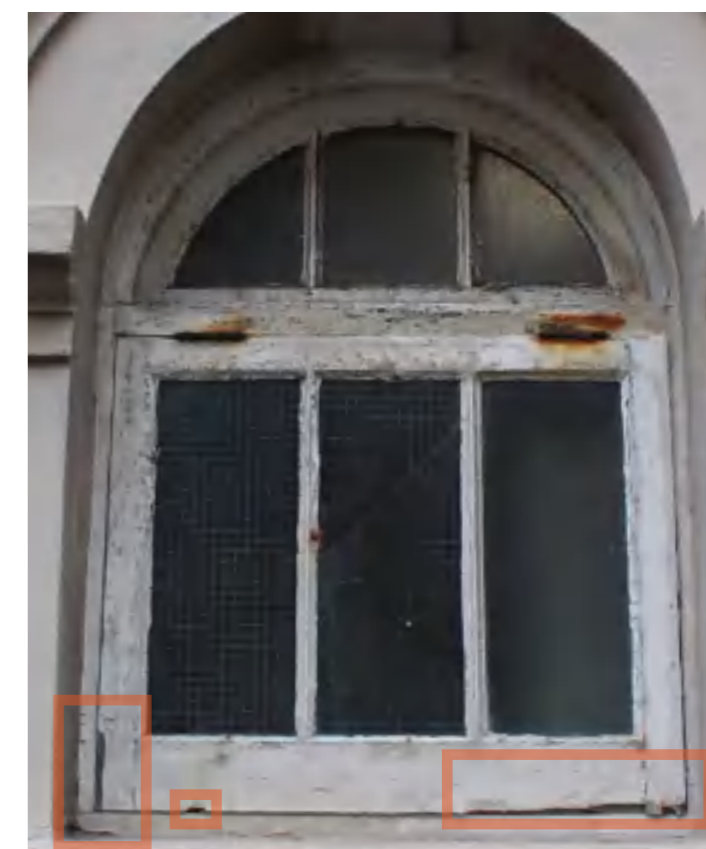
**Condition:** Fair

The timber lining, rails, styles and glazing bars appear in a fair and intact condition subject to paint failure across the windows. The 2 no. hinges to the top-hung casement are showing surface corrosion, in addition to embedded metal fixings at localised locations to the corners and arched heads. The glazing is a mix of single glazed obscure glass and security wired glass. Oil based glazing putty has failed generally.

1. Rub down and remove all defective paint from the timber surfaces.
2. Remove the lower casement and hinges, allowing for new stainless steel top hung casement hinges.

3. Ease opening lights where tight or rubbing.
4. Conduct scarf timber repairs to areas indicated in orange rectangles (W07)
5. Retain all brass casement window stays and polish.

6. Investigate areas of corrosion to window frame and remove any embedded metal fixings. Allow for making good from any removal with timber scarfing if necessary.

7. Remove all failed glazing putty and glazing beads.
8. Replace Georgian wire mesh glazing and clear glazing panes with obscure toughened single glazing to match original within fanlights (3 no. panes W04, 2 no. panes W05, 2 no. panes W07)

9. Install new hardwood glazing beads with linseed glazing putty.
10. Provide new sealant between window linings and reveals.
11. Allow for full external and internal redecoration with Dulux Weathershield System, inclusive of preservative primer and top coat (Colour and specification TBA)

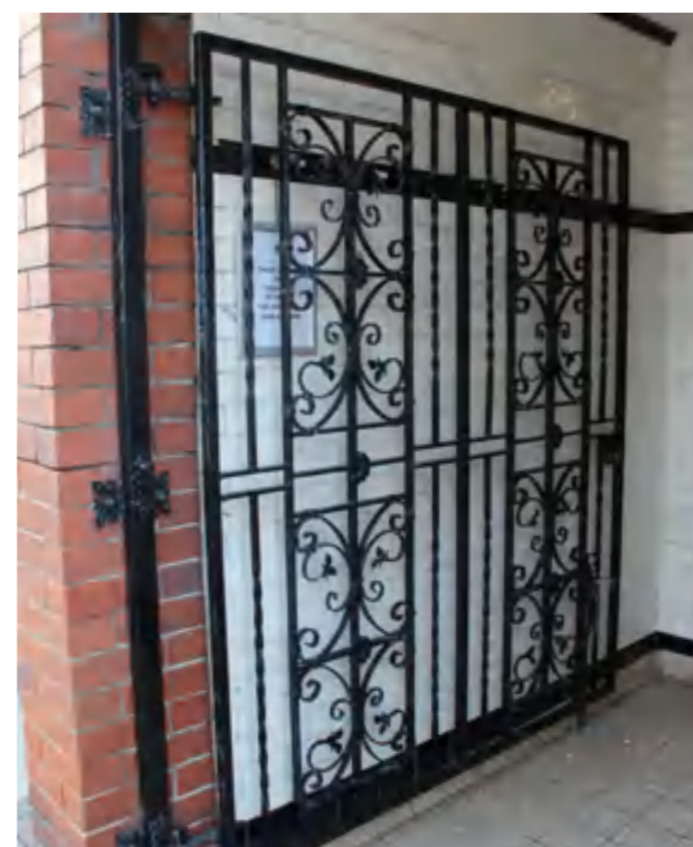
External Gate 01

**Condition:** Fair

The tympanum shows consistent surface corrosion and deterioration of paint finishes, requiring rubbing down and redecoration for corrosion protection and aesthetic enhancement. The gate beneath has recently been refurbished and is in good condition.

1. Allow for rubbing down and redecorating the wrought iron tympanum and WC signage to match the recently refurbished gate below. Decorate with Dulux Metalshield System comprising Zinc Phosphate Primer and Metalshield Top Coat in Black Gloss to manufacturers guidance.

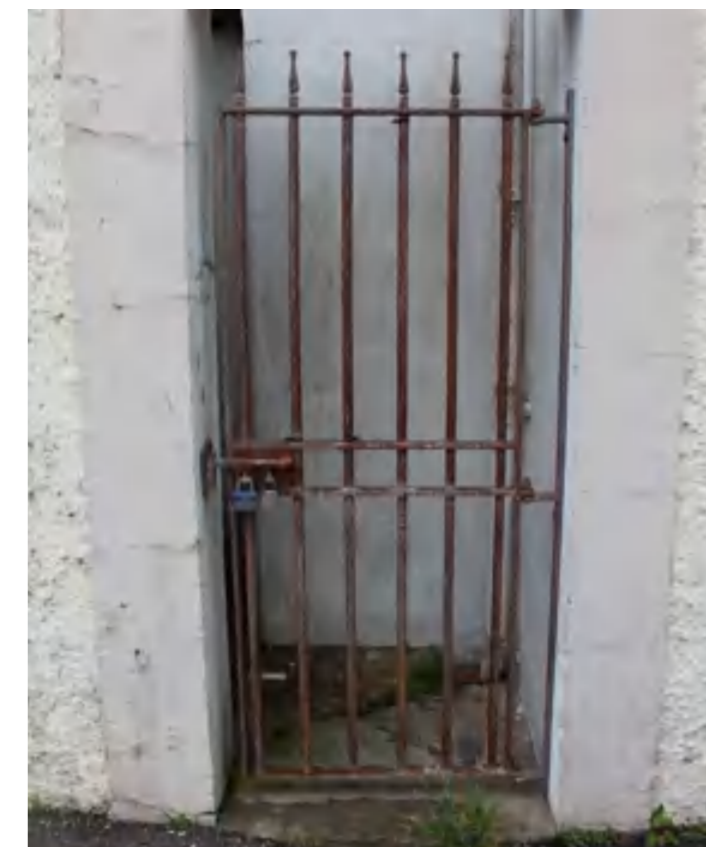
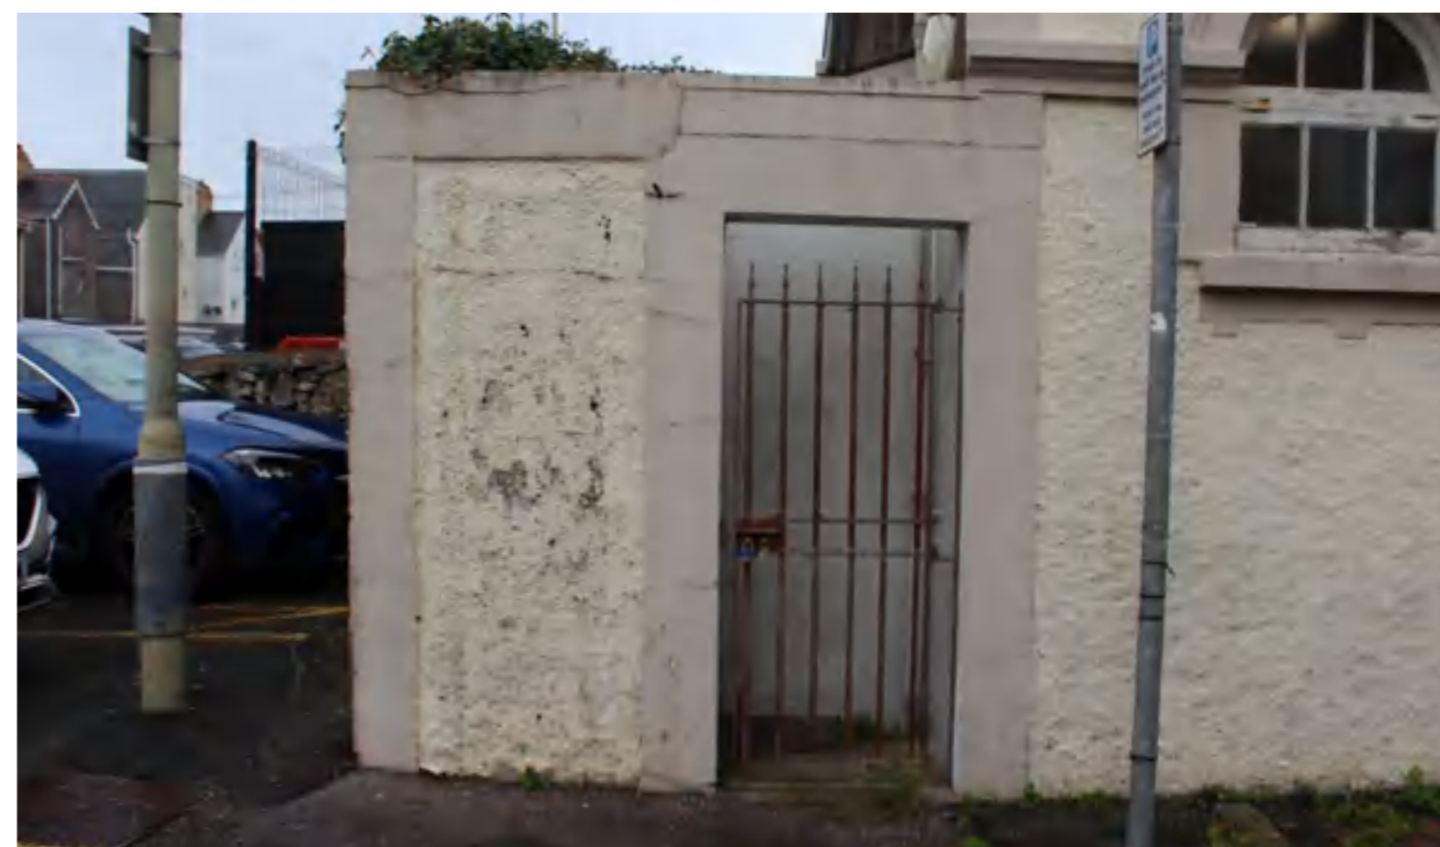
**Condition:** Fair

The gate is in good functional condition, though the paint coating shows general wear, requiring rubbing down and redecoration to improve aesthetic appearance.

**Recommendation: Repairs to External Gate 02**

Priority 3

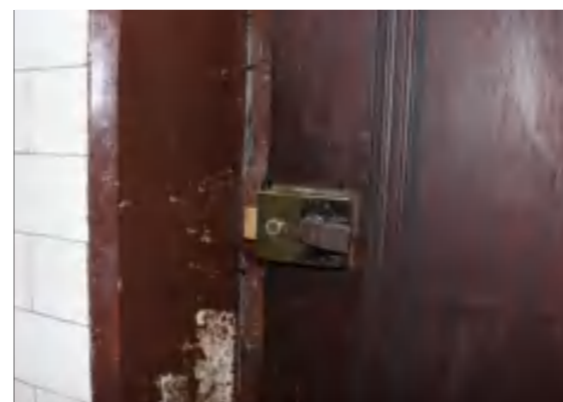
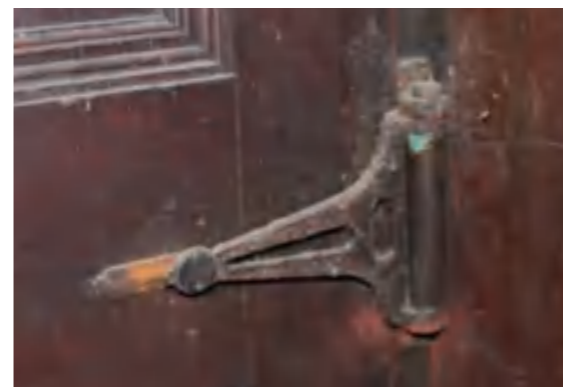
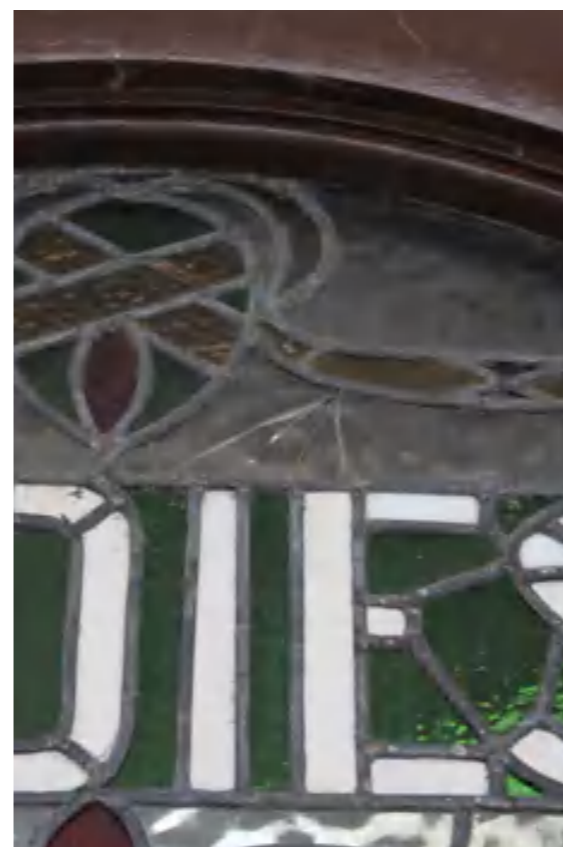
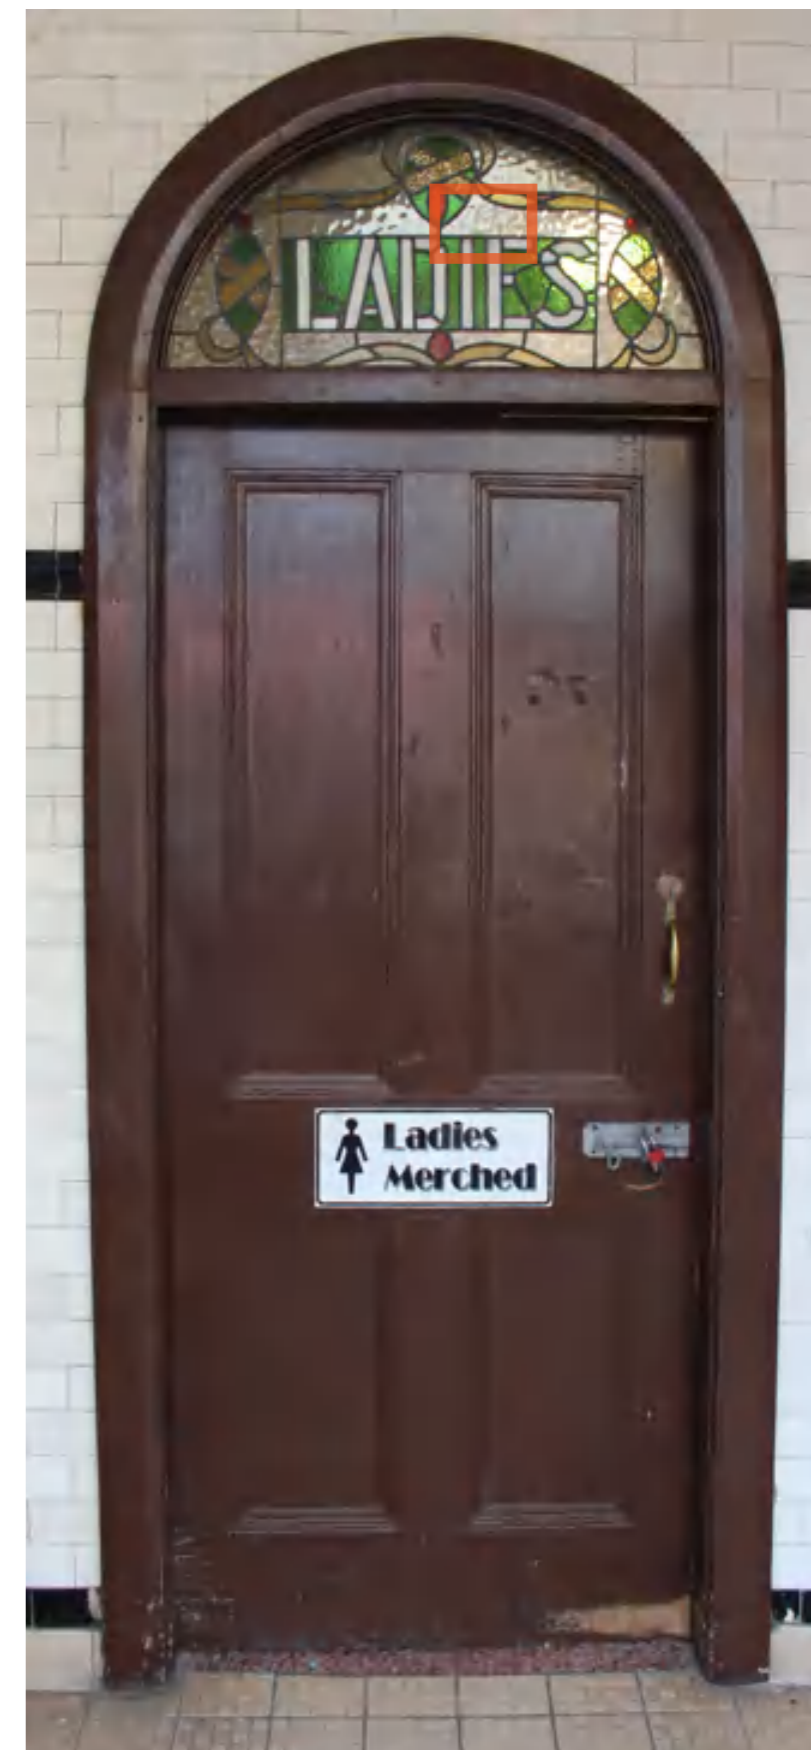
**Condition:** Fair

The hardwood door, frame and architraves are generally in good condition, exhibiting typical age-related wear. In areas, the stained finish has worn, and evidence of previous ironmongery or applied fixtures remains visible.

A Yale rim latch lock has been retrofitted to latch onto an existing historic stay within the frame and is functional. A historic hinge remains visible internally; it is now redundant and would benefit from decorative refurbishment. An inappropriate galvanised steel deadbolt has been fixed to the external face of the door and is visually intrusive. The stained-glass fanlight features one cracked pane.

1. Sand back existing finishes and allow for filling and making good areas of localised damage to panelled door, frame and architraves from prior fittings / wear.
2. Allow for redecorating the refurbished door with Osmo Oil Wood Stain (specification / colour TBA)
3. Retain, clean and service existing brass hinges and pull handle, renewing screws.
4. Install new brass pull handle to match existing on the internal face.
5. Remove galvanised steel Brenton Padbolt and install new solid brass padbolt if required by PTC.
6. Rub down and redecorate historic latch and hinge internally.
7. Allow for new brass signage 'Ladies Merched' (specification TBA).
8. Replace single cracked glazing pane to stained glass fanlight with like-for-like.

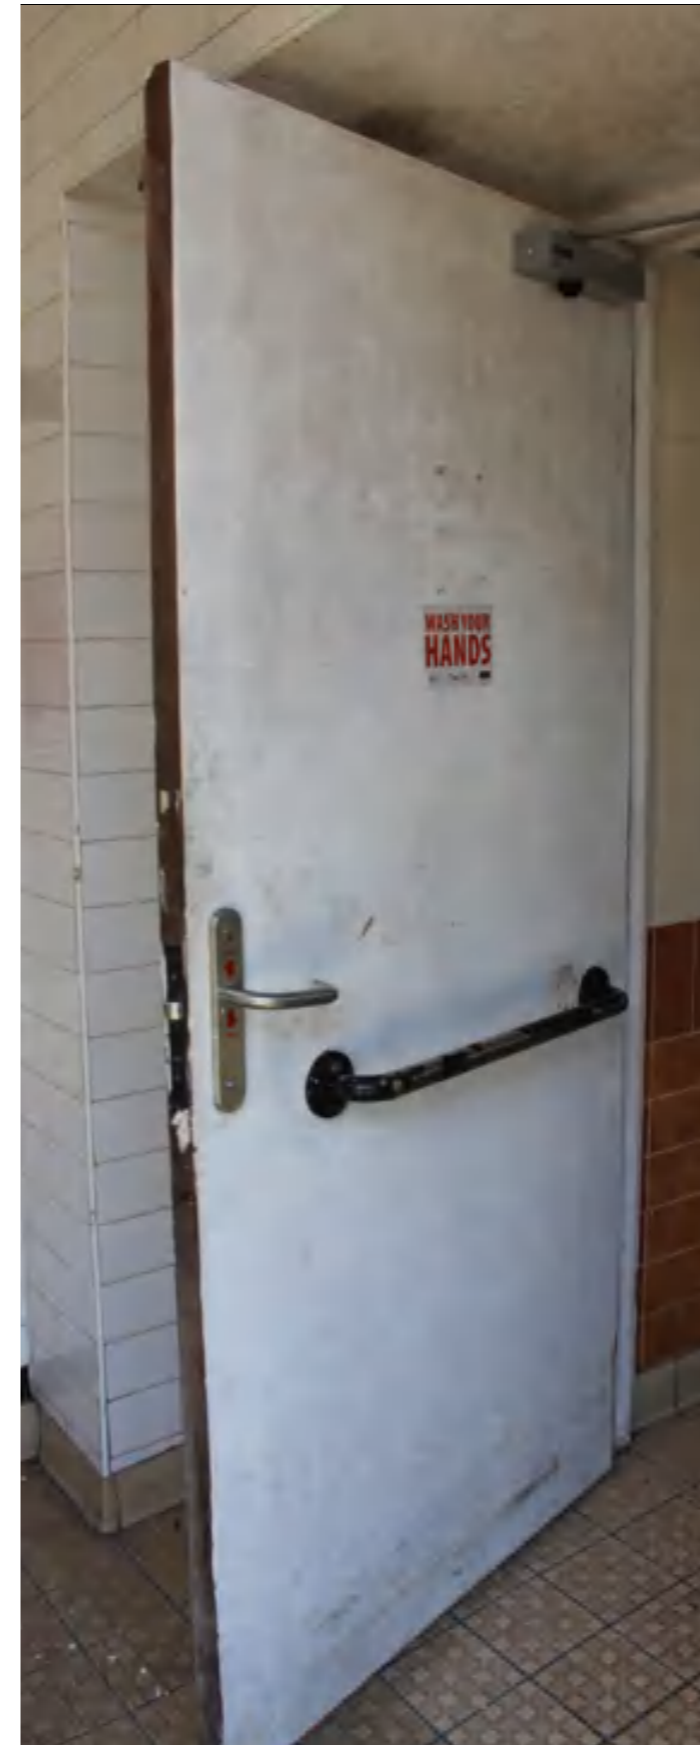
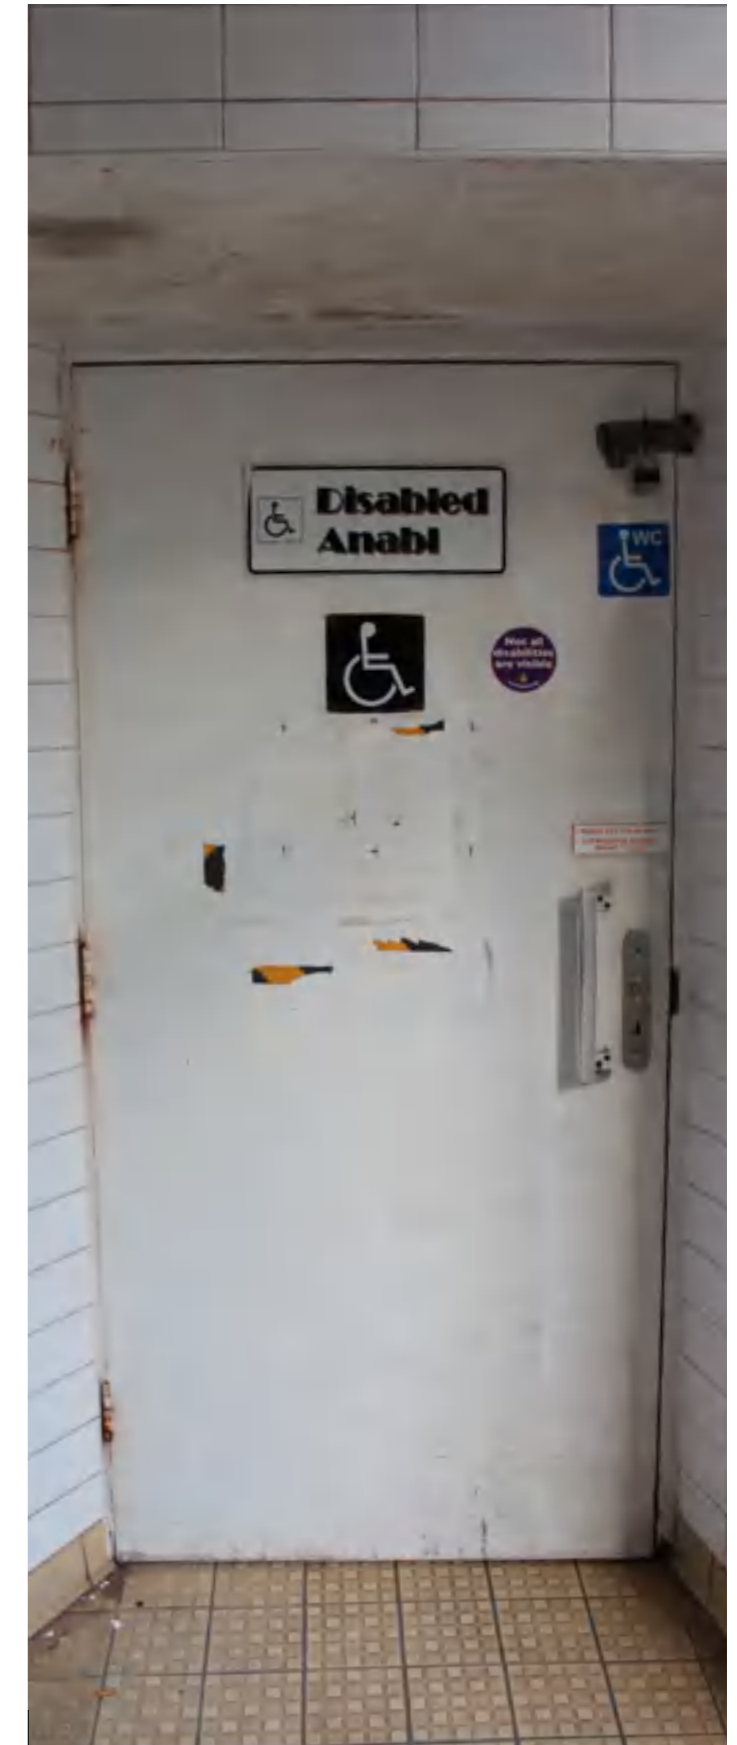
**Condition:** Fair

Whilst functional, the current modern door is utilitarian in appearance and distinctly out of character with the surrounding historic building fabric and the adjacent Female WC entrance; it is therefore recommended that the door be replaced with a hardwood, panelled door designed to match the adjacent entrance and fully coordinated with Doc M compliant ironmongery and accessibility requirements.

1. Remove existing flush door, frame and all signage / ironmongery.
2. Replace frame, linings and door with solid hardwood four panelled door with beads to match ED01 to Female WCs.
3. Allow for staining the hardwood door with Osmo Oil Wood Stain (specification TBA)
4. Hang door on new 1 1/2 pairs brass butt hinges, opening outward.
5. Provide new brass pull handle and reversible disabled bathroom lockset in brass (Radar Type).
6. Provide new solid brass padbolt if required by PTC.
7. Provide new brass grab rail to internal face of door.
8. Provide new brass self-closing device.
9. Allow for new brass signage 'Disabled Anabl' (specification TBA)
