Grade II Listed Public Conveniences, John St, Porthcawl:

# BUILDING CONDITION SURVEY

PORTHCAWL  
TOWN COUNCIL

Revision	
DRAFT	09.12.2025
P01	10.12.2025

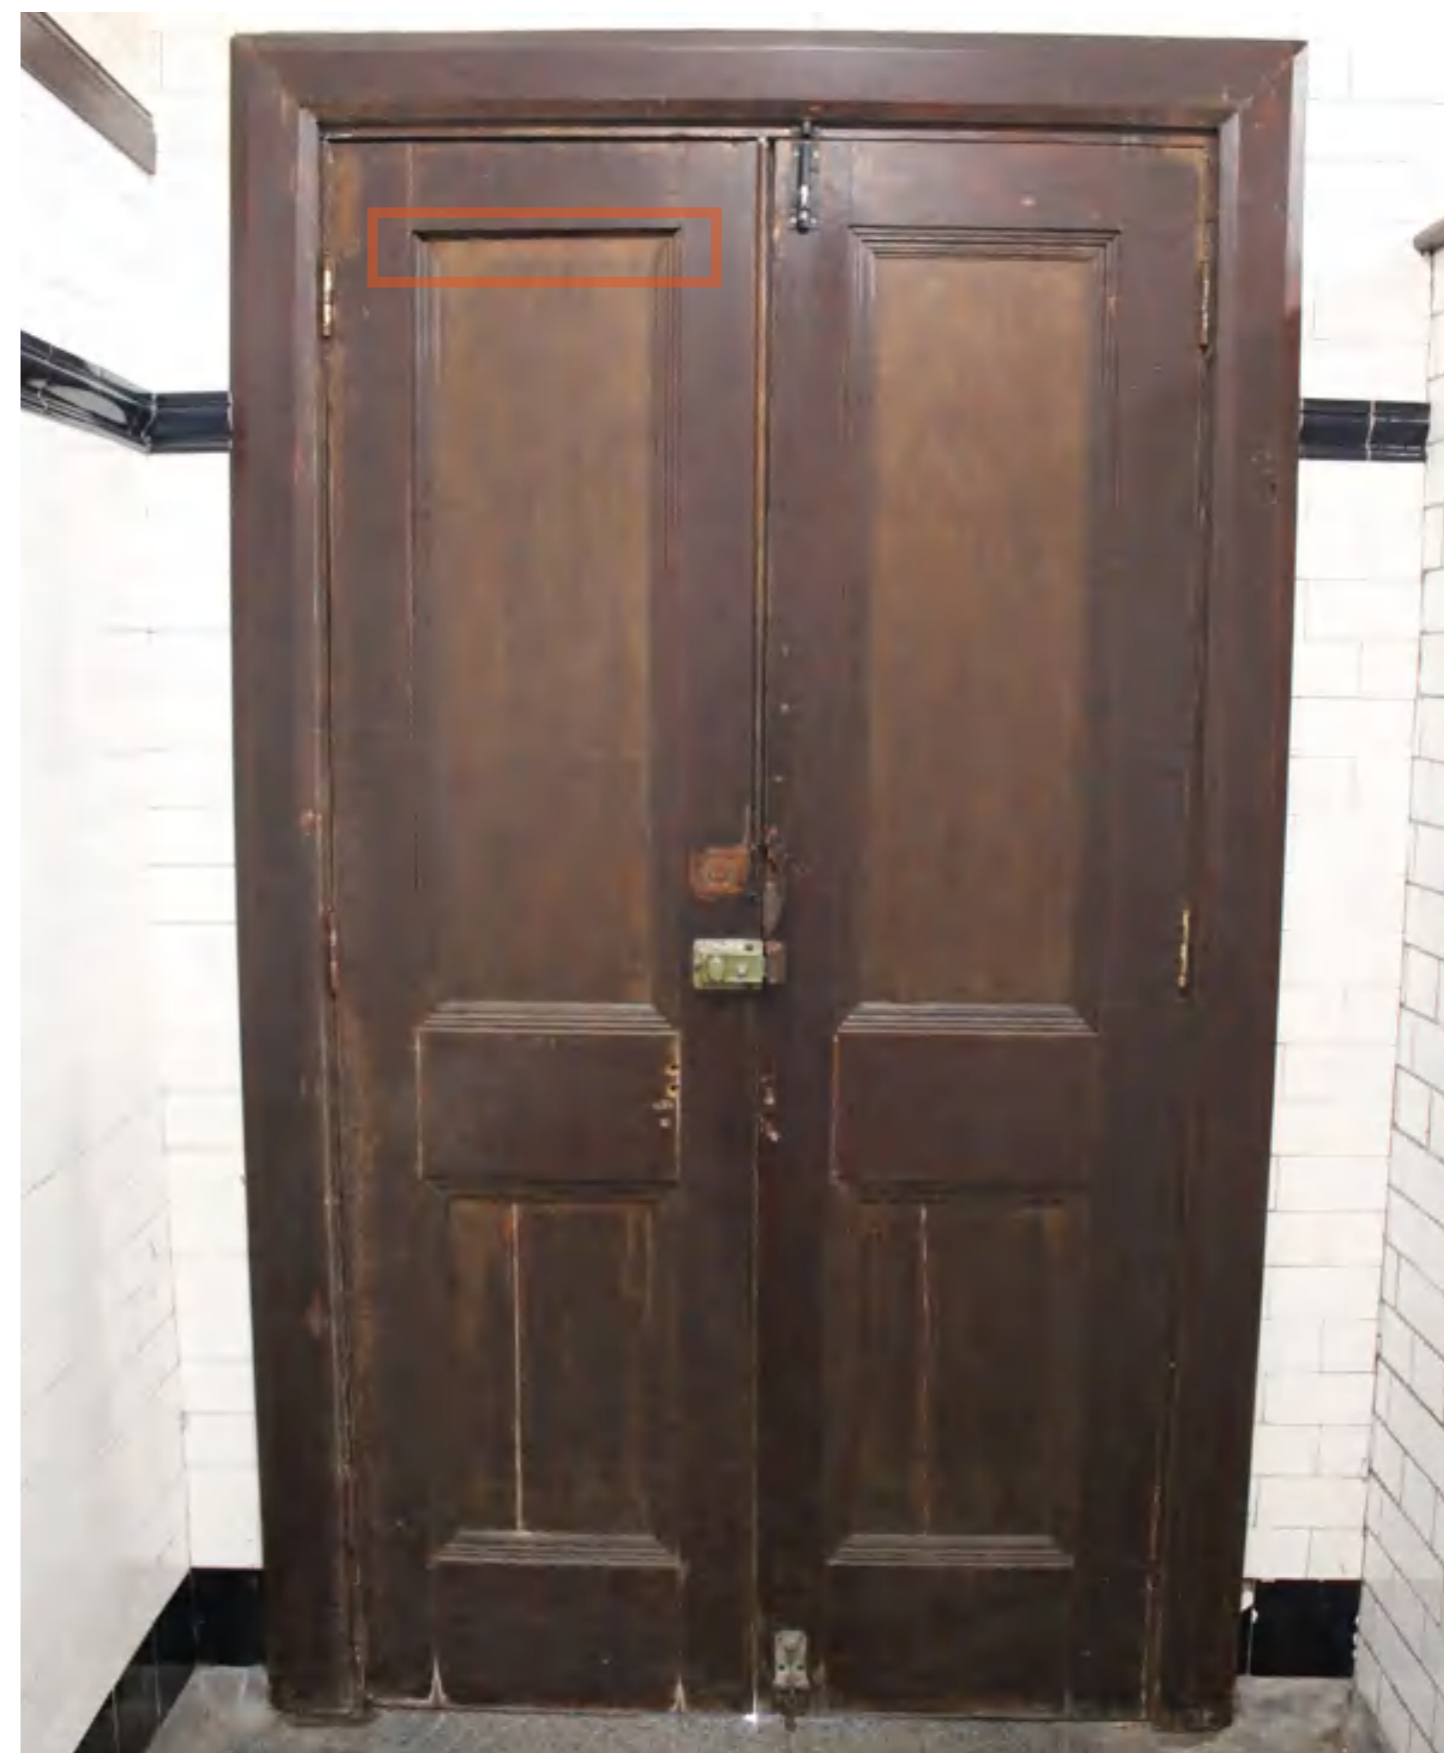
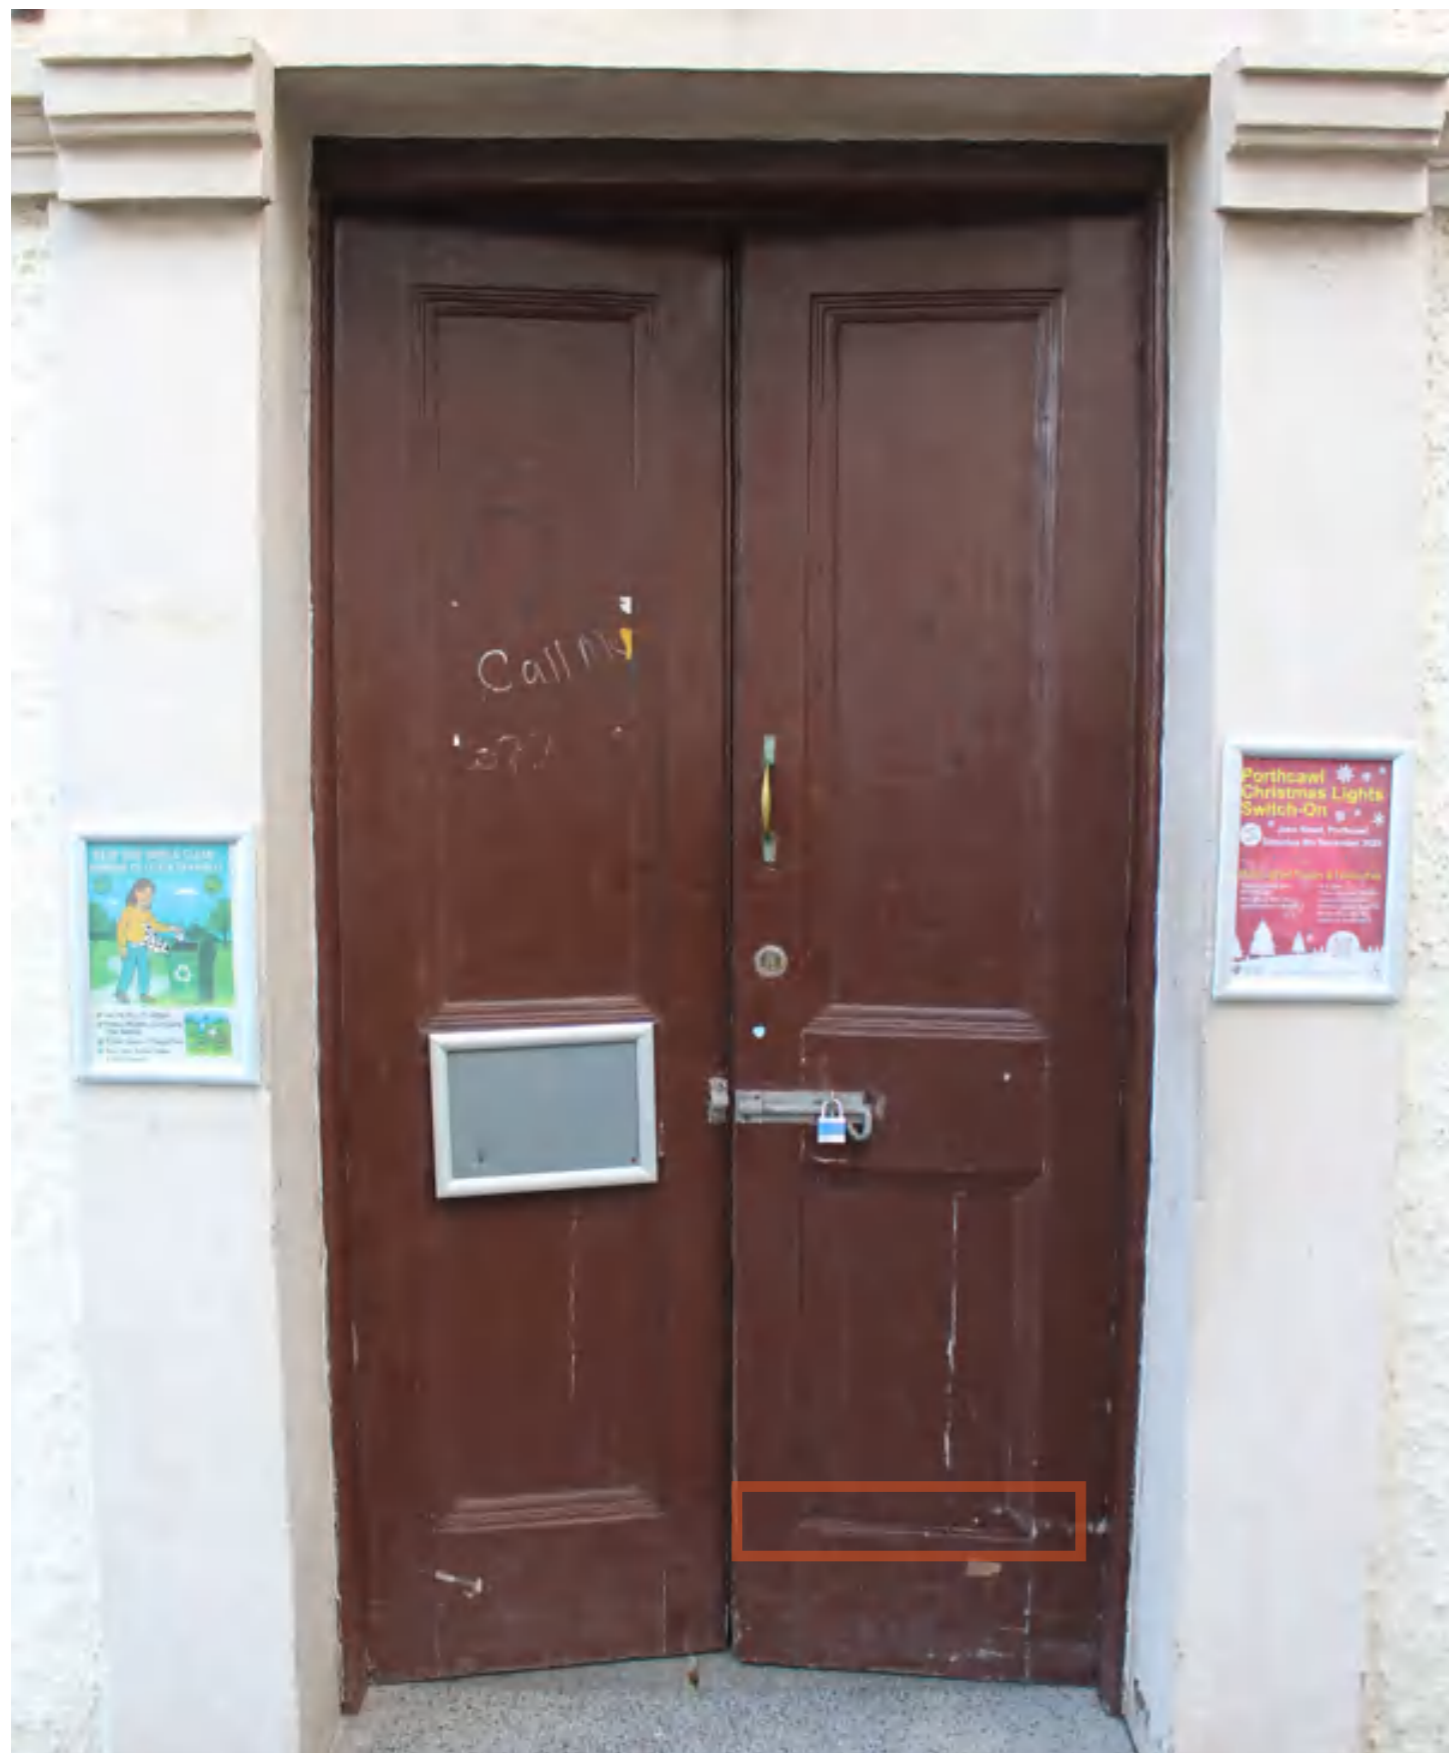
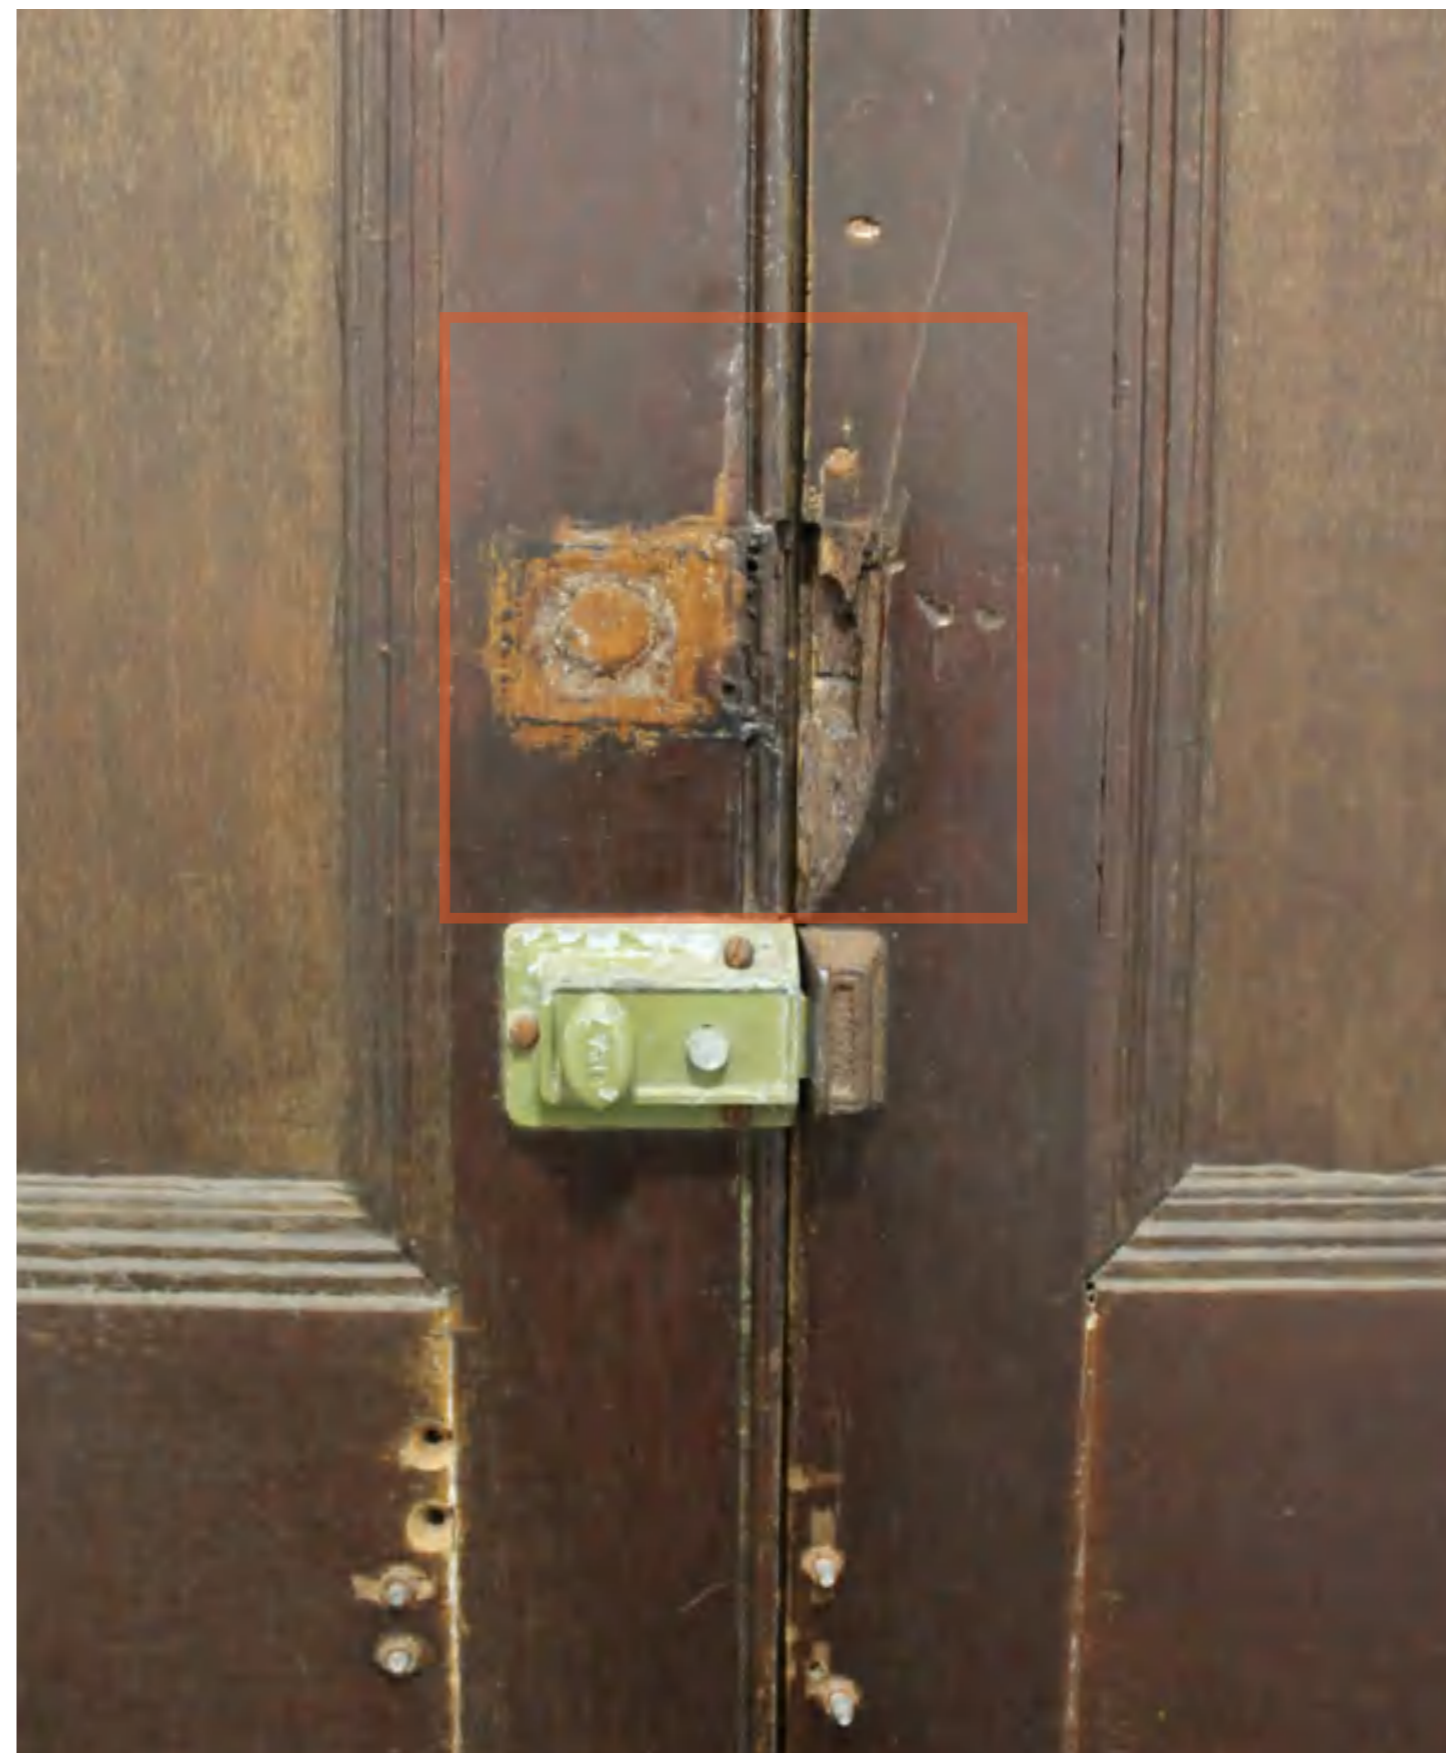
**Condition:** Fair to Poor

ED03 is in good, functional order however shows signs of age related wear and tear and insensitive previous alteration.

1. Remove external poster frame fixed to door.
2. Sand back existing finishes and allow for filling and making good areas of localised damage to panelled door, frame and architraves from prior fittings / wear.

3. Allow for hardwood scarf repair to location shown on P03.
4. Replace 2 no. missing hardwood panel beads (1 no. exterior, 1 no. interior)
5. Allow for redecorating the refurbished door leafs with Osmo Oil Wood Stain (specification / colour TBA)

6. Replace all existing brass butt hinges with like-for-like.
7. Clean, polish and reinstate external brass pull handle with new screw fixings.
8. Retain existing Yale rim latch lock on internal face and refurbish by rubbing down and decorating with gold metal paint (specification TBA)

9. Remove galvanised steel Brenton Padbolt from external face and install new solid brass padbolt if required by PTC.
10. Replace internal upper and lower deadbolts with solid brass equivalents.

11. Allow for new brass signage 'Mens Dynion' (specification TBA).

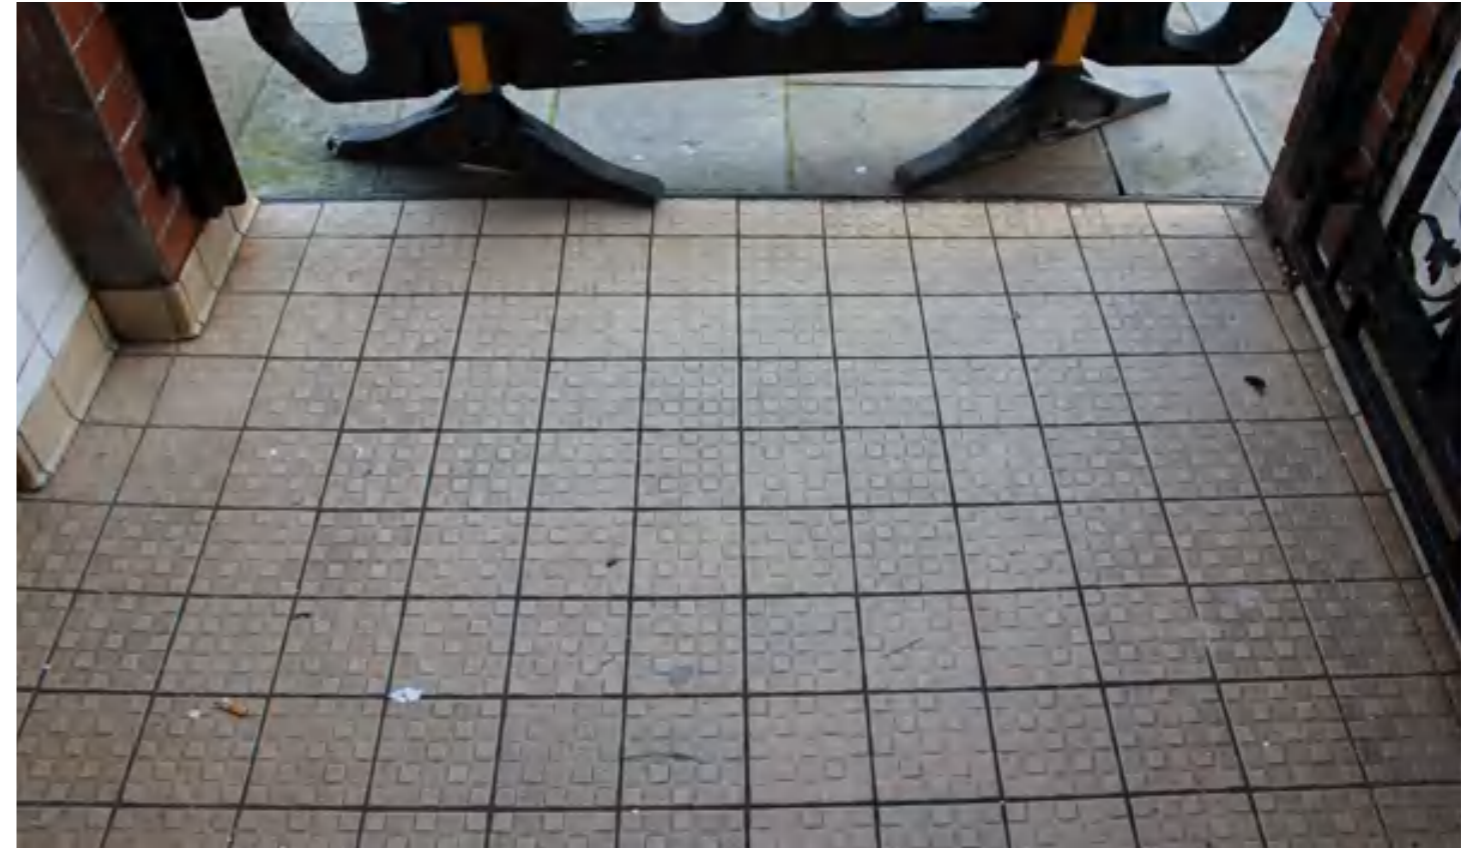
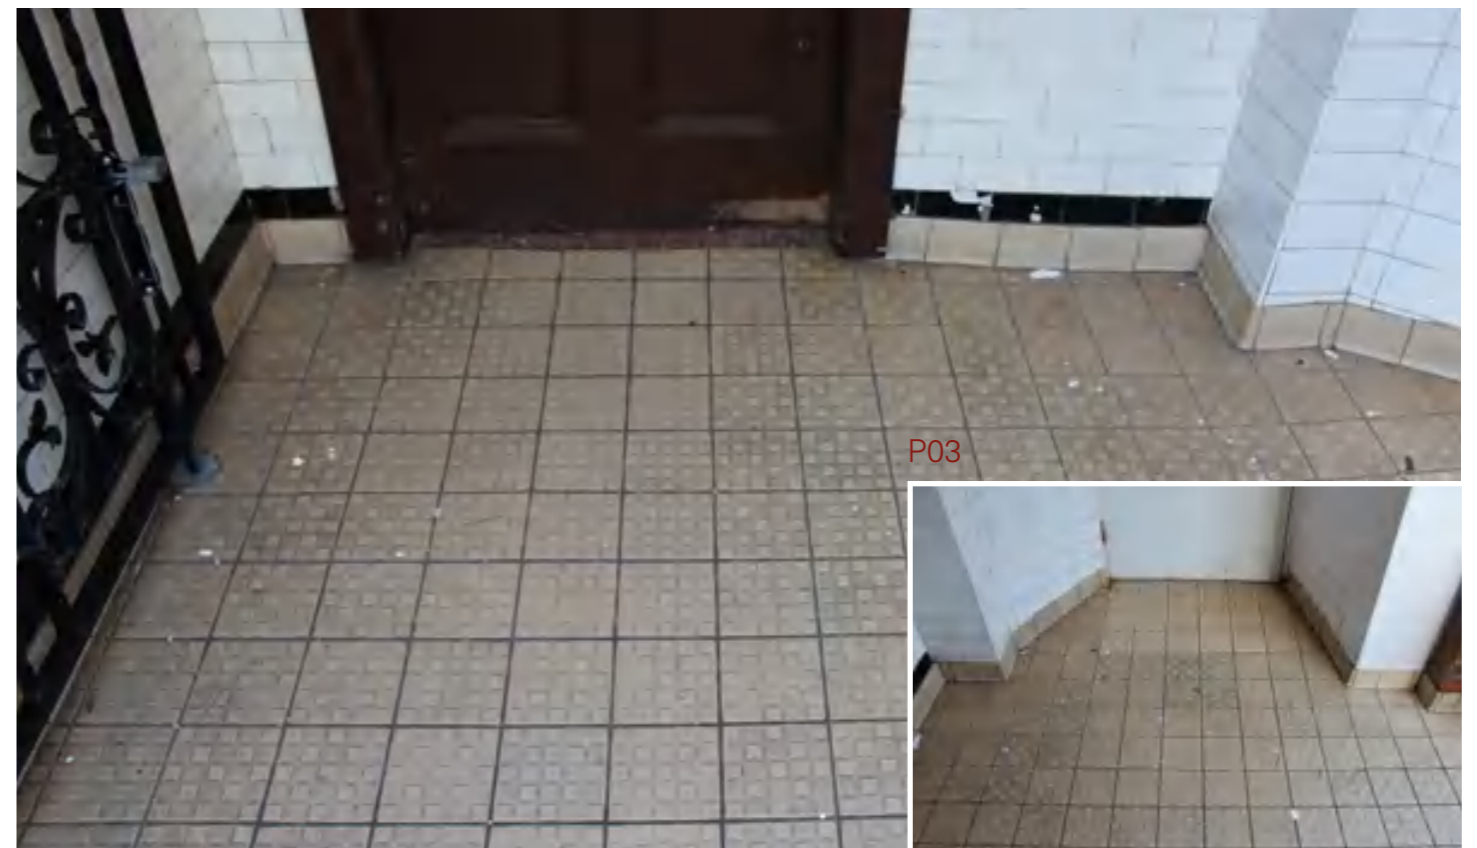
**Condition:** Fair to Good

**Recommendation: Replacement of Tiled Floor to Entrance Lobby (approx. 6sqm) Priority 3**

1. Carefully remove all square format tiles and kerbed upstands from the entrance lobby.
2. Allow for replacing with high-quality, slip resistant square format exterior tiles with associated kerbed upstands (specification TBA with Conservation Officer)
3. Allow for grouting (colour TBA).

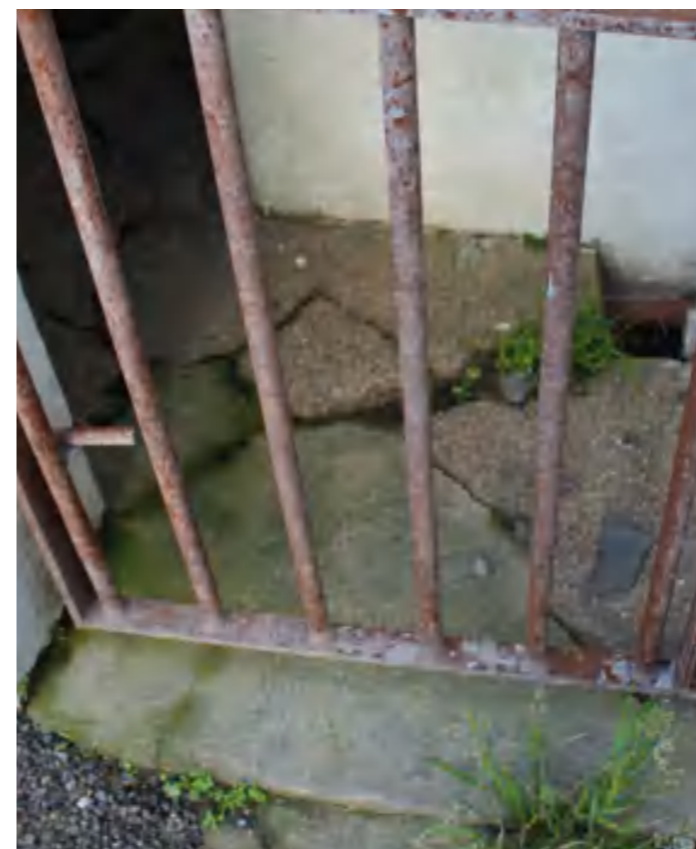
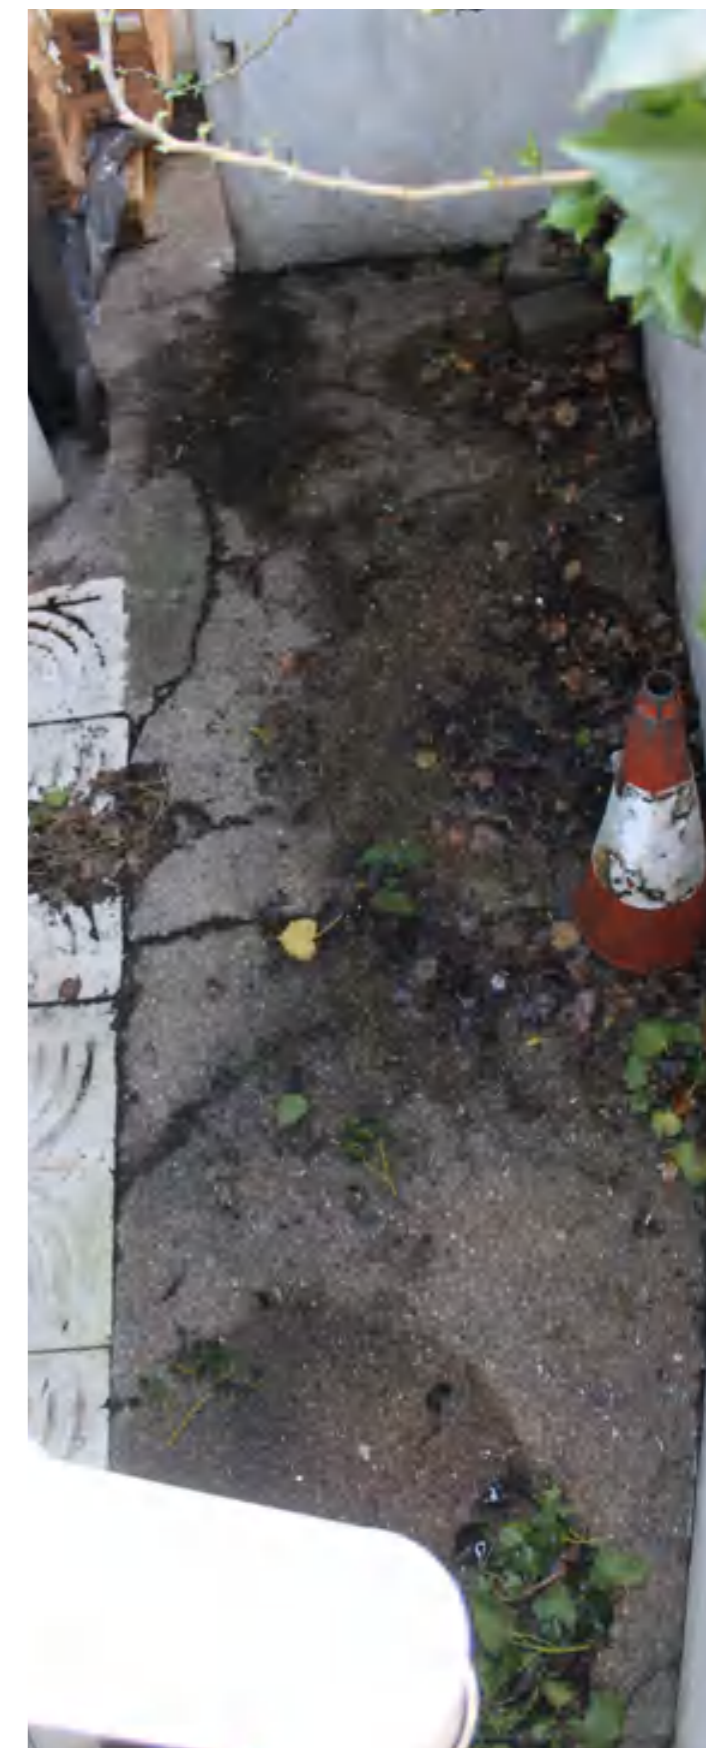
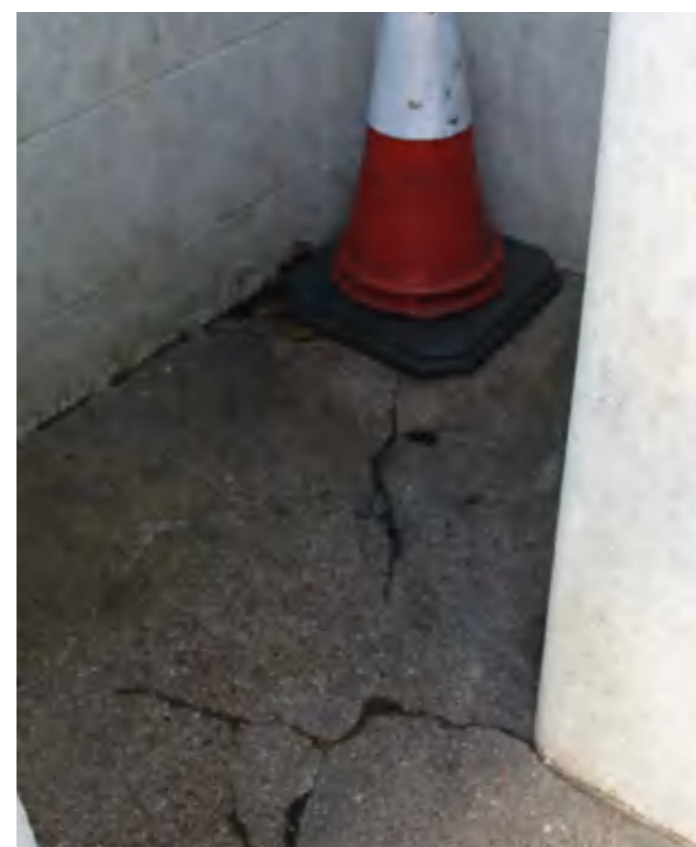
Heavily cracked and broken to the full floor area (approx. 7 sqm). If the intention is to re-open the currently closed external urinal space, the replacement of this floor is a priority for public safety.

**Recommendation: Replace Cast in-situ Concrete Floor**

**Priority 1**

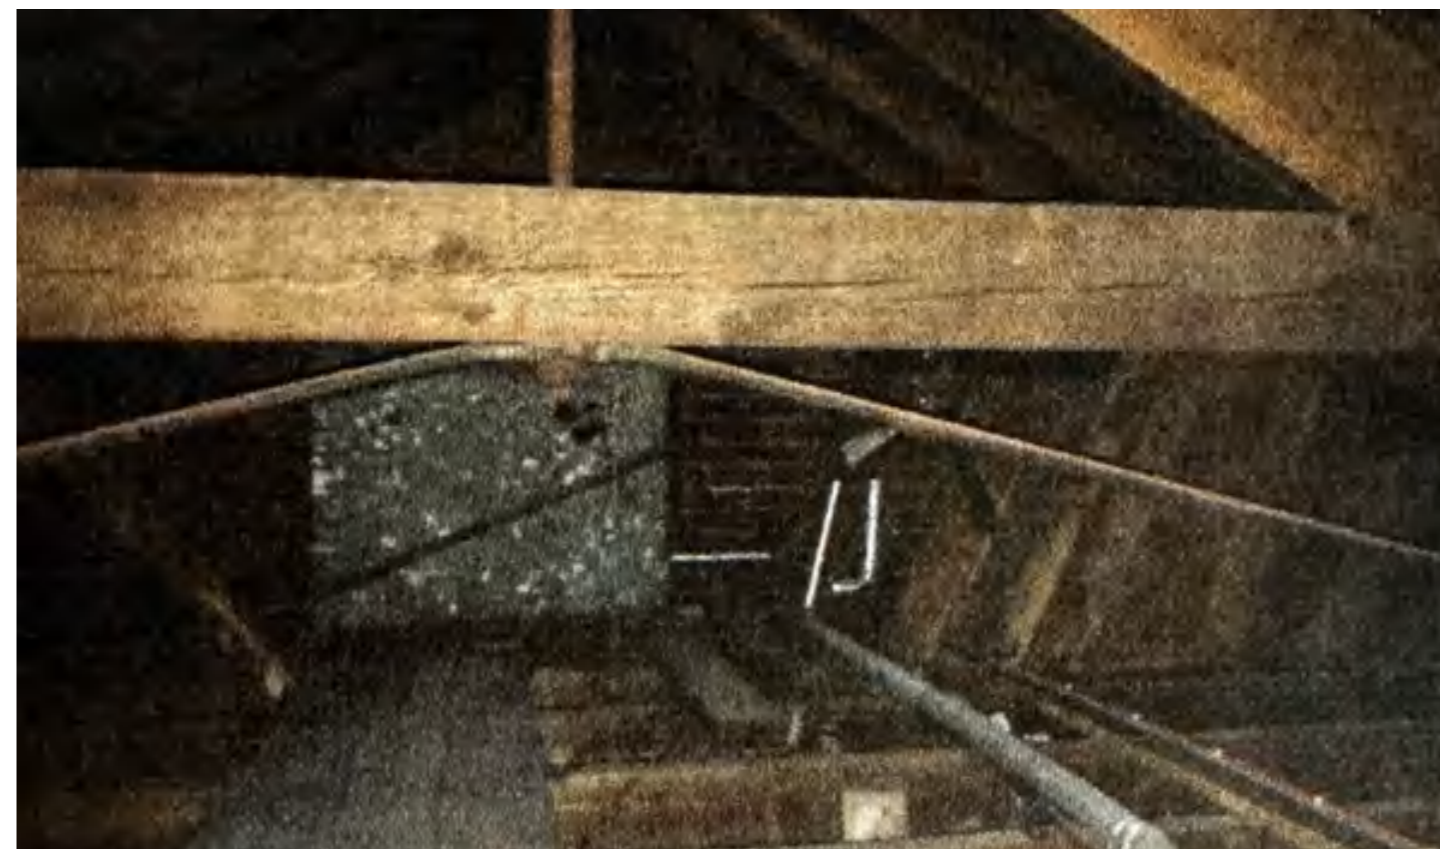
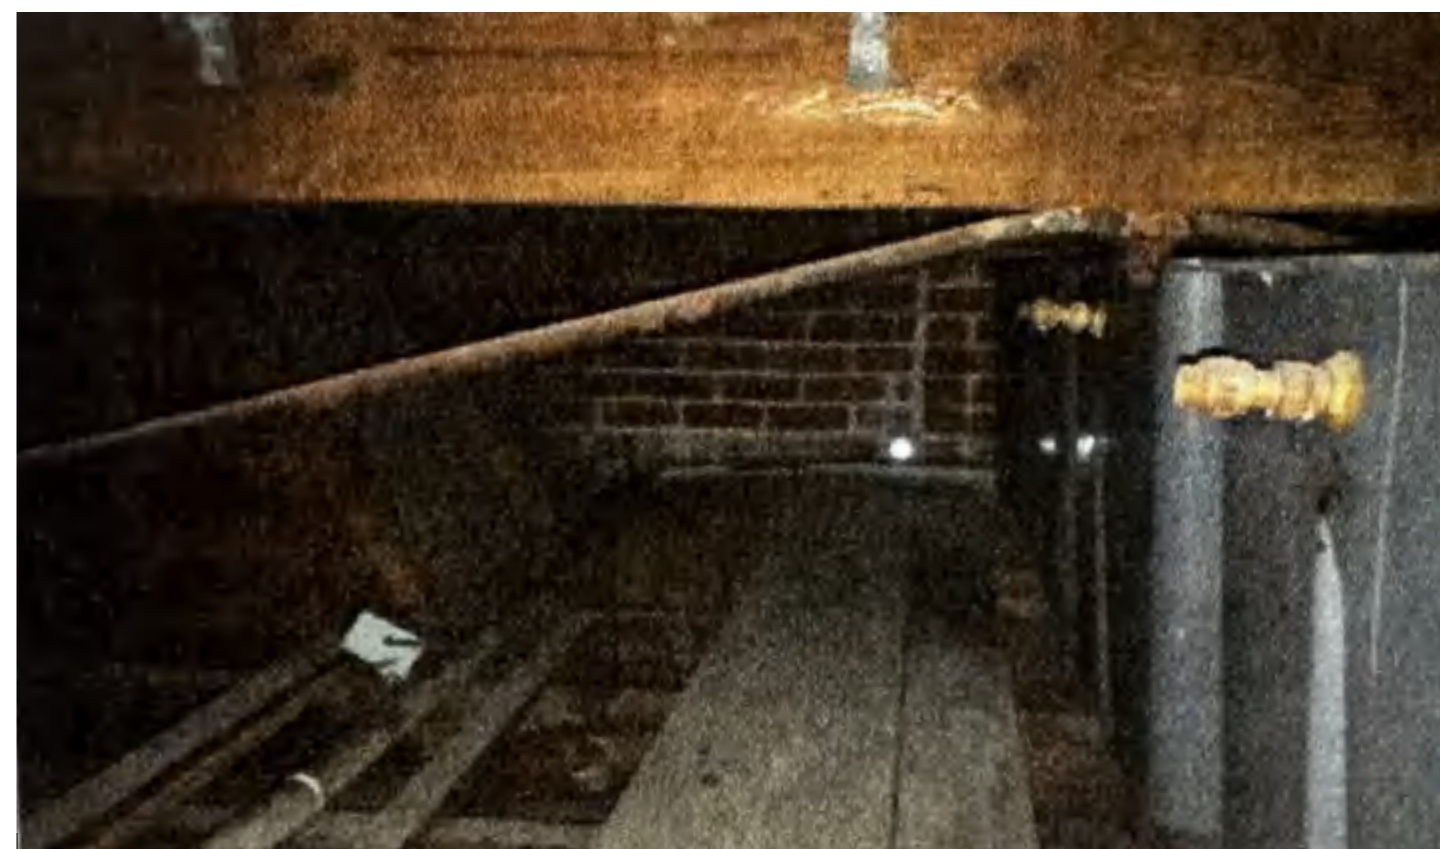
It is recommended that the loft-level is insulated to help mitigate condensation on the otherwise cold ceiling finishes.

**Recommendation: Provide Insulation to Ceiling-Level across Roof (approx. 90sqm) Priority 1**

1. Allow for insulating the cold-roof at ceiling level with;
2. 100mm mineral wool insulation quilt laid between ceiling joists
3. 100mm mineral wool insulation quilt continuously laid over ceiling joists

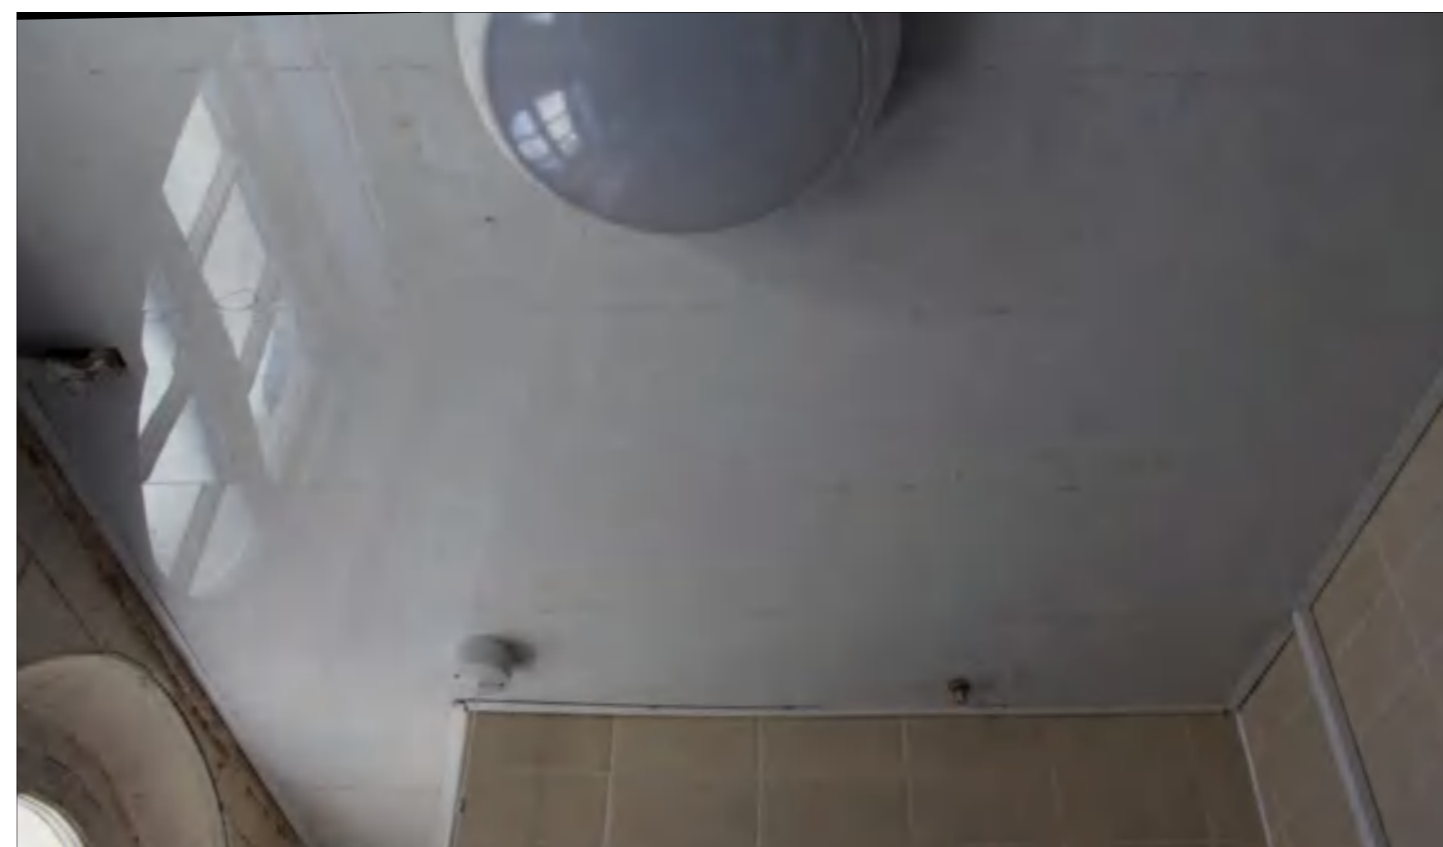
**Description:** As a later addition, the Accessible WC ceiling is clad with a white plastic hygienic sheeting.

1. Take down existing plastic sheet ceiling and allow for inspection of structure revealed above.
2. Allow for reinstating a slatted softwood T&G ceiling finish to match profiles of those seen internally to WCs.
3. Decorate the softwood slats with preservative primer and mould-resistant emulsion (specification and colour TBA)

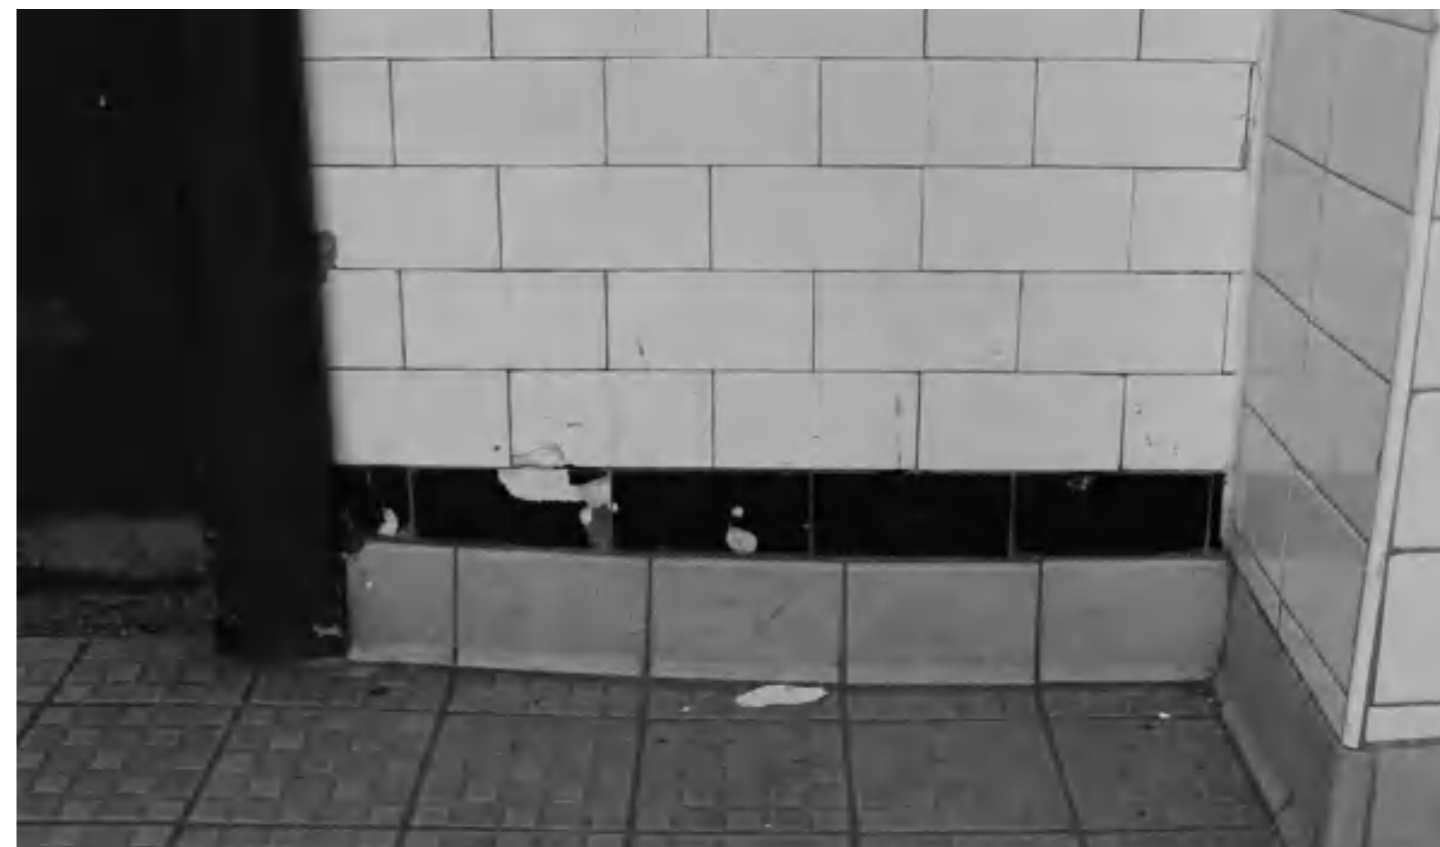
P01

The original tiles show localised areas of considerable damage from wear and tear (P01) and the long-term operation of the external gate making contact with the projecting ceramic string course (P02).

1. Remove all redundant fixtures and fittings from the original ceramic tiled wall finishes.
2. Conduct a package of specialist ceramic tile repairs to all hairline cracks and areas of damaged / chipped tiles (colour matched).
3. Allow for deep cleaning of all wall tiled areas.
4. Install wall mounted stop for the external gate to prevent contact with projecting string course (position TBC with Architect)

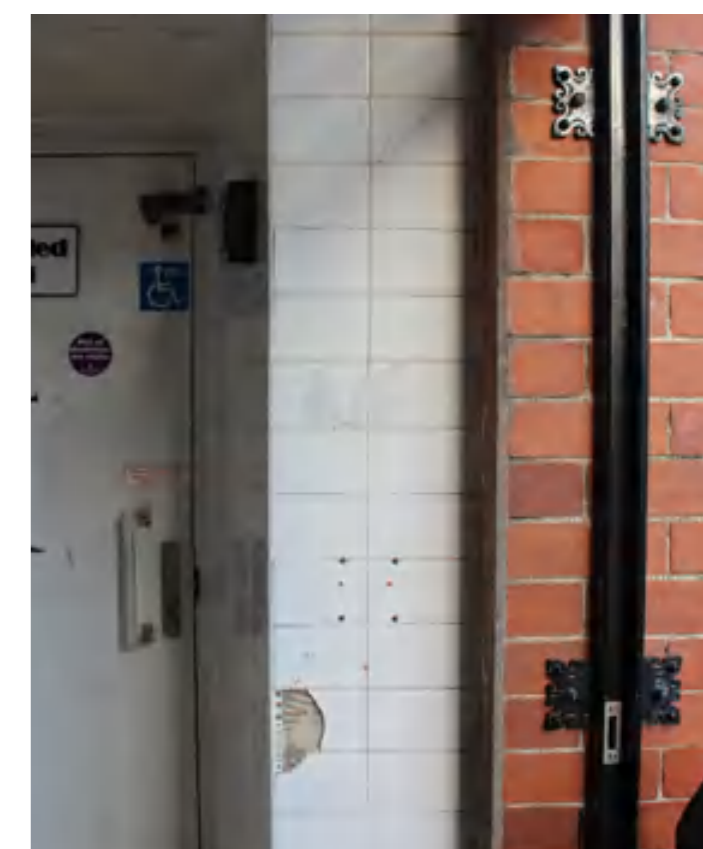
P03

The modern tiles to the Accessible WC partition are dated, with areas showing tile loss and debonding from the substrate (P03). Internally, extensive failure is evident, and tiles on the northern wall are at risk of complete detachment and causing a public health and safety concern.

1. Remove modern white ceramic tiles and redundant fixtures.
2. Allow for full re-tiling with new high quality ceramic wall tile and grout (specification TBA with Architect)
3. Remove painted hardboard soffit over door (P01)
4. Replace soffit with new painted softwood T&G slats to match recommendations for entrance lobby ceiling.

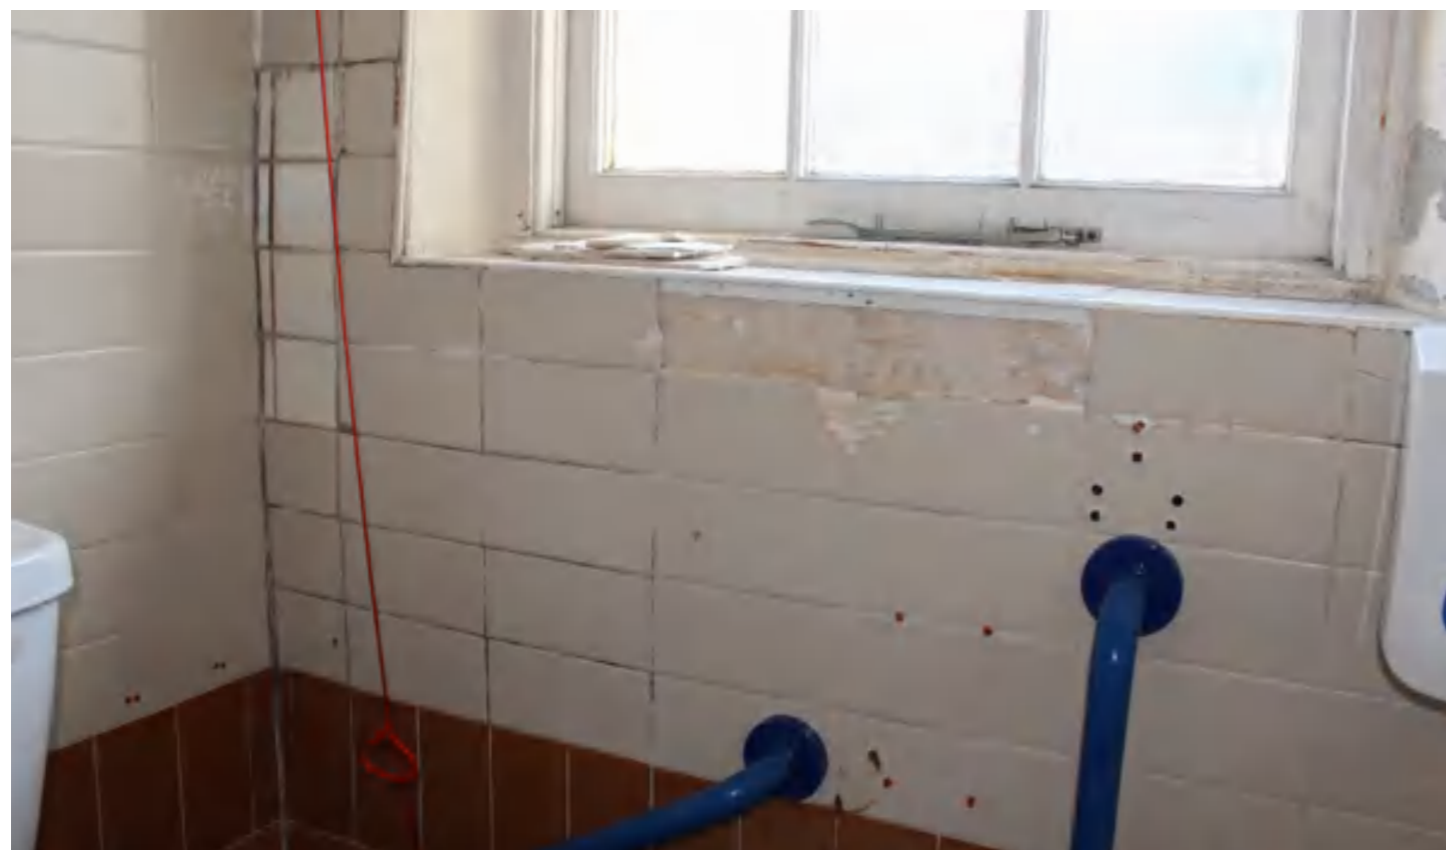
P06

**Description:** Modern white ceramic tiles have been applied within the east entrance lobby to a presumed later partition forming the Accessible WC. Internally, modern wall tiling runs from floor to ceiling, showing areas of tile loss and damage (P06) as well as full detachment from the substrate to the northern wall (P07).

1. Remove all wall tiles from internal faces of Accessible WC walls, including all fixtures and fittings.
2. Allow for complete re-tiling of walls with high quality ceramic wall tile and grout (specification TBA with Architect)
3. Remove all paint from window reveals and cills and allow for localised repair to render substrate.
4. Provide 2 no. new painted softwood bullnose cill boards to splayed reveals.
5. Allow for redecorating plastered window reveals (specification TBA)

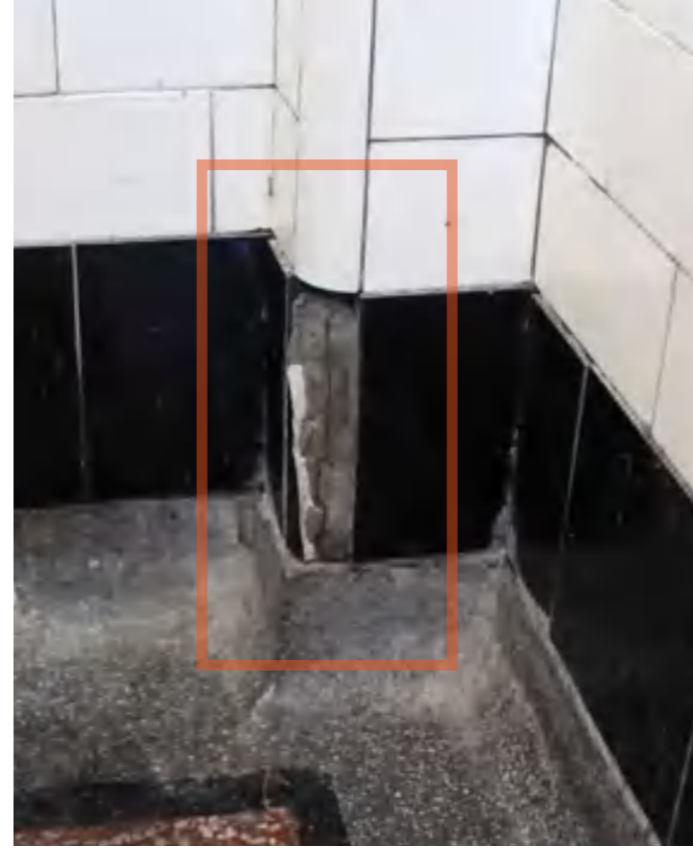
P05

The original tiled wall surfaces are generally in fair structural condition. They display extensive age-related wear, including localised areas of missing tiles (P05-6), damage from poor services / fixture installation and hairline cracking consistent with minor movement and settlement over time. **A wide vertical crack is present over the head of Window 09 (P04) however, within a 2023 Structural Assessment by Ferrier Hart Thomas, this was considered historical movement.** The walls have hosted numerous fixtures historically, and remnants such as redundant screws, fixings, and surface blemishes remain evident. Cement rendered splayed window reveals and cills to 4 no. round headed windows show extensive paint failure and hairline cracking.

1. Remove all redundant fixtures and fittings from the original ceramic tiled wall finishes.
2. Conduct a package of specialist ceramic tile repairs to all hairline cracks, localised damage around services penetrations and areas of damaged / chipped tiles from wear and tear (colour matched), as illustrated on photographs.
3. Replace 2 no. areas of missing quarter-round corner tiles (P05-6)
4. Allow for deep cleaning of all wall tiled areas.
5. Remove all paint from window reveals and cills and allow for localised repair to render substrate.
6. Provide 4 no. new painted softwood bullnose cill boards to splayed reveals
7. Allow for redecorating plastered window reveals (specification TBA)
