Grade II Listed Public Conveniences, John St, Porthcawl:

# BUILDING CONDITION SURVEY

PORTHCAWL  
TOWN COUNCIL

Revision	
DRAFT	09.12.2025
P01	10.12.2025

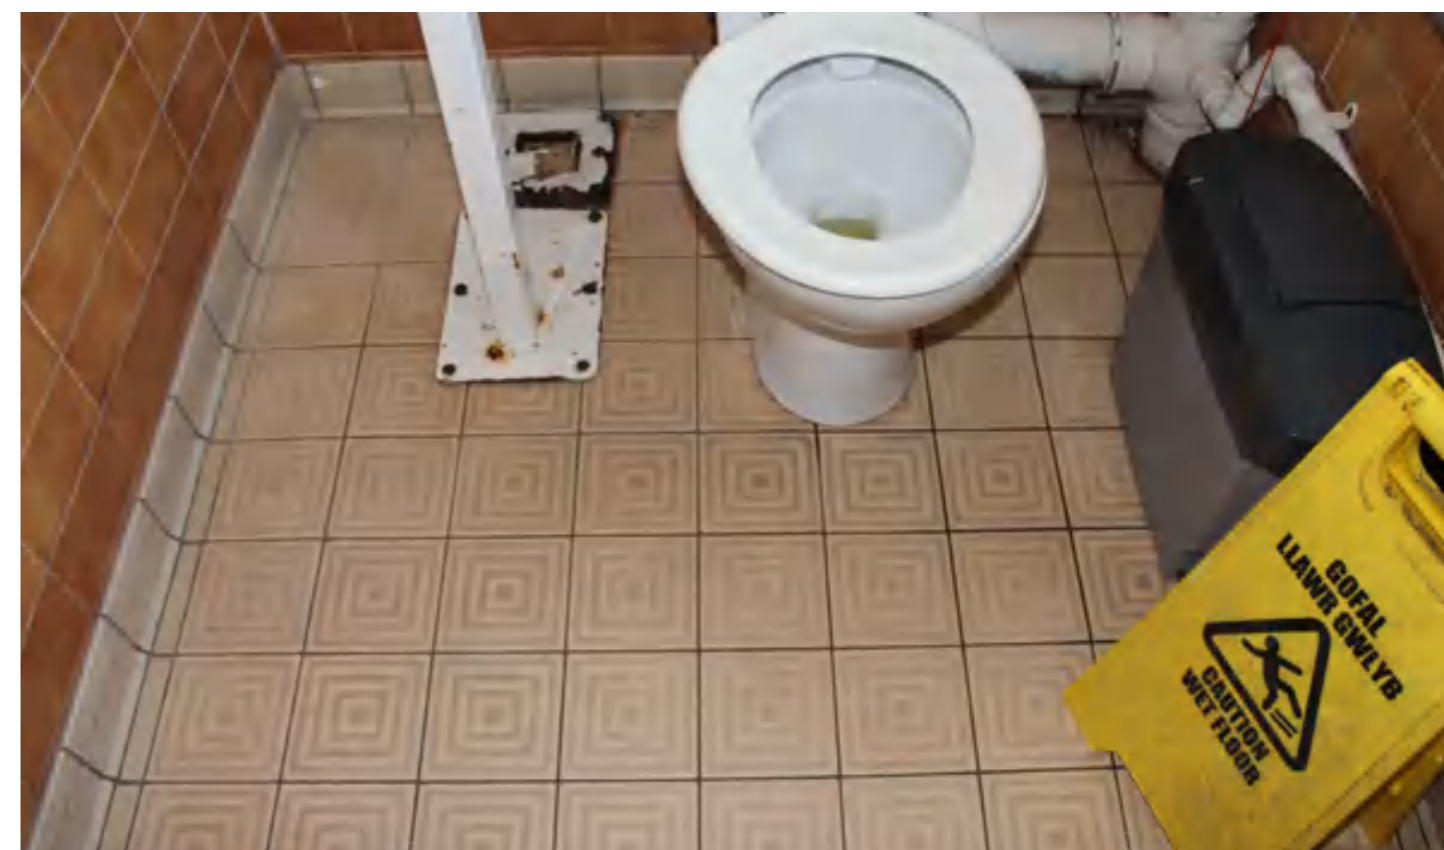
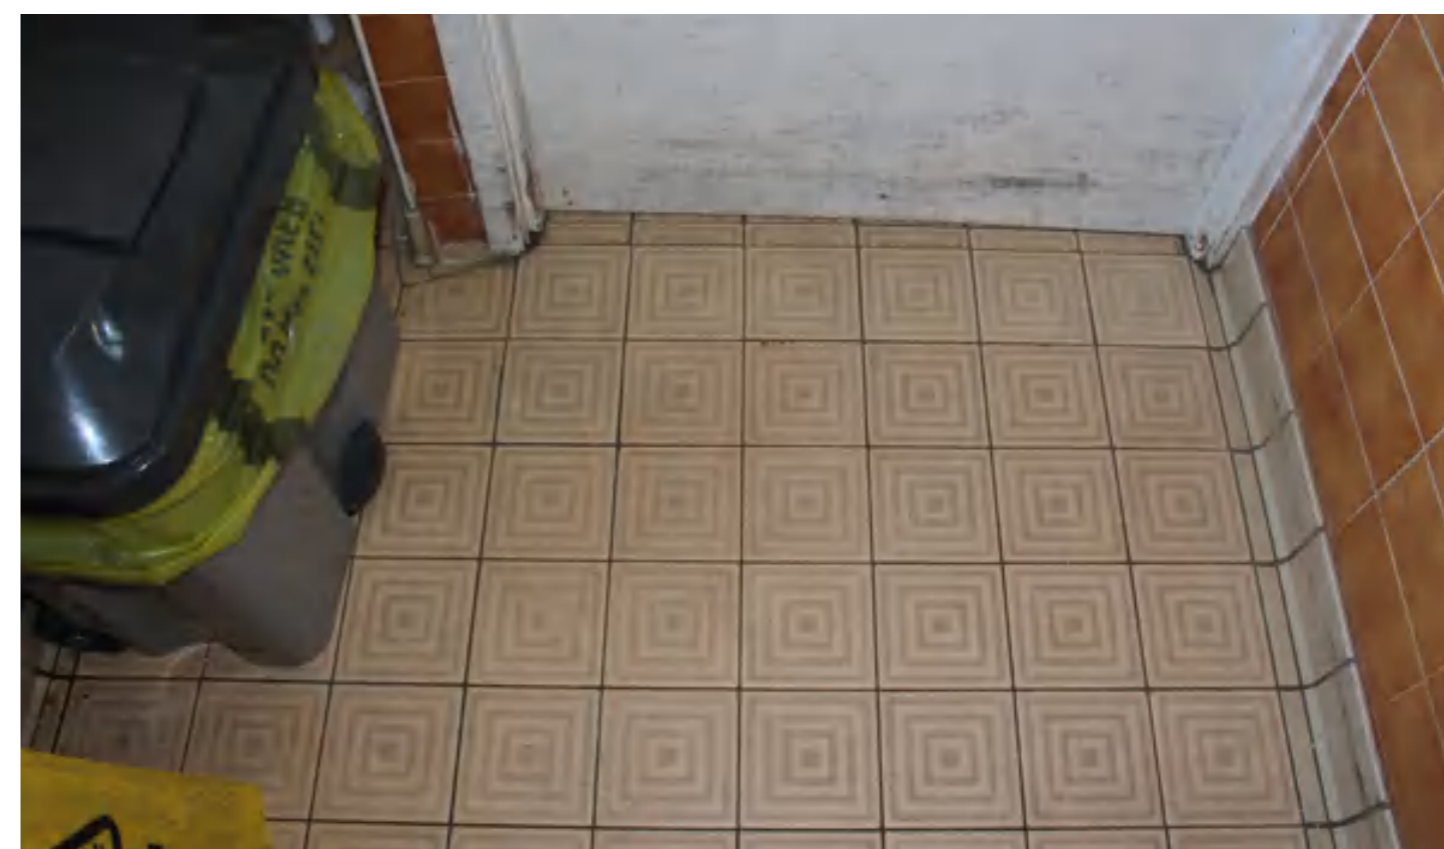
**Condition:** Good

The tiles themselves, including kerbed upstands, are in good condition remaining intact and functional. Similarly to those tiles used to the entrance lobby however, they are visually out of character with the historic building and, in the interest of aesthetic and experiential enhancement, are recommended for replacement.

**Recommendation: Replace Floor Tiles to Accessible WC (approx. 5sqm)**

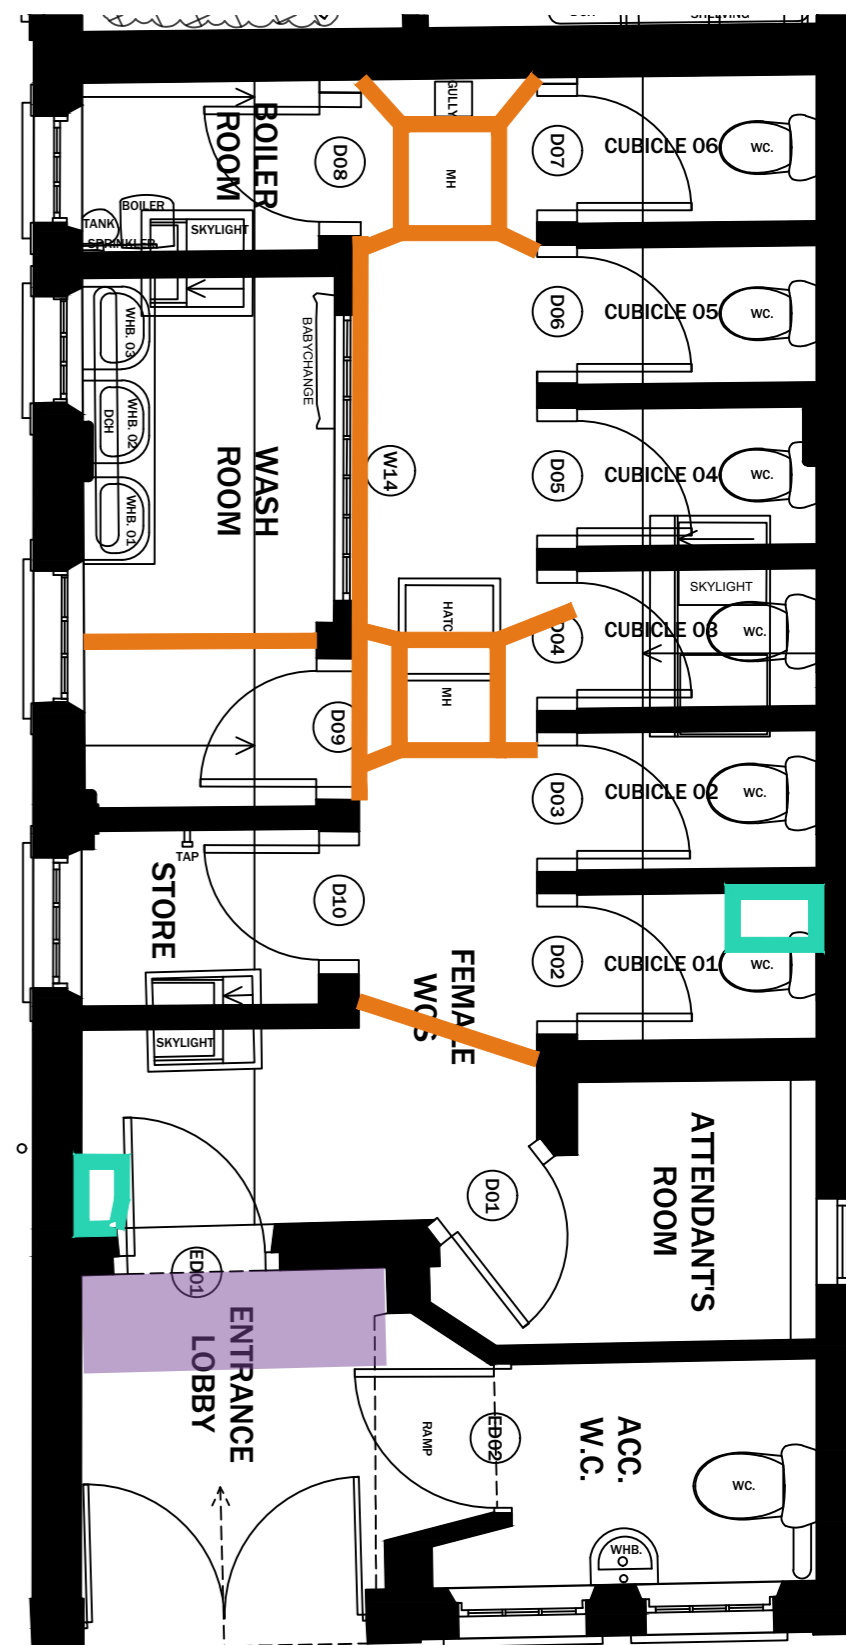
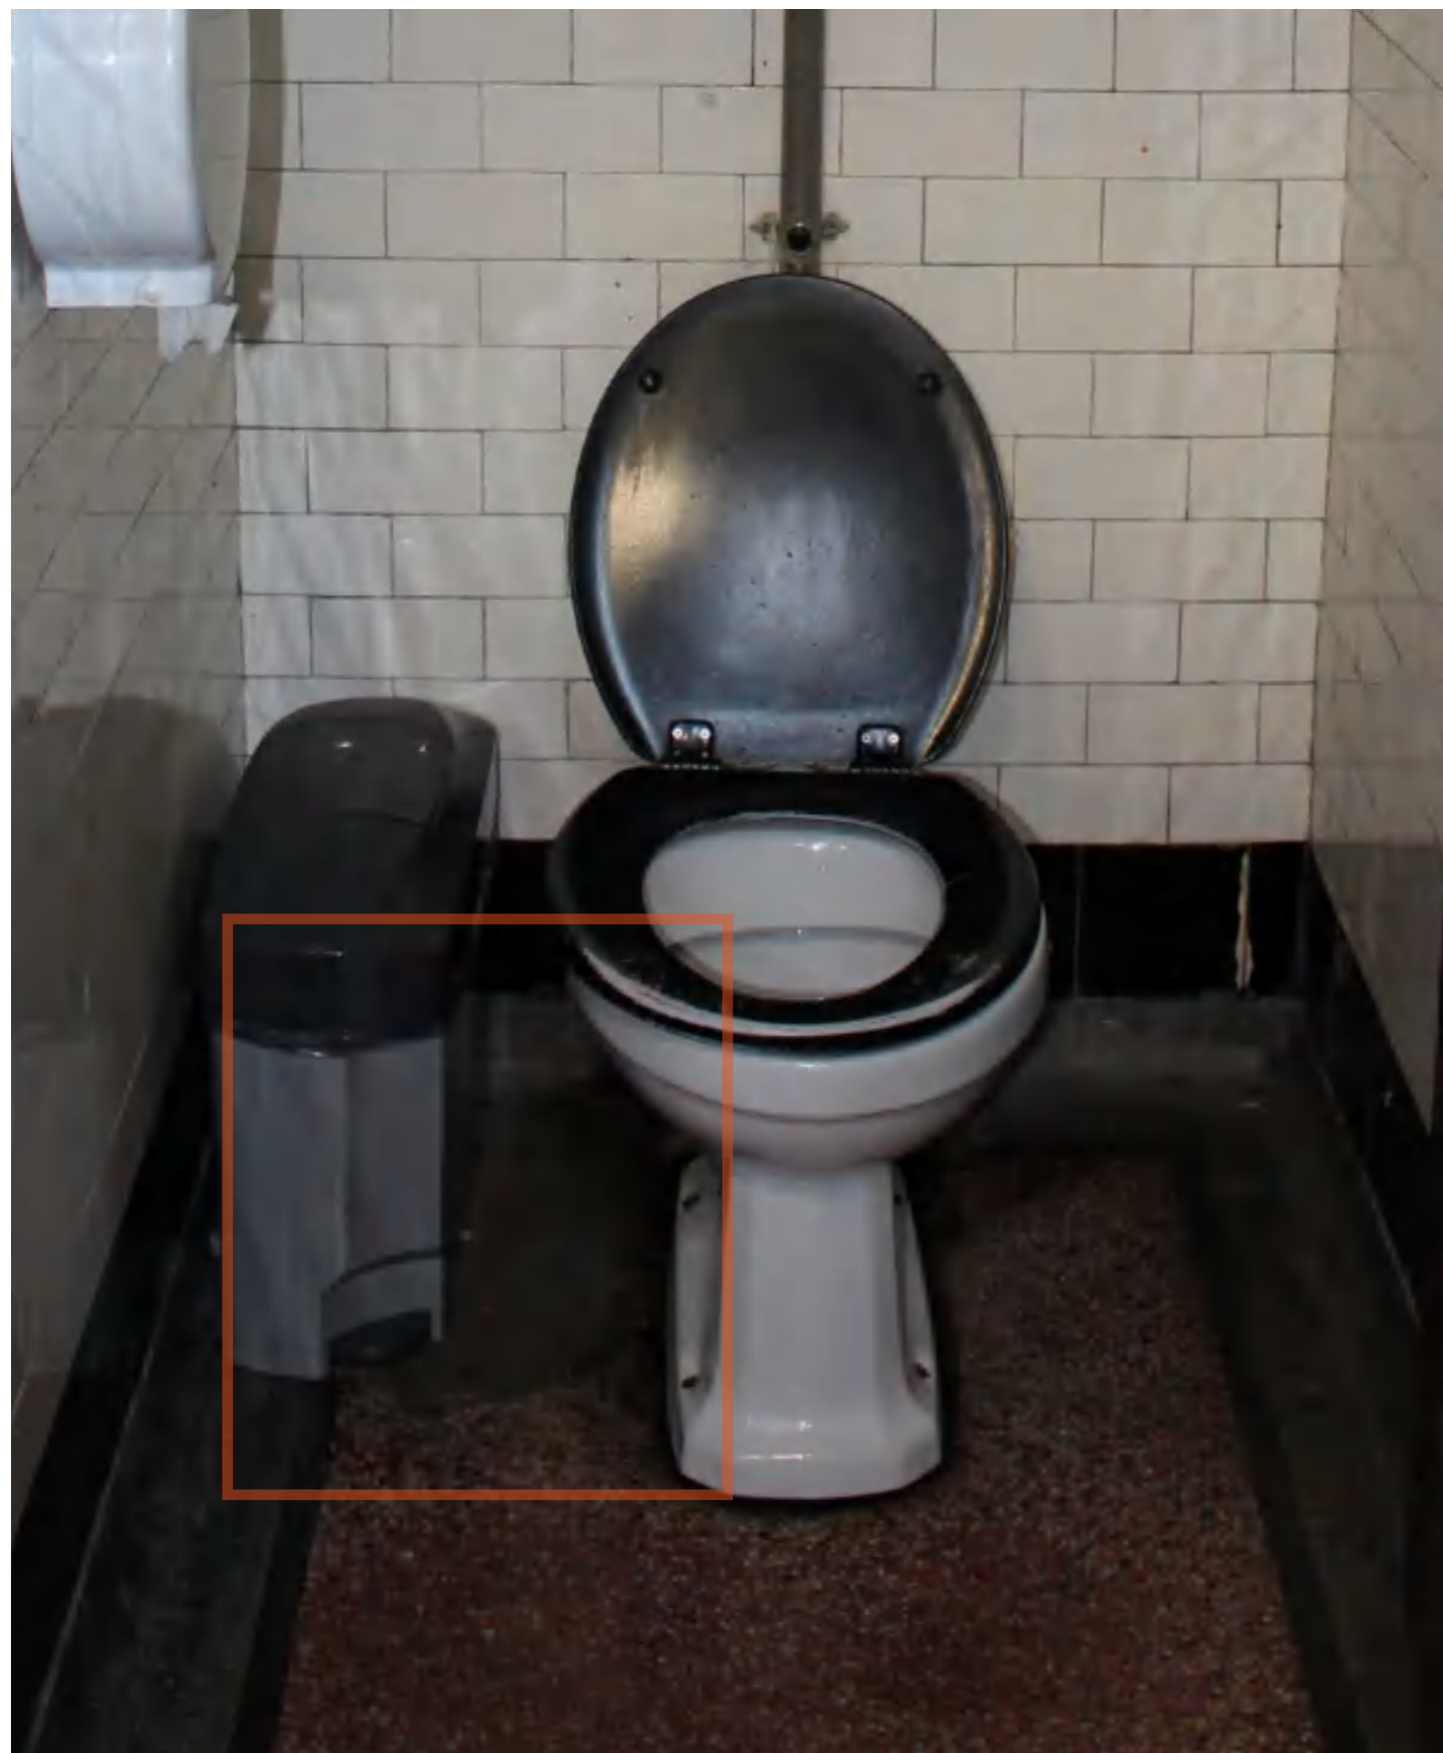
Female WC Plan Extract  
1:50 @ A3 L

**Condition:** Fair to Poor

Terrazzo is a robust floor finish and, while it shows typical age-related wear and some localised damage, it remains functional, hard-wearing and historically significant, making a positive contribution to the character of the building. Defects include a pattern of cracking (between 1–5 mm in width), likely attributable to historic settlement and expansion/contraction, together with areas of unsympathetic repair associated with past services and maintenance interventions, including patching in cementitious materials.

- Locations of cracks in terrazzo floor
- Locations of poor cement patch repairs
- Location for low-profile entrance matting

**Recommendation: Replace Defective Gully Cover** Priority 2

1. Replace with Interlaken Cast Iron Square Gully Cover (200mm 8" TBC) by Lateral Design Studio.
2. Allow for decorating gully cover with Gloss Black Metal Paint.

**Recommendation: Terrazzo Repairs to Female WCs (approx. 35sqm)** Priority 3

1. Allow for specialist terrazzo floor repairs and refurbishment comprising;
2. Sanding and polishing the terrazzo floor area using progressively fine grit sanding pads;
3. Remove heavy staining around junctions between terrazzo and toilets;
4. Rake out and fill all cracks with a colour-matched terrazzo crack repair filler to all hairline cracks and to the perimeter of the internal manholes (see drawing overleaf for extent);
5. Remove poor cement render repairs to indicated locations (see drawing overleaf) and repair with matching terrazzo, re-creating bands and design features where required;
6. Allow for sealing the repaired floor with Tile Doctor Colour Grow or similar approved.

**Recommendation: Install Low-Profile Entrance Matting** Priority 3

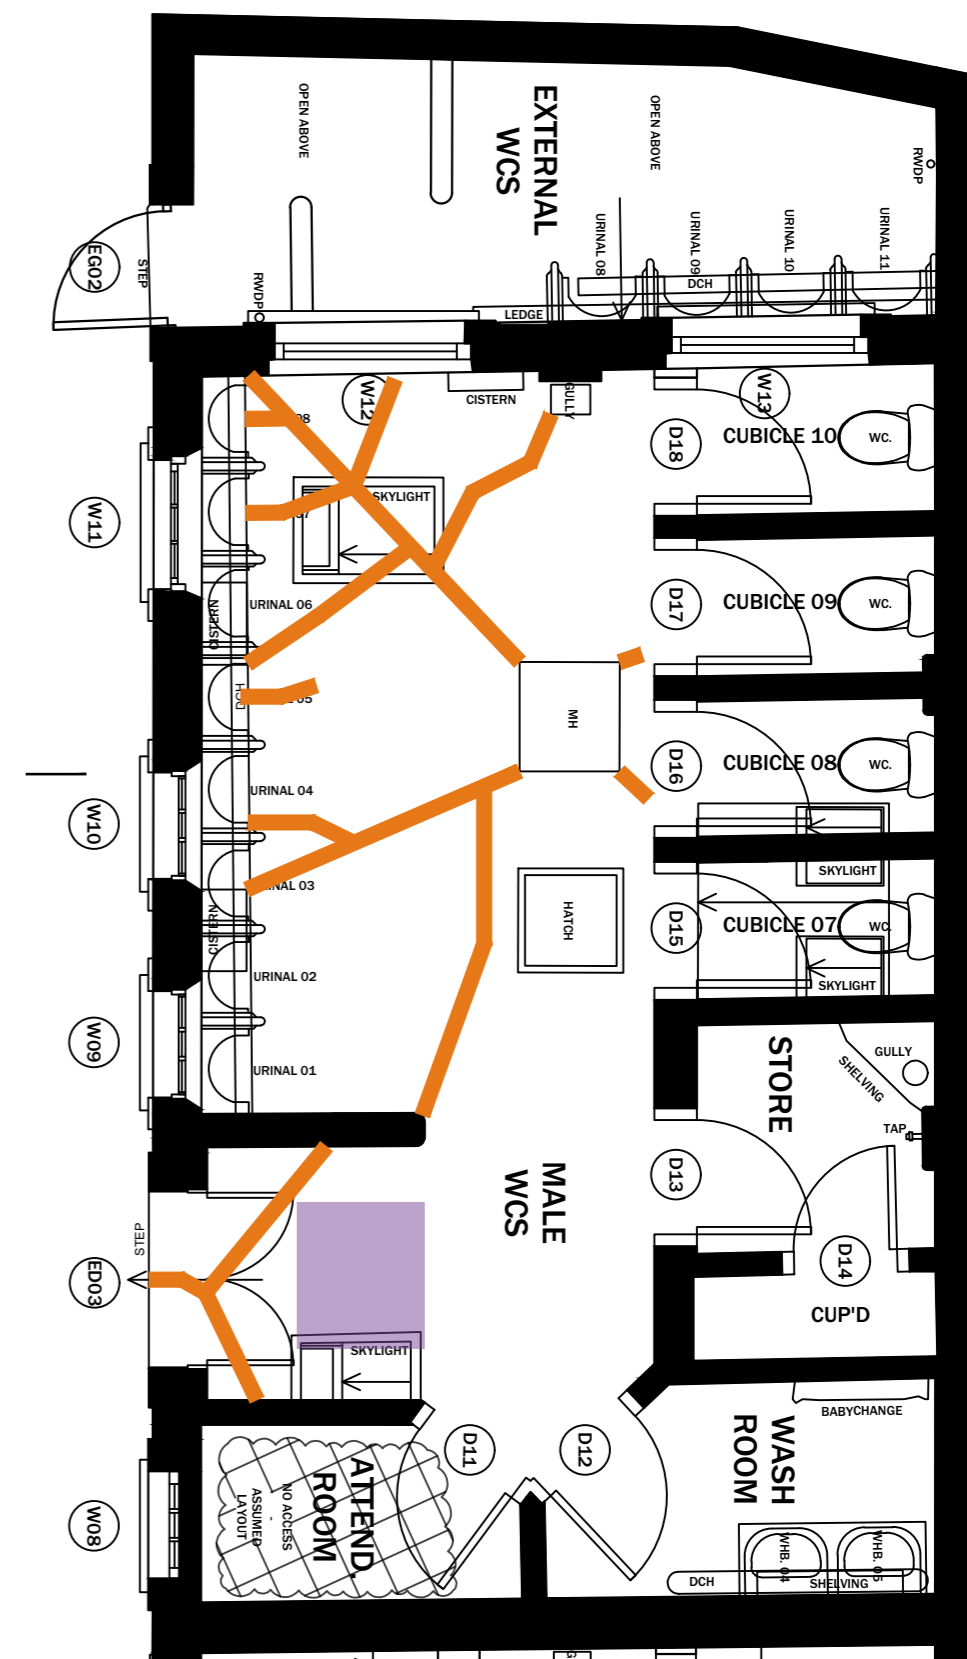
Male WC Plan Extract  
1:50 @ A3 L

**Condition:** Poor

Terrazzo is a robust floor finish and, while it shows typical age-related wear and some localised damage, it remains functional, hard-wearing and historically significant, making a positive contribution to the character of the building. Cracking is more extensive than seen in the Female WCs, including a widespread pattern (between 1–5 mm in width), likely attributable to historic settlement and expansion/contraction.

Locations of cracks in terrazzo floor

Location for low-profile entrance matting

**Recommendation: Replace Defective Gully Cover**

1. Replace with Interlaken Cast Iron Square Gully Cover (200mm 8" TBC) by Lateral Design Studio.
2. Allow for decorating gully cover with Gloss Black Metal Paint.

**Recommendation: Terrazzo Repairs to Male WCs (approx. 35sqm)**

1. Allow for specialist terrazzo floor repairs and refurbishment comprising;
2. Sanding and polishing the terrazzo floor area using progressively fine grit sanding pads;
3. Remove heavy staining around junctions between terrazzo and toilets;
4. Rake out and fill all cracks with a colour-matched terrazzo crack repair filler to all hairline cracks and to the perimeter of the internal manholes (see drawing overleaf for extent);
5. Allow for sealing the repaired floor with Tile Doctor Colour Grow or similar approved.

**Recommendation: Install Low-Profile Entrance Matting**

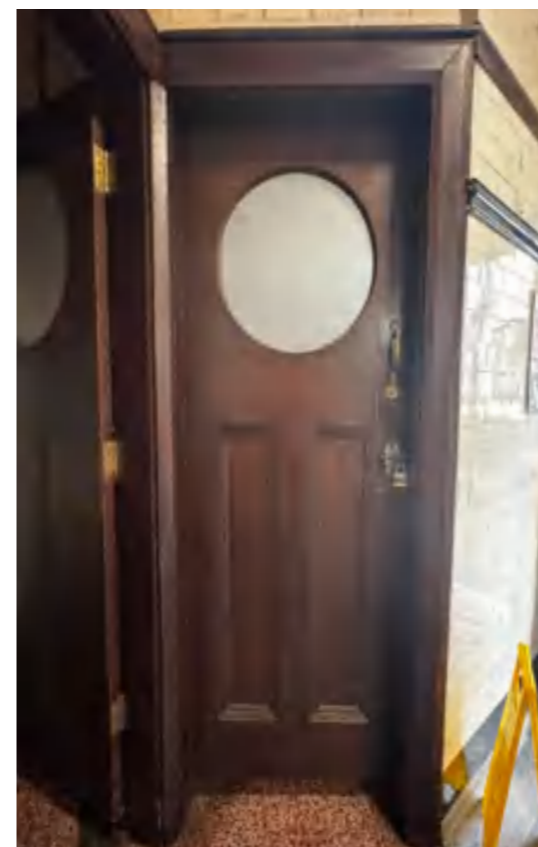
Door 11

**Condition:** Fair

All doors are in good structural order and are robust, well-made door sets. They do, however, exhibit age-related wear, a build-up of dirt and grime, and localised damage where previous ironmongery has been removed and / or modern ironmongery has been insensitively installed.

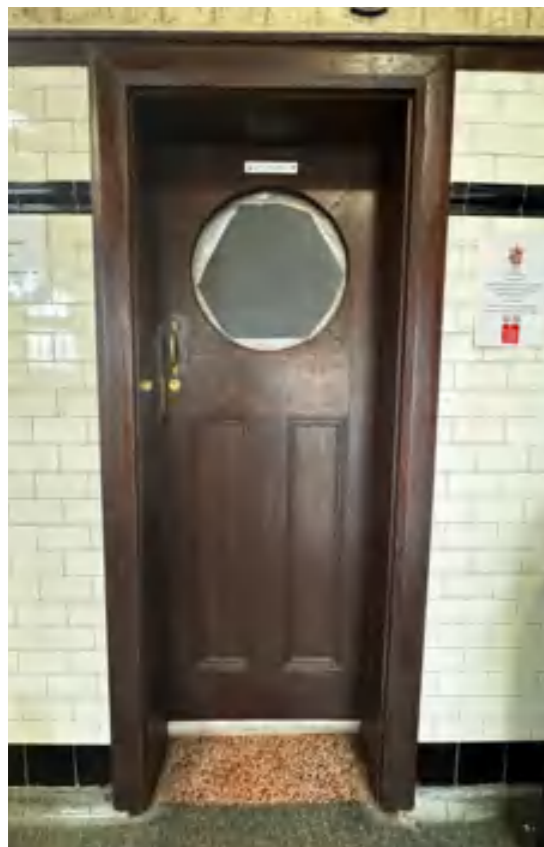
Door 13 Crack

1. Retain and polish brass handle, replace screw fixings
2. Replace cracked and damaged round privacy glass pane with like-for-like
3. Conduct scarf repair to damaged portion of door where notched for previous ironmongery installation
4. Fill crack within hardwood panel
5. Replace white plastic skirt with black counterpart

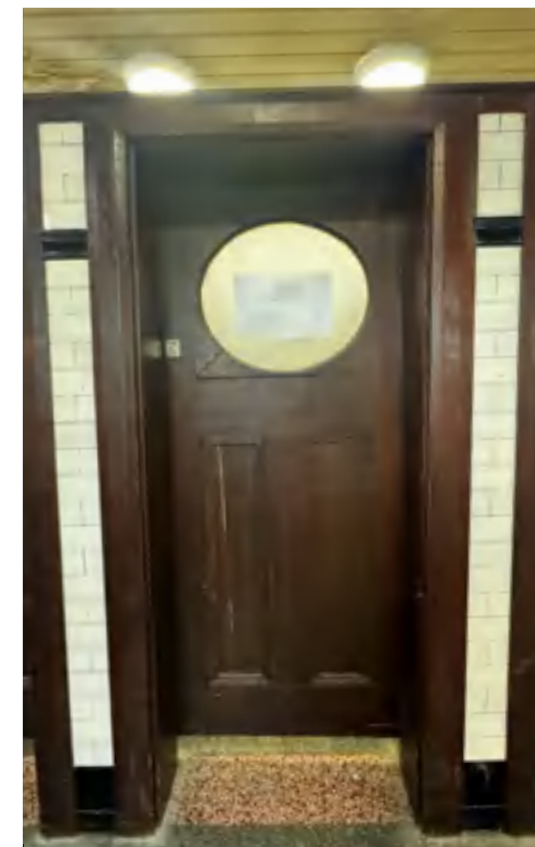
Door 13 Damaged Glazing

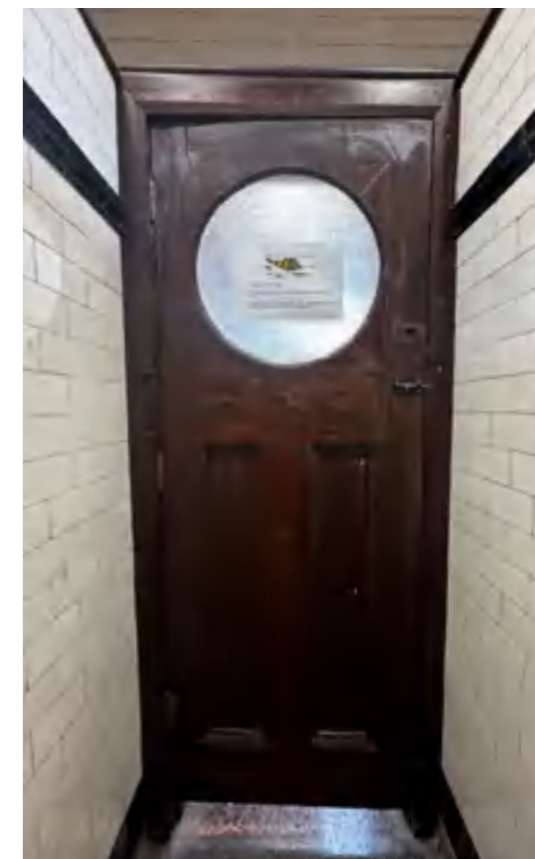
Door 13 Damage

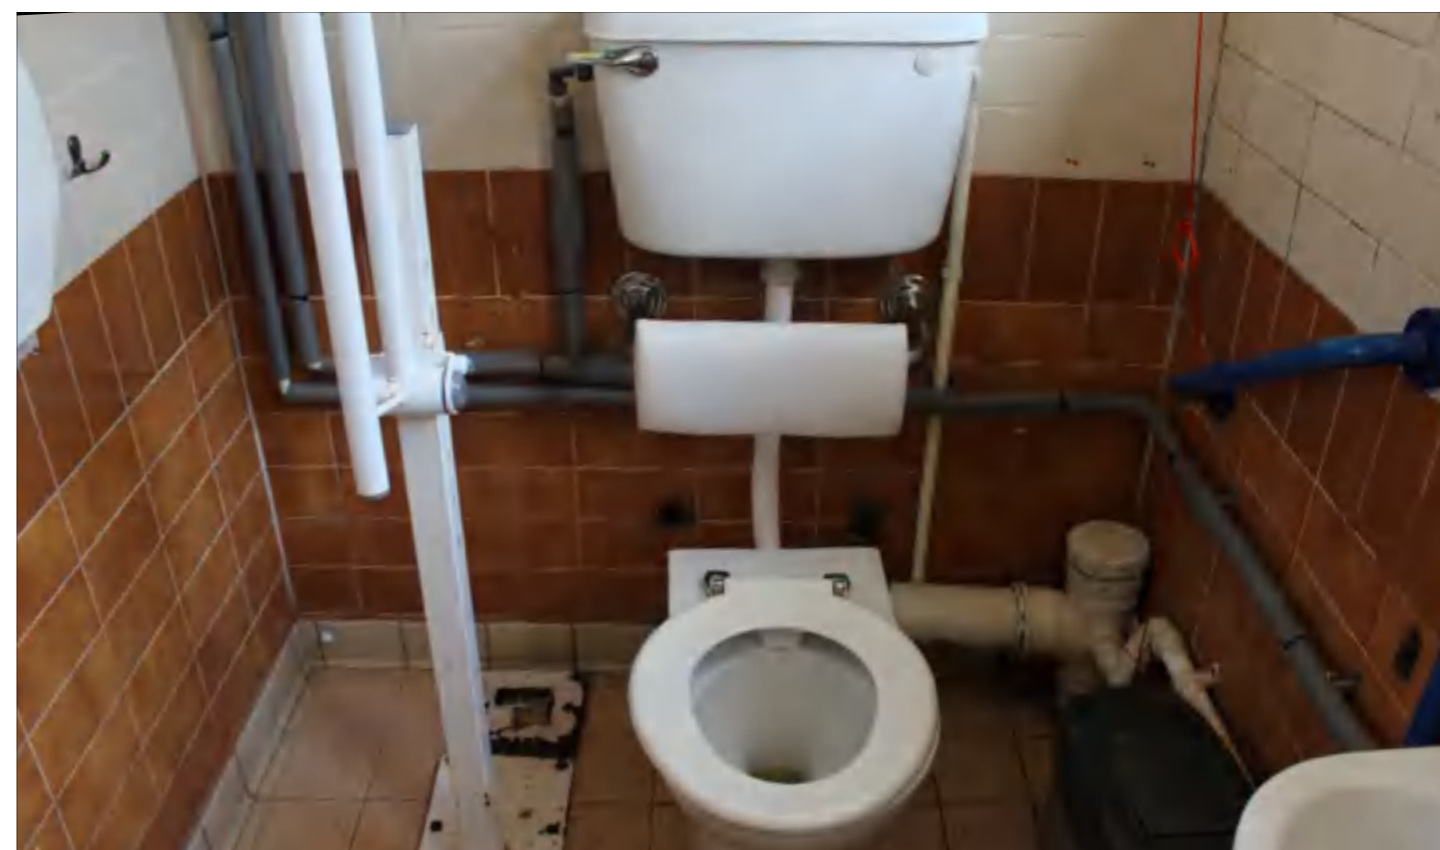
P01

The Accessible WC is fitted with a dated Doc M pack that is now in poor condition, with visible corrosion to fixtures and a highly congested layout that does not support ease of use.

1. Remove all fixtures and sanitaryware from the AWC and replace with a new Doc M Pack as per Commercial Washrooms Fitzroy Of London Low Level Doc M Toilet Pack with Exposed Fixing Grab Rails Dark Grey (Layout TBC with Architect).

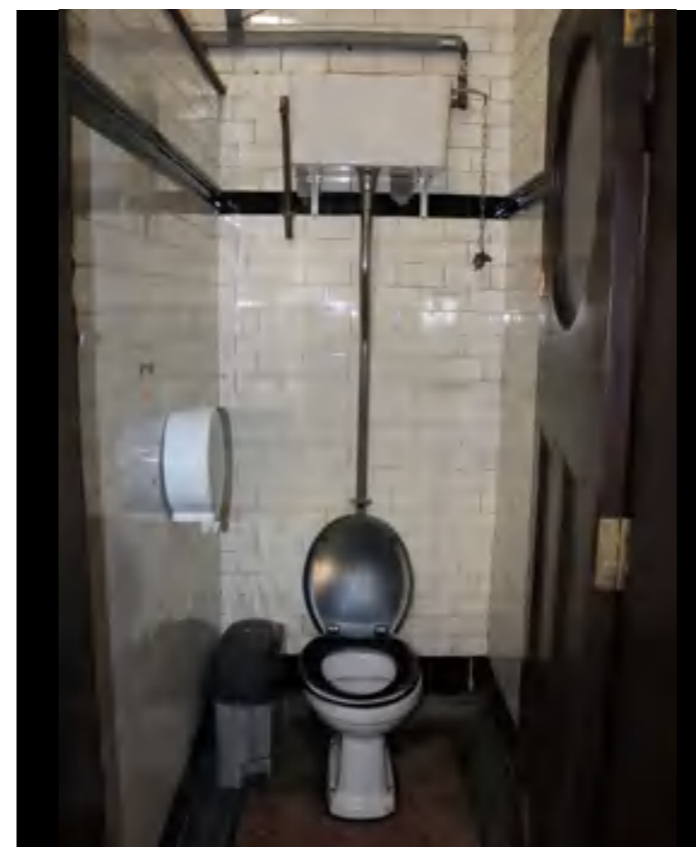
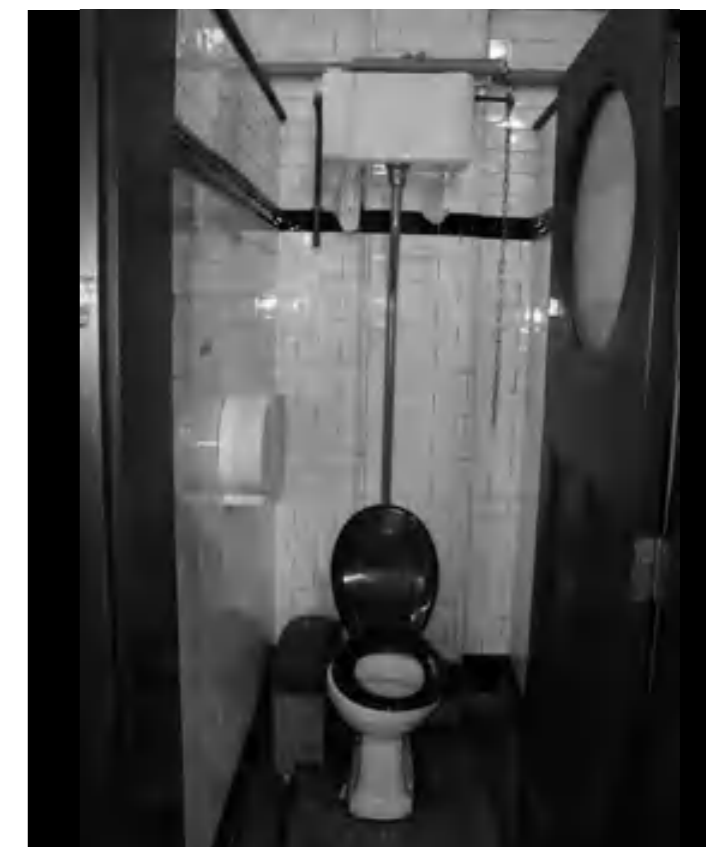
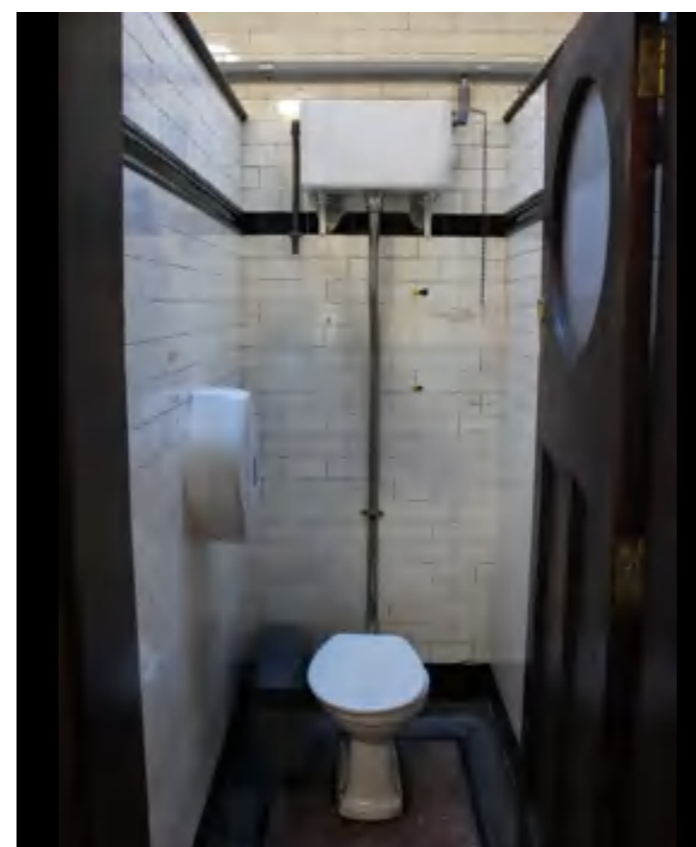
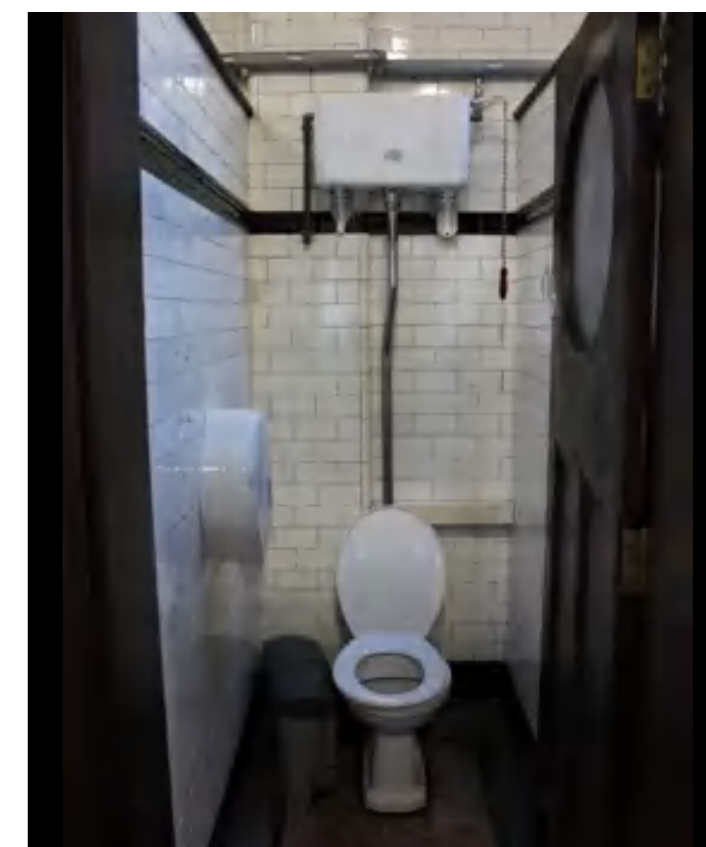
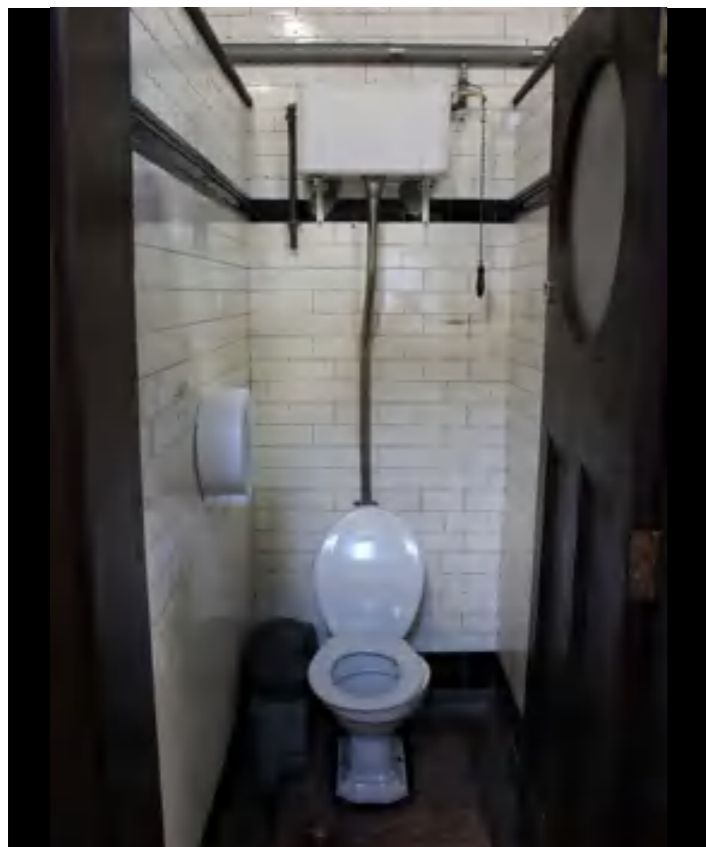
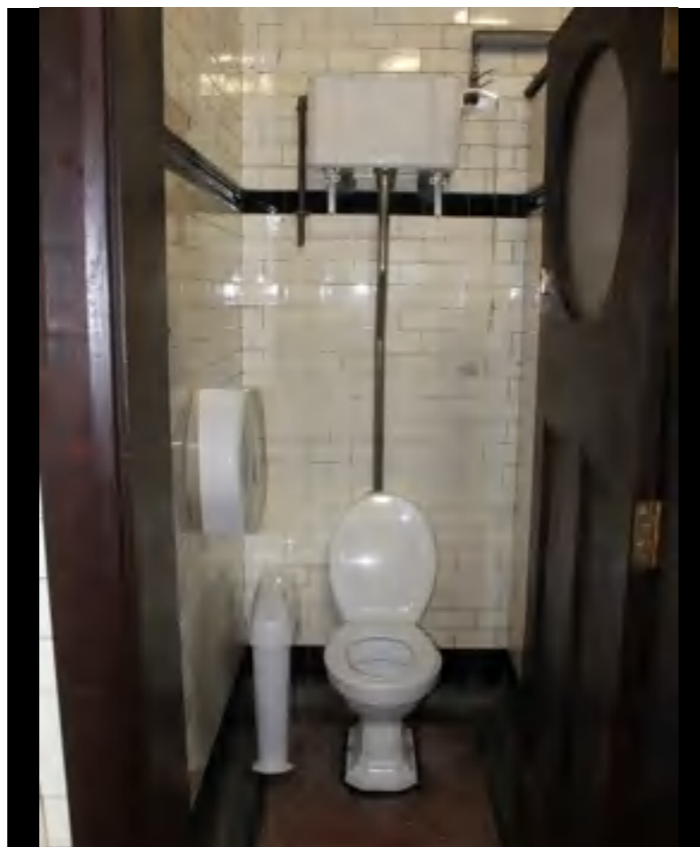
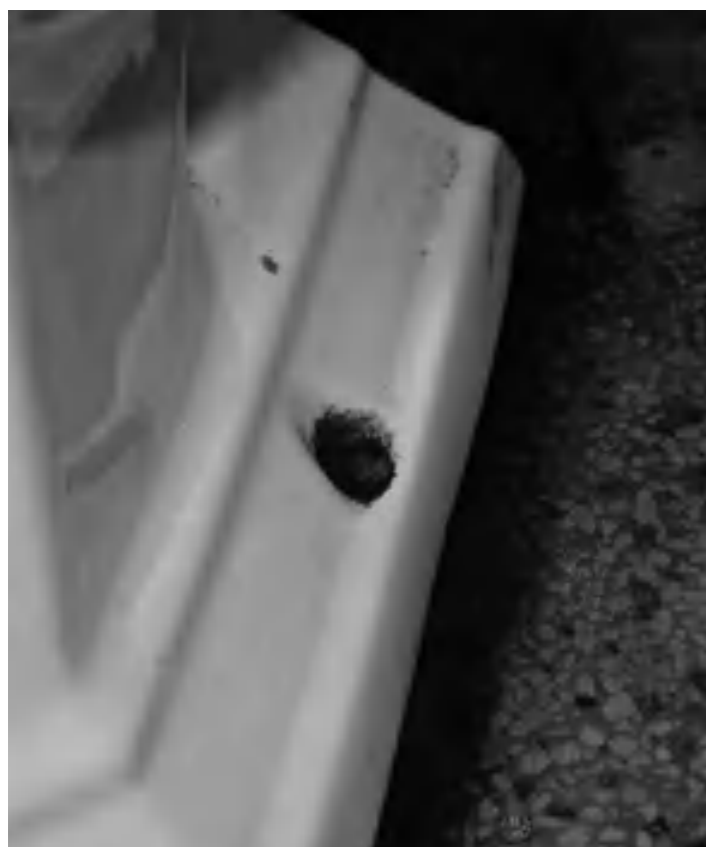
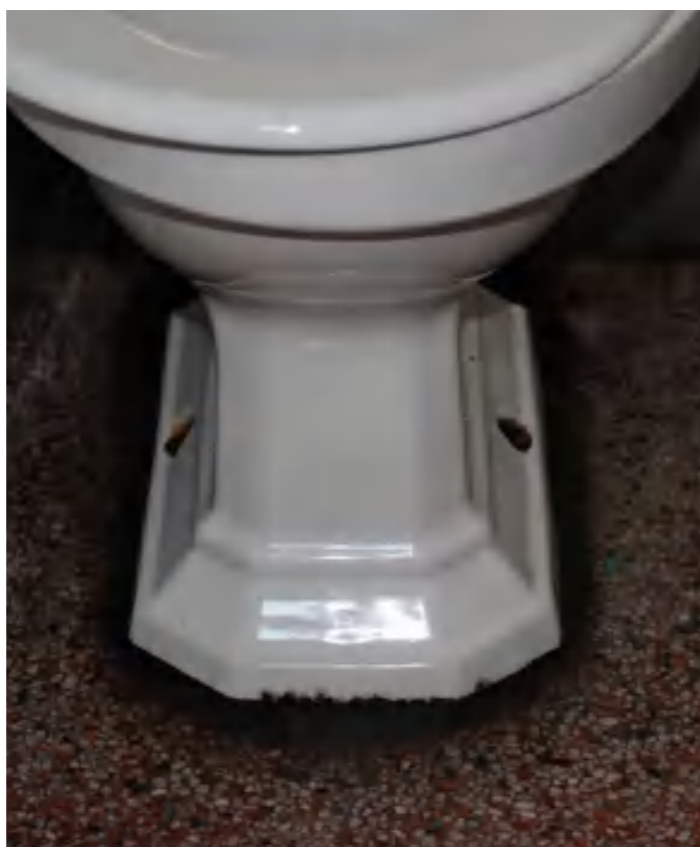
Generally, all cisterns are missing their lids and are in poor hygienic condition. Chain flushes have been broken and replaced with a variety of different chains and pull handles, with some handles missing. Original hardwood toilet seats have been replaced with a mixture of modern plastic seats. The cisterns are crudely fixed to the wall with metal stanchion brackets, and considerable damage has occurred to the original ceramic wall tiles behind due to existing and previous fixings. These damaged areas are present behind all cisterns and have been patch repaired with cement render.

1. Undertake a sterile clean of all 6 no. high-level cisterns
2. Provide 6 no. new Cistern Pulls with Ironmongery World Vintage Cistern Pull with Wooden Handle
3. Clean and polish chrome cistern pipes and connections
4. Clean and polish copper overflow pipes
5. Replace 2 no. corroding base fixings to all toilet pans with new stainless steel counterparts (P07/8)
6. Allow for re-sealing between all toilets and terrazzo floor with silicone
7. Replace all 6 no. modern plastic and damaged toilet seats with new hardwood effect toilet seats (specification TBC)
8. Allow for providing moisture resistant painted MDF pattresses between all cistern brackets and original damaged wall tiles. Allow for providing bullnosed edges and decorating to match white and black band (P09-P14). Profiles / Design TBC with Architect.
