Grade II Listed Public Conveniences, John St, Porthcawl:

# BUILDING CONDITION SURVEY

PORTHCAWL  
TOWN COUNCIL

Revision	
DRAFT	09.12.2025
P01	10.12.2025

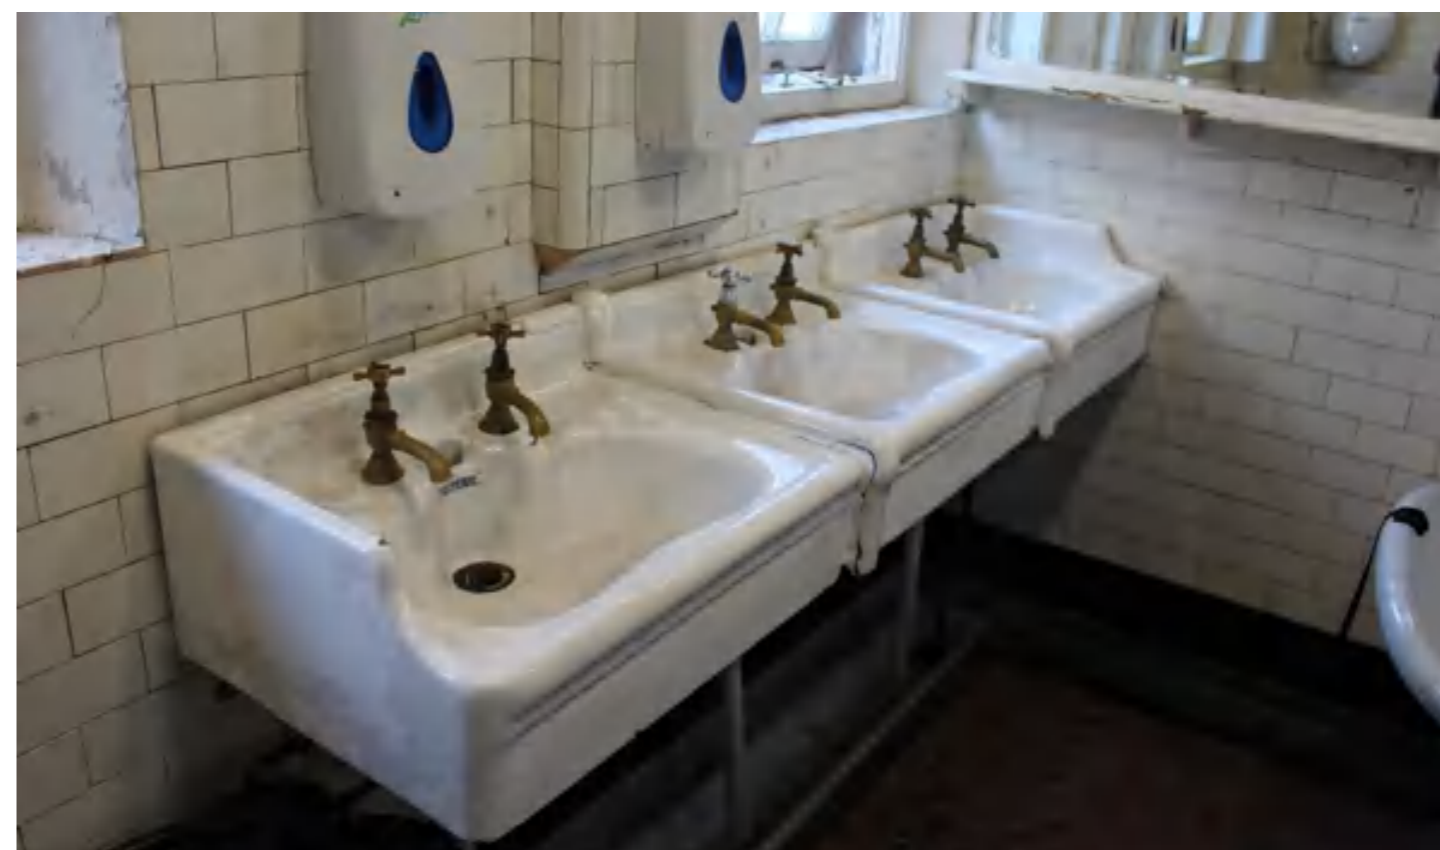
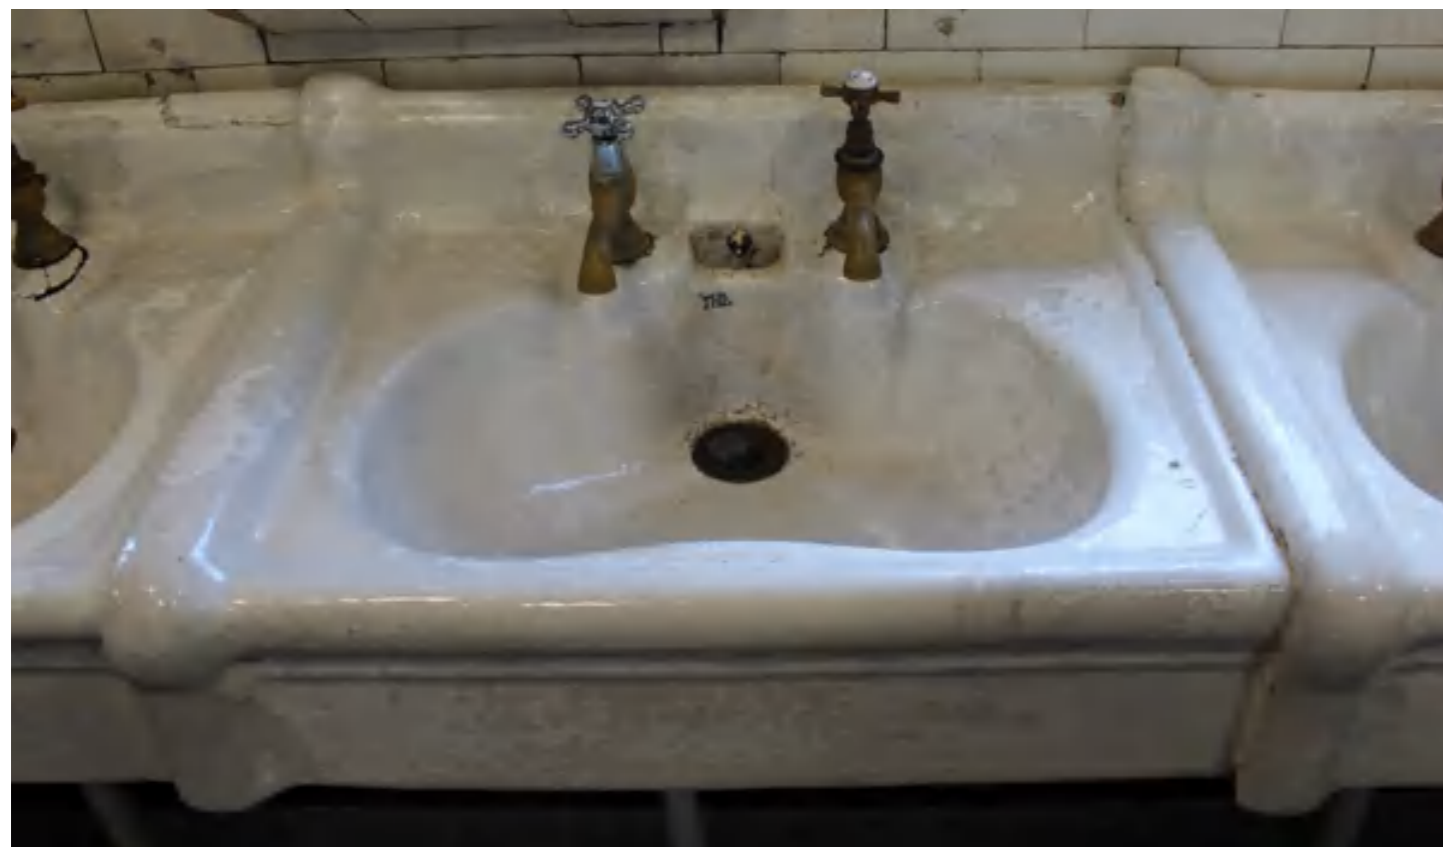
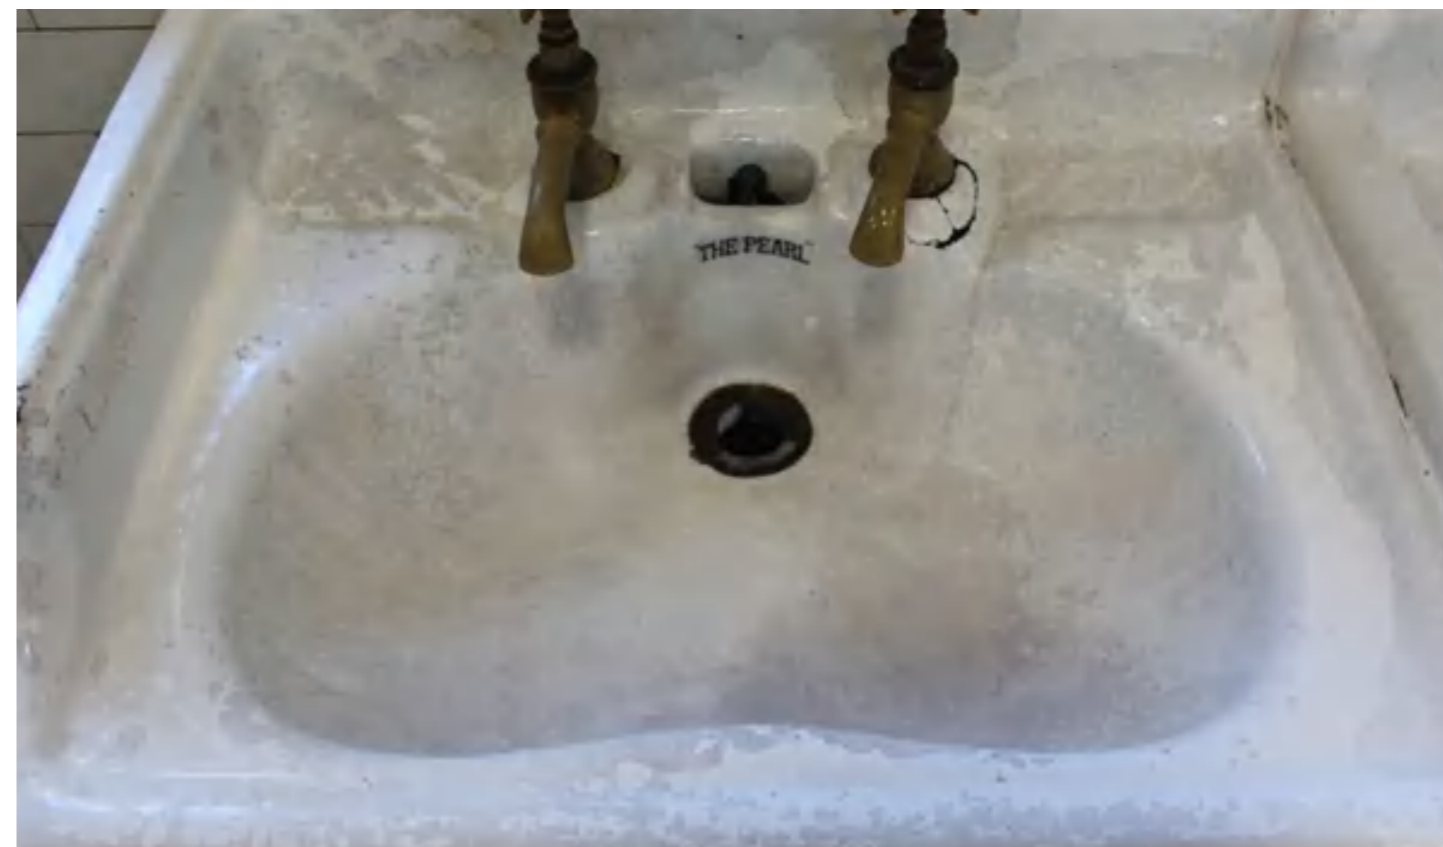
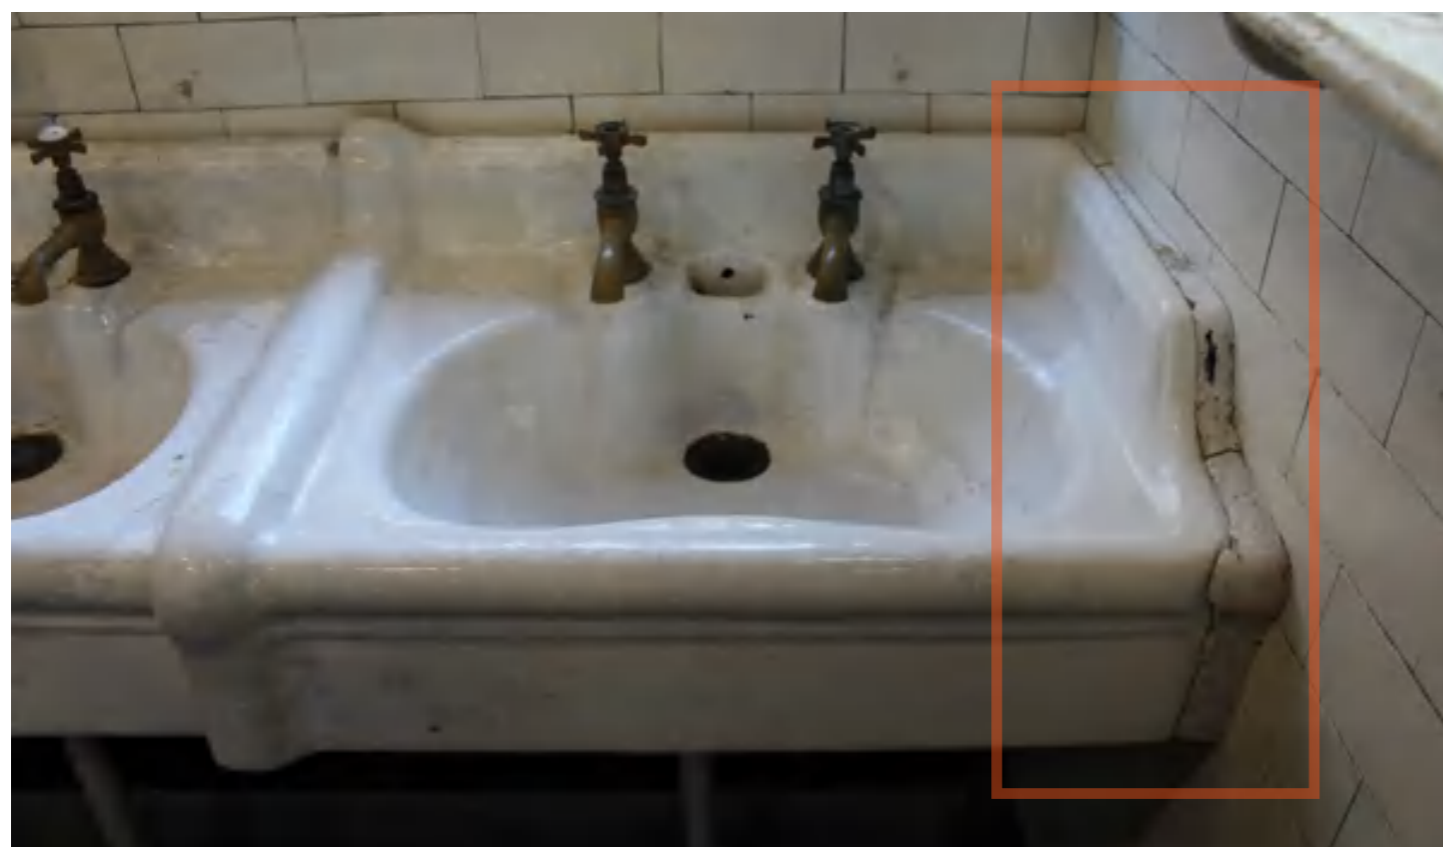
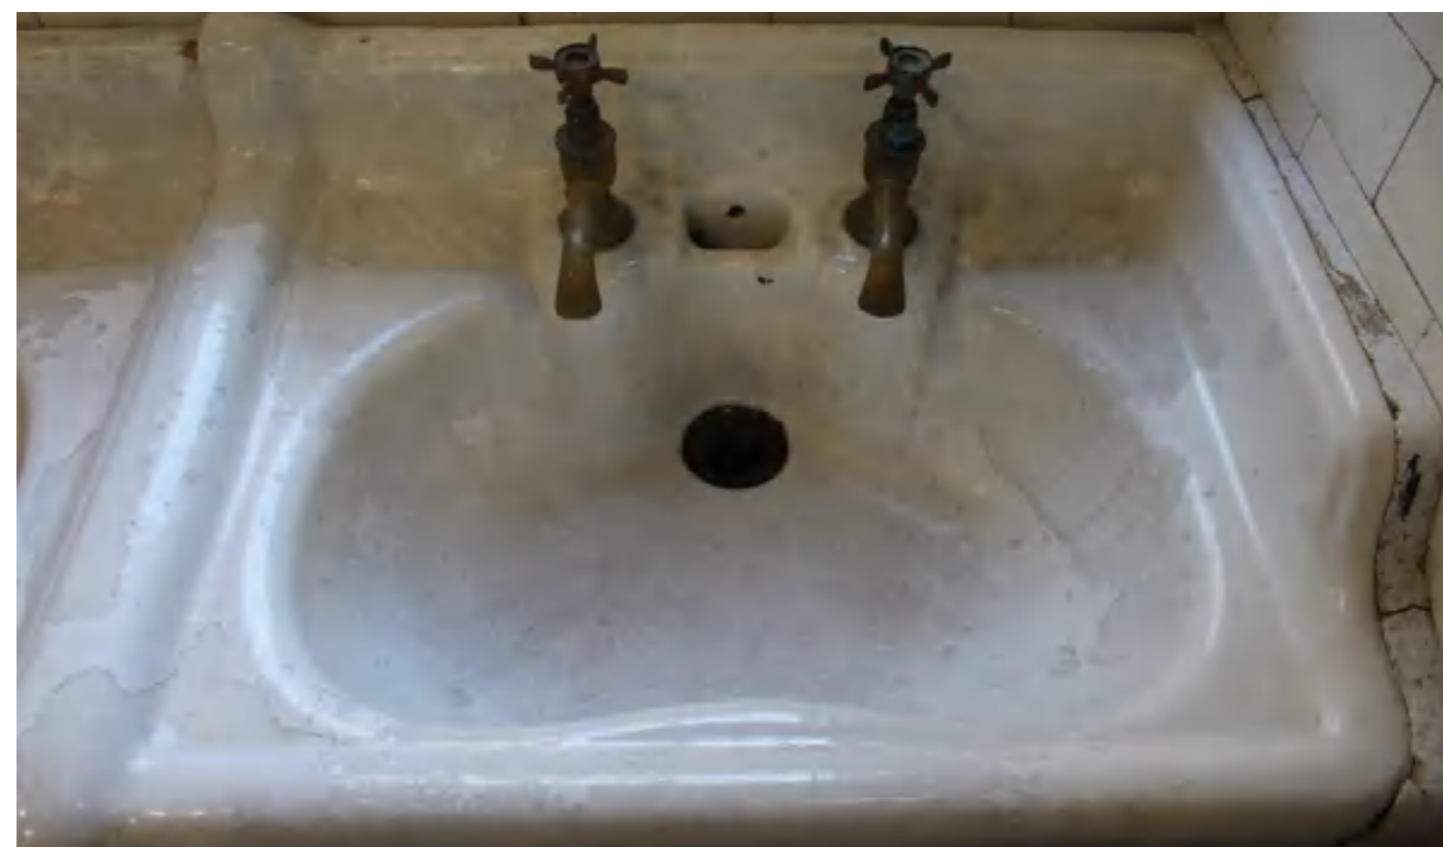
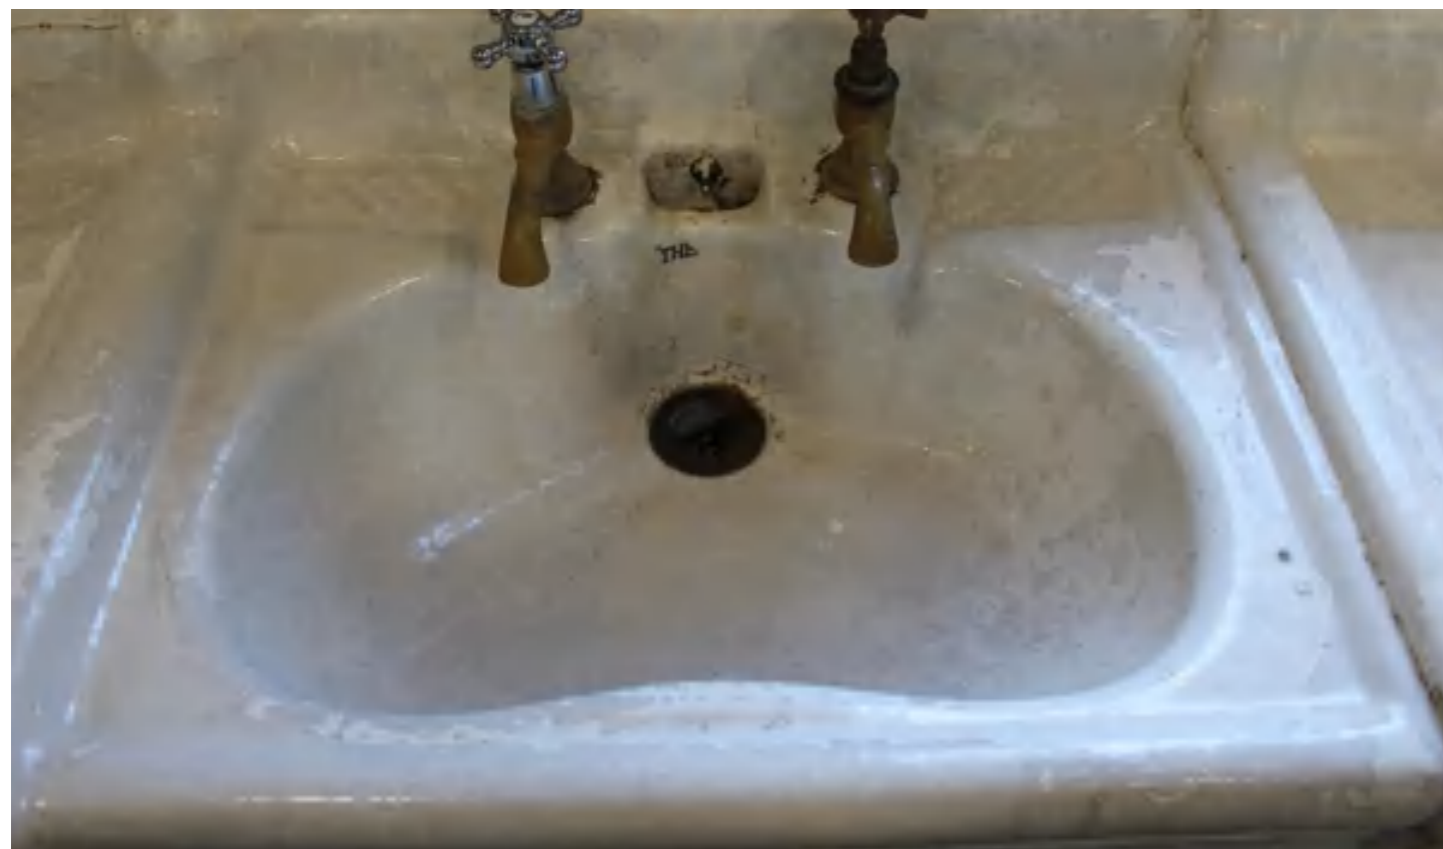
Wash basin condition is poor, with extensive wear and deterioration of enamel coating to all three basins. Wash basin 01 has two areas cracked areas that have been repaired previously (P02). Basins 02 and 03 are in better condition although show equal deterioration of enamel coating. Original brass taps remain present and are loose generally, with a mixture of replacement tap heads.

1. Conduct specialist repairs to 2 no. cracked areas to Basin 01 (P02)
2. Conduct specialist repair to chipped areas on underside of basins (P08)
3. Re-enamel all 3 no. basins by specialist, retaining 'The Pearl' motifs
4. Conduct enamel repairs to seal between Basin 03 and tiled partition wall (P04)
5. Allow for sealing all basins at wall junctions with mould-resistant silicone
6. Retain 6 no. original brass tap bodies, allowing for re-fixing securely and polishing
7. Install 6 no. new brass cartridges and tap heads
8. Install 3 no. new antique brass basin waste inserts
9. Wire brush 4 no. corroding metal basin support brackets and treat with corrosion inhibitor. Allow for redecorating with black metal paint.
10. Thoroughly clean underside of basins to remove limescale

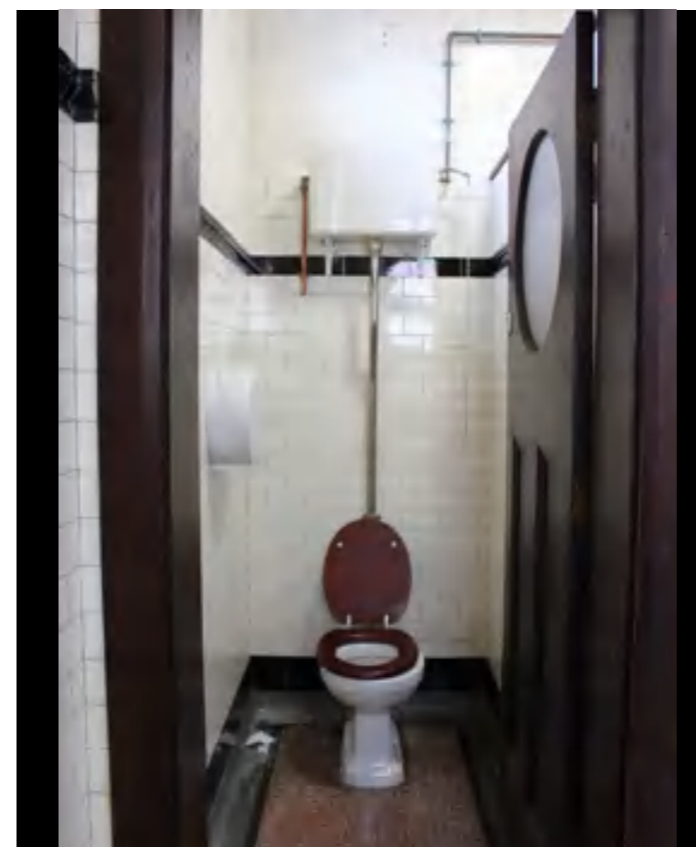
P01 - Cubicle 10

Generally, all cisterns are missing their lids and are in poor hygienic condition. Chain flushes have been broken and replaced with a variety of different chains and pull handles, with some handles missing. Original hardwood toilet seats have been replaced with a mixture of modern plastic seats. The cisterns are crudely fixed to the wall with metal stanchion brackets, and considerable damage has occurred to the original ceramic wall tiles behind due to existing and previous fixings. These damaged areas are present behind all cisterns and have been patch repaired with cement render.

1. Undertake a sterile clean of all 4 no. high-level cisterns
2. Provide 4 no. new Cistern Pulls with Ironmongery World Vintage Cistern Pull with Wooden Handle
3. Clean and polish chrome cistern pipes and connections
4. Clean and polish copper overflow pipes
5. Replace 2 no. corroding base fixings to all toilet pans with new stainless steel counterparts
6. Allow for re-sealing between all toilets and terrazzo floor with silicone
7. Replace all 4 no. modern toilet seats with new hardwood effect toilet seats (specification TBC)
8. Allow for providing moisture resistant painted MDF pattresses between all cistern brackets and original damaged wall tiles. Allow for providing bullnosed edges and decorating to match white and black band. Profiles / Design TBC with Architect.

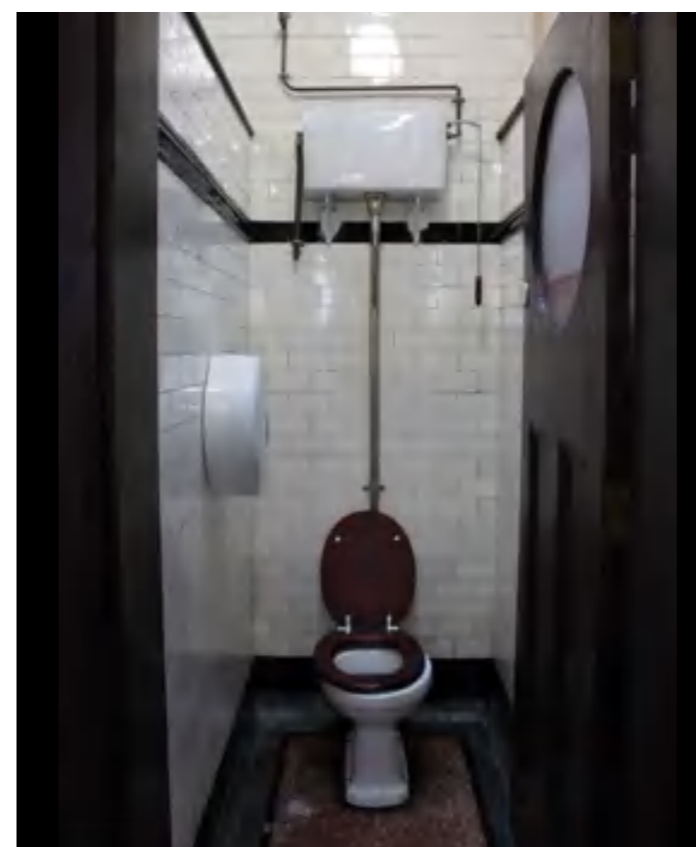
P03 - Cubicle 07

Typical Cistern Fixing / Damage

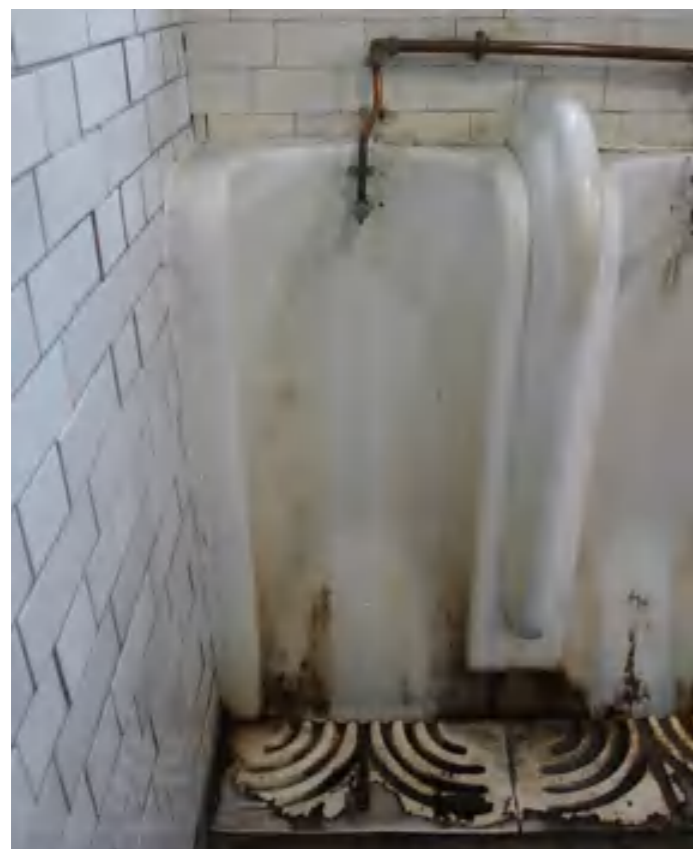
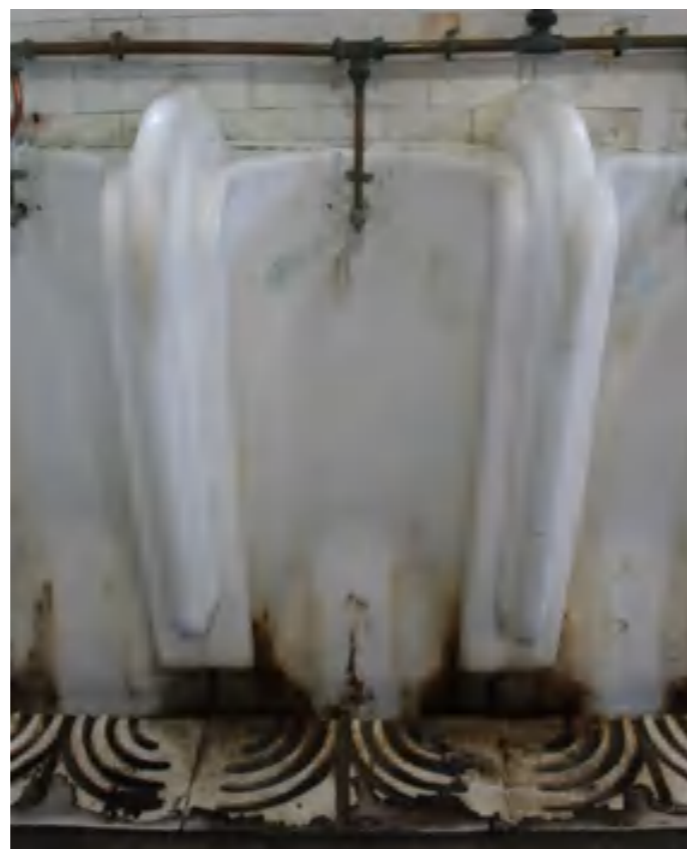
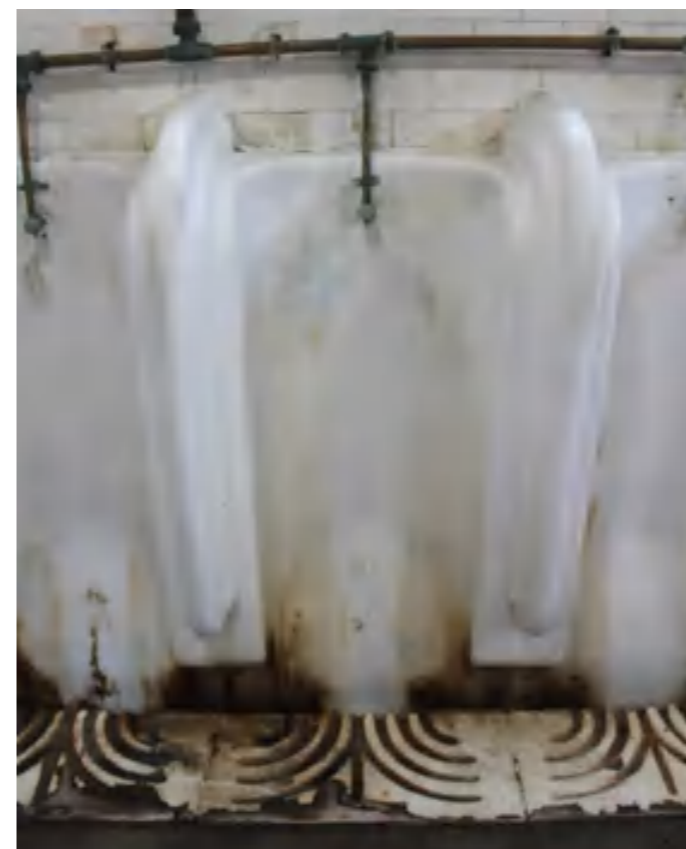
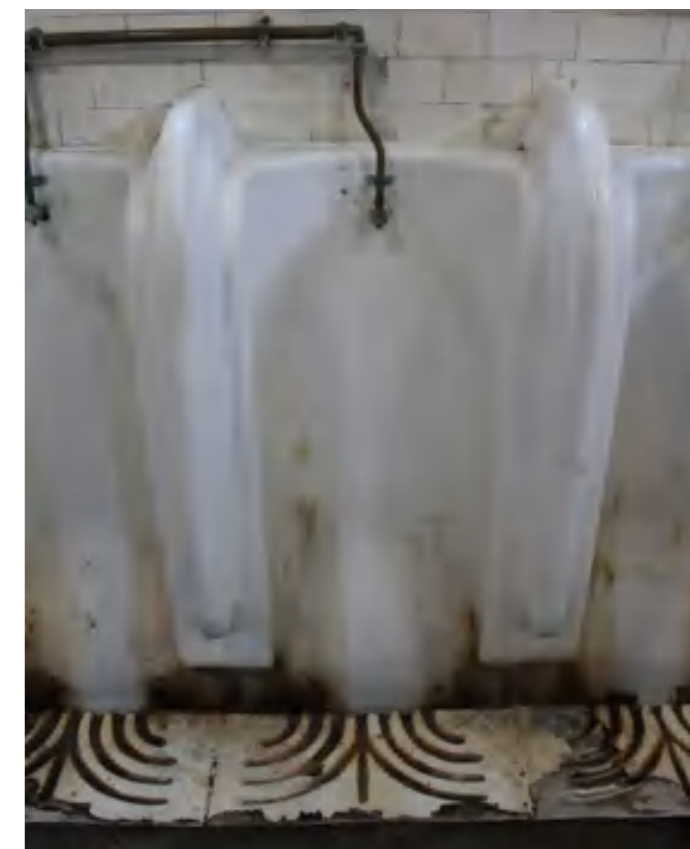
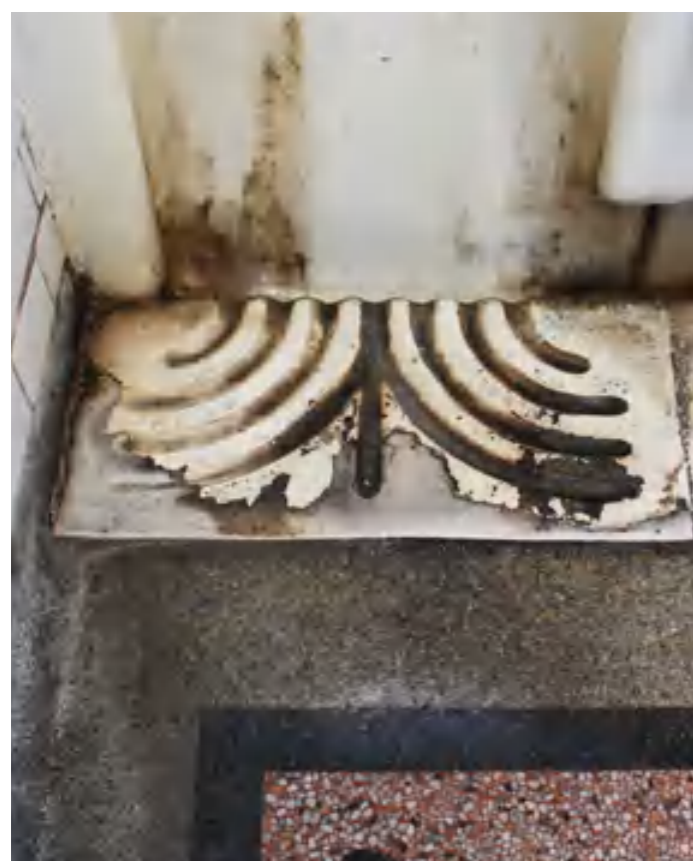
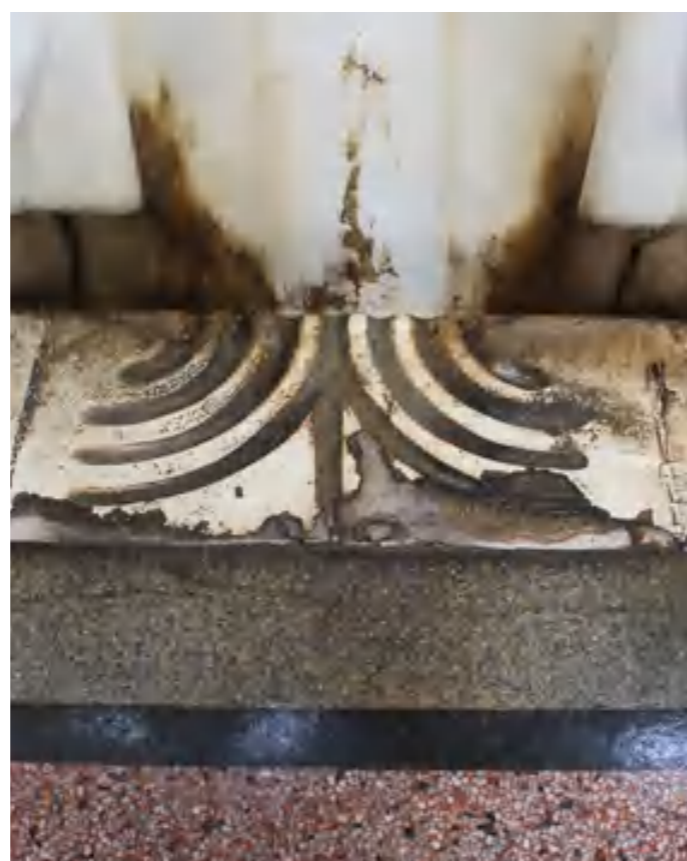
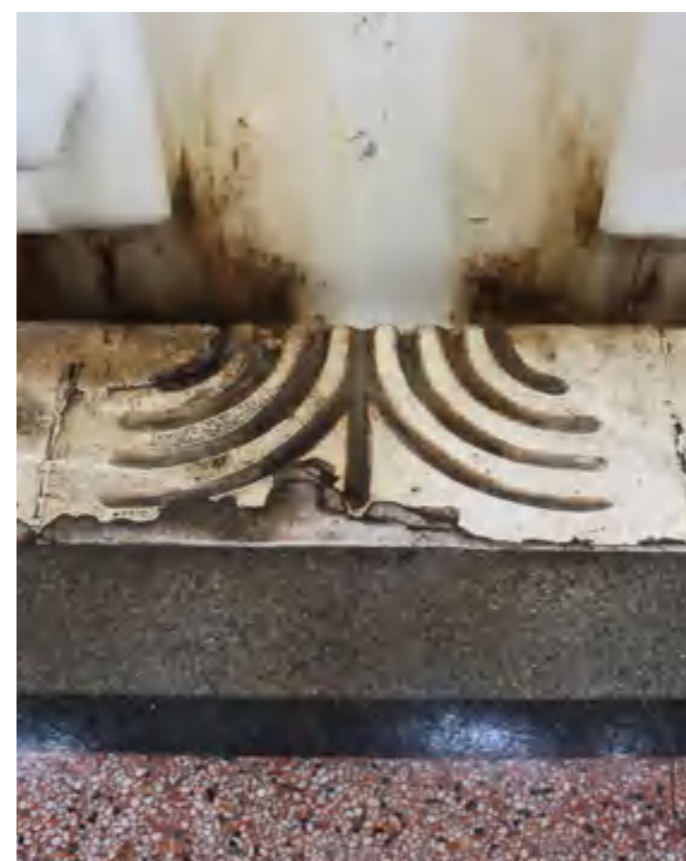
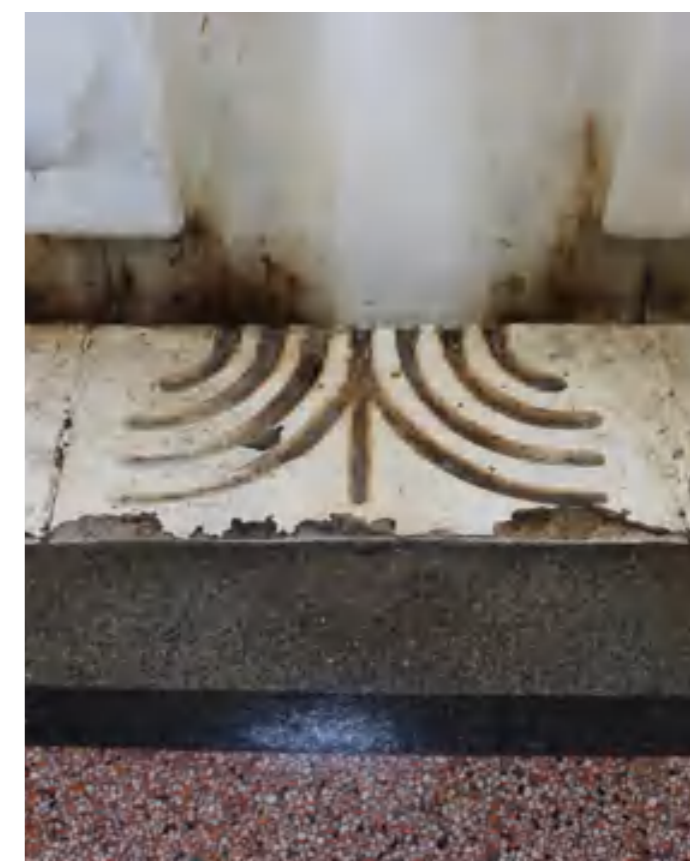
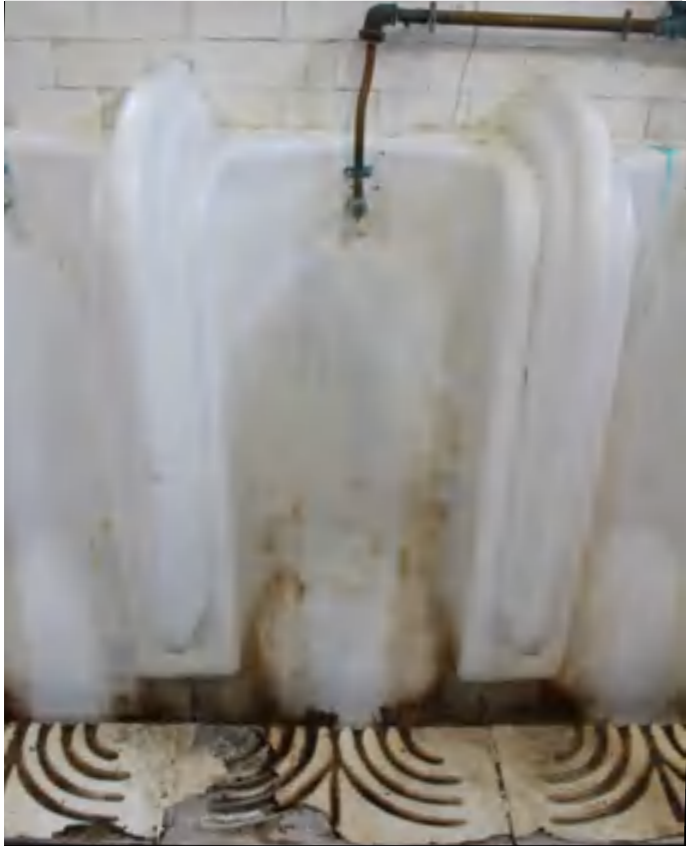
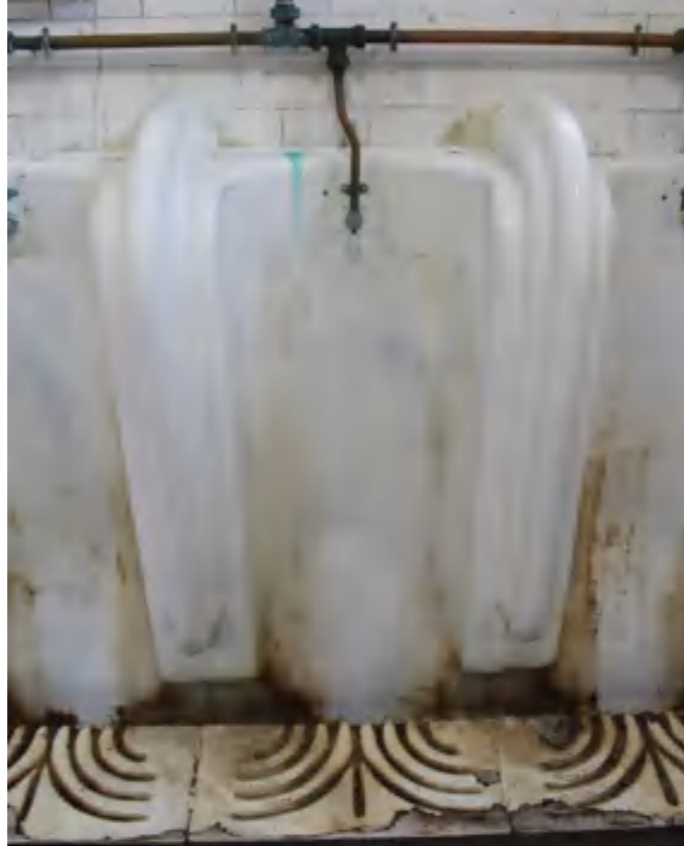
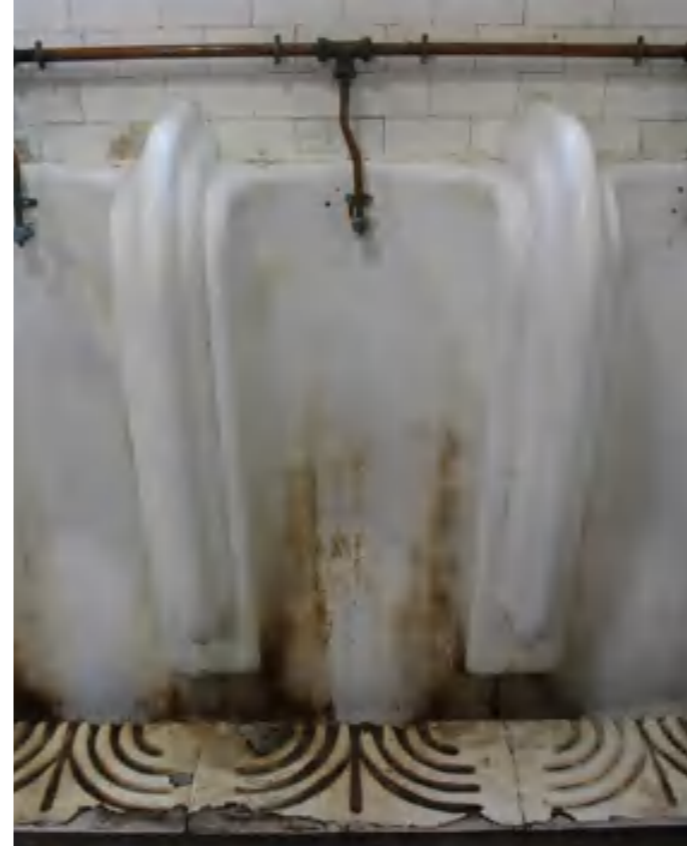
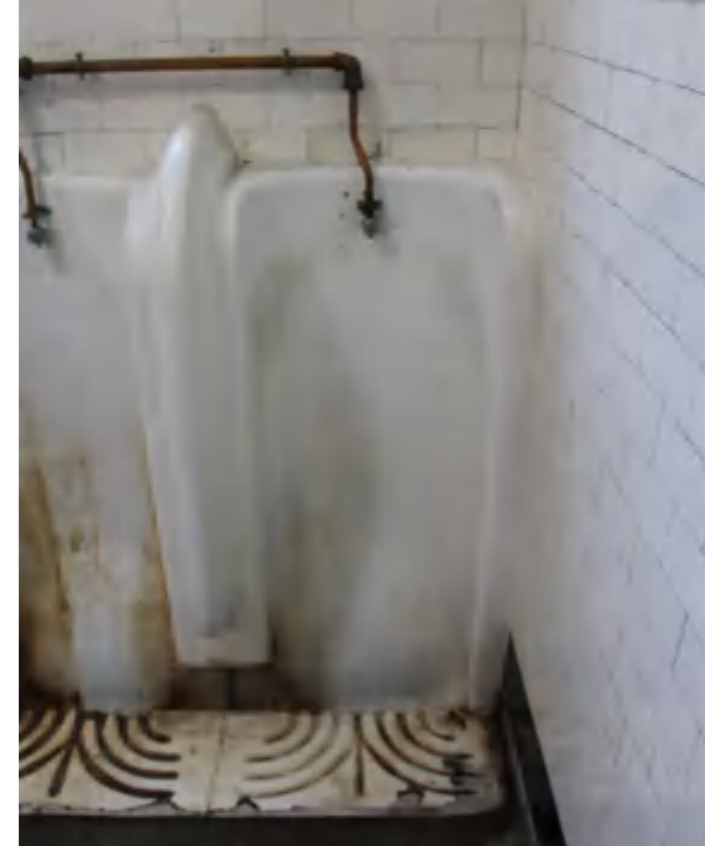
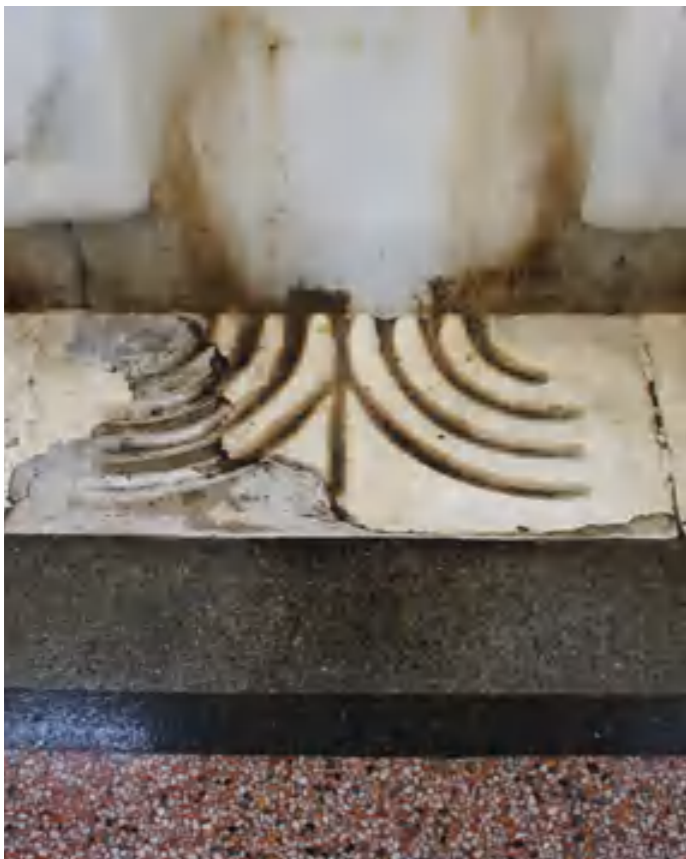
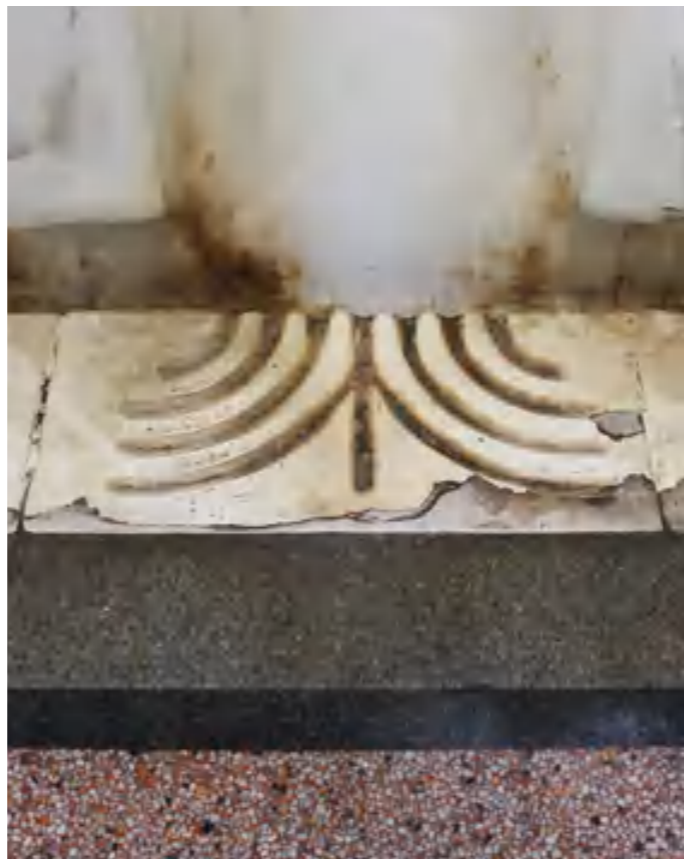
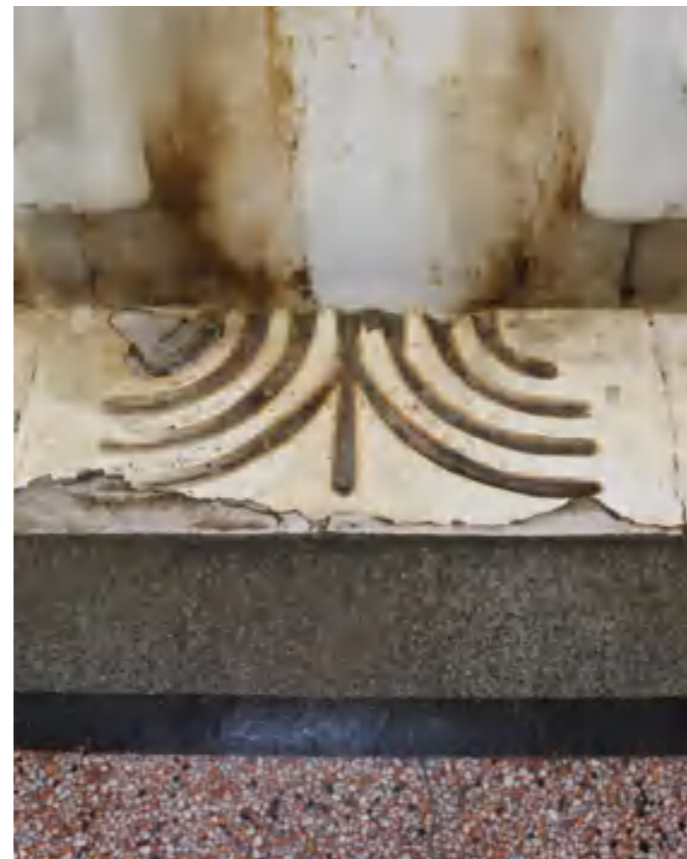
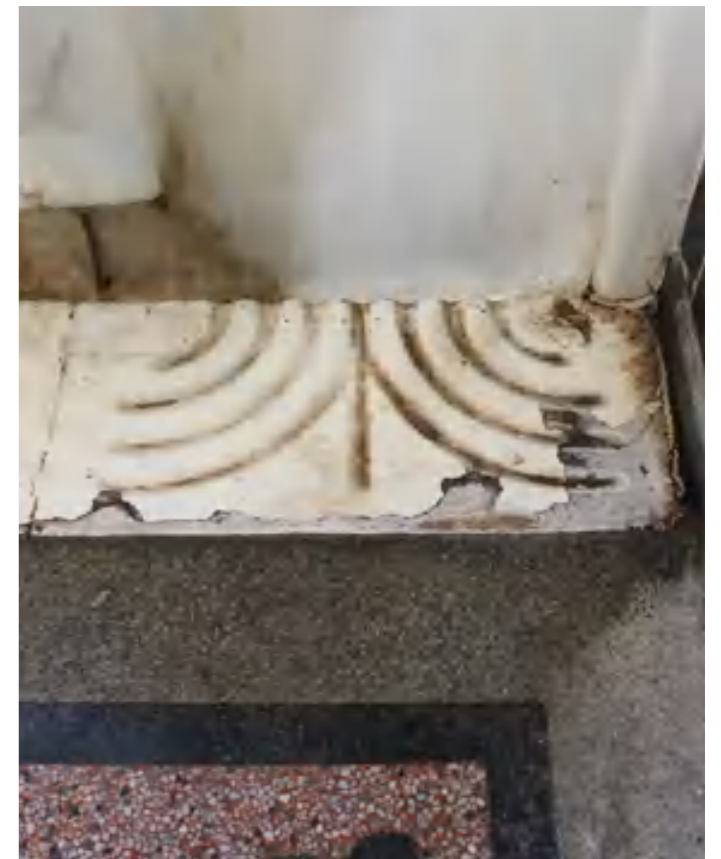
High-level cisterns and their porcelain brackets are in good condition, showing only minor wear to the enamel coatings. The copper plumbing serving the urinals is functioning well; however, surface oxidation is evident and a thorough clean and polish is required. The eight urinals are in poor decorative condition, with extensive enamel wear and heavy staining. The associated footplates have also lost the majority of their enamel coatings. Notwithstanding the cosmetic issues, no visible cracks were observed and the units appear to remain in sound structural condition.

1. Undertake a sterile clean of 2 no. high-level cisterns and all urinals
2. Clean, service and polish copper plumbing
3. Thoroughly clean surface of high-level cisterns
4. Conduct a package of specialist re-enamelling to 8 no. urinals and associated footplates
5. Allow for re-sealing junction between urinals and ceramic tile walls with silicone
