Grade II Listed Public Conveniences, John St, Porthcawl:

# BUILDING CONDITION SURVEY

PORTHCAWL  
TOWN COUNCIL

Revision	
DRAFT	09.12.2025
P01	10.12.2025

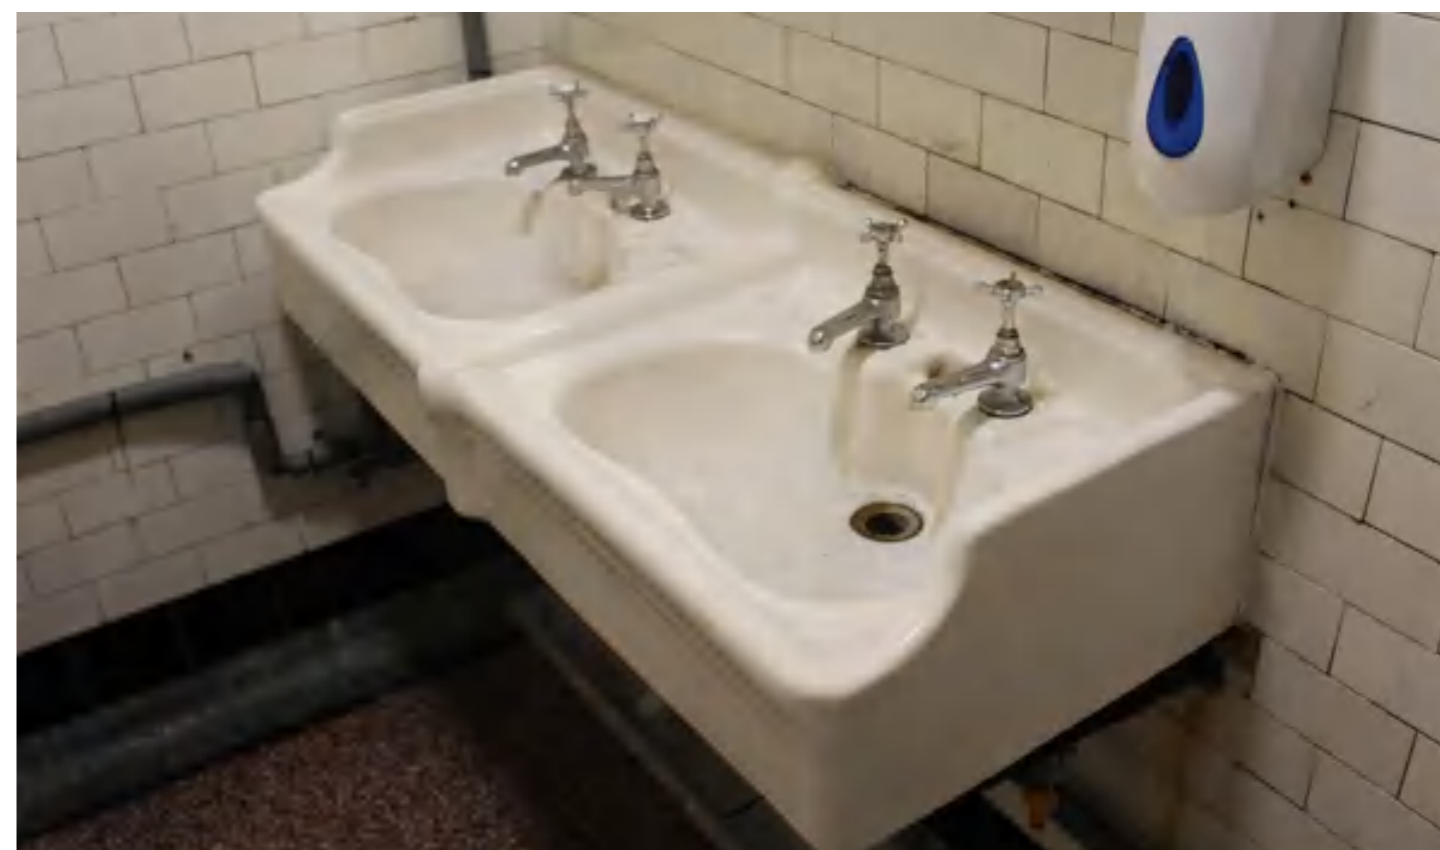
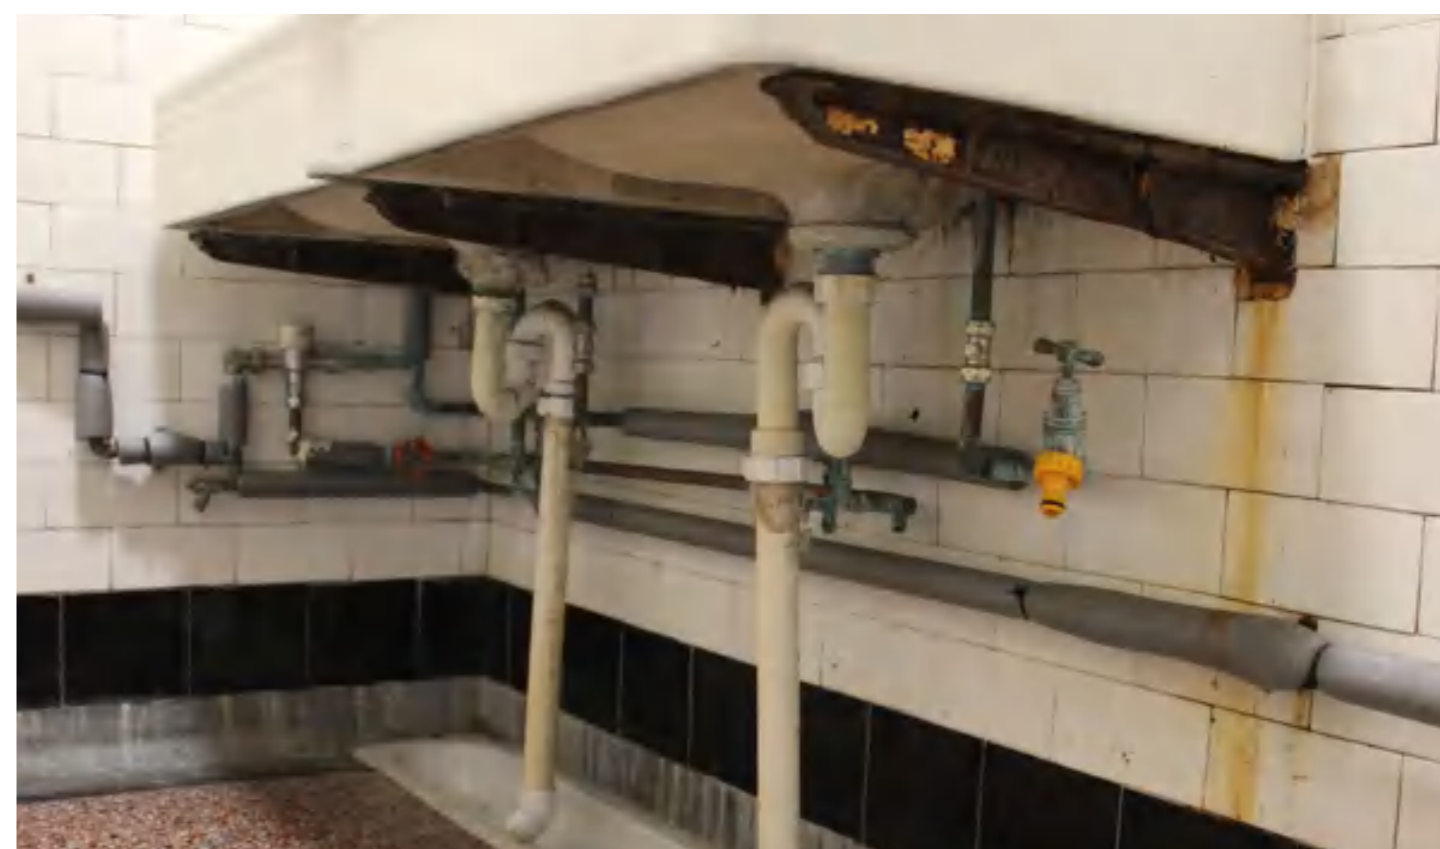
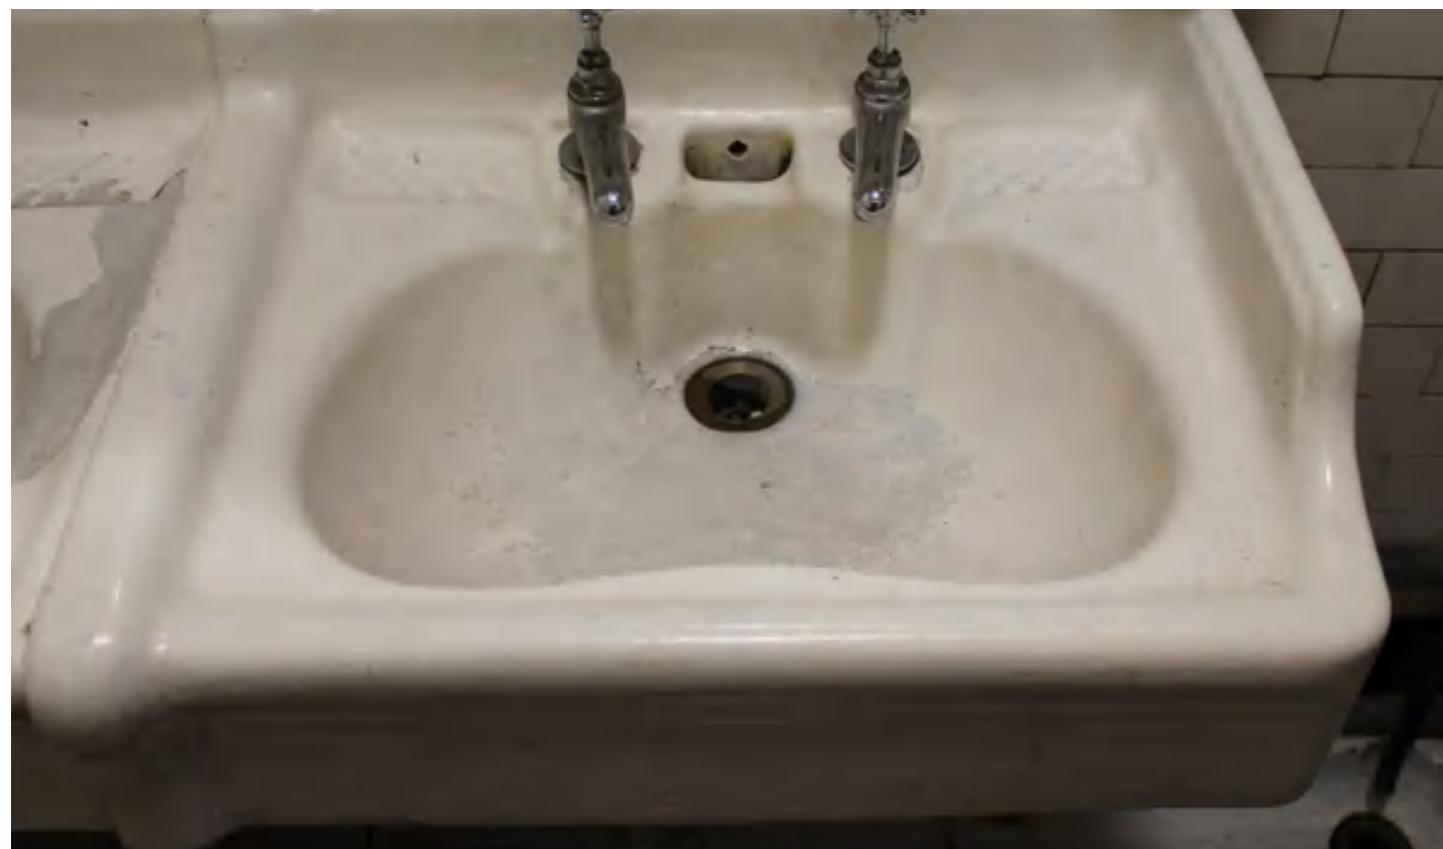
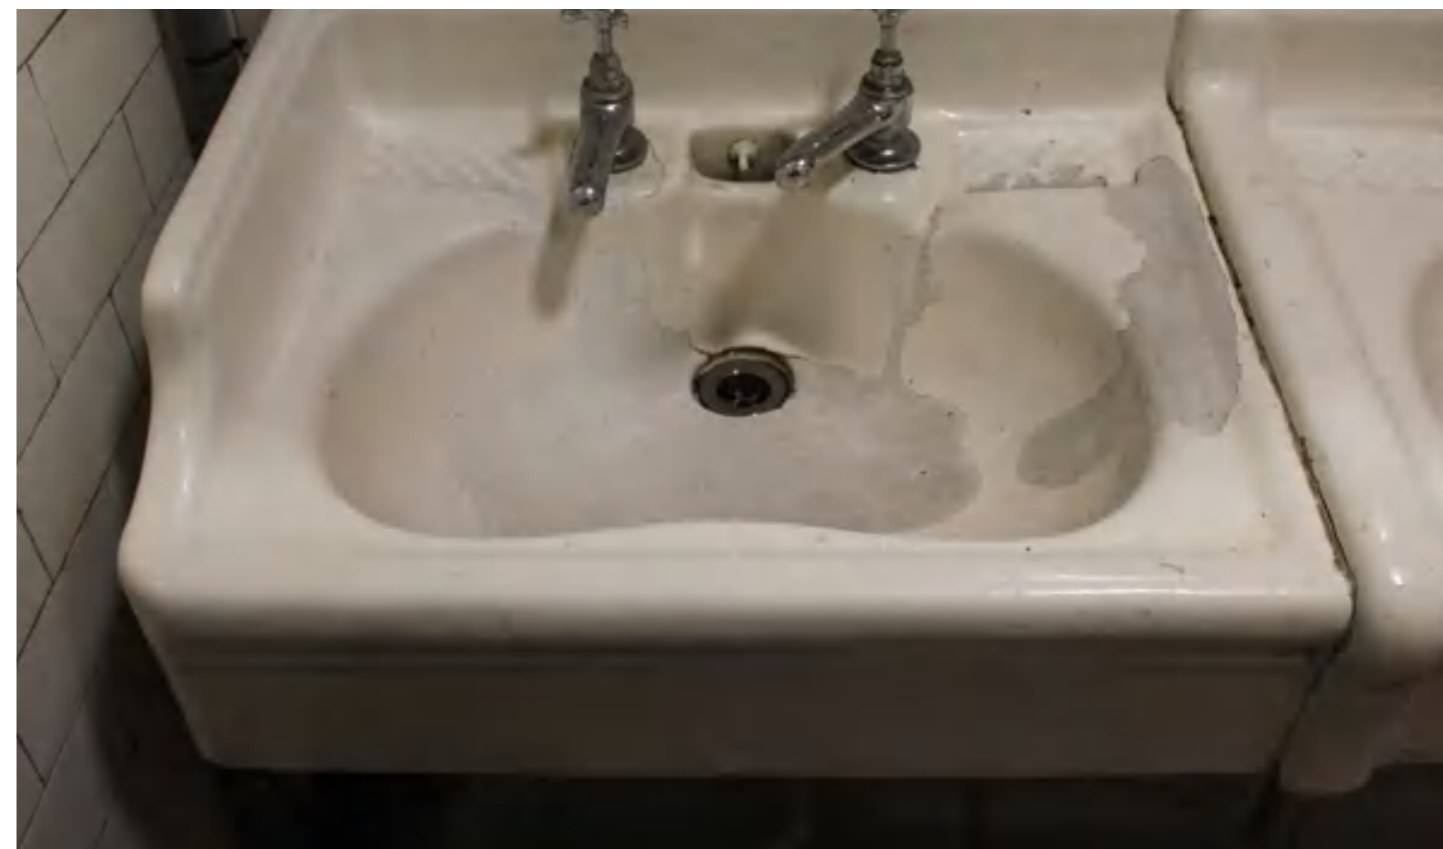
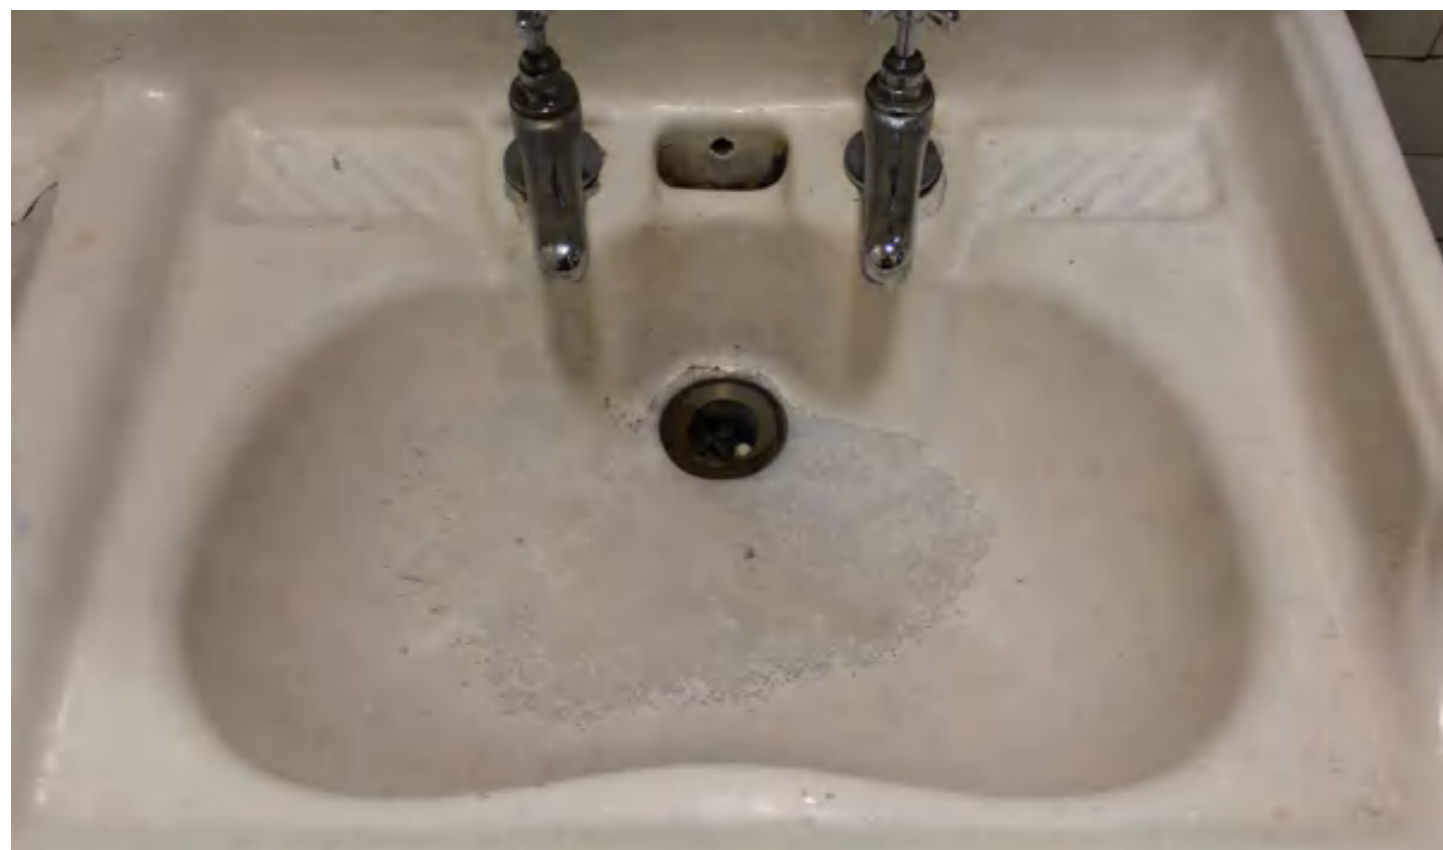
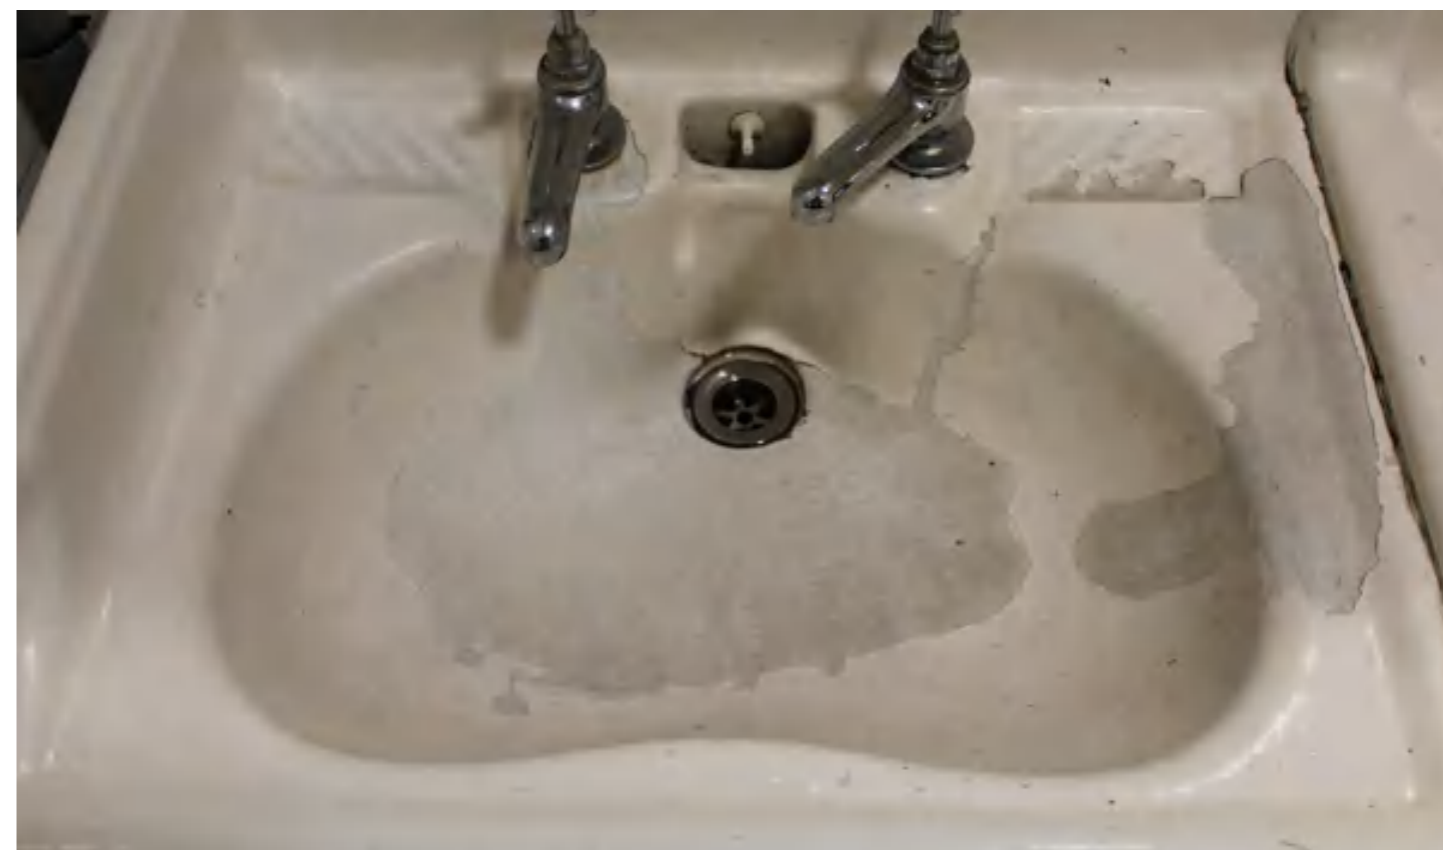
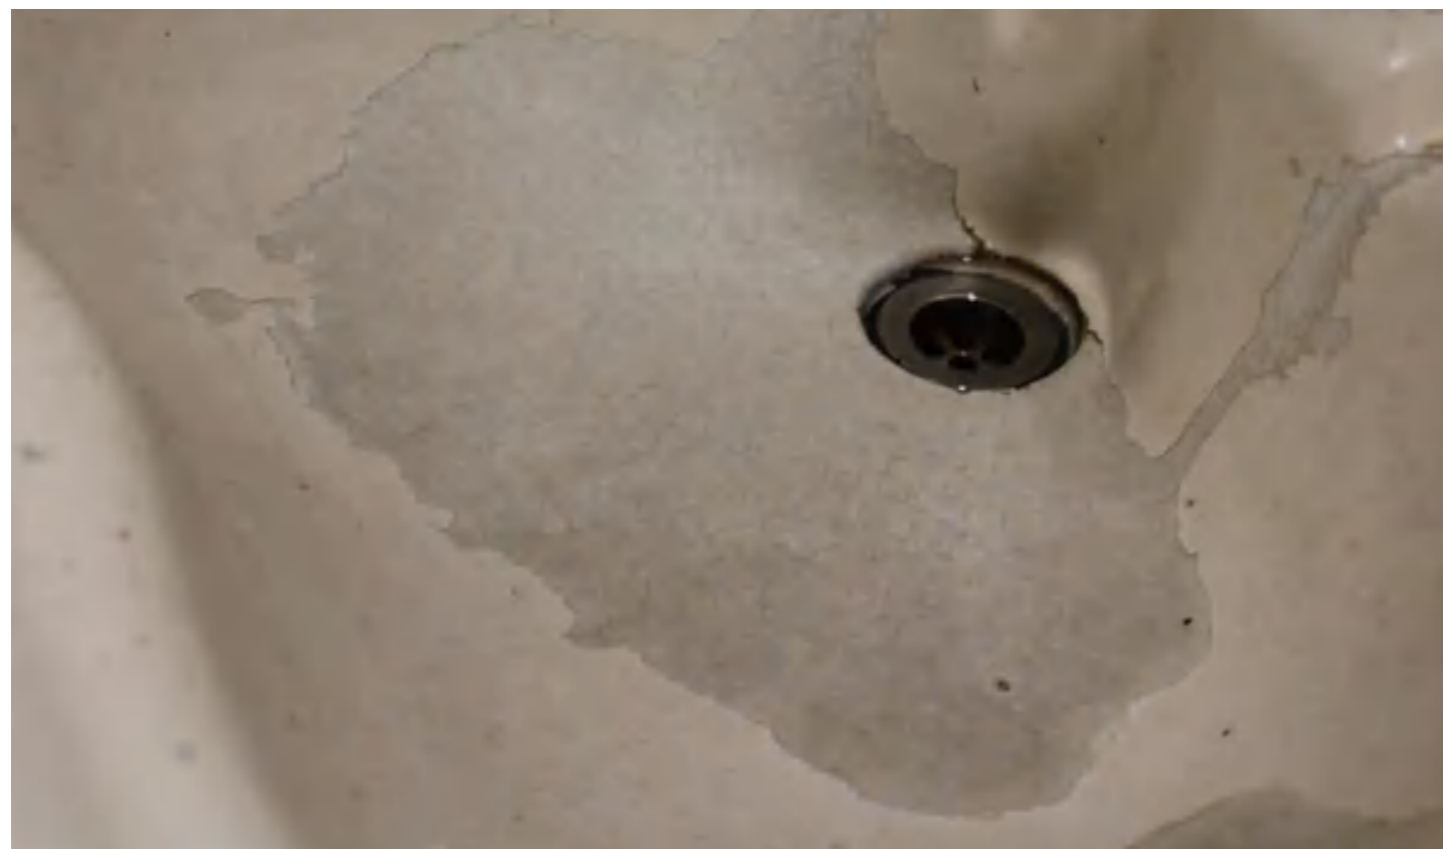
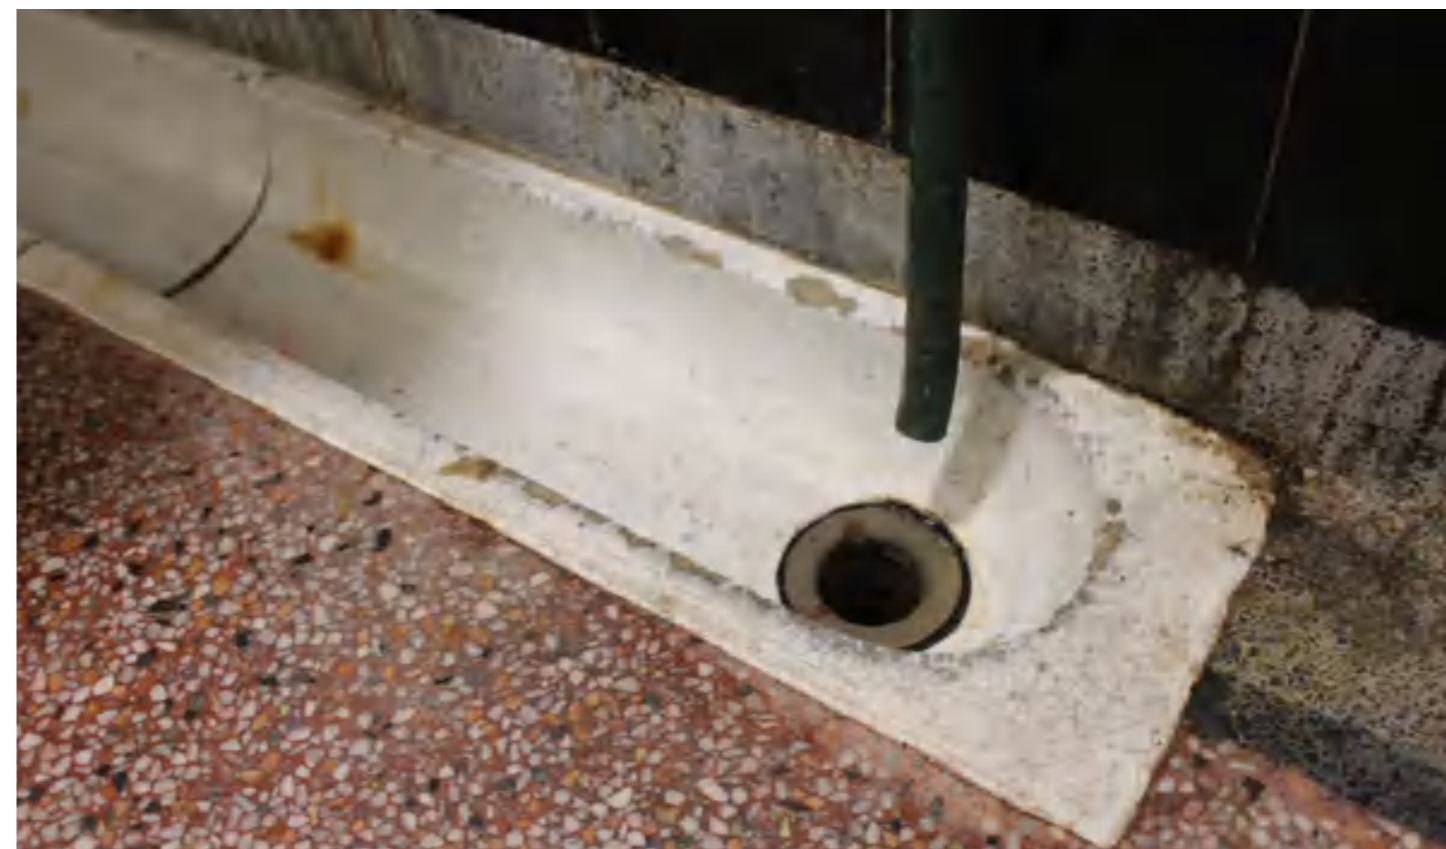
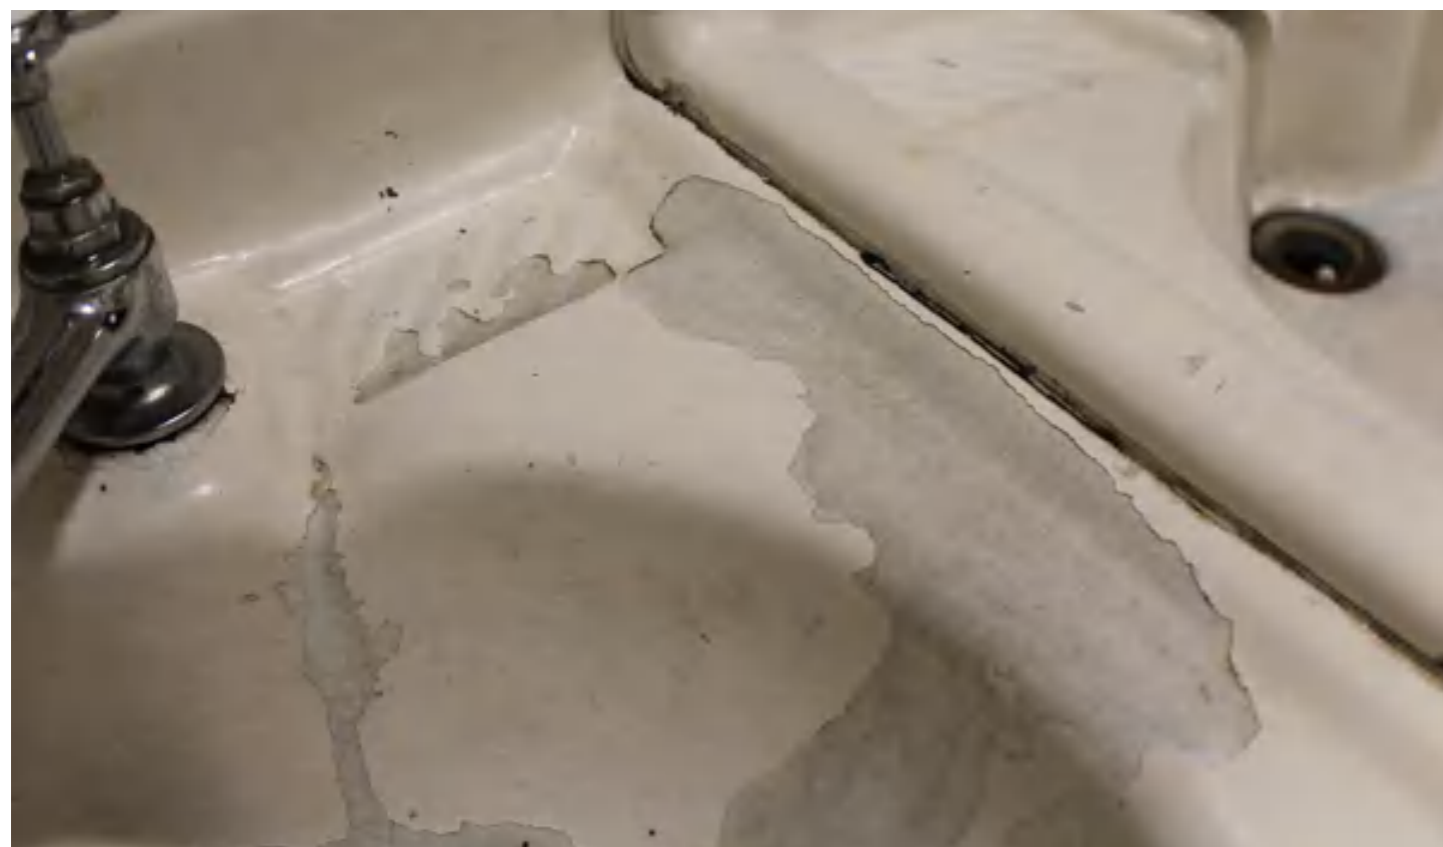
Whilst in stable structural order, the wash basin decorative condition is poor, exhibiting extensive deterioration of enamel coating. Original brass pillar taps have been replaced with modern chrome counterparts. White plastic pipes and traps are tired and show signs of prior repair.

1. Re-enamel 2 no. basins by specialist
2. Allow for sealing all basins at wall junctions with mould-resistant silicone
3. Replace modern chrome taps with new brass pillar taps as per Victoria Plumbing Trafalgar Crosshead Pillar Basin Taps Antique Brass or equal approved
4. Install 2 no. new antique brass basin waste inserts
5. Wire brush 4 no. corroding metal basin support brackets and treat with corrosion inhibitor. Allow for redecorating with black metal paint.
6. Thoroughly clean underside of basins to remove limescale
7. Replace waste pipes and traps

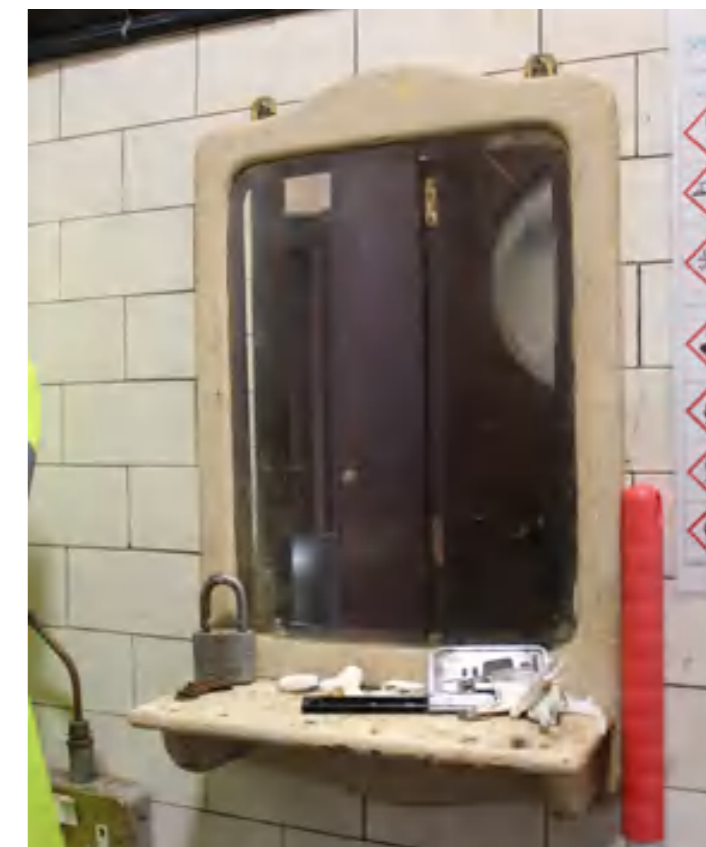
P01

Given their age and exposure to regular public footfall, the fixtures are in good structural order and require minor refurbishment.

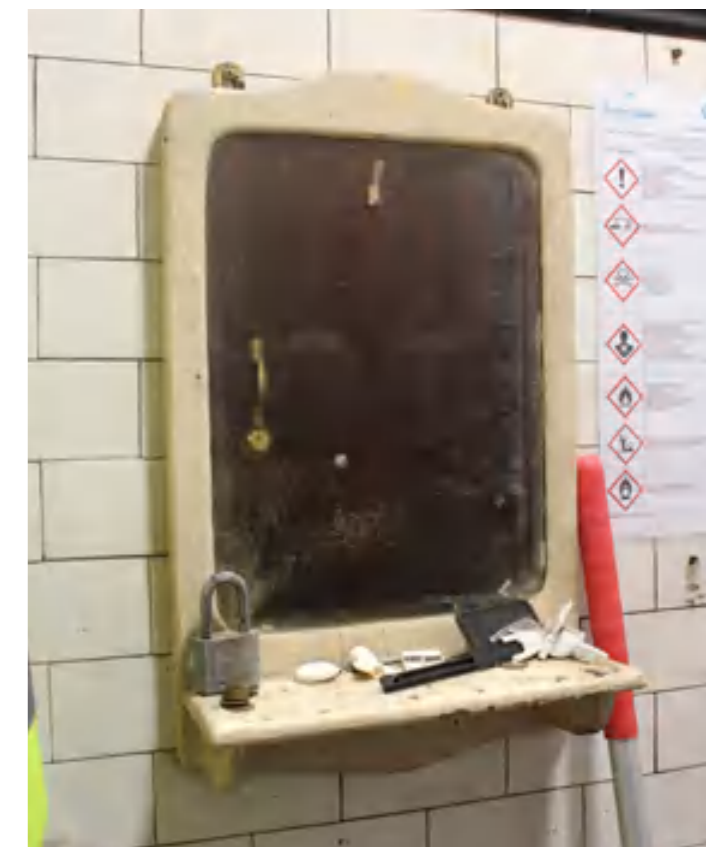
P01

Given their age and exposure to regular public footfall, the fixtures are in good structural order and require minor refurbishment.

1. Allow for rubbing down softwood frames to remove prior paint coatings.
2. Allow for 1 no. small scarf repair to shelf of large mirror unit (P02)
3. Thoroughly clean and polish mirror glass
4. Allow for redecoration (specification TBA)

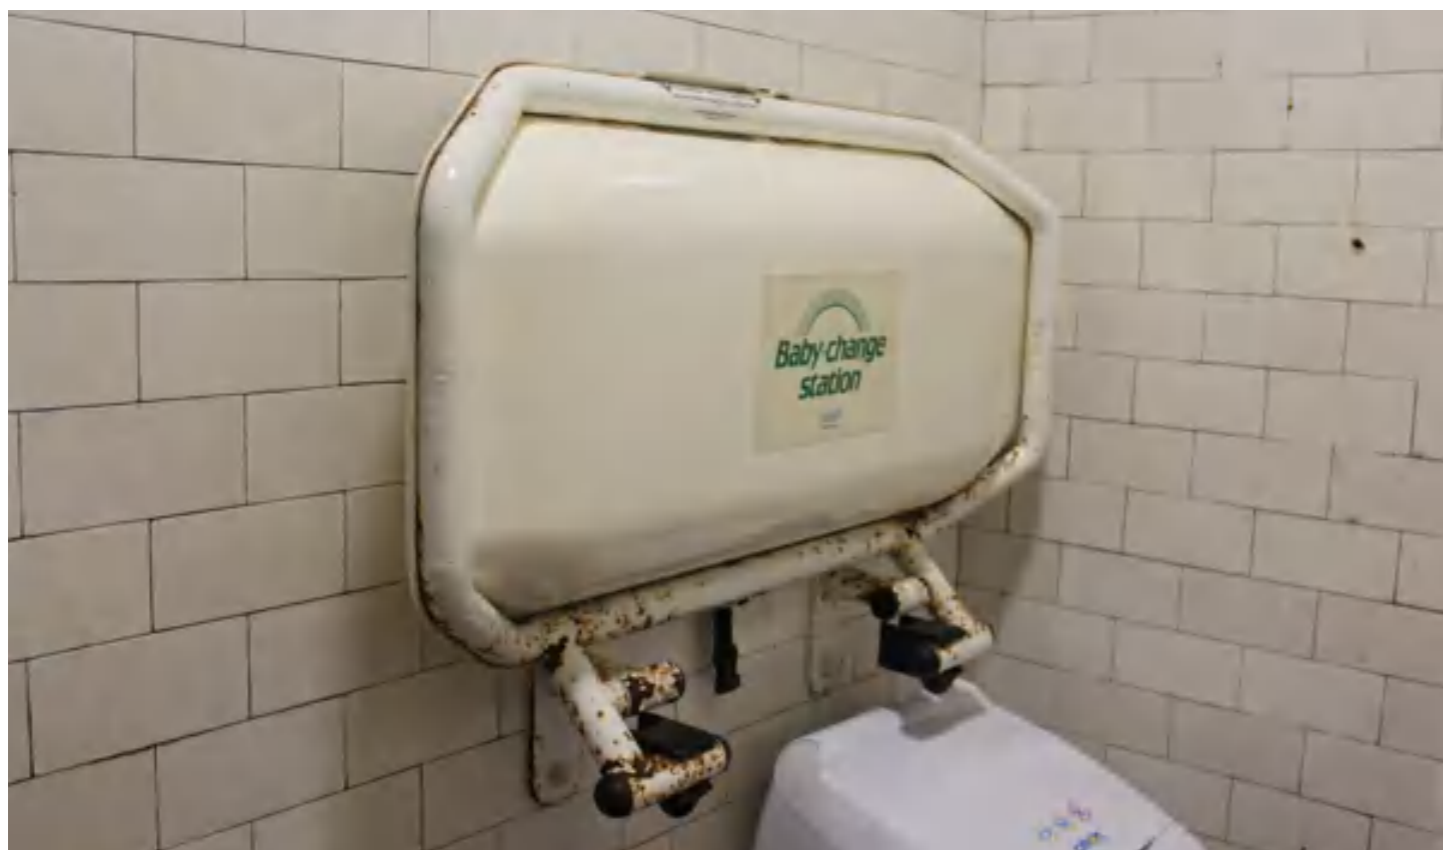
P07

It is recommended that a holistic approach is taken to all of these fixtures and they are renewed with new provisions under a contract with PHS (TBA with Porthcawl Town Council). Baby change fixture to the Male WCs is corroding and unhygienic, requiring replacement (P07).

1. Allow for complete replacement of sanitary fixtures to a PHS suite as above (TBA with Porthcawl Town Council)
2. Positions to be coordinated with Architect and Cons. Officer. Where suitable, they should replace existing positions and fixing holes. Allow for localised ceramic tile repair to damage from fixings no longer required.

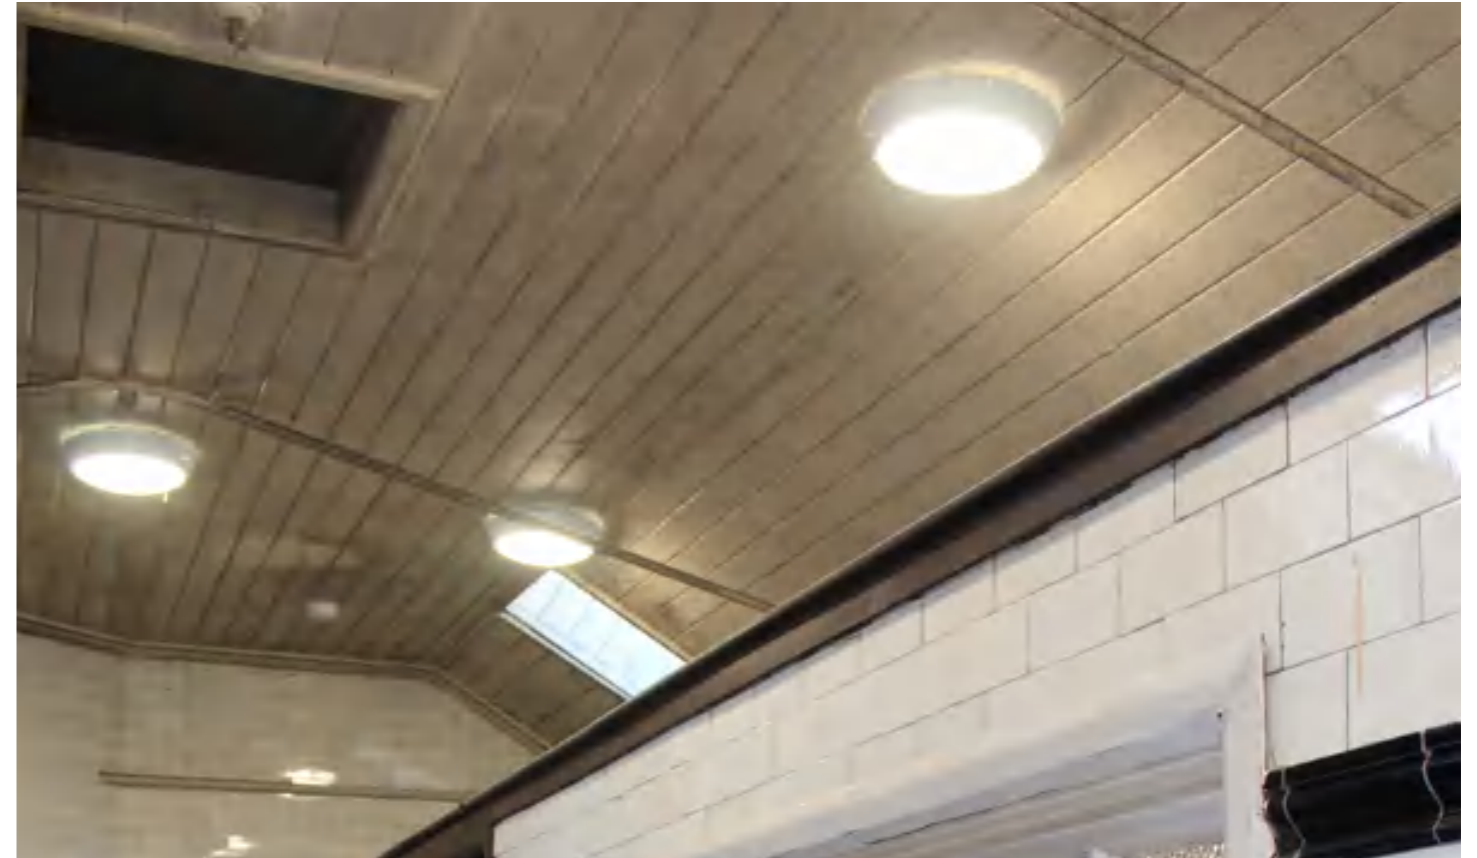
P01

**Condition:** Good

#### Recommendation: Replacement of Light Fittings Generally

1. Replace 1 no. modern round light fitting to AWC with LED fittings and presence detection
2. Replace 6 no. modern round light fittings to FWC with LED fittings and presence detection
3. Replace 6 no. modern round light fittings to MWC with LED fittings and presence detection
4. For pricing purposes only, allow for David Hunt Lighting Badger Bronze Pendant BAD0163 (final design and specification TBA with Architect).

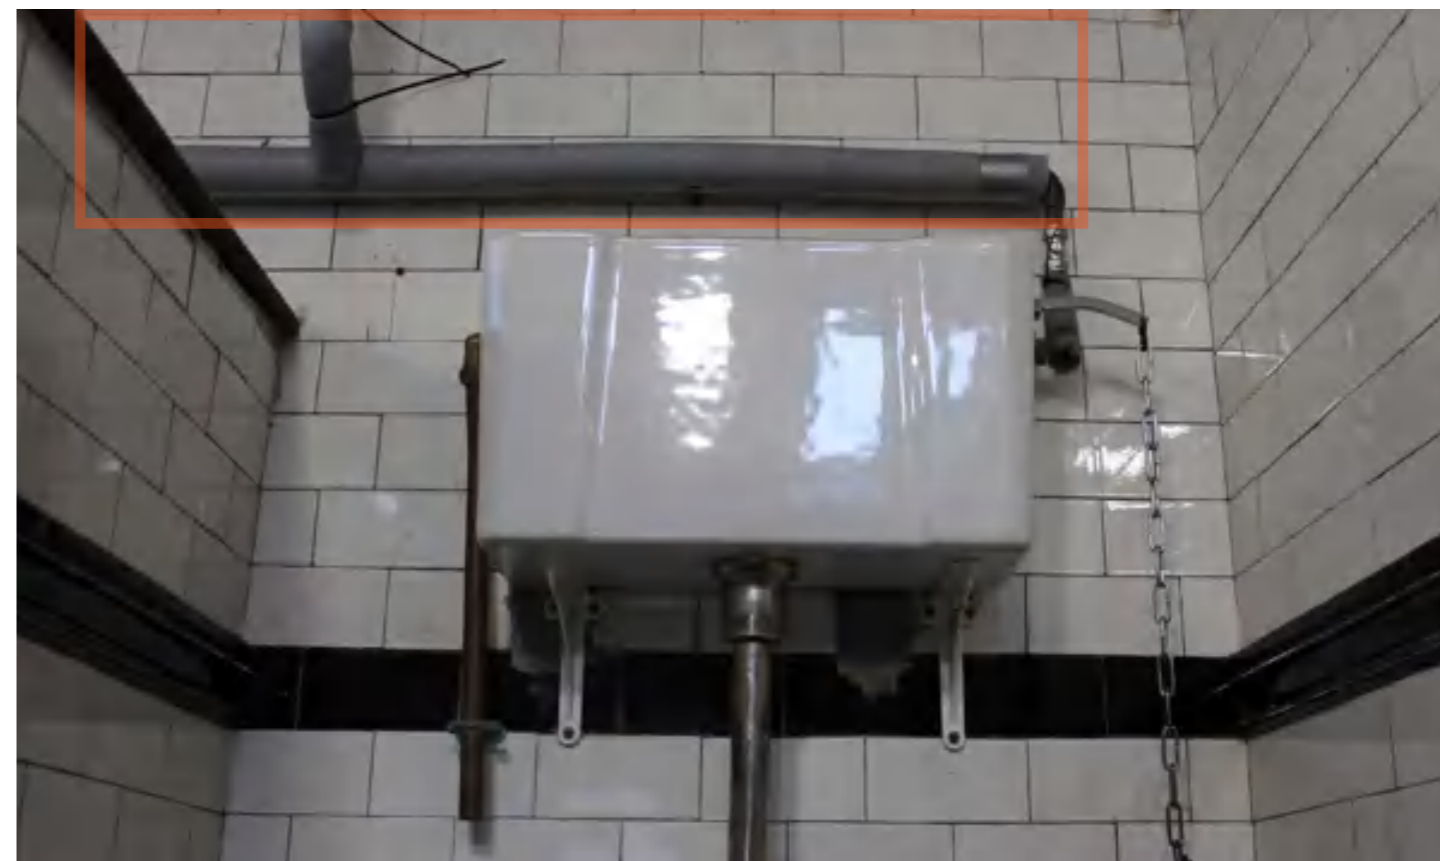
P01

**Description:** Plumbing for above-ground drainage, cisterns and urinals is 15mm copper pipework. Active leaking was not observed at the time of survey. Excluding the pipework serving the urinals, the pipes are generally insulated with foam lagging that is often applied insensitively or incompletely.

**Condition:** Fair

#### Recommendation: Clean, Check and Insulate of All Copper Plumbing

1. Allow for testing electrical installations throughout the building.
