Project Name: Porthcawl Public Conveniences
Project Description: Survey of existing drainage
Project Number: CLS/0609
Project Date: 30/10/2025
Inspection Standard: MSCC5 Sewers & Drainage GB (SRM5 Scoring)

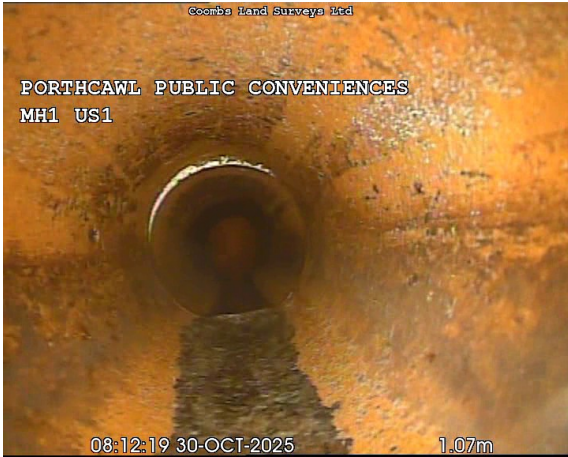
MH1US1X_55b3ed35-e792-439d-9ae8-b72801b28589_20251030_134838_261.jpg, 00:00:15, 1.07 m
 General photograph taken at this point

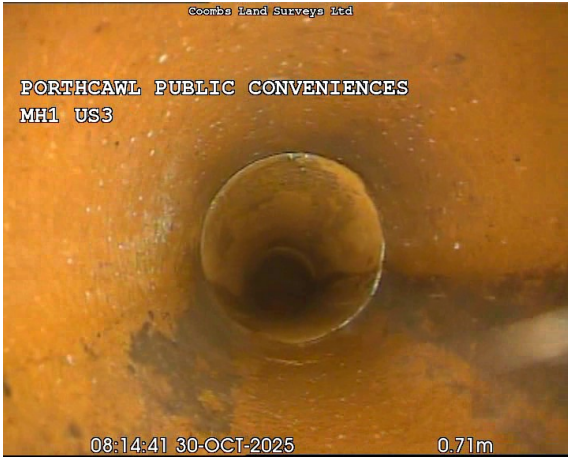
MH1US3X_df1fd66c-7089-4de6-b6e1-6fef8f46e5ac_2025103_0_141818_312.jpg, 00:00:14, 0.70 m
 General photograph taken at this point

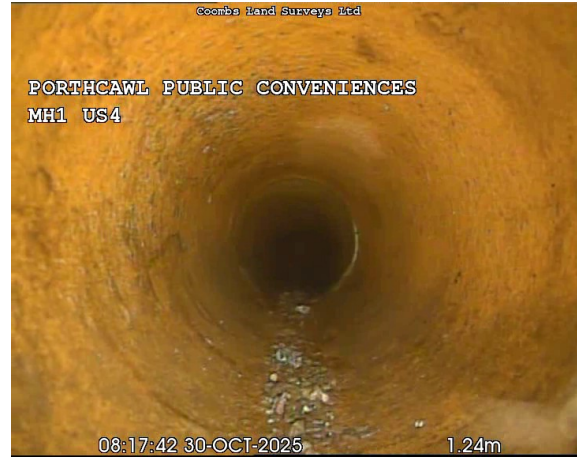
MH1US4X_e6c4bac9-74a9-40d8-9fc0-e4c3f518459d_20251030_142611_243.jpg, 00:00:37, 1.24 m
General photograph taken at this point

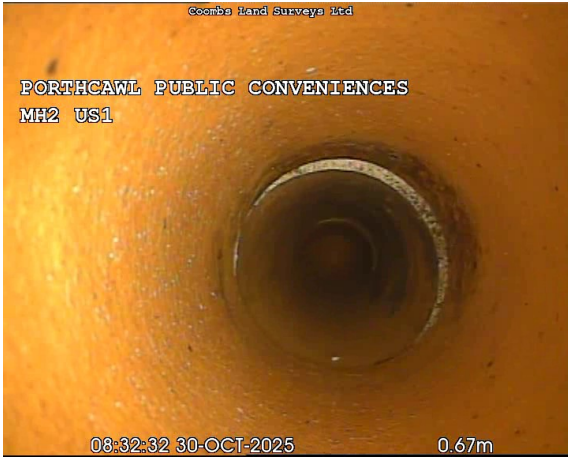
MH2US1X_490efec0-cf34-4e2c-b150-a3c6d1312257_20251030_143816_970.jpg, 00:00:17, 0.67 m
General photograph taken at this point

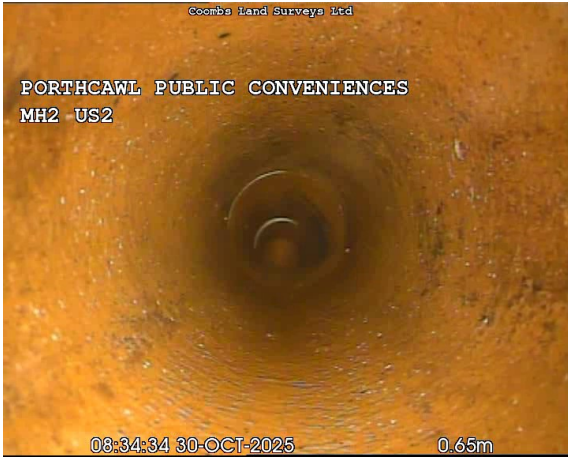
MH2US2X_a1bfc30e-20dd-43ef-a6c8-560bb12d1daa_202510
30_144603_850.jpg, 00:00:17, 0.65 m
General photograph taken at this point

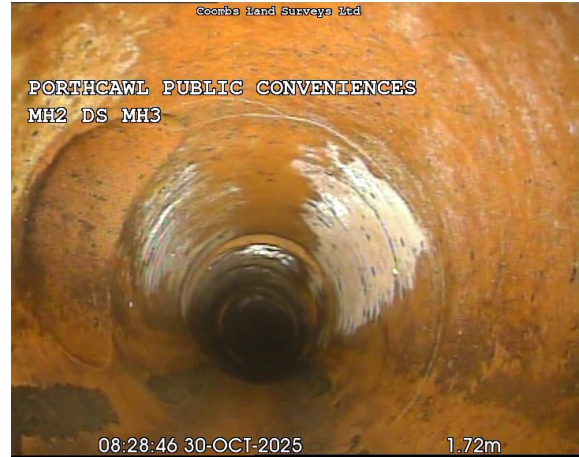
MH2X_af545427-5afb-4e4b-8427-72e837887416_20251030_152302_762.jpg, 00:00:57, 1.72 m
 Junction at 10 o'clock, 100mm dia

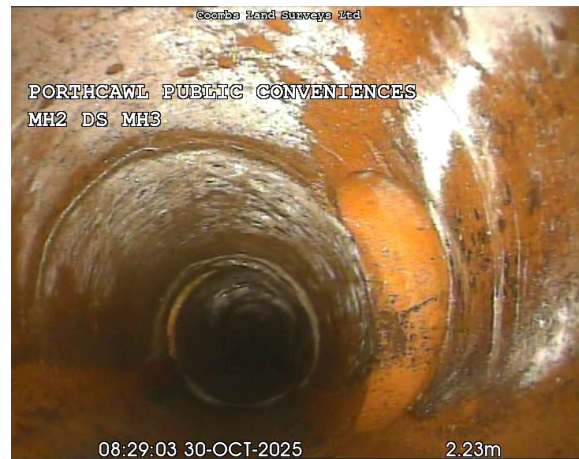
MH2X_e4d69121-2443-47b6-abbd-9630be055c17_20251030_152957_817.jpg, 00:01:14, 2.23 m
 Junction at 3 o'clock, 100mm dia

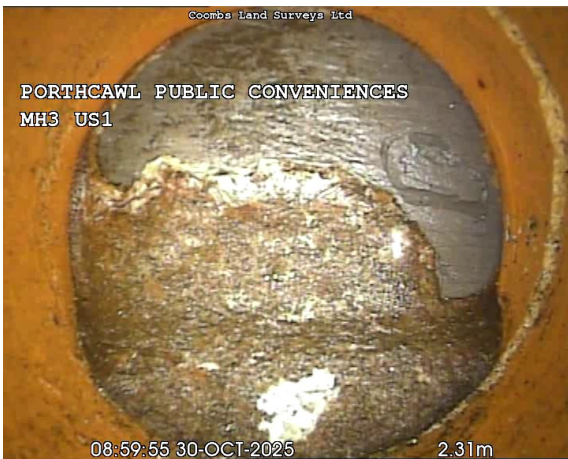
MH3US1X_eac89e69-8f42-4753-b16f-297848715ff8_20251030_155246_683.jpg, 00:00:33, 2.39 m
Finish node, other special chamber, reference: MH3US1, Pipe capped off

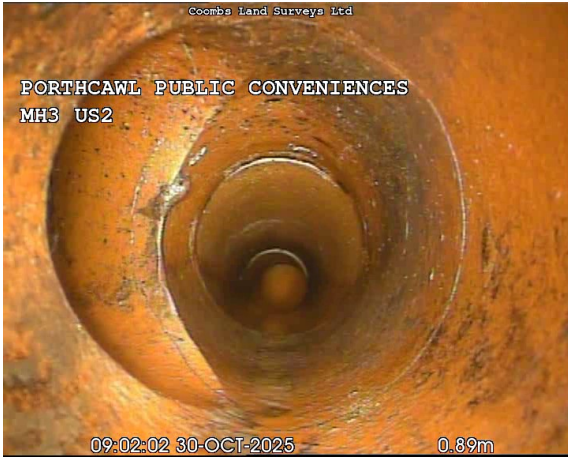
MH3US2X_9ded3e5a-d1b2-4c25-bc98-1abae4747150_20251030_155613_235.jpg, 00:00:14, 0.89 m
 Junction at 9 o'clock, 100mm dia

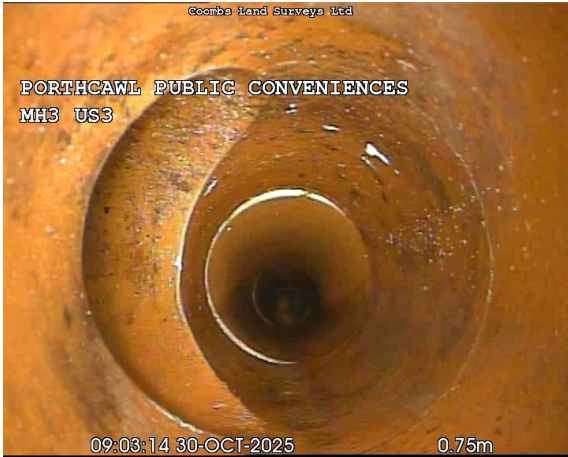
MH3US3X_3f4a6527-1d2c-4c5c-a04e-ee7332cf6774_20251030_155956_697.jpg, 00:00:07, 0.75 m
Junction at 9 o'clock, 100mm dia

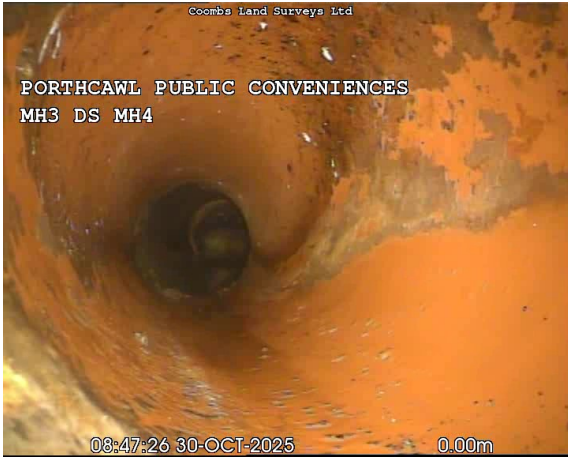
MH3X_418307b6-13d7-4593-ada3-9e94e3167a6f_20251030_161407_742.jpg, 00:00:00, 0.00 m
 Pipe material changes to polyvinyl chloride at this point

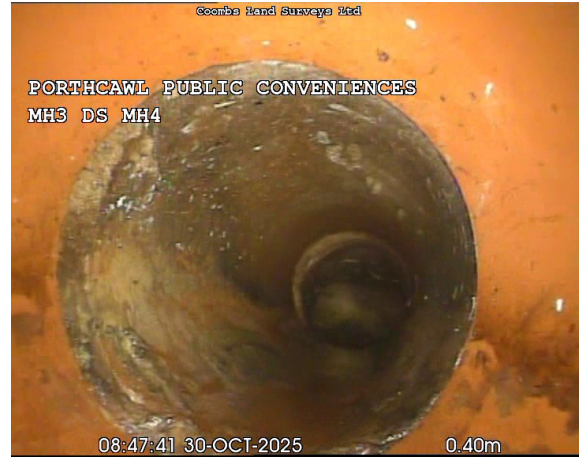
MH3X_b5803963-3c9b-4e64-8e15-a707f72d7986_20251030_161505_988.jpg, 00:00:14, 0.40 m
 Pipe material changes to vitrified clay at this point

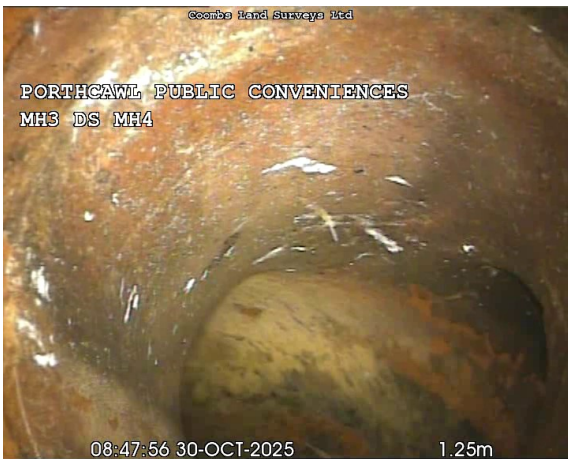
MH3X_b4968c10-8173-4a80-bf40-56862db04f1b_20251030_161739_248.jpg, 00:00:28, 1.25 m
 Junction at 3 o'clock, 100mm dia, Possible junction, angle not visible

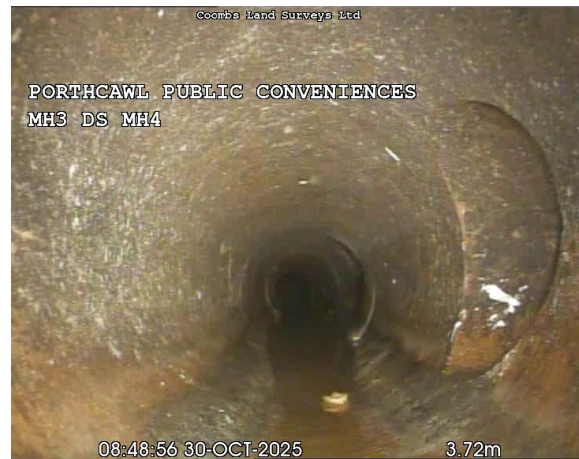
MH3X_290f36a5-6c77-42d8-b27b-cc6f493bf65a_20251030_162455_190.jpg, 00:01:23, 3.64 m
 Junction at 3 o'clock, 100mm dia

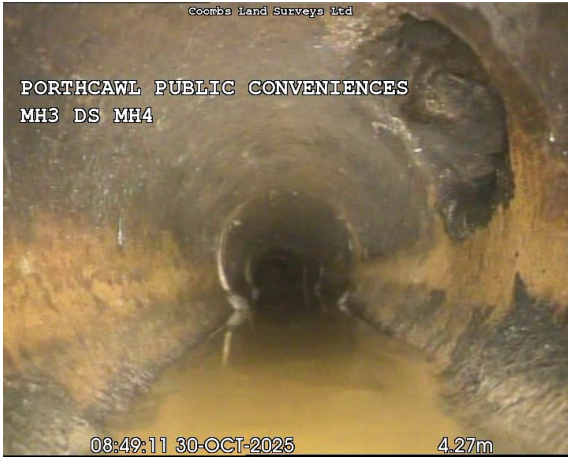
MH3X_60c0f3d8-877a-499b-9ba9-6412a4587609_20251030_163305_780.jpg, 00:01:43, 4.27 m
 Junction at 2 o'clock, 100mm dia

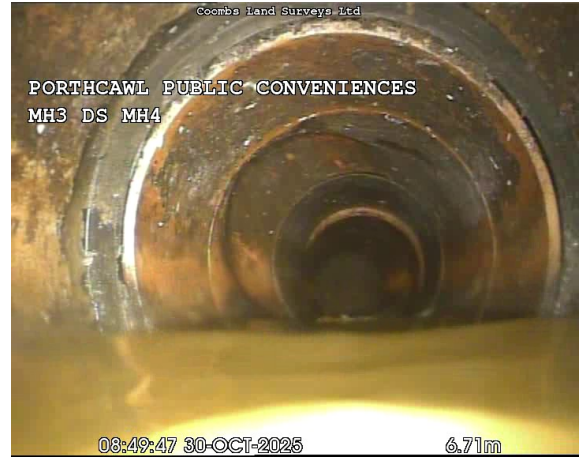
MH3X_f3c677d4-5b37-4da2-ba64-9a5289535fb3_20251030_163614_646.jpg, 00:02:19, 6.71 m
 Pipe material changes to polyvinyl chloride at this point

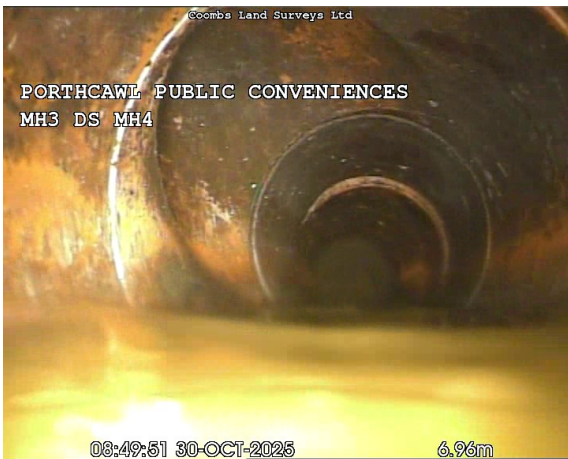
MH3X_32429f62-5b9a-4f69-b728-c850af3f61d2_20251030_163653_666.jpg, 00:02:24, 6.96 m
 Junction at 10 o'clock, 100mm dia

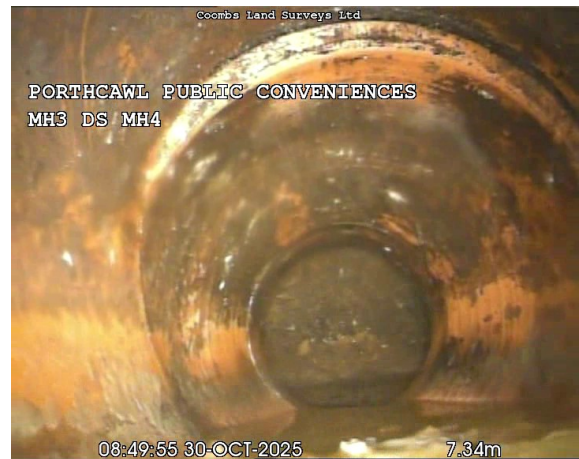
MH3X_bf86b677-1983-4596-8939-4c359911e1e4_20251030_163714_623.jpg, 00:02:28, 7.34 m
 Pipe material changes to vitrified clay at this point

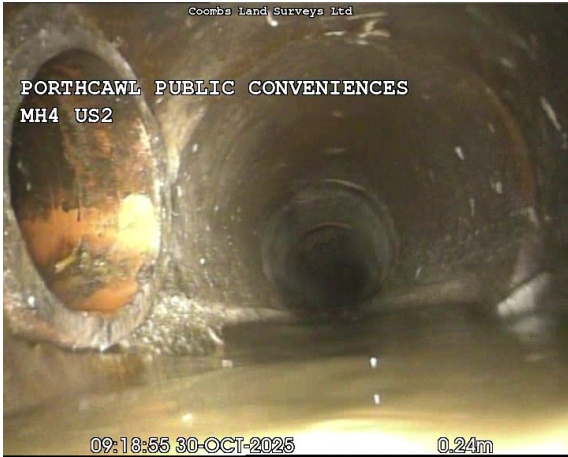
MH4US2X_ff93dd20-3959-4258-8813-d242b4256182_20251031_090608_715.jpg, 00:00:07, 0.24 m
 Connection other than junction at 9 o'clock, 150mm dia, from MH3, Incoming connection from MH3

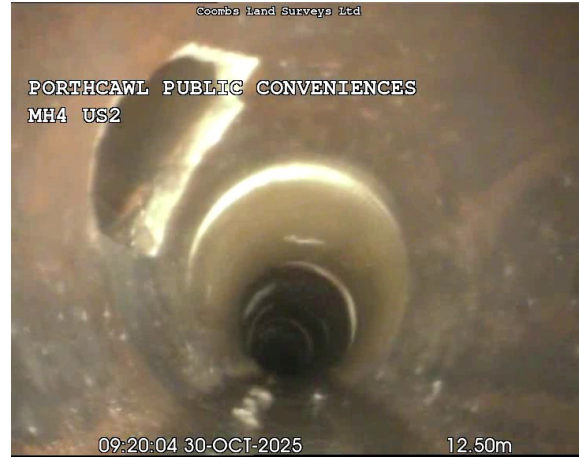
MH4US2X_2ae1a038-8453-4358-a1cf-b82174d65e0b_20251031_091821_216.jpg, 00:01:15, 12.50 m
 Connection other than junction at 10 o'clock, 100mm dia

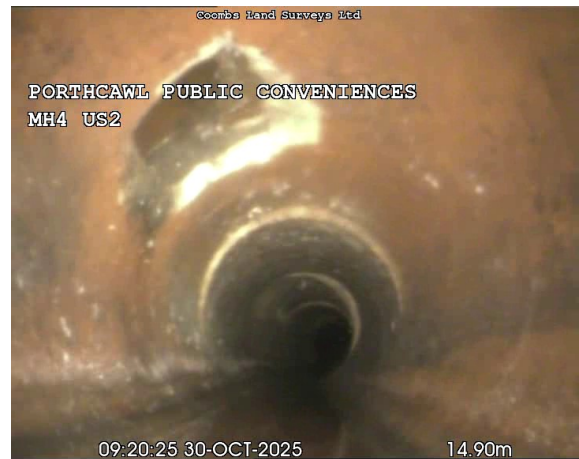
MH4US2X_37c44d2c-2031-455a-8325-96fc91747aee_20251031_092008_466.jpg, 00:01:36, 14.77 m
 Connection other than junction at 11 o'clock, 100mm dia
