Roof Condition Report

Project:
Llwynderw Flats

Project ID: SP157083
Date of issue: 20/05/2026

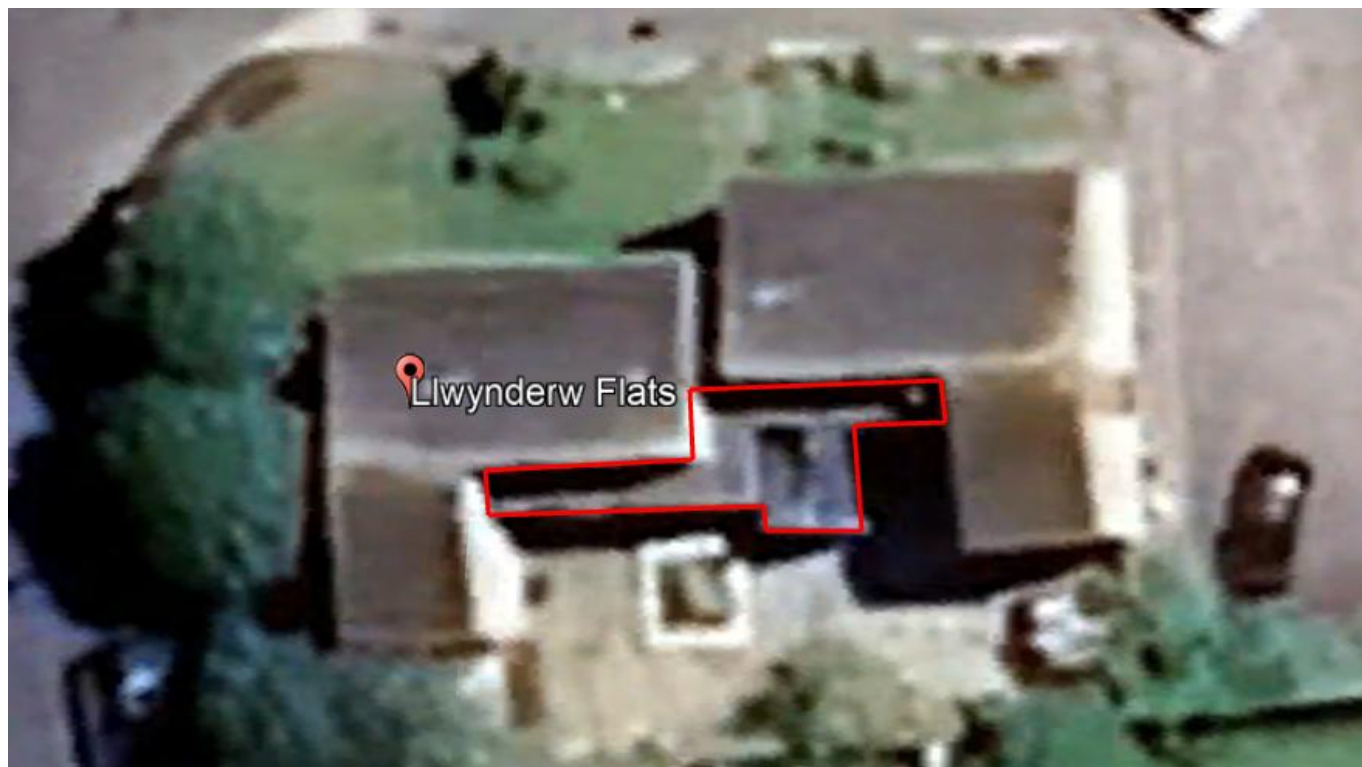
ROOF PLAN

Roof name:	Roof Area Highlighted in Red		
Approx. area:	75 m ²	Slope:	≥1:80
Height:	9 m	Exposure:	High
Humidity class:	High occupancy	Ceiling type:	Exposed ceiling

Roof type:	Cold	Visual condition:	Reasonable
Existing build-up:	Concrete deck, liquid coating		
Existing to be retained:	Yes	U-value req. if applicable:	N/A
Perimeter type:	Wetted drip edge	Parapet/Perimeter height:	N/A
Drainage type:	N/A	Dia. of rainwater pipes:	N/A
