Management Asbestos Survey

Ysgol Maes Owen
Morfa Avenue
Towyn
Abergele
LL18 5LE

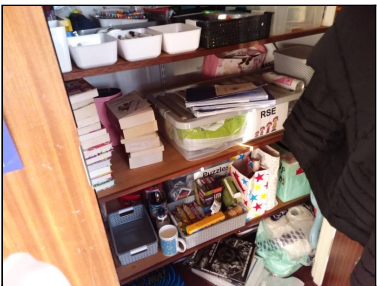
Inspection No. 5

Survey Date:	Lead Surveyor	Survey Type	Floor	Analysis
	08 Mar 2022	James Doherty, Shaun Doherty	Management Survey	Ground Floor	N/A
	Building	Room	Item	Quantity	
	Ysgol Maes Owen	Store B014	Accessed - no suspect materials found	N/A	Accessibility
	Sample No (S,SP,P,As)	Product Type	Surface Treatment	Condition	
	Visual (P)	N/A	N/A	N/A	N/A
	Material Risk Score				
Recommended action		No further action required			
Surveyor comments		N/A

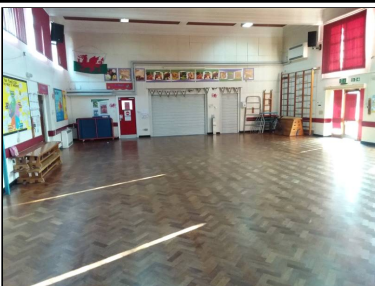
Inspection No. 8

Survey Date:	Lead Surveyor	Survey Type	Floor	Analysis
	08 Mar 2022	James Doherty, Shaun Doherty	Management Survey	Ground Floor	N/A
	Building	Room	Item	Quantity	
	Ysgol Maes Owen	Hall B063	Accessed - no suspect materials found	N/A	
	Sample No (S,SP,P,As)	Product Type	Surface Treatment	Condition	Accessibility
	Visual (P)	N/A	N/A	N/A	N/A
	Material Risk Score				
N/A					
Recommended action		No further action required			
Surveyor comments		N/A

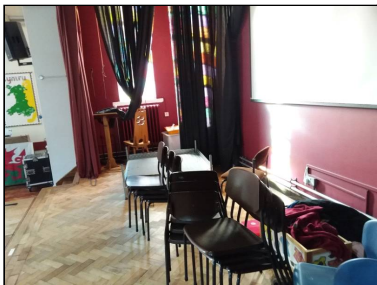
Inspection No. 9

Survey Date:	Lead Surveyor	Survey Type	Floor	Analysis
	08 Mar 2022	James Doherty, Shaun Doherty	Management Survey	Ground Floor	N/A
	Building	Room	Item	Quantity	
	Ysgol Maes Owen	Stage B062	Accessed - no suspect materials found	N/A	
	Sample No (S,SP,P,As)	Product Type	Surface Treatment	Condition	Accessibility
	Visual (P)	N/A	N/A	N/A	N/A
	Material Risk Score				
	N/A				
Recommended action	No further action required				
Surveyor comments	N/A

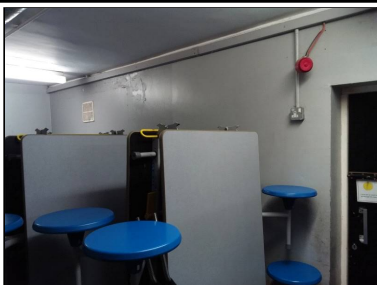
Inspection No. 10

Survey Date:	Lead Surveyor	Survey Type	Floor	Analysis
	08 Mar 2022	James Doherty, Shaun Doherty	Management Survey	Ground Floor	N/A
	Building	Room	Item	Quantity	
	Ysgol Maes Owen	Store B061	Accessed - no suspect materials found	N/A	
	Sample No (S,SP,P,As)	Product Type	Surface Treatment	Condition	Accessibility
	Visual (P)	N/A	N/A	N/A	N/A
	Material Risk Score				
	N/A				
Recommended action	No further action required				
Surveyor comments	N/A

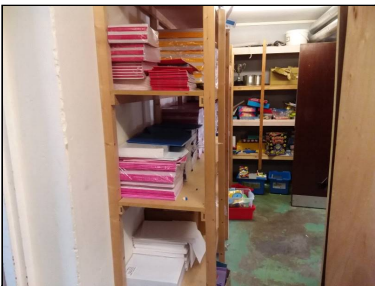
Inspection No. 11

Survey Date:	Lead Surveyor	Survey Type	Floor	Analysis
	08 Mar 2022	James Doherty, Shaun Doherty	Management Survey	Ground Floor	N/A
	Building	Room	Item	Quantity	
	Ysgol Maes Owen	Store B060	Accessed - no suspect materials found	N/A	
	Sample No (S,SP,P,As)	Product Type	Surface Treatment	Condition	Accessibility
	Visual (P)	N/A	N/A	N/A	N/A
	Material Risk Score				
Recommended action		No further action required			
Surveyor comments		N/A

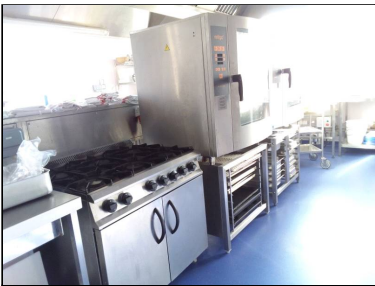
Inspection No. 14

Survey Date:	Lead Surveyor	Survey Type	Floor	Analysis
	08 Mar 2022	James Doherty, Shaun Doherty	Management Survey	Ground Floor	N/A
	Building	Room	Item	Quantity	
	Ysgol Maes Owen	Kitchen B064	Accessed - no suspect materials found	N/A	
	Sample No (S,SP,P,As)	Product Type	Surface Treatment	Condition	Accessibility
	Visual (P)	N/A	N/A	N/A	N/A
	Material Risk Score				
Recommended action		No further action required			
Surveyor comments		N/A

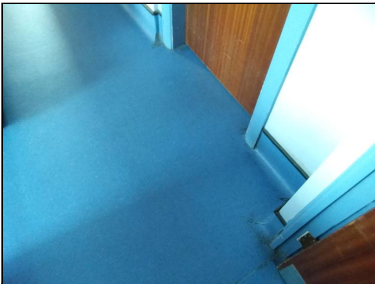
Inspection No. 15

Survey Date:	Lead Surveyor	Survey Type	Floor	Analysis
	08 Mar 2022	James Doherty, Shaun Doherty	Management Survey	Ground Floor	N/A
	Building	Room	Item	Quantity	
	Ysgol Maes Owen	Corridor B067	Fitted modern altro flooring not accessed below to prevent damage.	N/A	
	Sample No (S,SP,P,As)	Product Type	Surface Treatment	Condition	Accessibility
	Visual (P)	N/A	N/A	N/A	N/A
	Material Risk Score				
Recommended action		Inspection Required			
Surveyor comments		N/A

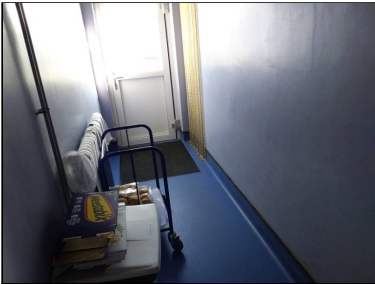
Inspection No. 16

Survey Date:	Lead Surveyor	Survey Type	Floor	Analysis
	08 Mar 2022	James Doherty, Shaun Doherty	Management Survey	Ground Floor	N/A
	Building	Room	Item	Quantity	
	Ysgol Maes Owen	Corridor B067	Accessed - no suspect materials found	N/A	
	Sample No (S,SP,P,As)	Product Type	Surface Treatment	Condition	Accessibility
	Visual (P)	N/A	N/A	N/A	N/A
	Material Risk Score				
Recommended action		No further action required			
Surveyor comments		N/A

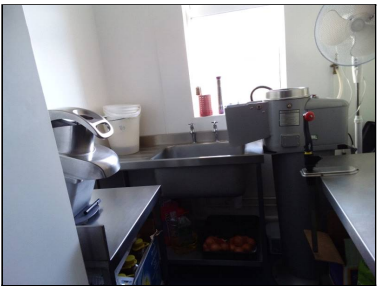
Inspection No. 18

Survey Date:	Lead Surveyor	Survey Type	Floor	Analysis
	08 Mar 2022	James Doherty, Shaun Doherty	Management Survey	Ground Floor	N/A
	Building	Room	Item	Quantity	
	Ysgol Maes Owen	Store B065	Accessed - no suspect materials found	N/A	
	Sample No (S,SP,P,As)	Product Type	Surface Treatment	Condition	Accessibility
	Visual (P)	N/A	N/A	N/A	N/A
	Material Risk Score				
Recommended action		No further action required			
Surveyor comments		N/A

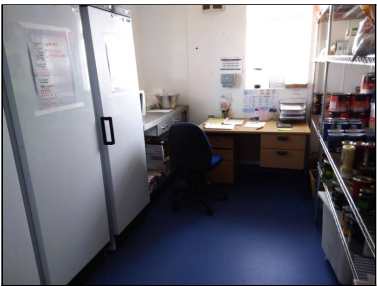
Inspection No. 20

Survey Date:	Lead Surveyor	Survey Type	Floor	Analysis
	08 Mar 2022	James Doherty, Shaun Doherty	Management Survey	Ground Floor	N/A
	Building	Room	Item	Quantity	
	Ysgol Maes Owen	Store B069	Accessed - no suspect materials found	N/A	
	Sample No (S,SP,P,As)	Product Type	Surface Treatment	Condition	Accessibility
	Visual (P)	N/A	N/A	N/A	N/A
	Material Risk Score				
Recommended action		No further action required			
Surveyor comments		N/A

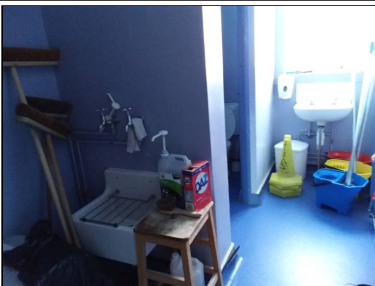
Inspection No. 22

Survey Date:	Lead Surveyor	Survey Type	Floor	Analysis
	08 Mar 2022	James Doherty, Shaun Doherty	Management Survey	Ground Floor	N/A
	Building	Room	Item	Quantity	
	Ysgol Maes Owen	Toilet B068	Accessed - no suspect materials found	N/A	
	Sample No (S,SP,P,As)	Product Type	Surface Treatment	Condition	Accessibility
	Visual (P)	N/A	N/A	N/A	N/A
	Material Risk Score				
Recommended action		No further action required			
Surveyor comments		N/A

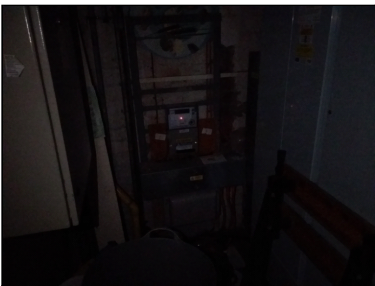
Inspection No. 23

Survey Date:	Lead Surveyor	Survey Type	Floor	Analysis
	08 Mar 2022	James Doherty, Shaun Doherty	Management Survey	Ground Floor	N/A
	Building	Room	Item	Quantity	
	Ysgol Maes Owen	Mains Cupboard B066	Accessed - no suspect materials found	N/A	
	Sample No (S,SP,P,As)	Product Type	Surface Treatment	Condition	Accessibility
	Visual (P)	N/A	N/A	N/A	N/A
	Material Risk Score				
Recommended action		No further action required			
Surveyor comments		N/A

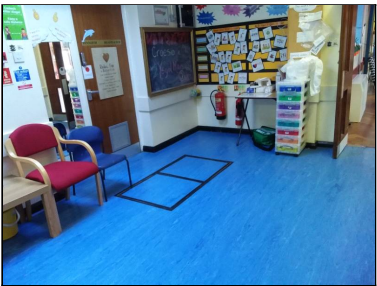
Inspection No. 26

Survey Date:	Lead Surveyor	Survey Type	Floor	Analysis
	08 Mar 2022	James Doherty, Shaun Doherty	Management Survey	Ground Floor	N/A
	Building	Room	Item	Quantity	
	Ysgol Maes Owen	Corridor B002	Accessed - no suspect materials found	N/A	
	Sample No (S,SP,P,As)	Product Type	Surface Treatment	Condition	Accessibility
	Visual (P)	N/A	N/A	N/A	N/A
	Material Risk Score				
Recommended action		No further action required			
Surveyor comments		N/A

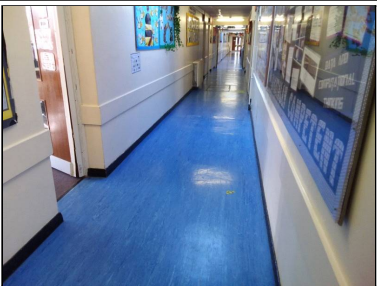
Inspection No. 28

Survey Date:	Lead Surveyor	Survey Type	Floor	Analysis
	08 Mar 2022	James Doherty, Shaun Doherty	Management Survey	Ground Floor	N/A
	Building	Room	Item	Quantity	
	Ysgol Maes Owen	Corridor B005	Accessed - no suspect materials found	N/A	
	Sample No (S,SP,P,As)	Product Type	Surface Treatment	Condition	Accessibility
	Visual (P)	N/A	N/A	N/A	N/A
	Material Risk Score				
Recommended action		No further action required			
Surveyor comments		N/A

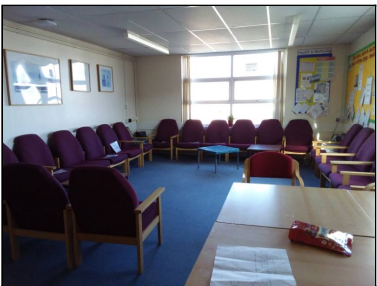
Inspection No. 29

Survey Date:	Lead Surveyor	Survey Type	Floor	Analysis
	08 Mar 2022	James Doherty, Shaun Doherty	Management Survey	Ground Floor	N/A
	Building	Room	Item	Quantity	
	Ysgol Maes Owen	Staff Room B050	Accessed - no suspect materials found	N/A	Accessibility
	Sample No (S,SP,P,As)	Product Type	Surface Treatment	Condition	
	Visual (P)	N/A	N/A	N/A	
	Material Risk Score				
Recommended action		No further action required			
Surveyor comments		N/A

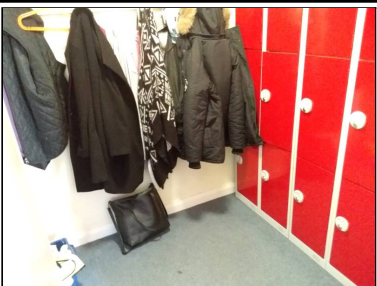
Inspection No. 30

Survey Date:	Lead Surveyor	Survey Type	Floor	Analysis
	08 Mar 2022	James Doherty, Shaun Doherty	Management Survey	Ground Floor	N/A
	Building	Room	Item	Quantity	
	Ysgol Maes Owen	Cloak Room B048	Accessed - no suspect materials found	N/A	Accessibility
	Sample No (S,SP,P,As)	Product Type	Surface Treatment	Condition	
	Visual (P)	N/A	N/A	N/A	
	Material Risk Score				
Recommended action		No further action required			
Surveyor comments		N/A

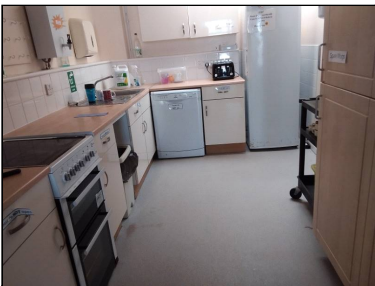
Inspection No. 31

Survey Date:	Lead Surveyor	Survey Type	Floor	Analysis
	08 Mar 2022	James Doherty, Shaun Doherty	Management Survey	Ground Floor	N/A
	Building	Room	Item	Quantity	
	Ysgol Maes Owen	Kitchen B051	Accessed - no suspect materials found	N/A	
	Sample No (S,SP,P,As)	Product Type	Surface Treatment	Condition	Accessibility
	Visual (P)	N/A	N/A	N/A	N/A
	Material Risk Score				
Recommended action		No further action required			
Surveyor comments		N/A

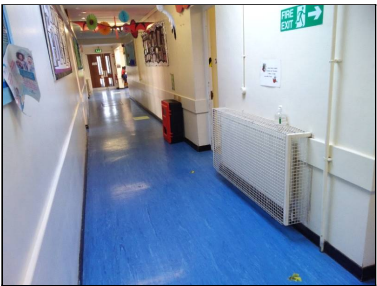
Inspection No. 34

Survey Date:	Lead Surveyor	Survey Type	Floor	Analysis
	08 Mar 2022	James Doherty, Shaun Doherty	Management Survey	Ground Floor	N/A
	Building	Room	Item	Quantity	
	Ysgol Maes Owen	Corridor B072	Accessed - no suspect materials found	N/A	
	Sample No (S,SP,P,As)	Product Type	Surface Treatment	Condition	Accessibility
	Visual (P)	N/A	N/A	N/A	N/A
	Material Risk Score				
Recommended action		No further action required			
Surveyor comments		N/A

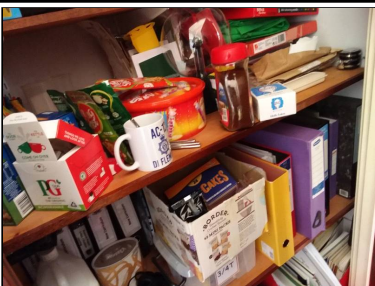
Inspection No. 36

Survey Date:	Lead Surveyor	Survey Type	Floor	Analysis
	08 Mar 2022	James Doherty, Shaun Doherty	Management Survey	Ground Floor	N/A
	Building	Room	Item	Quantity	
	Ysgol Maes Owen	Store B018	Accessed - no suspect materials found	N/A	
	Sample No (S,SP,P,As)	Product Type	Surface Treatment	Condition	Accessibility
	Visual (P)	N/A	N/A	N/A	N/A
	Material Risk Score				
Recommended action		No further action required			
Surveyor comments		N/A

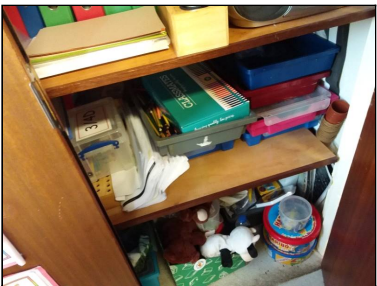
Inspection No. 39

Survey Date:	Lead Surveyor	Survey Type	Floor	Analysis
	08 Mar 2022	James Doherty, Shaun Doherty	Management Survey	Ground Floor	N/A
	Building	Room	Item	Quantity	
	Ysgol Maes Owen	Store B070	Accessed - no suspect materials found	N/A	
	Sample No (S,SP,P,As)	Product Type	Surface Treatment	Condition	Accessibility
	Visual (P)	N/A	N/A	N/A	N/A
	Material Risk Score				
Recommended action		No further action required			
Surveyor comments		N/A

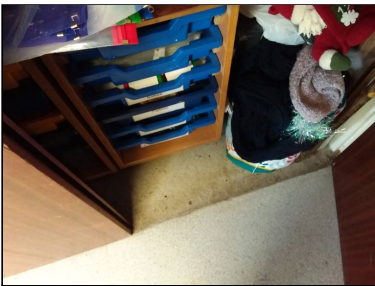
Inspection No. 42

Survey Date:	Lead Surveyor	Survey Type	Floor	Analysis
	08 Mar 2022	James Doherty, Shaun Doherty	Management Survey	Ground Floor	N/A
	Building	Room	Item	Quantity	
	Ysgol Maes Owen	Store B071	Accessed - no suspect materials found	N/A	
	Sample No (S,SP,P,As)	Product Type	Surface Treatment	Condition	Accessibility
	Visual (P)	N/A	N/A	N/A	N/A
	Material Risk Score				
Recommended action		No further action required			
Surveyor comments		N/A

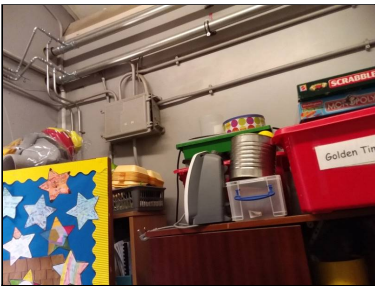
Inspection No. 44

Survey Date:	Lead Surveyor	Survey Type	Floor	Analysis
	08 Mar 2022	James Doherty, Shaun Doherty	Management Survey	Ground Floor	N/A
	Building	Room	Item	Quantity	
	Ysgol Maes Owen	Store B007	Accessed - no suspect materials found	N/A	
	Sample No (S,SP,P,As)	Product Type	Surface Treatment	Condition	Accessibility
	Visual (P)	N/A	N/A	N/A	N/A
	Material Risk Score				
Recommended action		No further action required			
Surveyor comments		N/A

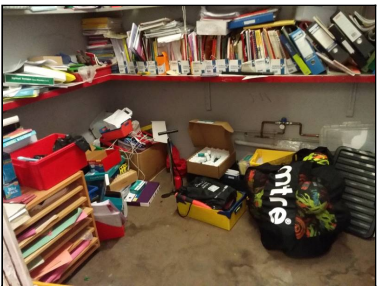
Inspection No. 45

Survey Date:	Lead Surveyor	Survey Type	Floor	Analysis
	08 Mar 2022	James Doherty, Shaun Doherty	Management Survey	Ground Floor	N/A
	Building	Room	Item	Quantity	
	Ysgol Maes Owen	Store B011	Accessed - no suspect materials found	N/A	Accessibility
	Sample No (S,SP,P,As)	Product Type	Surface Treatment	Condition	
	Visual (P)	N/A	N/A	N/A	
	Material Risk Score				
Recommended action		No further action required			
Surveyor comments		N/A

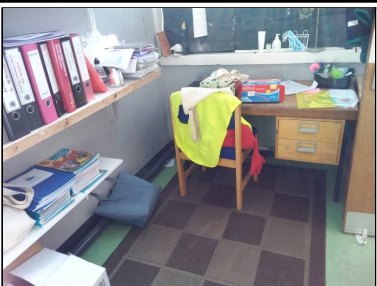
Inspection No. 46

Survey Date:	Lead Surveyor	Survey Type	Floor	Analysis
	08 Mar 2022	James Doherty, Shaun Doherty	Management Survey	Ground Floor	N/A
	Building	Room	Item	Quantity	
	Ysgol Maes Owen	Store B013	Accessed - no suspect materials found	N/A	Accessibility
	Sample No (S,SP,P,As)	Product Type	Surface Treatment	Condition	
	Visual (P)	N/A	N/A	N/A	
	Material Risk Score				
Recommended action		No further action required			
Surveyor comments		N/A

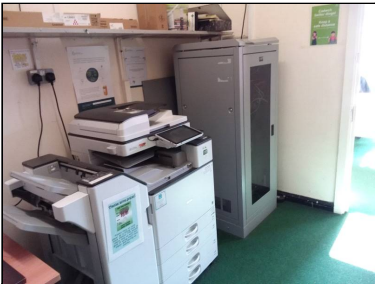
Inspection No. 47

Survey Date:	Lead Surveyor	Survey Type	Floor	Analysis
	08 Mar 2022	James Doherty, Shaun Doherty	Management Survey	Ground Floor	N/A
	Building	Room	Item	Quantity	
	Ysgol Maes Owen	Office B003	Accessed - no suspect materials found	N/A	
	Sample No (S,SP,P,As)	Product Type	Surface Treatment	Condition	Accessibility
	Visual (P)	N/A	N/A	N/A	N/A
	Material Risk Score				
Recommended action		No further action required			
Surveyor comments		N/A

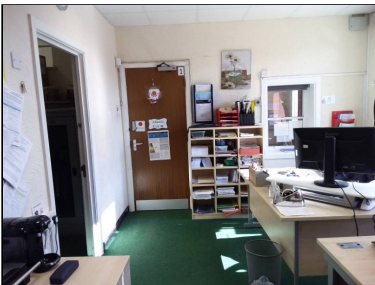
Inspection No. 48

Survey Date:	Lead Surveyor	Survey Type	Floor	Analysis
	08 Mar 2022	James Doherty, Shaun Doherty	Management Survey	Ground Floor	N/A
	Building	Room	Item	Quantity	
	Ysgol Maes Owen	Office B004	Accessed - no suspect materials found	N/A	
	Sample No (S,SP,P,As)	Product Type	Surface Treatment	Condition	Accessibility
	Visual (P)	N/A	N/A	N/A	N/A
	Material Risk Score				
Recommended action		No further action required			
Surveyor comments		N/A

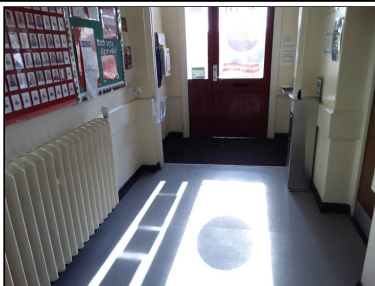
Inspection No. 50

Survey Date:	Lead Surveyor	Survey Type	Floor	Analysis
	08 Mar 2022	James Doherty, Shaun Doherty	Management Survey	Ground Floor	N/A
	Building	Room	Item	Quantity	
	Ysgol Maes Owen	Lobby B001	Accessed - no suspect materials found	N/A	
	Sample No (S,SP,P,As)	Product Type	Surface Treatment	Condition	Accessibility
	Visual (P)	N/A	N/A	N/A	N/A
	Material Risk Score				
	N/A				
Recommended action	No further action required				
Surveyor comments	N/A

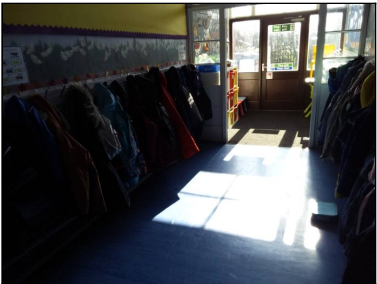
Inspection No. 53

Survey Date:	Lead Surveyor	Survey Type	Floor	Analysis
	08 Mar 2022	James Doherty, Shaun Doherty	Management Survey	Ground Floor	N/A
	Building	Room	Item	Quantity	
	Ysgol Maes Owen	Corridor B008	Accessed - no suspect materials found	N/A	
	Sample No (S,SP,P,As)	Product Type	Surface Treatment	Condition	Accessibility
	Visual (P)	N/A	N/A	N/A	N/A
	Material Risk Score				
Recommended action		No further action required			
Surveyor comments		N/A

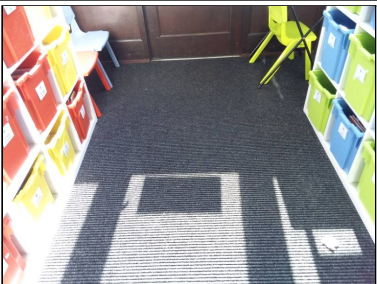
Inspection No. 54

Survey Date:	Lead Surveyor	Survey Type	Floor	Analysis
	08 Mar 2022	James Doherty, Shaun Doherty	Management Survey	Ground Floor	N/A
	Building	Room	Item	Quantity	
	Ysgol Maes Owen	Lobby B009	Fitted carpet flooring not accessed below to prevent damage.	N/A	
	Sample No (S,SP,P,As)	Product Type	Surface Treatment	Condition	Accessibility
	Visual (P)	N/A	N/A	N/A	N/A
	Material Risk Score				
Recommended action		Inspection Required			
Surveyor comments		N/A

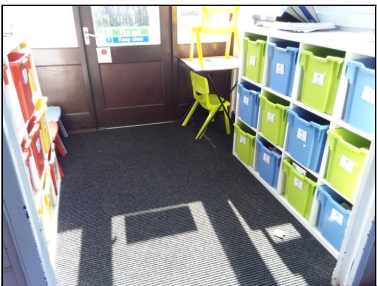
Inspection No. 55

Survey Date:	Lead Surveyor	Survey Type	Floor	Analysis
	08 Mar 2022	James Doherty, Shaun Doherty	Management Survey	Ground Floor	N/A
	Building	Room	Item	Quantity	
	Ysgol Maes Owen	Lobby B009	Accessed - no suspect materials found	N/A	Accessibility
	Sample No (S,SP,P,As)	Product Type	Surface Treatment	Condition	
	Visual (P)	N/A	N/A	N/A	
	Material Risk Score				
Recommended action		No further action required			
Surveyor comments		N/A

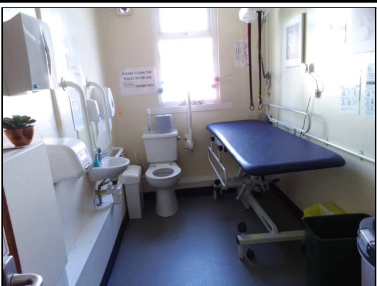
Inspection No. 56

Survey Date:	Lead Surveyor	Survey Type	Floor	Analysis
	08 Mar 2022	James Doherty, Shaun Doherty	Management Survey	Ground Floor	N/A
	Building	Room	Item	Quantity	
	Ysgol Maes Owen	Toilet B057	Accessed - no suspect materials found	N/A	Accessibility
	Sample No (S,SP,P,As)	Product Type	Surface Treatment	Condition	
	Visual (P)	N/A	N/A	N/A	
	Material Risk Score				
Recommended action		No further action required			
Surveyor comments		N/A

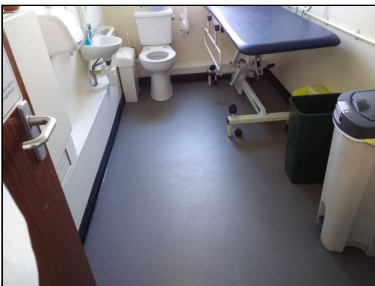
Inspection No. 57

Survey Date:	Lead Surveyor	Survey Type	Floor	Analysis
	08 Mar 2022	James Doherty, Shaun Doherty	Management Survey	Ground Floor	N/A
	Building	Room	Item	Quantity	
	Ysgol Maes Owen	Toilet B057	Fitted modern altro flooring not accessed below to prevent damage.	N/A	
	Sample No (S,SP,P,As)	Product Type	Surface Treatment	Condition	Accessibility
	Visual (P)	N/A	N/A	N/A	N/A
	Material Risk Score				
Recommended action		Inspection Required			
Surveyor comments		N/A

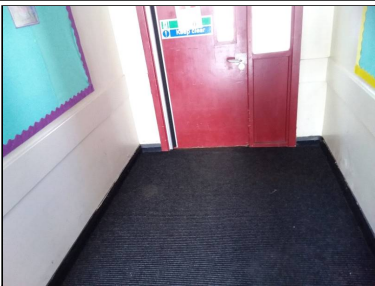
Inspection No. 59

Survey Date:	Lead Surveyor	Survey Type	Floor	Analysis
	08 Mar 2022	James Doherty, Shaun Doherty	Management Survey	Ground Floor	N/A
	Building	Room	Item	Quantity	
	Ysgol Maes Owen	Lobby B052	Accessed - no suspect materials found	N/A	
	Sample No (S,SP,P,As)	Product Type	Surface Treatment	Condition	Accessibility
	Visual (P)	N/A	N/A	N/A	N/A
	Material Risk Score				
Recommended action		No further action required			
Surveyor comments		N/A

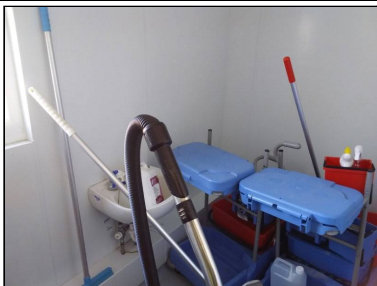
Inspection No. 60

Survey Date:	Lead Surveyor	Survey Type	Floor	Analysis
	08 Mar 2022	James Doherty, Shaun Doherty	Management Survey	Ground Floor	N/A
	Building	Room	Item	Quantity	
	Ysgol Maes Owen	Cleaners Cupboard B053	Accessed - no suspect materials found	N/A	
	Sample No (S,SP,P,As)	Product Type	Surface Treatment	Condition	Accessibility
	Visual (P)	N/A	N/A	N/A	N/A
	Material Risk Score				
	N/A				
Recommended action	No further action required				
Surveyor comments	N/A

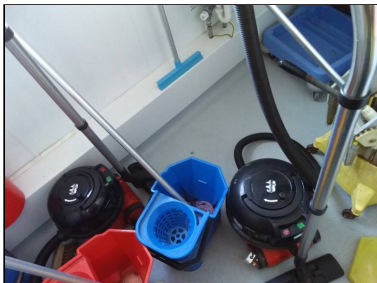
Inspection No. 61

Survey Date:	Lead Surveyor	Survey Type	Floor	Analysis
	08 Mar 2022	James Doherty, Shaun Doherty	Management Survey	Ground Floor	N/A
	Building	Room	Item	Quantity	
	Ysgol Maes Owen	Cleaners Cupboard B053	Fitted modern altro flooring not accessed below to prevent damage.	N/A	
	Sample No (S,SP,P,As)	Product Type	Surface Treatment	Condition	Accessibility
	Visual (P)	N/A	N/A	N/A	N/A
	Material Risk Score				
	N/A				
Recommended action	Inspection Required				
Surveyor comments	N/A

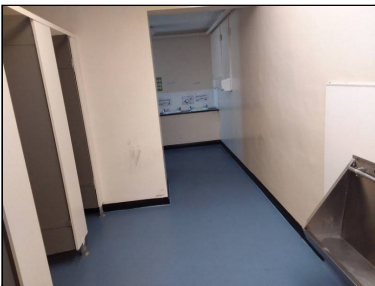
Inspection No. 62

Survey Date:	Lead Surveyor	Survey Type	Floor	Analysis
	08 Mar 2022	James Doherty, Shaun Doherty	Management Survey	Ground Floor	N/A
	Building	Room	Item	Quantity	
	Ysgol Maes Owen	Toilets B054	Accessed - no suspect materials found	N/A	
	Sample No (S,SP,P,As)	Product Type	Surface Treatment	Condition	Accessibility
	Visual (P)	N/A	N/A	N/A	N/A
	Material Risk Score				
Recommended action		No further action required			
Surveyor comments		N/A

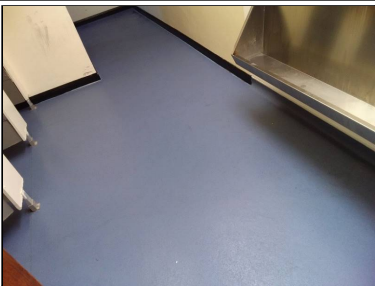
Inspection No. 63

Survey Date:	Lead Surveyor	Survey Type	Floor	Analysis
	08 Mar 2022	James Doherty, Shaun Doherty	Management Survey	Ground Floor	N/A
	Building	Room	Item	Quantity	
	Ysgol Maes Owen	Toilets B054	Fitted modern altro flooring not accessed below to prevent damage.	N/A	
	Sample No (S,SP,P,As)	Product Type	Surface Treatment	Condition	Accessibility
	Visual (P)	N/A	N/A	N/A	N/A
	Material Risk Score				
Recommended action		Inspection Required			
Surveyor comments		N/A

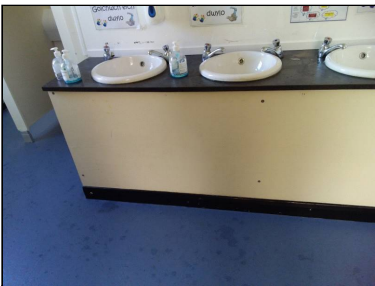
Inspection No. 64

Survey Date:	Lead Surveyor	Survey Type	Floor	Analysis
	08 Mar 2022	James Doherty, Shaun Doherty	Management Survey	Ground Floor	N/A
	Building	Room	Item	Quantity	
	Ysgol Maes Owen	Toilets B054	Timber boxing below basins not accessed beyond to prevent damage.	N/A	
	Sample No (S,SP,P,As)	Product Type	Surface Treatment	Condition	Accessibility
	Visual (P)	N/A	N/A	N/A	N/A
	Material Risk Score				
Recommended action		Inspection Required			
Surveyor comments		N/A

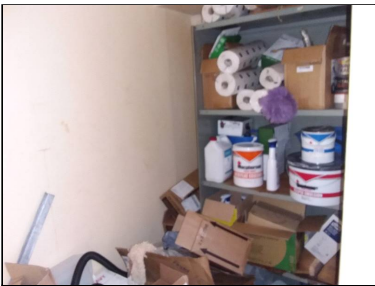
Inspection No. 65

Survey Date:	Lead Surveyor	Survey Type	Floor	Analysis
	08 Mar 2022	James Doherty, Shaun Doherty	Management Survey	Ground Floor	N/A
	Building	Room	Item	Quantity	
	Ysgol Maes Owen	Store B055	No suspect materials found.	N/A	
	Sample No (S,SP,P,As)	Product Type	Surface Treatment	Condition	Accessibility
	Visual (P)	N/A	N/A	N/A	N/A
	Material Risk Score				
Recommended action		Inspection Required			
Surveyor comments		N/A

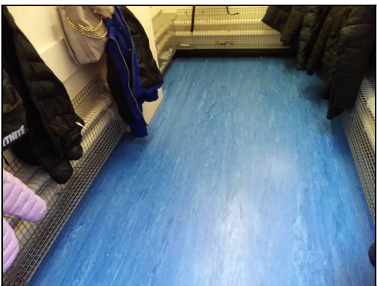
Inspection No. 66

Survey Date:	Lead Surveyor	Survey Type	Floor	Analysis
	08 Mar 2022	James Doherty, Shaun Doherty	Management Survey	Ground Floor	N/A
	Building	Room	Item	Quantity	
	Ysgol Maes Owen	Corridor B045	Fitted modern altro flooring not accessed below to prevent damage.	N/A	
	Sample No (S,SP,P,As)	Product Type	Surface Treatment	Condition	Accessibility
	Visual (P)	N/A	N/A	N/A	N/A
	Material Risk Score				
Recommended action		Inspection Required			
Surveyor comments		N/A

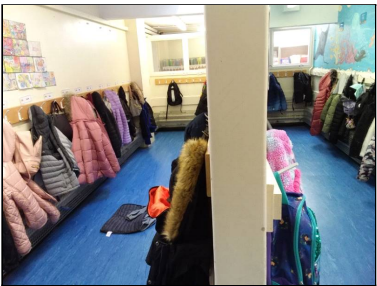
Inspection No. 67

Survey Date:	Lead Surveyor	Survey Type	Floor	Analysis
	08 Mar 2022	James Doherty, Shaun Doherty	Management Survey	Ground Floor	N/A
	Building	Room	Item	Quantity	
	Ysgol Maes Owen	Corridor B045	Accessed - no suspect materials found	N/A	
	Sample No (S,SP,P,As)	Product Type	Surface Treatment	Condition	Accessibility
	Visual (P)	N/A	N/A	N/A	N/A
	Material Risk Score				
Recommended action		No further action required			
Surveyor comments		N/A

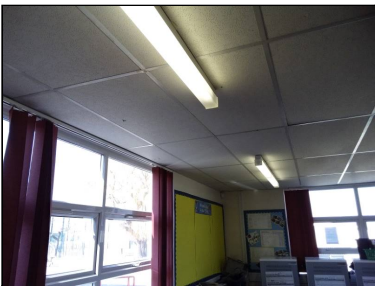
Inspection No. 69

Survey Date:	Lead Surveyor	Survey Type	Floor	Analysis
	08 Mar 2022	James Doherty, Shaun Doherty	Management Survey	Ground Floor	N/A
	Building	Room	Item	Quantity	
	Ysgol Maes Owen	Class B046	Suspended ceiling not accessed above to prevent damage.	N/A	
	Sample No (S,SP,P,As)	Product Type	Surface Treatment	Condition	Accessibility
	Visual (P)	N/A	N/A	N/A	N/A
	Material Risk Score				
Recommended action		Inspection Required			
Surveyor comments		N/A

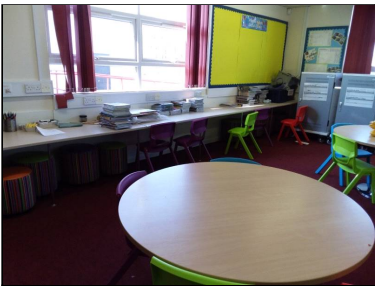
Inspection No. 70

Survey Date:	Lead Surveyor	Survey Type	Floor	Analysis
	08 Mar 2022	James Doherty, Shaun Doherty	Management Survey	Ground Floor	N/A
	Building	Room	Item	Quantity	
	Ysgol Maes Owen	Class B046	Accessed - no suspect materials found	N/A	
	Sample No (S,SP,P,As)	Product Type	Surface Treatment	Condition	Accessibility
	Visual (P)	N/A	N/A	N/A	N/A
	Material Risk Score				
Recommended action		No further action required			
Surveyor comments		N/A

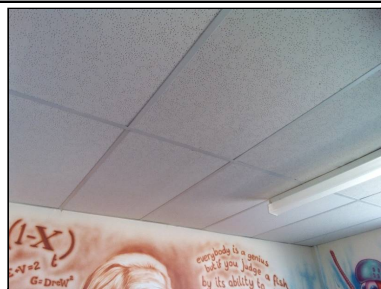
Inspection No. 71

Survey Date:	Lead Surveyor	Survey Type	Floor	Analysis
	08 Mar 2022	James Doherty, Shaun Doherty	Management Survey	Ground Floor	N/A
	Building	Room	Item	Quantity	
	Ysgol Maes Owen	Class B049	Suspended ceiling not accessed above to prevent damage.	N/A	
	Sample No (S,SP,P,As)	Product Type	Surface Treatment	Condition	Accessibility
	Visual (P)	N/A	N/A	N/A	N/A
	Material Risk Score				
Recommended action		Inspection Required			
Surveyor comments		N/A

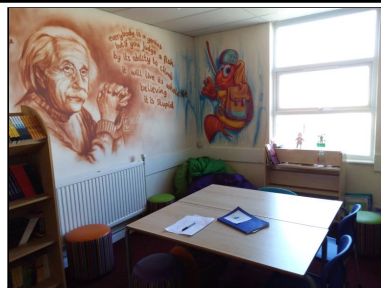
Inspection No. 72

Survey Date:	Lead Surveyor	Survey Type	Floor	Analysis
	08 Mar 2022	James Doherty, Shaun Doherty	Management Survey	Ground Floor	N/A
	Building	Room	Item	Quantity	
	Ysgol Maes Owen	Class B049	Accessed - no suspect materials found	N/A	
	Sample No (S,SP,P,As)	Product Type	Surface Treatment	Condition	Accessibility
	Visual (P)	N/A	N/A	N/A	N/A
	Material Risk Score				
Recommended action		No further action required			
Surveyor comments		N/A

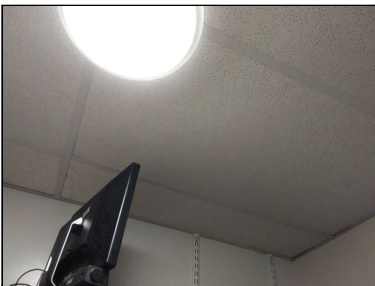
Inspection No. 73

Survey Date:	Lead Surveyor	Survey Type	Floor	Analysis
	08 Mar 2022	James Doherty, Shaun Doherty	Management Survey	Ground Floor	N/A
	Building	Room	Item	Quantity	
	Ysgol Maes Owen	Store B047	Suspended ceiling not accessed above to prevent damage.	N/A	
	Sample No (S,SP,P,As)	Product Type	Surface Treatment	Condition	Accessibility
	Visual (P)	N/A	N/A	N/A	N/A
	Material Risk Score				
Recommended action		Inspection Required			
Surveyor comments		N/A

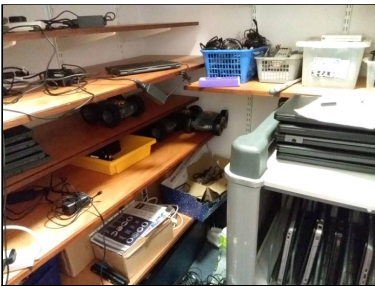
Inspection No. 74

Survey Date:	Lead Surveyor	Survey Type	Floor	Analysis
	08 Mar 2022	James Doherty, Shaun Doherty	Management Survey	Ground Floor	N/A
	Building	Room	Item	Quantity	
	Ysgol Maes Owen	Store B047	Accessed - no suspect materials found	N/A	
	Sample No (S,SP,P,As)	Product Type	Surface Treatment	Condition	Accessibility
	Visual (P)	N/A	N/A	N/A	N/A
	Material Risk Score				
Recommended action		No further action required			
Surveyor comments		N/A

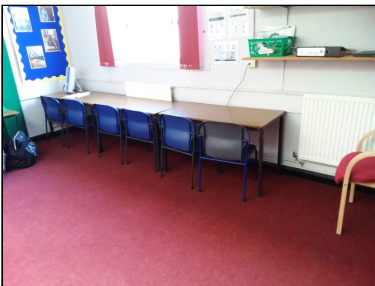
Inspection No. 76

Survey Date:	Lead Surveyor	Survey Type	Floor	Analysis
	08 Mar 2022	James Doherty, Shaun Doherty	Management Survey	Ground Floor	N/A
	Building	Room	Item	Quantity	
	Ysgol Maes Owen	Class B044	Accessed - no suspect materials found	N/A	Accessibility
	Sample No (S,SP,P,As)	Product Type	Surface Treatment	Condition	
	Visual (P)	N/A	N/A	N/A	
	Material Risk Score				
Recommended action		No further action required			
Surveyor comments		N/A

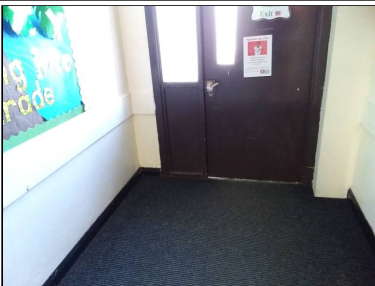
Inspection No. 77

Survey Date:	Lead Surveyor	Survey Type	Floor	Analysis
	08 Mar 2022	James Doherty, Shaun Doherty	Management Survey	Ground Floor	N/A
	Building	Room	Item	Quantity	
	Ysgol Maes Owen	Lobby B043	Accessed - no suspect materials found	N/A	Accessibility
	Sample No (S,SP,P,As)	Product Type	Surface Treatment	Condition	
	Visual (P)	N/A	N/A	N/A	
	Material Risk Score				
Recommended action		No further action required			
Surveyor comments		N/A

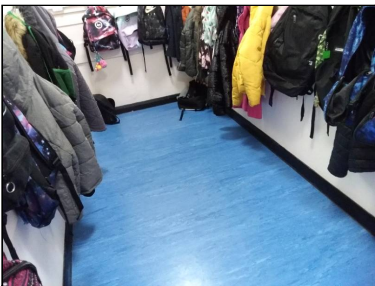
Inspection No. 78

Survey Date:	Lead Surveyor	Survey Type	Floor	Analysis
	08 Mar 2022	James Doherty, Shaun Doherty	Management Survey	Ground Floor	N/A
	Building	Room	Item	Quantity	
	Ysgol Maes Owen	Cloak Room B042	Fitted modern altro flooring not accessed below to prevent damage.	N/A	
	Sample No (S,SP,P,As)	Product Type	Surface Treatment	Condition	Accessibility
	Visual (P)	N/A	N/A	N/A	N/A
	Material Risk Score				
Recommended action		Inspection Required			
Surveyor comments		N/A

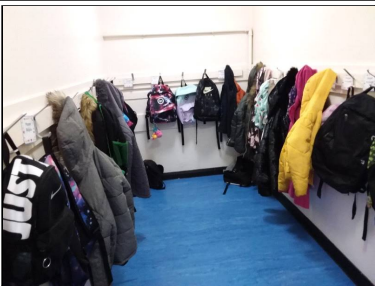
Inspection No. 79

Survey Date:	Lead Surveyor	Survey Type	Floor	Analysis
	08 Mar 2022	James Doherty, Shaun Doherty	Management Survey	Ground Floor	N/A
	Building	Room	Item	Quantity	
	Ysgol Maes Owen	Cloak Room B042	Accessed - no suspect materials found	N/A	
	Sample No (S,SP,P,As)	Product Type	Surface Treatment	Condition	Accessibility
	Visual (P)	N/A	N/A	N/A	N/A
	Material Risk Score				
Recommended action		No further action required			
Surveyor comments		N/A

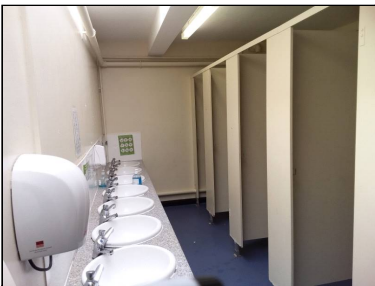
Inspection No. 80

Survey Date:	Lead Surveyor	Survey Type	Floor	Analysis
	08 Mar 2022	James Doherty, Shaun Doherty	Management Survey	Ground Floor	N/A
	Building	Room	Item	Quantity	
	Ysgol Maes Owen	Toilets B041	Accessed - no suspect materials found	N/A	
	Sample No (S,SP,P,As)	Product Type	Surface Treatment	Condition	Accessibility
	Visual (P)	N/A	N/A	N/A	N/A
	Material Risk Score				
Recommended action		No further action required			
Surveyor comments		N/A

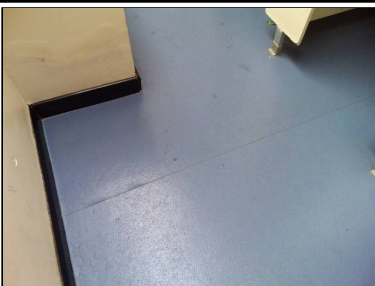
Inspection No. 81

Survey Date:	Lead Surveyor	Survey Type	Floor	Analysis
	08 Mar 2022	James Doherty, Shaun Doherty	Management Survey	Ground Floor	N/A
	Building	Room	Item	Quantity	
	Ysgol Maes Owen	Toilets B041	Fitted modern altro flooring not accessed below to prevent damage.	N/A	
	Sample No (S,SP,P,As)	Product Type	Surface Treatment	Condition	Accessibility
	Visual (P)	N/A	N/A	N/A	N/A
	Material Risk Score				
Recommended action		Inspection Required			
Surveyor comments		N/A

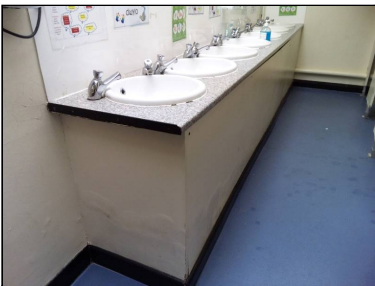
Inspection No. 82

Survey Date:	Lead Surveyor	Survey Type	Floor	Analysis
	08 Mar 2022	James Doherty, Shaun Doherty	Management Survey	Ground Floor	N/A
	Building	Room	Item	Quantity	
	Ysgol Maes Owen	Toilets B041	Timber boxing below basins not accessed beyond to prevent damage.	N/A	
	Sample No (S,SP,P,As)	Product Type	Surface Treatment	Condition	Accessibility
	Visual (P)	N/A	N/A	N/A	N/A
	Material Risk Score				
Recommended action		Inspection Required			
Surveyor comments		N/A

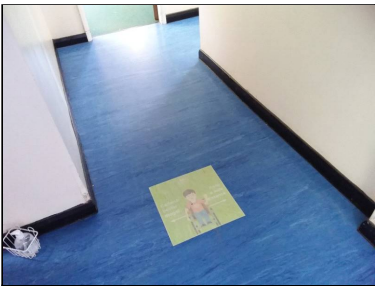
Inspection No. 83

Survey Date:	Lead Surveyor	Survey Type	Floor	Analysis
	08 Mar 2022	James Doherty, Shaun Doherty	Management Survey	Ground Floor	N/A
	Building	Room	Item	Quantity	
	Ysgol Maes Owen	Corridor B034	Fitted modern altro flooring not accessed below to prevent damage.	N/A	
	Sample No (S,SP,P,As)	Product Type	Surface Treatment	Condition	Accessibility
	Visual (P)	N/A	N/A	N/A	N/A
	Material Risk Score				
Recommended action		Inspection Required			
Surveyor comments		N/A

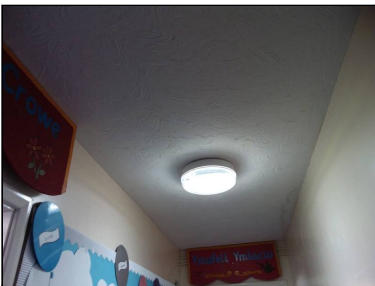
Inspection No. 84

Survey Date:	Lead Surveyor	Survey Type	Floor	Analysis
	08 Mar 2022	James Doherty, Shaun Doherty	Management Survey	Ground Floor	No Asbestos Detected
	Building	Room	Item	Quantity	
	Ysgol Maes Owen	Corridor B034	Textured coating to ceiling.	4m ²	
	Sample No (S,SP,P,As)	Product Type	Surface Treatment	Condition	Accessibility
	NE002637 (S)	N/A	N/A	N/A	N/A
	Material Risk Score				
Recommended action		No further action required			
Surveyor comments		N/A

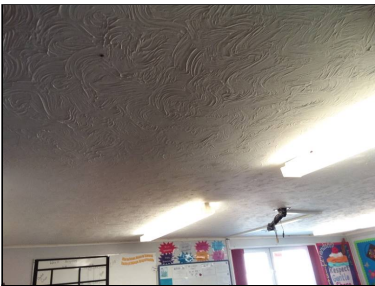
Inspection No. 86

Survey Date:	Lead Surveyor	Survey Type	Floor	Analysis
	08 Mar 2022	James Doherty, Shaun Doherty	Management Survey	Ground Floor	No Asbestos Detected
	Building	Room	Item	Quantity	
	Ysgol Maes Owen	Class B037	Textured coating to ceiling.	36m ²	
	Sample No (S,SP,P,As)	Product Type	Surface Treatment	Condition	Accessibility
	As NE002637 (SP)	N/A	N/A	N/A	N/A
	Material Risk Score				
Recommended action		No further action required			
Surveyor comments		N/A

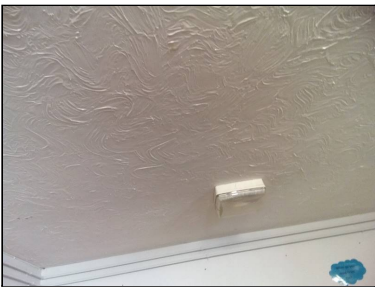
Inspection No. 87

Survey Date:	Lead Surveyor	Survey Type	Floor	Analysis
	08 Mar 2022	James Doherty, Shaun Doherty	Management Survey	Ground Floor	No Asbestos Detected
	Building	Room	Item	Quantity	
	Ysgol Maes Owen	Kitchen B040	Textured coating to ceiling.	6m ²	
	Sample No (S,SP,P,As)	Product Type	Surface Treatment	Condition	Accessibility
	As NE002637 (SP)	N/A	N/A	N/A	N/A
	Material Risk Score				
Recommended action		No further action required			
Surveyor comments		N/A

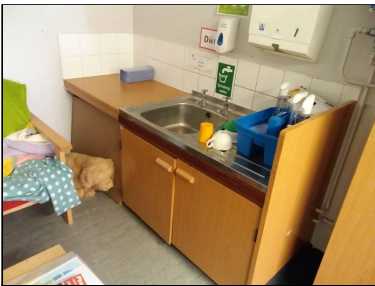
Inspection No. 88

Survey Date:	Lead Surveyor	Survey Type	Floor	Analysis
	08 Mar 2022	James Doherty, Shaun Doherty	Management Survey	Ground Floor	No Asbestos Detected
	Building	Room	Item	Quantity	
	Ysgol Maes Owen	Kitchen B040	Sink pad to underside of sink.	<1m ²	
	Sample No (S,SP,P,As)	Product Type	Surface Treatment	Condition	Accessibility
	As NE002635 (SP)	N/A	N/A	N/A	N/A
	Material Risk Score				
Recommended action		No further action required			
Surveyor comments		N/A

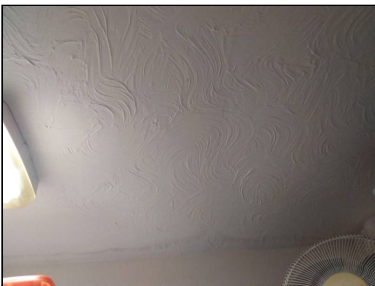
Inspection No. 89

Survey Date:	Lead Surveyor	Survey Type	Floor	Analysis
	08 Mar 2022	James Doherty, Shaun Doherty	Management Survey	Ground Floor	No Asbestos Detected
	Building	Room	Item	Quantity	
	Ysgol Maes Owen	Store B038	Textured coating to ceiling.	3m ²	
	Sample No (S,SP,P,As)	Product Type	Surface Treatment	Condition	Accessibility
	As NE002637 (SP)	N/A	N/A	N/A	N/A
	Material Risk Score				
Recommended action		No further action required			
Surveyor comments		N/A

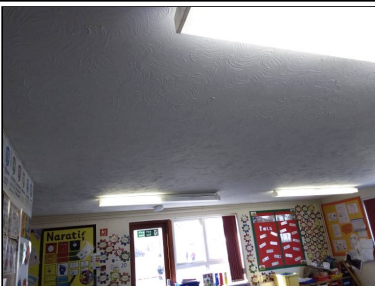
Inspection No. 90

Survey Date:	Lead Surveyor	Survey Type	Floor	Analysis
	08 Mar 2022	James Doherty, Shaun Doherty	Management Survey	Ground Floor	No Asbestos Detected
	Building	Room	Item	Quantity	
	Ysgol Maes Owen	Class B035	Textured coating to ceiling.	36m ²	
	Sample No (S,SP,P,As)	Product Type	Surface Treatment	Condition	Accessibility
	As NE002637 (SP)	N/A	N/A	N/A	N/A
	Material Risk Score				
Recommended action		No further action required			
Surveyor comments		N/A

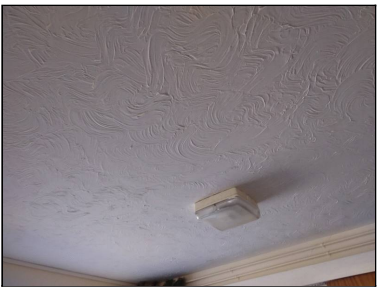
Inspection No. 91

Survey Date:	Lead Surveyor	Survey Type	Floor	Analysis
	08 Mar 2022	James Doherty, Shaun Doherty	Management Survey	Ground Floor	No Asbestos Detected
	Building	Room	Item	Quantity	
	Ysgol Maes Owen	Kitchen B039	Textured coating to ceiling.	6m ²	
	Sample No (S,SP,P,As)	Product Type	Surface Treatment	Condition	Accessibility
	As NE002637 (SP)	N/A	N/A	N/A	N/A
	Material Risk Score				
Recommended action		No further action required			
Surveyor comments		N/A

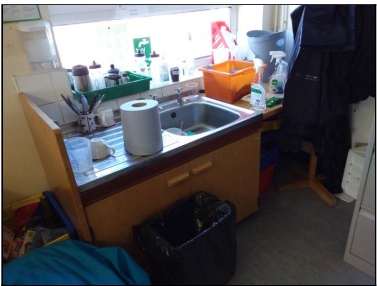
Inspection No. 92

Survey Date:	Lead Surveyor	Survey Type	Floor	Analysis
	08 Mar 2022	James Doherty, Shaun Doherty	Management Survey	Ground Floor	No Asbestos Detected
	Building	Room	Item	Quantity	
	Ysgol Maes Owen	Kitchen B039	Sink pad to underside of sink.	<1m ²	
	Sample No (S,SP,P,As)	Product Type	Surface Treatment	Condition	Accessibility
	As NE002635 (SP)	N/A	N/A	N/A	N/A
	Material Risk Score				
Recommended action		No further action required			
Surveyor comments		N/A

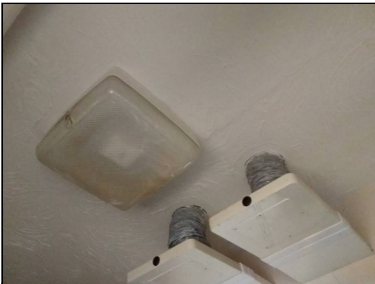
Inspection No. 93

Survey Date:	Lead Surveyor	Survey Type	Floor	Analysis
	08 Mar 2022	James Doherty, Shaun Doherty	Management Survey	Ground Floor	No Asbestos Detected
	Building	Room	Item	Quantity	
	Ysgol Maes Owen	Store B036	Textured coating to ceiling.	3m ²	
	Sample No (S,SP,P,As)	Product Type	Surface Treatment	Condition	Accessibility
	As NE002637 (SP)	N/A	N/A	N/A	N/A
	Material Risk Score				
Recommended action		No further action required			
Surveyor comments		N/A

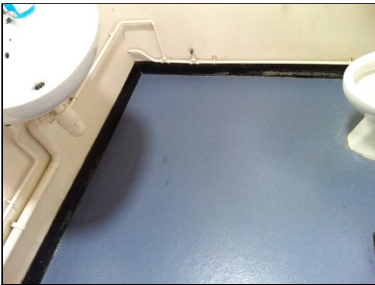
Inspection No. 94

Survey Date:	Lead Surveyor	Survey Type	Floor	Analysis
	08 Mar 2022	James Doherty, Shaun Doherty	Management Survey	Ground Floor	N/A
	Building	Room	Item	Quantity	
	Ysgol Maes Owen	Toilet B033	Fitted modern altro flooring not accessed below to prevent damage.	N/A	
	Sample No (S,SP,P,As)	Product Type	Surface Treatment	Condition	Accessibility
	Visual (P)	N/A	N/A	N/A	N/A
	Material Risk Score				
Recommended action		Inspection Required			
Surveyor comments		N/A

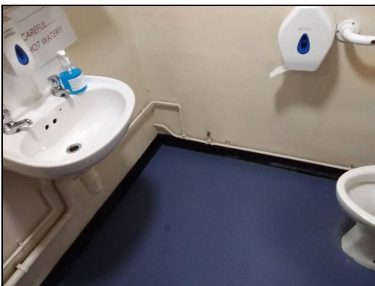
Inspection No. 95

Survey Date:	Lead Surveyor	Survey Type	Floor	Analysis
	08 Mar 2022	James Doherty, Shaun Doherty	Management Survey	Ground Floor	N/A
	Building	Room	Item	Quantity	
	Ysgol Maes Owen	Toilet B033	Accessed - no suspect materials found	N/A	Accessibility
	Sample No (S,SP,P,As)	Product Type	Surface Treatment	Condition	
	Visual (P)	N/A	N/A	N/A	
	Material Risk Score				
Recommended action		No further action required			
Surveyor comments		N/A

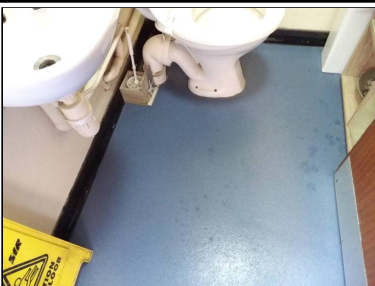
Inspection No. 96

Survey Date:	Lead Surveyor	Survey Type	Floor	Analysis
	08 Mar 2022	James Doherty, Shaun Doherty	Management Survey	Ground Floor	N/A
	Building	Room	Item	Quantity	
	Ysgol Maes Owen	Toilet B032	Fitted modern altro flooring not accessed below to prevent damage.	N/A	Accessibility
	Sample No (S,SP,P,As)	Product Type	Surface Treatment	Condition	
	Visual (P)	N/A	N/A	N/A	
	Material Risk Score				
Recommended action		Inspection Required			
Surveyor comments		N/A

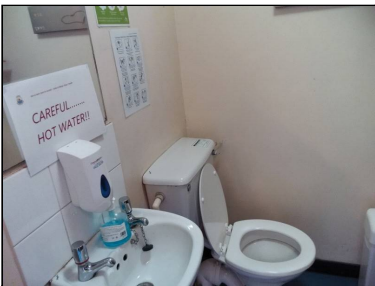
Inspection No. 97

Survey Date:	Lead Surveyor	Survey Type	Floor	Analysis
	08 Mar 2022	James Doherty, Shaun Doherty	Management Survey	Ground Floor	N/A
	Building	Room	Item	Quantity	
	Ysgol Maes Owen	Toilet B032	Accessed - no suspect materials found	N/A	
	Sample No (S,SP,P,As)	Product Type	Surface Treatment	Condition	Accessibility
	Visual (P)	N/A	N/A	N/A	N/A
	Material Risk Score				
Recommended action		No further action required			
Surveyor comments		N/A

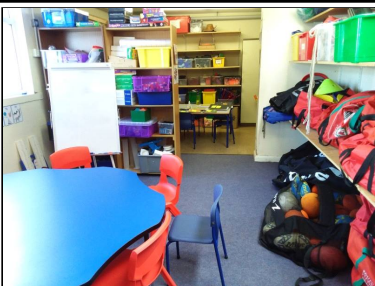
Inspection No. 98

Survey Date:	Lead Surveyor	Survey Type	Floor	Analysis
	08 Mar 2022	James Doherty, Shaun Doherty	Management Survey	Ground Floor	N/A
	Building	Room	Item	Quantity	
	Ysgol Maes Owen	Class B031	Accessed - no suspect materials found	N/A	
	Sample No (S,SP,P,As)	Product Type	Surface Treatment	Condition	Accessibility
	Visual (P)	N/A	N/A	N/A	N/A
	Material Risk Score				
Recommended action		No further action required			
Surveyor comments		N/A

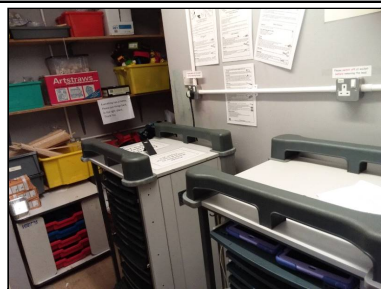
Inspection No. 99

Survey Date:	Lead Surveyor	Survey Type	Floor	Analysis
	08 Mar 2022	James Doherty, Shaun Doherty	Management Survey	Ground Floor	N/A
	Building	Room	Item	Quantity	
	Ysgol Maes Owen	Store B030	Accessed - no suspect materials found	N/A	
	Sample No (S,SP,P,As)	Product Type	Surface Treatment	Condition	Accessibility
	Visual (P)	N/A	N/A	N/A	N/A
	Material Risk Score				
Recommended action		No further action required			
Surveyor comments		N/A

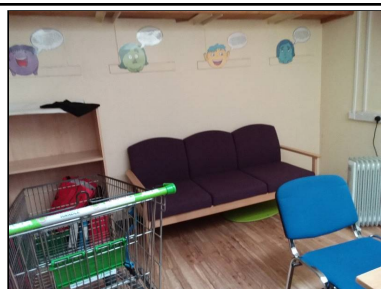
Inspection No. 100

Survey Date:	Lead Surveyor	Survey Type	Floor	Analysis
	08 Mar 2022	James Doherty, Shaun Doherty	Management Survey	Ground Floor	N/A
	Building	Room	Item	Quantity	
	Ysgol Maes Owen	Office B029	Accessed - no suspect materials found	N/A	
	Sample No (S,SP,P,As)	Product Type	Surface Treatment	Condition	Accessibility
	Visual (P)	N/A	N/A	N/A	N/A
	Material Risk Score				
Recommended action		No further action required			
Surveyor comments		N/A

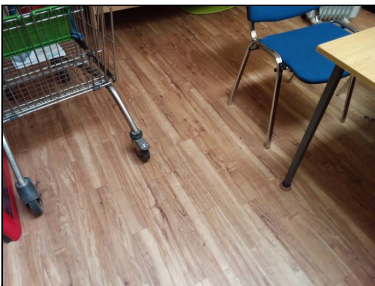
Inspection No. 101

Survey Date:	Lead Surveyor	Survey Type	Floor	Analysis
	08 Mar 2022	James Doherty, Shaun Doherty	Management Survey	Ground Floor	N/A
	Building	Room	Item	Quantity	
	Ysgol Maes Owen	Office B029	Fitted modern altro flooring not accessed below to prevent damage.	N/A	
	Sample No (S,SP,P,As)	Product Type	Surface Treatment	Condition	Accessibility
	Visual (P)	N/A	N/A	N/A	N/A
	Material Risk Score				
Recommended action		Inspection Required			
Surveyor comments		N/A

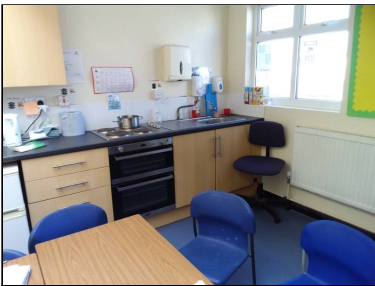
Inspection No. 102

Survey Date:	Lead Surveyor	Survey Type	Floor	Analysis
	08 Mar 2022	James Doherty, Shaun Doherty	Management Survey	Ground Floor	N/A
	Building	Room	Item	Quantity	
	Ysgol Maes Owen	Office B028	Accessed - no suspect materials found	N/A	
	Sample No (S,SP,P,As)	Product Type	Surface Treatment	Condition	Accessibility
	Visual (P)	N/A	N/A	N/A	N/A
	Material Risk Score				
Recommended action		No further action required			
Surveyor comments		N/A

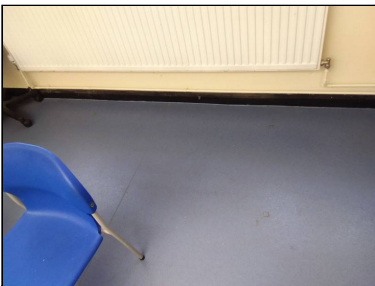
Inspection No. 103

Survey Date:	Lead Surveyor	Survey Type	Floor	Analysis
	08 Mar 2022	James Doherty, Shaun Doherty	Management Survey	Ground Floor	N/A
	Building	Room	Item	Quantity	
	Ysgol Maes Owen	Office B028	Fitted modern altro flooring not accessed below to prevent damage.	N/A	
	Sample No (S,SP,P,As)	Product Type	Surface Treatment	Condition	Accessibility
	Visual (P)	N/A	N/A	N/A	N/A
	Material Risk Score				
Recommended action		Inspection Required			
Surveyor comments		N/A

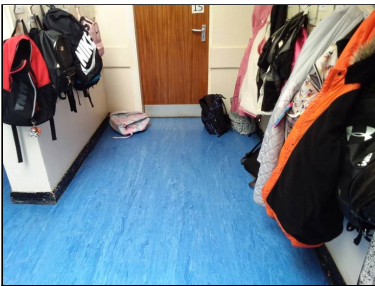
Inspection No. 104

Survey Date:	Lead Surveyor	Survey Type	Floor	Analysis
	08 Mar 2022	James Doherty, Shaun Doherty	Management Survey	Ground Floor	N/A
	Building	Room	Item	Quantity	
	Ysgol Maes Owen	Cloak Room B026	Fitted modern altro flooring not accessed below to prevent damage.	N/A	
	Sample No (S,SP,P,As)	Product Type	Surface Treatment	Condition	Accessibility
	Visual (P)	N/A	N/A	N/A	N/A
	Material Risk Score				
Recommended action		Inspection Required			
Surveyor comments		N/A

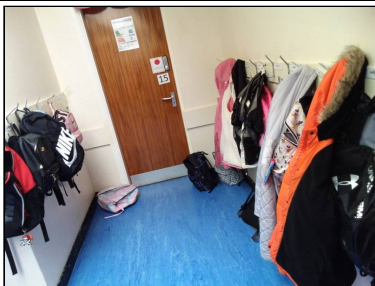
Inspection No. 105

Survey Date:	Lead Surveyor	Survey Type	Floor	Analysis
	08 Mar 2022	James Doherty, Shaun Doherty	Management Survey	Ground Floor	N/A
	Building	Room	Item	Quantity	
	Ysgol Maes Owen	Cloak Room B026	Accessed - no suspect materials found	N/A	
	Sample No (S,SP,P,As)	Product Type	Surface Treatment	Condition	Accessibility
	Visual (P)	N/A	N/A	N/A	N/A
	Material Risk Score				
N/A					
Recommended action	No further action required				
Surveyor comments	N/A

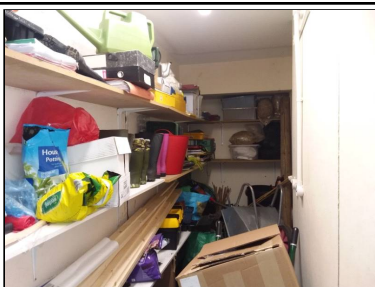
Inspection No. 106

Survey Date:	Lead Surveyor	Survey Type	Floor	Analysis
	08 Mar 2022	James Doherty, Shaun Doherty	Management Survey	Ground Floor	N/A
	Building	Room	Item	Quantity	
	Ysgol Maes Owen	Store B027	No suspect materials found.	N/A	
	Sample No (S,SP,P,As)	Product Type	Surface Treatment	Condition	Accessibility
	Visual (P)	N/A	N/A	N/A	N/A
	Material Risk Score				
N/A					
Recommended action	Inspection Required				
Surveyor comments	N/A

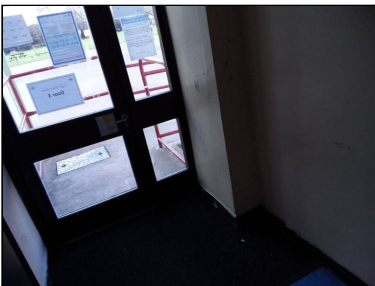
Inspection No. 107

Survey Date:	Lead Surveyor	Survey Type	Floor	Analysis
	08 Mar 2022	James Doherty, Shaun Doherty	Management Survey	Ground Floor	N/A
	Building	Room	Item	Quantity	
	Ysgol Maes Owen	Lobby B016	Accessed - no suspect materials found	N/A	Accessibility
	Sample No (S,SP,P,As)	Product Type	Surface Treatment	Condition	
	Visual (P)	N/A	N/A	N/A	N/A
	Material Risk Score				
Recommended action		No further action required			
Surveyor comments		N/A

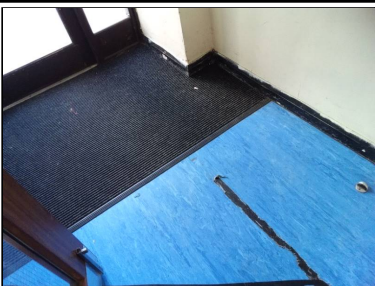
Inspection No. 108

Survey Date:	Lead Surveyor	Survey Type	Floor	Analysis
	08 Mar 2022	James Doherty, Shaun Doherty	Management Survey	Ground Floor	N/A
	Building	Room	Item	Quantity	
	Ysgol Maes Owen	Lobby B016	Fitted flooring not accessed below to prevent damage.	N/A	Accessibility
	Sample No (S,SP,P,As)	Product Type	Surface Treatment	Condition	
	Visual (P)	N/A	N/A	N/A	N/A
	Material Risk Score				
Recommended action		Inspection Required			
Surveyor comments		N/A

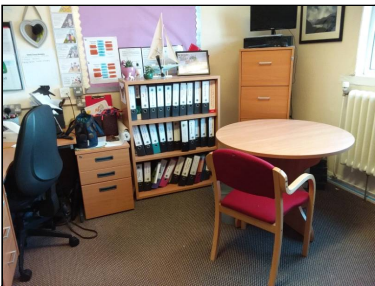
Inspection No. 109

Survey Date:	Lead Surveyor	Survey Type	Floor	Analysis
	08 Mar 2022	James Doherty, Shaun Doherty	Management Survey	Ground Floor	N/A
	Building	Room	Item	Quantity	
	Ysgol Maes Owen	Office B058	Accessed - no suspect materials found	N/A	Accessibility
	Sample No (S,SP,P,As)	Product Type	Surface Treatment	Condition	
	Visual (P)	N/A	N/A	N/A	
	Material Risk Score				
Recommended action		No further action required			
Surveyor comments		N/A

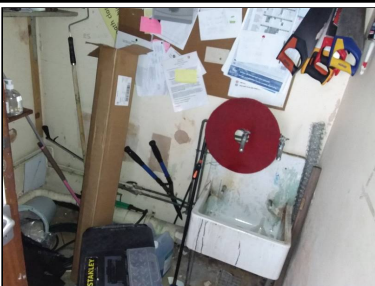
Inspection No. 110

Survey Date:	Lead Surveyor	Survey Type	Floor	Analysis
	08 Mar 2022	James Doherty, Shaun Doherty	Management Survey	Ground Floor	N/A
	Building	Room	Item	Quantity	
	Ysgol Maes Owen	Caretakers Room B056	No suspect materials found.	N/A	Accessibility
	Sample No (S,SP,P,As)	Product Type	Surface Treatment	Condition	
	Visual (P)	N/A	N/A	N/A	
	Material Risk Score				
Recommended action		Inspection Required			
Surveyor comments		N/A

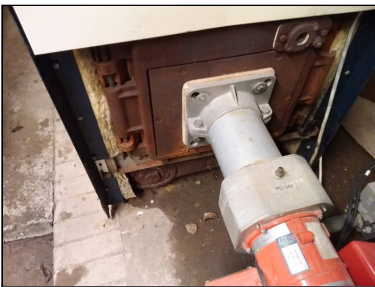
Inspection No. 111

Survey Date:	Lead Surveyor	Survey Type	Floor	Analysis
	08 Mar 2022	James Doherty, Shaun Doherty	Management Survey	Ground Floor	No Asbestos Detected
	Building	Room	Item	Quantity	
	Ysgol Maes Owen	Boiler House A001	Gaskets to boilers.	<1m ²	
	Sample No (S,SP,P,As)	Product Type	Surface Treatment	Condition	Accessibility
	NE002638 (S)	N/A	N/A	N/A	N/A
	Material Risk Score				
Recommended action		No further action required			
Surveyor comments		N/A

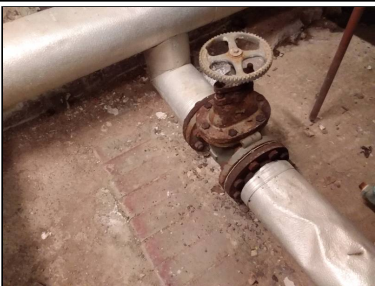
Inspection No. 112

Survey Date:	Lead Surveyor	Survey Type	Floor	Analysis
	08 Mar 2022	James Doherty, Shaun Doherty	Management Survey	Ground Floor	Chrysotile (1)
	Building	Room	Item	Quantity	
	Ysgol Maes Owen	Boiler House A001	Gaskets to pipework.	<1m ²	
	Sample No (S,SP,P,As)	Product Type	Surface Treatment	Condition	Accessibility
	NE002639 (S)	Gasket (2)	Surface Sealed (1)	Low Damage (1)	Usually inaccessible or unlikely to be disturbed
	Material Risk Score				
Recommended action		Manage			
Surveyor comments		N/A

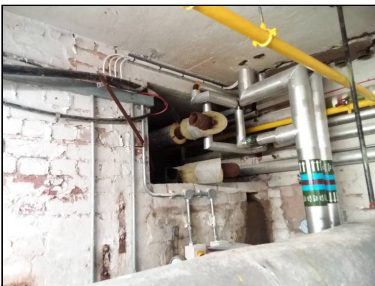
Inspection No. 113

Survey Date:	Lead Surveyor	Survey Type	Floor	Analysis
	08 Mar 2022	James Doherty, Shaun Doherty	Management Survey	Ground Floor	N/A
	Building	Room	Item	Quantity	
	Ysgol Maes Owen	Boiler House A001	Ducts not accessed within due to live services.	N/A	
	Sample No (S,SP,P,As)	Product Type	Surface Treatment	Condition	Accessibility
	Visual (P)	N/A	N/A	N/A	N/A
	Material Risk Score				
Recommended action		Inspection Required			
Surveyor comments		N/A

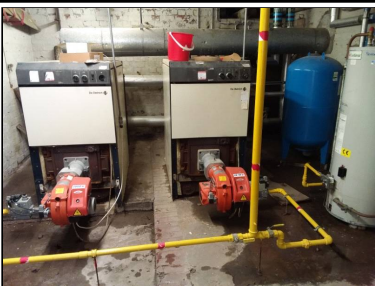
Inspection No. 114

Survey Date:	Lead Surveyor	Survey Type	Floor	Analysis
	08 Mar 2022	James Doherty, Shaun Doherty	Management Survey	Ground Floor	N/A
	Building	Room	Item	Quantity	
	Ysgol Maes Owen	Boiler House A001	Plant not accessed within as services remain live.	N/A	
	Sample No (S,SP,P,As)	Product Type	Surface Treatment	Condition	Accessibility
	Visual (P)	N/A	N/A	N/A	N/A
	Material Risk Score				
Recommended action		Inspection Required			
Surveyor comments		N/A

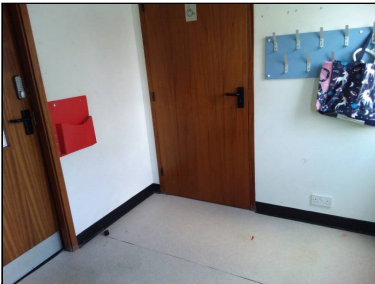
Inspection No. 115

Survey Date:	Lead Surveyor	Survey Type	Floor	Analysis
	08 Mar 2022	James Doherty, Shaun Doherty	Management Survey	Ground Floor	N/A
	Building	Room	Item	Quantity	
	Ysgol Maes Owen	Lobby C004	Accessed - no suspect materials found	N/A	Accessibility
	Sample No (S,SP,P,As)	Product Type	Surface Treatment	Condition	
	Visual (P)	N/A	N/A	N/A	
	Material Risk Score				
Recommended action		No further action required			
Surveyor comments		N/A

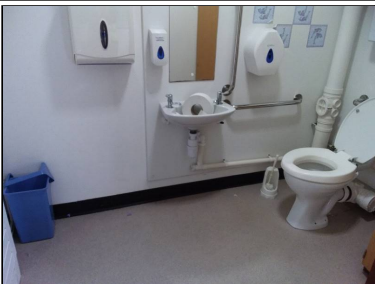
Inspection No. 116

Survey Date:	Lead Surveyor	Survey Type	Floor	Analysis
	08 Mar 2022	James Doherty, Shaun Doherty	Management Survey	Ground Floor	N/A
	Building	Room	Item	Quantity	
	Ysgol Maes Owen	Toilet C003	Accessed - no suspect materials found	N/A	Accessibility
	Sample No (S,SP,P,As)	Product Type	Surface Treatment	Condition	
	Visual (P)	N/A	N/A	N/A	
	Material Risk Score				
Recommended action		No further action required			
Surveyor comments		N/A

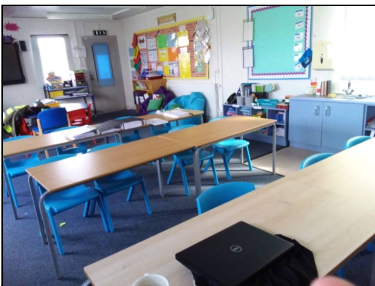
Inspection No. 117

Survey Date:	Lead Surveyor	Survey Type	Floor	Analysis
	08 Mar 2022	James Doherty, Shaun Doherty	Management Survey	Ground Floor	N/A
	Building	Room	Item	Quantity	
	Ysgol Maes Owen	Class C001	Accessed - no suspect materials found	N/A	Accessibility
	Sample No (S,SP,P,As)	Product Type	Surface Treatment	Condition	
	Visual (P)	N/A	N/A	N/A	
	Material Risk Score				
Recommended action		No further action required			
Surveyor comments		N/A

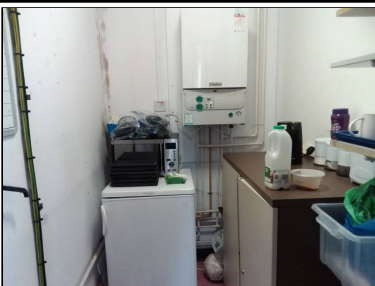
Inspection No. 118

Survey Date:	Lead Surveyor	Survey Type	Floor	Analysis
	08 Mar 2022	James Doherty, Shaun Doherty	Management Survey	Ground Floor	N/A
	Building	Room	Item	Quantity	
	Ysgol Maes Owen	Store C002	Accessed - no suspect materials found	N/A	Accessibility
	Sample No (S,SP,P,As)	Product Type	Surface Treatment	Condition	
	Visual (P)	N/A	N/A	N/A	
	Material Risk Score				
Recommended action		No further action required			
Surveyor comments		N/A

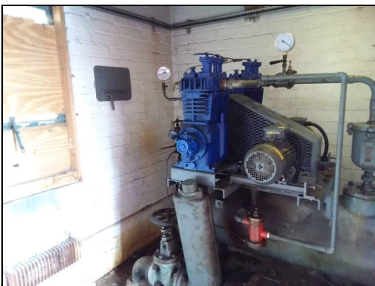
Inspection No. 119

Survey Date:	Lead Surveyor	Survey Type	Floor	Analysis
	08 Mar 2022	James Doherty, Shaun Doherty	Management Survey	Ground Floor	N/A
	Building	Room	Item	Quantity	
	Ysgol Maes Owen	Pump House D001	Accessed - no suspect materials found	N/A	
	Sample No (S,SP,P,As)	Product Type	Surface Treatment	Condition	Accessibility
	Visual (P)	N/A	N/A	N/A	N/A
	Material Risk Score				
Recommended action		No further action required			
Surveyor comments		N/A

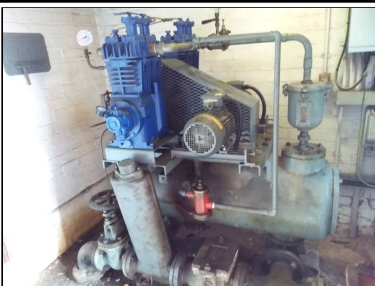
Inspection No. 120

Survey Date:	Lead Surveyor	Survey Type	Floor	Analysis
	08 Mar 2022	James Doherty, Shaun Doherty	Management Survey	Ground Floor	N/A
	Building	Room	Item	Quantity	
	Ysgol Maes Owen	Pump House D001	Plant not accessed within as services remain live.	N/A	
	Sample No (S,SP,P,As)	Product Type	Surface Treatment	Condition	Accessibility
	Visual (P)	N/A	N/A	N/A	N/A
	Material Risk Score				
Recommended action		Inspection Required			
Surveyor comments		N/A

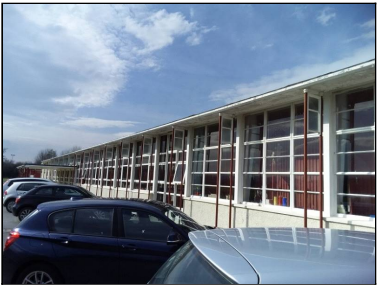
Inspection No. 121

Survey Date:	Lead Surveyor	Survey Type	Floor	Analysis
	08 Mar 2022	James Doherty, Shaun Doherty	Management Survey	External	No Asbestos Detected
	Building	Room	Item	Quantity	
	Ysgol Maes Owen	Externals E001	Putty to windows.	300lm	
	Sample No (S,SP,P,As)	Product Type	Surface Treatment	Condition	Accessibility
	NE002640 (S)	N/A	N/A	N/A	N/A
	Material Risk Score				
Recommended action		No further action required			
Surveyor comments		N/A

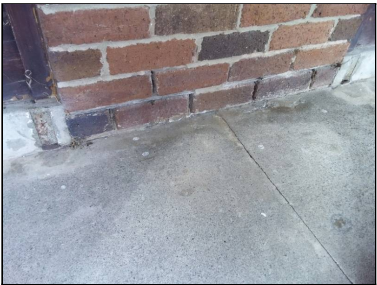
Inspection No. 122

Survey Date:	Lead Surveyor	Survey Type	Floor	Analysis
	08 Mar 2022	James Doherty, Shaun Doherty	Management Survey	External	No Asbestos Detected
	Building	Room	Item	Quantity	
	Ysgol Maes Owen	Externals E001	Damp proof course to brickwork.	360lm	
	Sample No (S,SP,P,As)	Product Type	Surface Treatment	Condition	Accessibility
	NE002641 (S)	N/A	N/A	N/A	N/A
	Material Risk Score				
Recommended action		No further action required			
Surveyor comments		N/A
