# Asbestos Re-inspection Report (with Priority Assessments)

**Block 1-20 (A-D) The Tower**  
**Southville, Cwmbran Torfaen, NP44 3QY**  
**648838**  
**Lois Hobbs**

Job Number: W96459/1  
Issue Date: 04/05/2023  
Issue No: 1

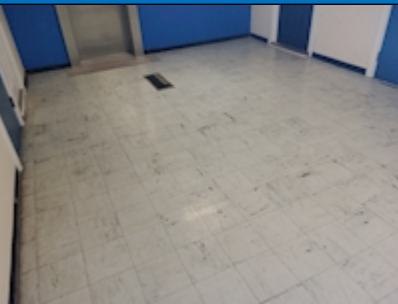
| <b>Item</b> | Floor | | | | | | |
| <b>Material</b> | Floor Tiles (Thermoplastic) | <b>Extent</b> | 24 m <sup>2</sup> | | | | |

| <b>Recommended Action</b> | <b>Manage and Re-inspect</b> | | | | | | |

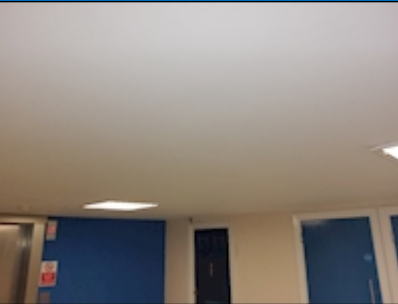
| <b>Item</b> | Ceiling | | | | | | |
| <b>Material</b> | Textured Coating | <b>Extent</b> | 24 m <sup>2</sup> | | | | |

| <b>Recommended Action</b> | <b>Manage and Re-inspect</b> | | | | | | |

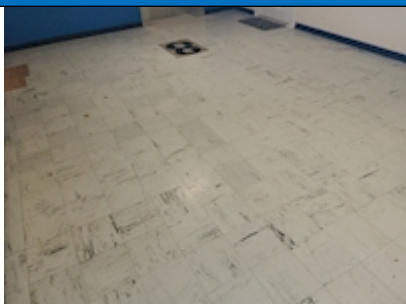
| <b>Item</b> | Floor | | | | | | |
| <b>Material</b> | Floor Tiles (Thermoplastic) | <b>Extent</b> | 24 m <sup>2</sup> | | | | |

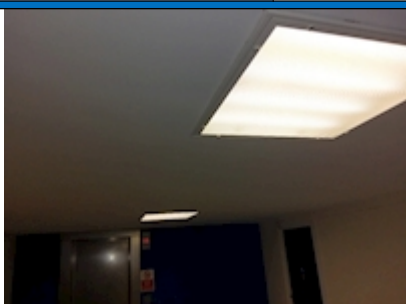
| <b>Item</b> | Ceiling | | | | | | |
| <b>Material</b> | Textured Coating | <b>Extent</b> | 24 m <sup>2</sup> | | | | |

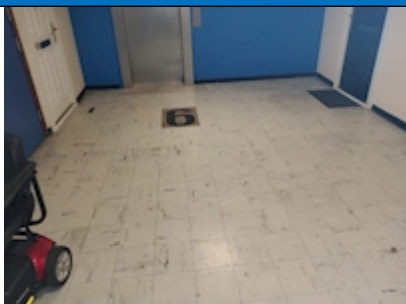
| <b>Item</b> | Floor | | | | | | |
| <b>Material</b> | Floor Tiles (Thermoplastic) | <b>Extent</b> | 24 m <sup>2</sup> | | | | |

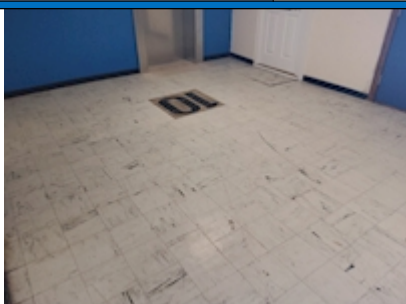
| <b>Item</b> | Floor | | | | | | |
| <b>Material</b> | Floor Tiles (Thermoplastic) | <b>Extent</b> | 24 m <sup>2</sup> | | | | |

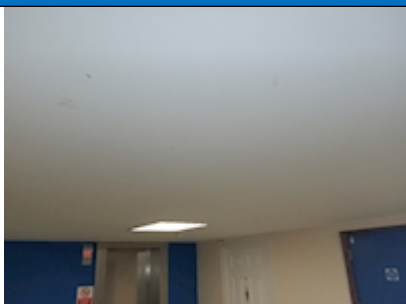
| <b>Item</b> | Ceiling | | | | | | |
| <b>Material</b> | Textured Coating | <b>Extent</b> | 24 m <sup>2</sup> | | | | |

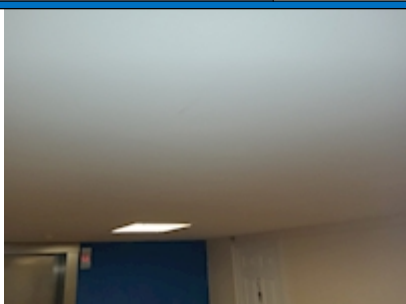
| <b>Item</b> | Ceiling | | | | | | |
| <b>Material</b> | Textured Coating | <b>Extent</b> | 24 m <sup>2</sup> | | | | |

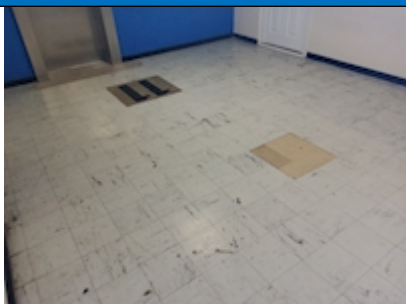
| <b>Item</b> | Floor | | | | | | |
| <b>Material</b> | Floor Tiles (Thermoplastic) | <b>Extent</b> | 24 m <sup>2</sup> | | | | |

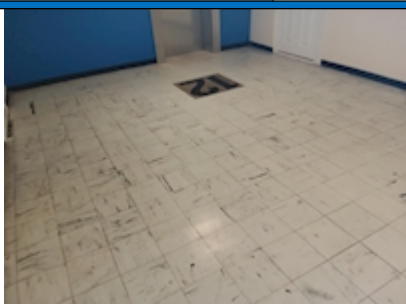
| <b>Item</b> | Floor | | | | | | |
| <b>Material</b> | Floor Tiles (Thermoplastic) | <b>Extent</b> | 24 m <sup>2</sup> | | | | |

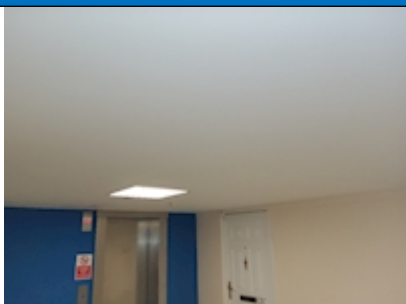
| <b>Item</b> | Ceiling | | | | | | |
| <b>Material</b> | Textured Coating | <b>Extent</b> | 24 m <sup>2</sup> | | | | |

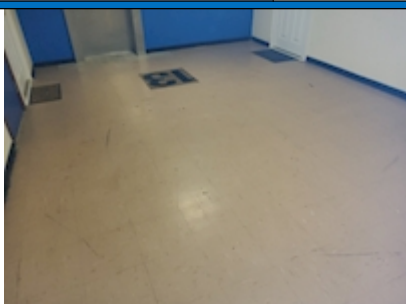
| <b>Item</b> | Floor | | | | | | |
| <b>Material</b> | Floor Tiles (Thermoplastic) | <b>Extent</b> | 24 m <sup>2</sup> | | | | |

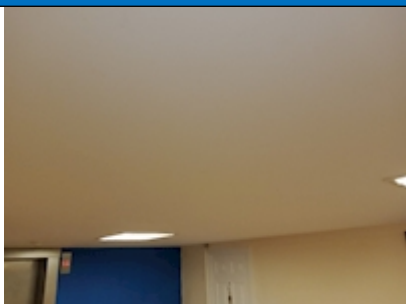
| <b>Item</b> | Ceiling | | | | | | |
| <b>Material</b> | Textured Coating | <b>Extent</b> | 24 m <sup>2</sup> | | | | |

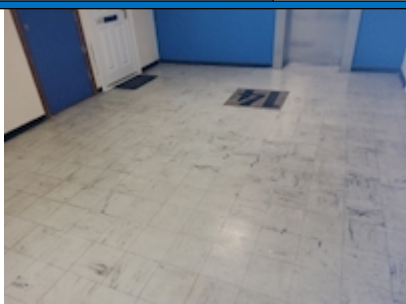
| <b>Item</b> | Floor | | | | | | |
| <b>Material</b> | Floor Tiles (Thermoplastic) | <b>Extent</b> | 24 m <sup>2</sup> | | | | |

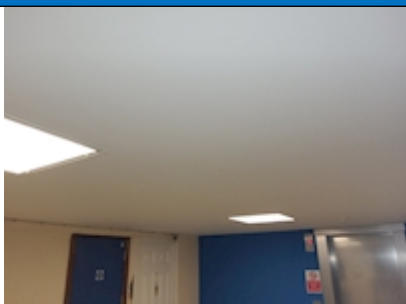
| <b>Item</b> | Ceiling | | | | | | |
| <b>Material</b> | Textured Coating | <b>Extent</b> | 24 m <sup>2</sup> | | | | |

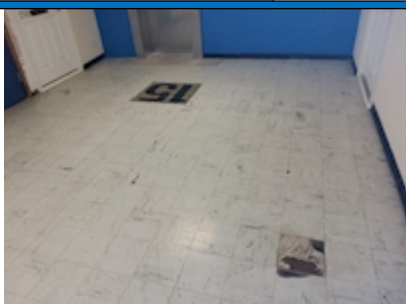
| <b>Item</b> | Floor | | | | | | |
| <b>Material</b> | Floor Tiles (Thermoplastic) | <b>Extent</b> | 24 m <sup>2</sup> | | | | |

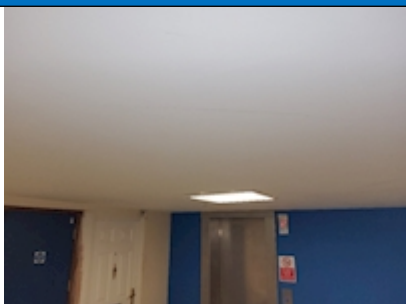
| <b>Item</b> | Ceiling | | | | | | |
| <b>Material</b> | Textured Coating | <b>Extent</b> | 24 m <sup>2</sup> | | | | |

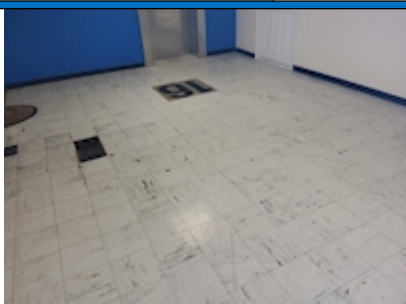
| <b>Item</b> | Floor | | | | | | |
| <b>Material</b> | Floor Tiles (Thermoplastic) | <b>Extent</b> | 24 m <sup>2</sup> | | | | |

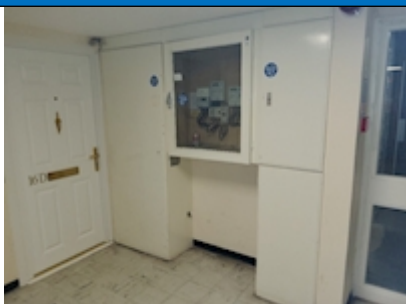
| <b>Item</b> | Panel | | | | | | |
| <b>Material</b> | Insulating Board | <b>Extent</b> | 1 m <sup>2</sup> | | | | |

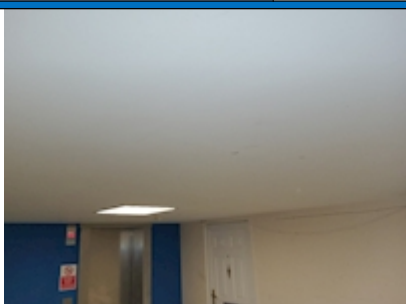
| <b>Item</b> | Ceiling | | | | | | |
| <b>Material</b> | Textured Coating | <b>Extent</b> | 24 m <sup>2</sup> | | | | |

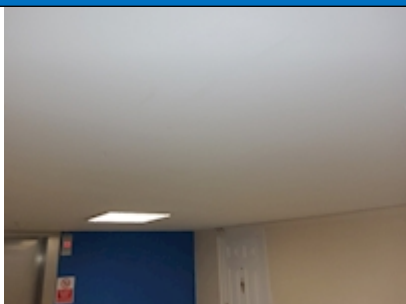
| <b>Item</b> | Ceiling | | | | | | |
| <b>Material</b> | Textured Coating | <b>Extent</b> | 24 m <sup>2</sup> | | | | |

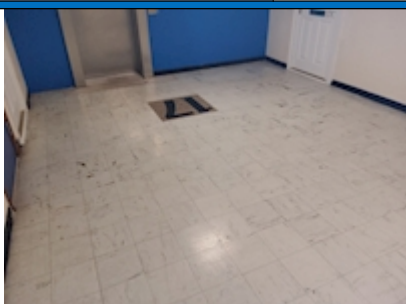
| <b>Item</b> | Floor | | | | | | |
| <b>Material</b> | Floor Tiles (Thermoplastic) | <b>Extent</b> | 24 m <sup>2</sup> | | | | |

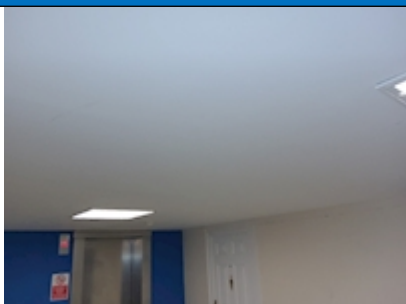
| <b>Item</b> | Ceiling | | | | | | |
| <b>Material</b> | Textured Coating | <b>Extent</b> | 24 m <sup>2</sup> | | | | |

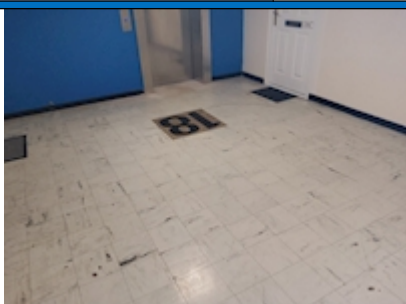
| <b>Item</b> | Floor | | | | | | |
| <b>Material</b> | Floor Tiles (Thermoplastic) | <b>Extent</b> | 24 m <sup>2</sup> | | | | |

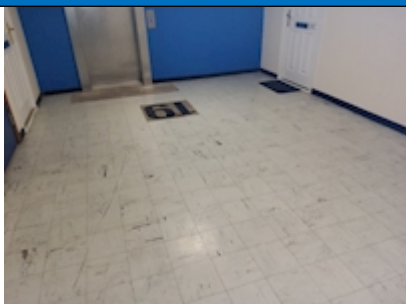
| <b>Item</b> | Floor | | | | | | |
| <b>Material</b> | Floor Tiles (Thermoplastic) | <b>Extent</b> | 24 m <sup>2</sup> | | | | |

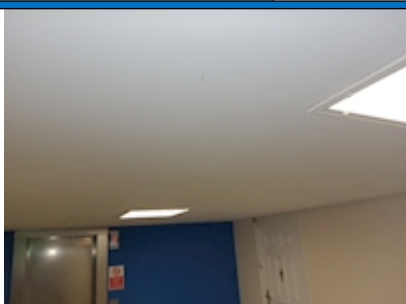
| <b>Item</b> | Ceiling | | | | | | |
| <b>Material</b> | Textured Coating | <b>Extent</b> | 24 m <sup>2</sup> | | | | |

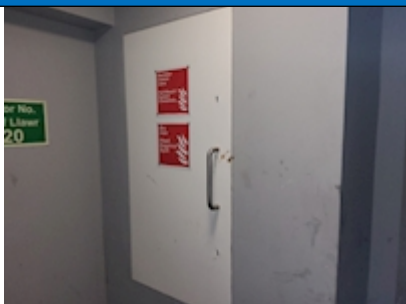
| <b>Item</b> | Pipe | | | | | | |
| <b>Material</b> | Cement Product | <b>Extent</b> | 1 lm | | | | |

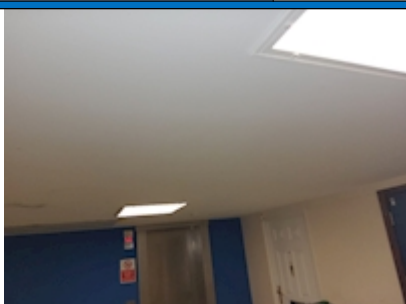
| <b>Item</b> | Ceiling | | | | | | |
| <b>Material</b> | Textured Coating | <b>Extent</b> | 24 m <sup>2</sup> | | | | |

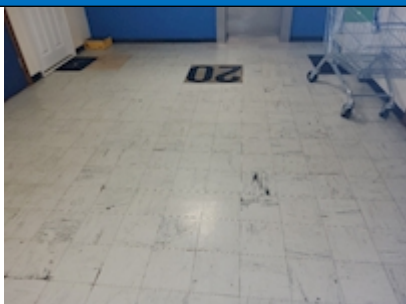
| <b>Item</b> | Floor | | | | | | |
| <b>Material</b> | Floor Tiles (Thermoplastic) | <b>Extent</b> | 24 m <sup>2</sup> | | | | |
