Project		Padarn Country Park   Llanberis Fire Queen Shed		<div>TRP</div> <div>Consulting Engineers Ltd</div> <div>Tel: 07713 342522 email: mail@trpce.com</div>			
Title		Fire Queen Steelwork Support Frame to Rails					
Cad Rev		Scale 1:25 @A3					
		<div><div>0mm10203040</div></div>					
Date	Drawn	Checked	Approved	Project Ref.	Drg. No.	Rev.	
Mar 2025	TP			23035	FQ - 01

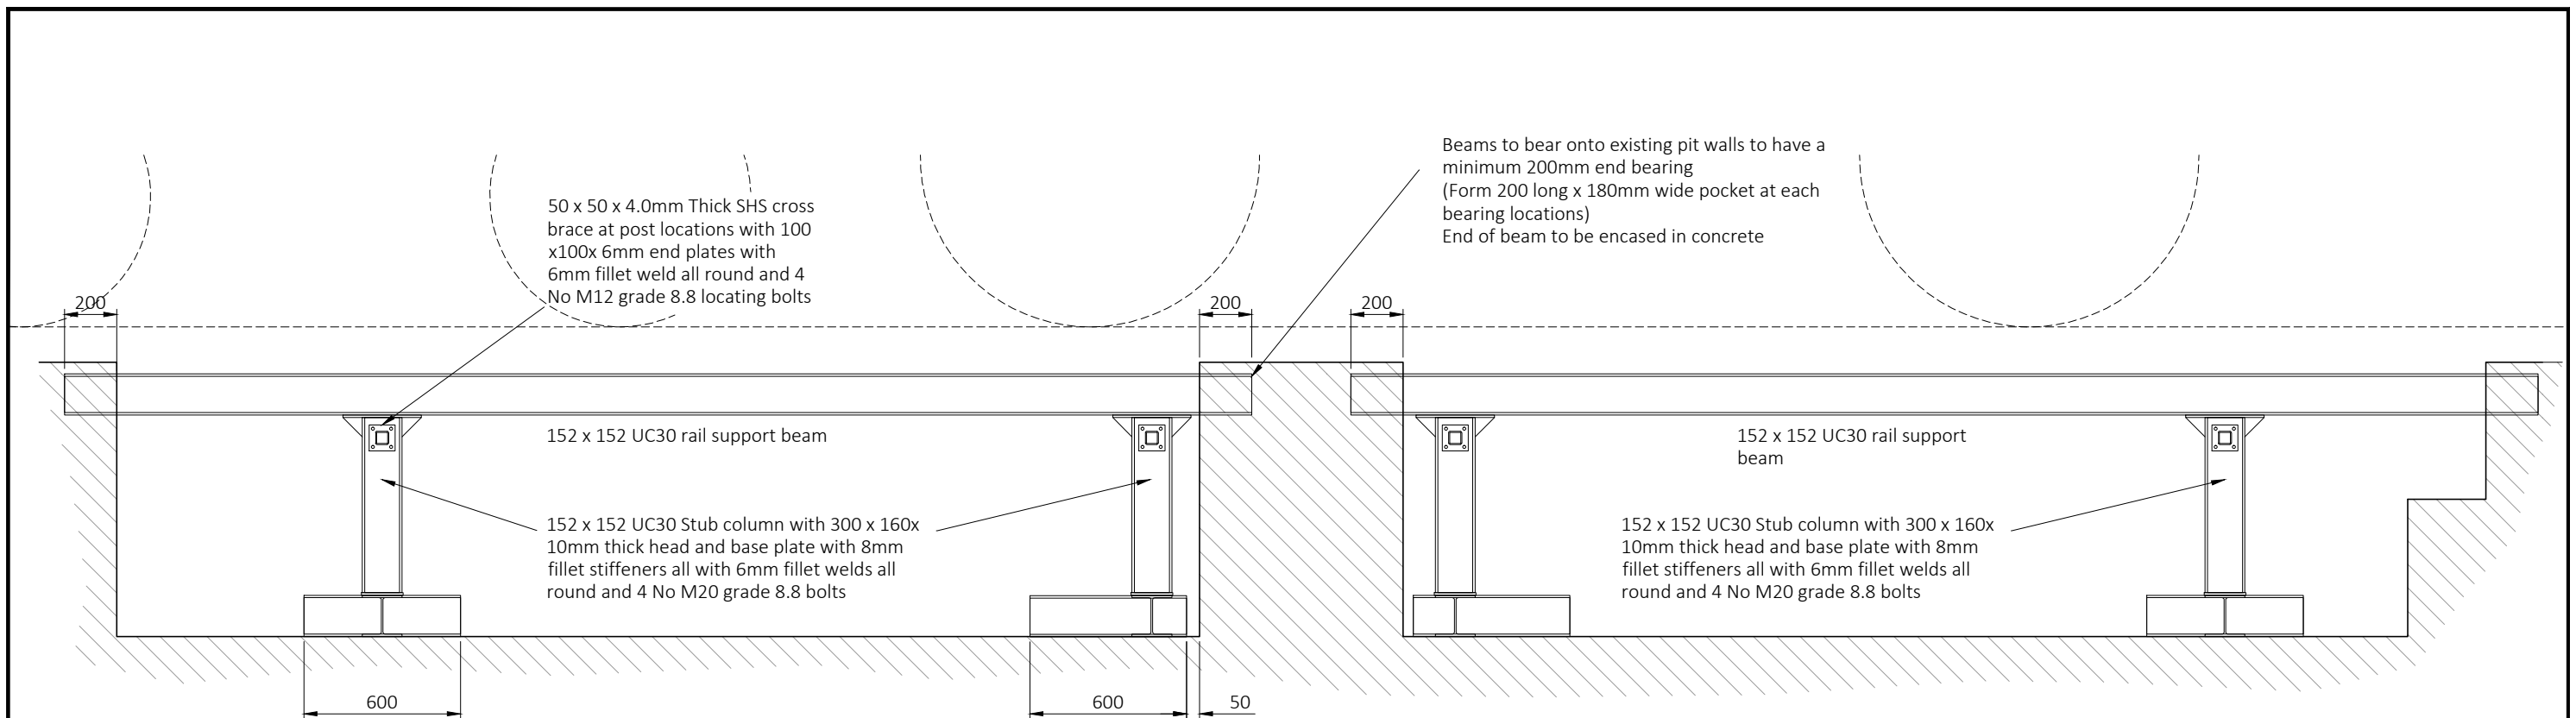
Longitudinal Section Existing Inspection Pit  
(Showing Fire Queen Support Steelwork)  
(1:25)

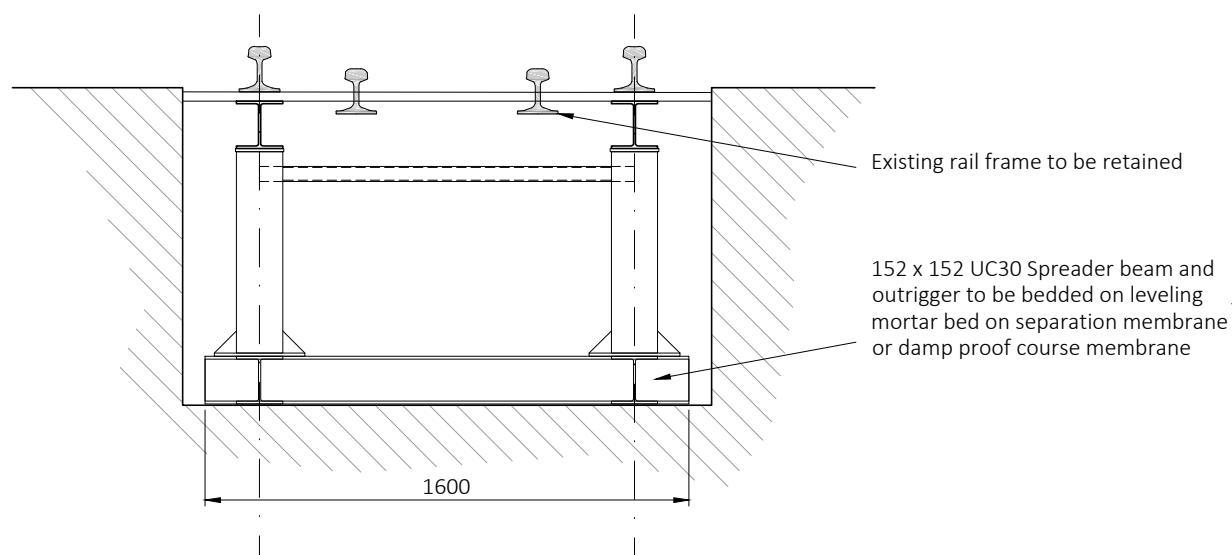
Typical Cross Section Existing Inspection Pit  
(Showing Fire Queen Support Steelwork)  
(1:25)

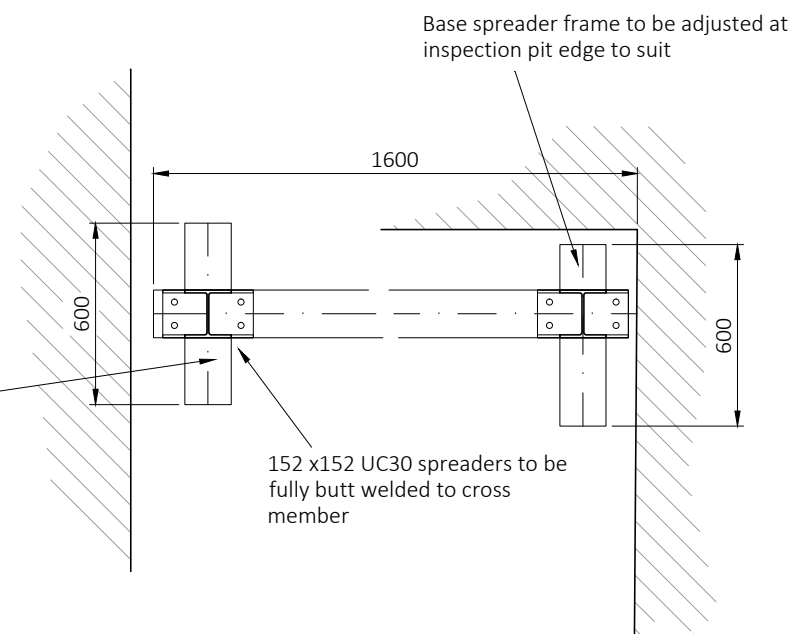
Plan on Spreader Frame to bottom of Inspection Pit  
(1:25)
