# REPORT

## VENUE CYMRU, LLANDUDNO UPGRADE AND IMPROVEMENT OPPORTUNITIES FEASIBILITY STUDY

Issued for Information

June 2022

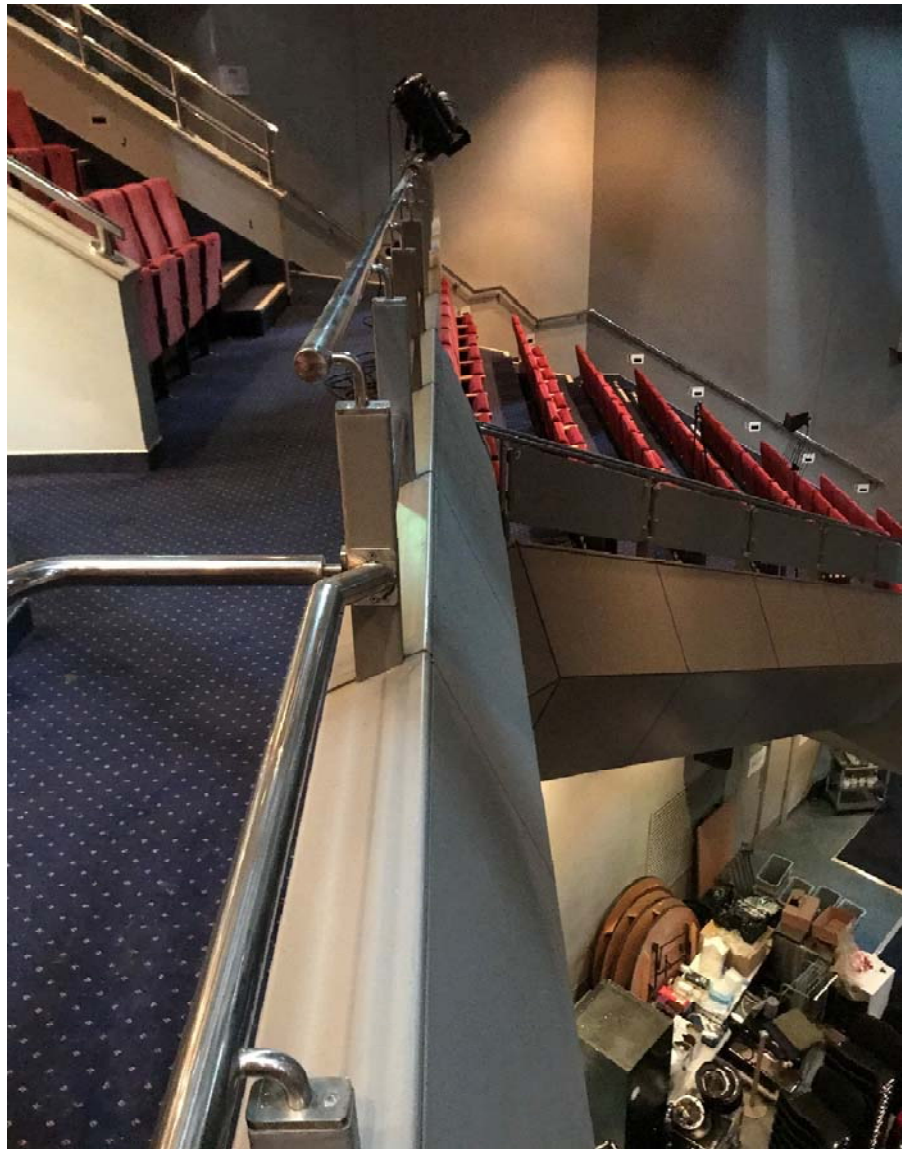
Circle side blocks, cross-aisle and raised rail

The aisle crosses in front of the wheelchair spaces and companion seats placing the seats in these areas of the auditorium too far away from the balcony front to have a good view of the stage. The view is obstructed by the solid balcony front and the upstanding rail at 1100mm which also protects passage along the aisle to the escape doors.

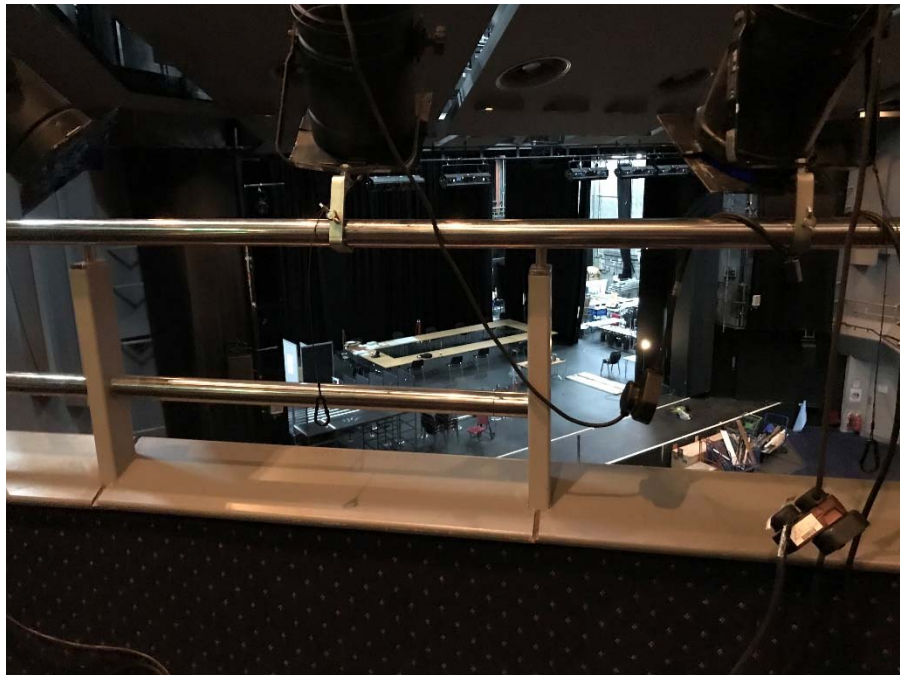
An immediate improvement could reduce the impact of the rail. Currently the shiny aluminium rails are 50mm diameter at a height of 1100mm. Reducing these to thinner sections at the same height would diminish their impact. 10mm plate would be compliant and less conspicuous.

Existing Condition: the view from Row I Seat 1

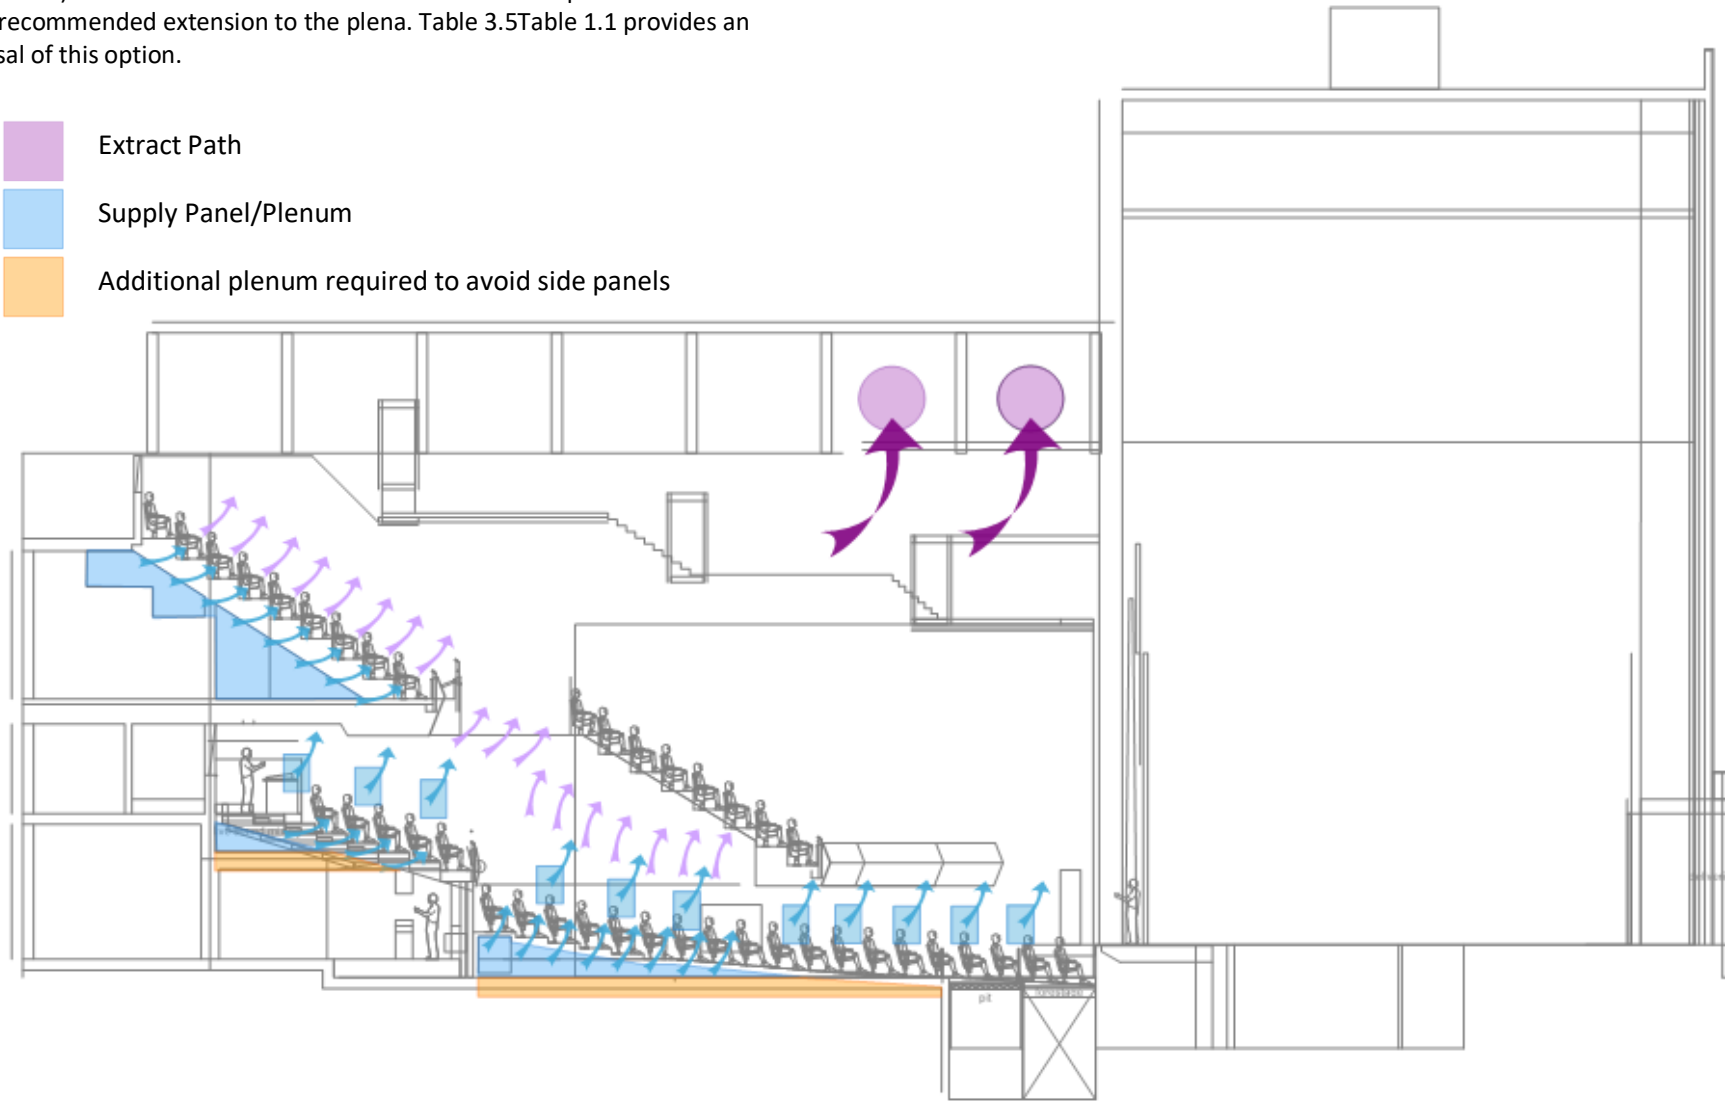
- Extract Path
- Supply Panel/Plenum
- Additional plenum required to avoid side panels

(A) Long Section

(B) Notional Layout

In this option we consider the feasibility of reversing the ventilation system within auditorium to make use of the under-seat plenum for supplying air directly to the audience. Air could then be extracted through high level grilles above suspended panelling. Replace central AHU plant including heat recovery, recirculation, efficient fans to both the East and West AHUs. Commission system.

Figure 3.3Figure 2.1 shows the potential reversal of the ventilation system overlaid with the proposed seating scheme and new AHUs in each plant room (not to scale). This includes notional additional side wall displacement vents or the recommended extension to the plenum. Table 3.5Table 1.1 provides an appraisal of this option.

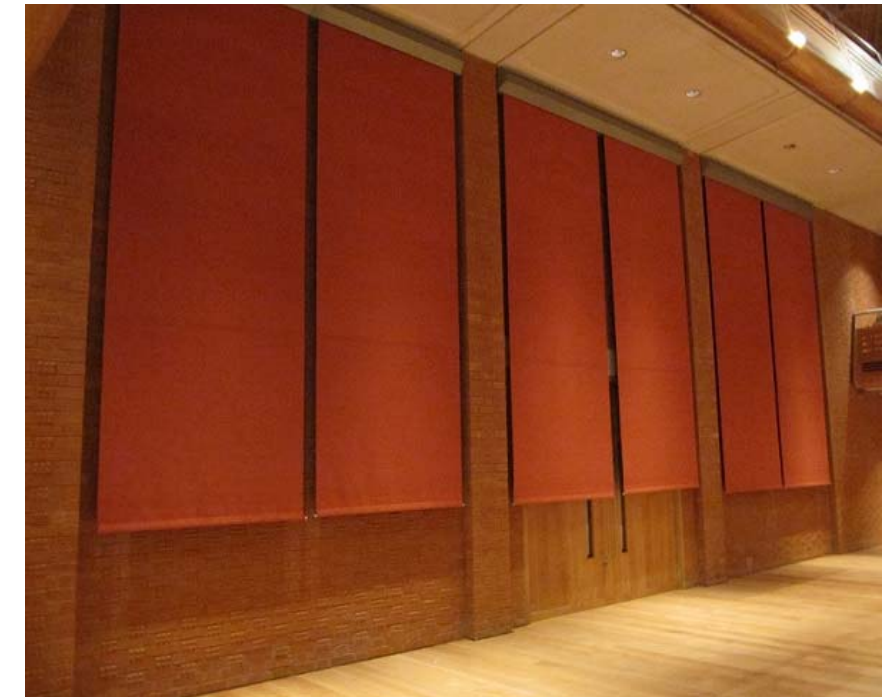
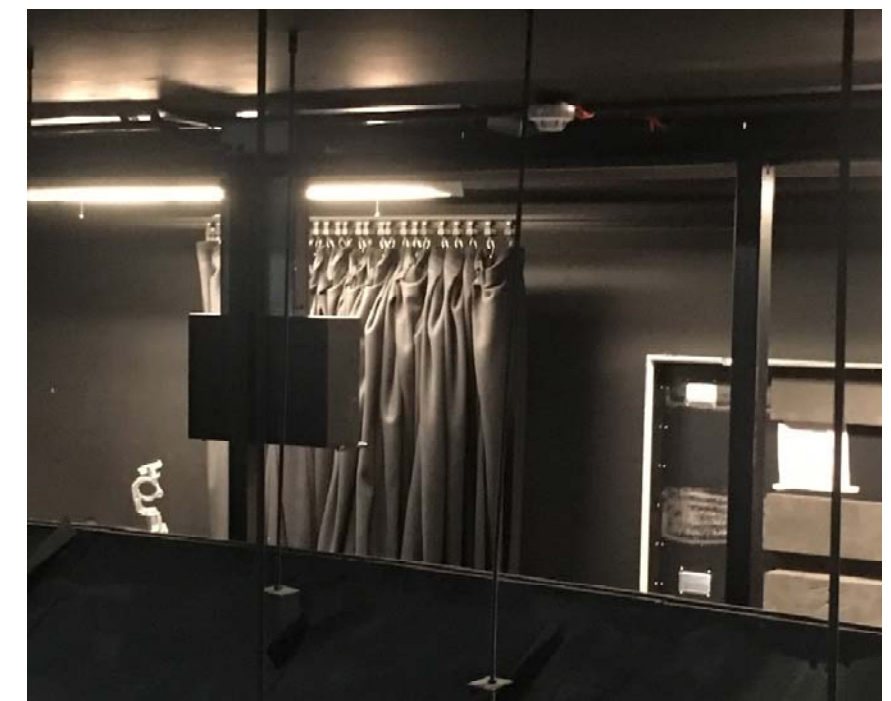
Figure 3: Variable acoustic solutions. Retractable banner (above) and curtains (below)
