ASBESTOS REFURBISHMENT SURVEY  
TO SPECIFIED AREAS OF  
10 THIRD AVENUE, PENPARCAU, ABERYSTWYTH, CEREDIGION, SY23 1RF

CLIENT: BARCUD  
TY CANOL HOUSE, FFORDD CROESAWDY, NEWTOWN,, SY16 1AL

UPRN NO: 101210  
PROJECT NO: J1105086  
DATE: June 2026

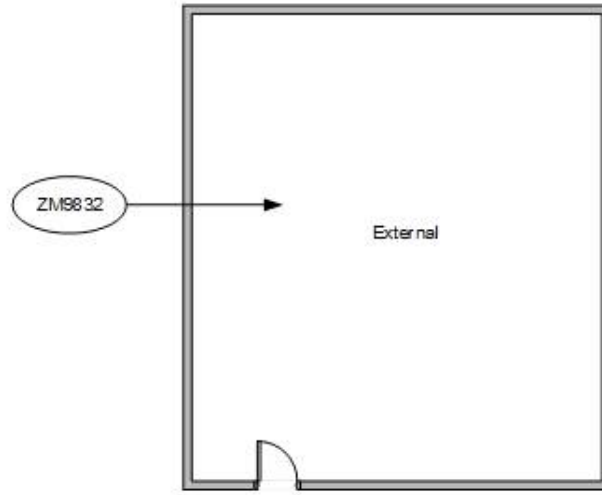
**S** = Sample Location

**Red** = Identified, strongly presumed and presumed asbestos

**The accuracy of the plans / sketches cannot be guaranteed.**
