# Life Safety Fire Risk Assessment - General Premises

| <b>Premises Name</b> | 1-20 (A-D) The Tower |
| <b>Premises Location</b> | 1-20 (A-D) The Tower<br>Southville<br>Cwmbran<br>NP44 3QY |
| <b>Date of Visit</b> | 14/04/2026 |

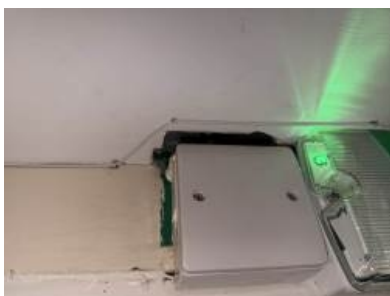
RM14878\_001

| UID & Image | Action Plan |
|---|---|
| <p>RM14878_001</p> | <p><b>Location:</b> 1-20 (A-D) The Tower &gt; Various locations<br/> <b>Category:</b> Construction<br/> <b>Issue:</b> Pipework and or other services penetrate the one hour fire-resisting wall(s).</p> <p><b>Sub-Category:</b> Compartment/Separating Walls<br/> <b>Remedial:</b> Provide appropriate fire stopping around services that penetrate the fire-resisting wall partition as listed below:</p> <ul style="list-style-type: none"> <li>- Fire stopping above flat 13a on level 13</li> <li>- Fire stopping above lobby door &amp; flat 12a on level 12</li> <li>- Fire stopping needed above flat 11b on level 11</li> <li>- Fire stopping needed above flat 8c on level 8</li> <li>- Fire stop above light to lobby on level 6</li> <li>- Fire stop above flat 4b on Level 4</li> <li>- Fire stop above flat 1c on Level 1</li> <li>- Fire stop in sprinkler room</li> </ul> <p>. Ref: A.01.12<br/> <b>Priority:</b> Medium<br/> <b>Due Date:</b> 22/07/2026<br/> <b>Completed Date:</b> DD/MM/YYYY</p> <p><b>Risk:</b> Moderate<br/> <b>Responsible:</b><br/> <b>Completed By:</b> Insert Name</p> |

| <b>Comment</b> | <p>It was noted that works were still ongoing to the electrical riser cupboards enclosing the electrical meters within the risers. It was noted during the assessment that the fire stopping of these risers where cables pass through the walls and ceiling back into lobby were not yet fire stopped but Bron Afon Fire Safety Manager confirmed this works will be part of the overall works and will be completed by FIRAS as a third party accredited contractor. A fire stopping report will also be provided to evidence this. It is recommended that a sample check should be carried out on completion.</p> |

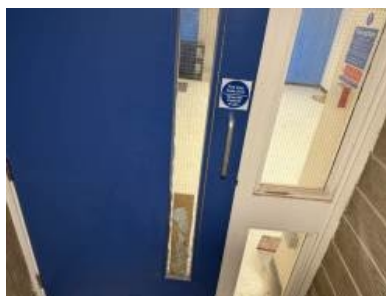
RM14878\_002

| UID & Image | Action Plan |
|---|---|
| <p>RM14878_002</p> | <p><b>Location:</b> 1-20 (A-D) The Tower &gt; Various locations<br/> <b>Category:</b> Means of Escape<br/> <b>Issue:</b> There are holes/splits/defects from forced openings to the door which compromise its fire resistant standard.</p> <p><b>Sub-Category:</b> Fire Doors Standards and Maintenance<br/> <b>Remedial:</b> Repair the fire doors listed below to the same fire resisting standard or if required to be replaced then upgrade to FD60s. These were:</p> <ul style="list-style-type: none"> <li>- Screw missing on riser door by flat 19d on level 19</li> <li>- Lobby door on level 16 beading loose</li> <li>- Lobby door on level 13 beading loose</li> <li>- Lobby door on level 11 not closing fully and beading loose/damaged</li> <li>- Lobby door on level 3 has smashed vision panel</li> <li>- Lobby door on level 1 has damaged to beading</li> </ul> <p>Ref: B.08.22<br/> <b>Priority:</b> Medium<br/> <b>Due Date:</b> 22/07/2026<br/> <b>Completed Date:</b> DD/MM/YYYY</p> <p><b>Risk:</b> Moderate<br/> <b>Responsible:</b><br/> <b>Completed By:</b> Insert Name</p> |

| <b>Issue</b> | There are holes/splits/defects from forced openings to the door which compromise its fire resistant standard. |

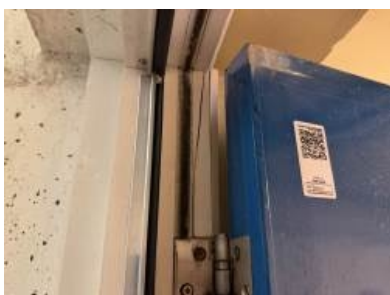
RM14878\_003

| UID & Image | Action Plan |
|---|---|
| RM14878_003<br> | <p><b>Location:</b> 1-20 (A-D) The Tower &gt; Car park fire door<br/> <b>Category:</b> Means of Escape<br/> <b>Issue:</b> Doors not deemed to be fire resisting to the appropriate standard.</p> <p><b>Risk:</b> Moderate<br/> <b>Responsible:</b><br/> <b>Completed By:</b> Insert Name</p> <p><b>Sub-Category:</b> Fire Doors Standards and Maintenance<br/> <b>Remedial:</b> The door had some damage and was timber with only being FD30s. Due to being a car park separating from escape route it is recommended to be replaced the door with one which provides the required FD60S standard of fire resistance which also to be metal to be more robust.. Ref: B.08.06<br/> <b>Priority:</b> Medium<br/> <b>Due Date:</b> 22/07/2026<br/> <b>Completed Date:</b> DD/MM/YYYY</p> |

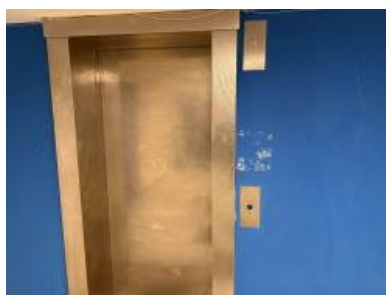
RM14878\_004

| UID & Image | Action Plan |
|---|---|
| RM14878_004<br> | <p><b>Location:</b> 1-20 (A-D) The Tower &gt; Various locations<br/> <b>Category:</b> Signs and Notices<br/> <b>Issue:</b> "Do not use lift in the event of fire" signs missing.</p> <p><b>Risk:</b> Moderate<br/> <b>Responsible:</b><br/> <b>Completed By:</b> Insert Name</p> <p><b>Sub-Category:</b> Life Signs<br/> <b>Remedial:</b> Provide a "Do Not Use Lift in Case of Fire" sign to the below floors:<br/> - Lower ground<br/> - Level 11.</p> <p>Ref: C.08.01<br/> <b>Priority:</b> Medium<br/> <b>Due Date:</b> 22/07/2026<br/> <b>Completed Date:</b> DD/MM/YYYY</p> |

| <b>Issue</b> | "Do not use lift in the event of fire" signs missing. |

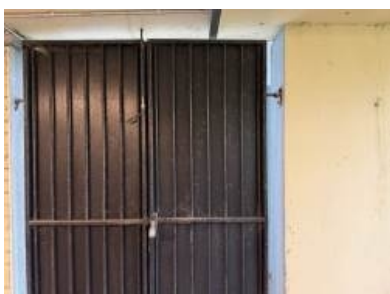
RM14878\_005

| UID & Image | Action Plan |
|---|---|
| RM14878_005<br> | <p><b>Location:</b> 1-20 (A-D) The Tower &gt; Car Park Exit<br/> <b>Category:</b> Signs and Notices<br/> <b>Issue:</b> Final fire exit doors are not provided with appropriate signage.<br/> <b>Risk:</b> Moderate<br/> <b>Responsible:</b><br/> <b>Completed By:</b> Insert Name</p> <p><b>Sub-Category:</b> Signs - Fire Exit<br/> <b>Remedial:</b> Provide a "Fire Exit" sign for each fire door indicated Ref: C.04.01<br/> <b>Priority:</b> Medium<br/> <b>Due Date:</b> 22/07/2026<br/> <b>Completed Date:</b> DD/MM/YYYY</p> |

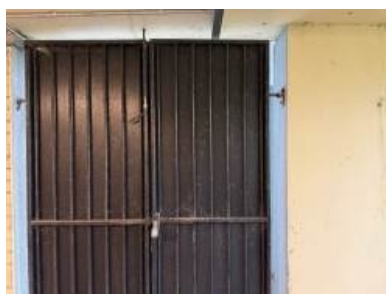
RM14878\_006

| UID & Image | Action Plan |
|---|---|
| RM14878_006<br> | <p><b>Location:</b> 1-20 (A-D) The Tower &gt; Car Park Exit<br/> <b>Category:</b> Signs and Notices<br/> <b>Issue:</b> No "Push Pad to Open" signs provided.</p> <p><b>Risk:</b> Moderate<br/> <b>Responsible:</b><br/> <b>Completed By:</b> Insert Name</p> <p><b>Sub-Category:</b> Fire Door - Exit fastenings signs<br/> <b>Remedial:</b> Provide a "Push Pad to Open" sign to Fire exit door(s) fitted with a push pad Ref: C.05.02<br/> <b>Priority:</b> Medium<br/> <b>Due Date:</b> 22/07/2026<br/> <b>Completed Date:</b> DD/MM/YYYY</p> |

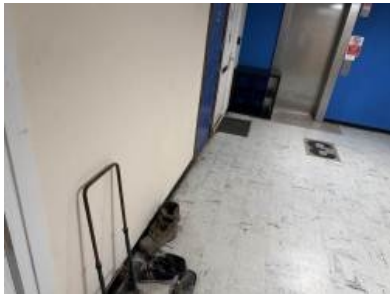
RM14878\_007

| UID & Image | Action Plan |
|---|---|
| RM14878_007<br> | <p><b>Location:</b> 1-20 (A-D) The Tower &gt; Various locations<br/> <b>Category:</b> Fire Safety Management<br/> <b>Issue:</b> There is combustible storage in escape routes within lobby areas</p> <p><b>Risk:</b> Moderate<br/> <b>Responsible:</b><br/> <b>Completed By:</b> Insert Name</p> <p><b>Sub-Category:</b> Escape Route Inspections<br/> <b>Remedial:</b> Remove combustible materials stored in escape routes as listed below:<br/> - Items outside flats in lobby on level 3<br/> - Clear items from Lower Ground floor electrical board</p> <p>Ref: I.09.02<br/> <b>Priority:</b> Medium<br/> <b>Due Date:</b> 22/07/2026<br/> <b>Completed Date:</b> DD/MM/YYYY</p> |

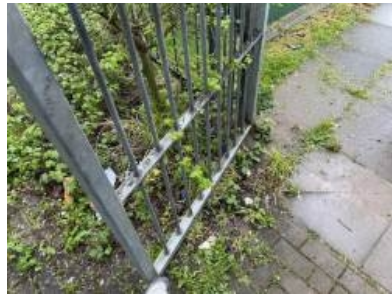
RM14878\_008

| UID & Image | Action Plan |
|---|---|
| RM14878_008<br> | <p><b>Location:</b> 1-20 (A-D) The Tower &gt; External<br/> <b>Category:</b> Means of Escape<br/> <b>Issue:</b> An excess of overgrown vegetation obstructs the external exit route.</p> <p><b>Risk:</b> Moderate<br/> <b>Responsible:</b><br/> <b>Completed By:</b> Insert Name</p> <p><b>Sub-Category:</b> External Escape Routes<br/> <b>Remedial:</b> Install a preventative maintenance programme to cut back vegetation. Ref: B.17.04<br/> <b>Priority:</b> Medium<br/> <b>Due Date:</b> 22/07/2026<br/> <b>Completed Date:</b> DD/MM/YYYY</p> |

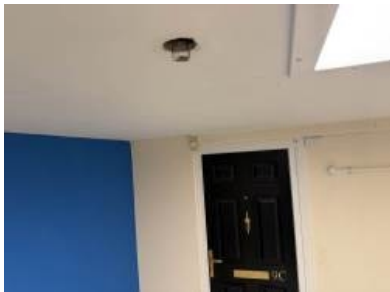
RM14878\_009

| UID & Image | Action Plan |
|---|---|
| RM14878_009<br> | <p> <b>Location:</b> 1-20 (A-D) The Tower &gt; Floor 9<br/> <b>Category:</b> Fixed Fire Safety Systems<br/> <b>Issue:</b> Fire sprinkler head cover missing </p> <p> <b>Risk:</b> Moderate<br/> <b>Responsible:</b><br/> <b>Completed By:</b> Insert Name </p> <p> <b>Sub-Category:</b> Fire Suppression Systems<br/> <b>Remedial:</b> Replace detector head cover to prevent damaged to sprinkler head<br/> <b>Priority:</b> Medium<br/> <b>Due Date:</b> 22/07/2026<br/> <b>Completed Date:</b> DD/MM/YYYY </p> |

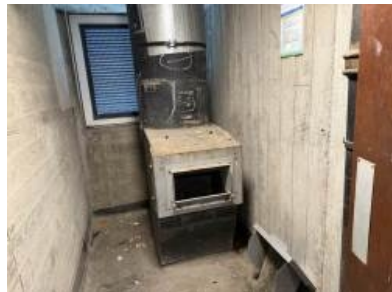
RM14878\_010

| UID & Image | Action Plan |
|---|---|
| RM14878_010<br> | <p> <b>Location:</b> 1-20 (A-D) The Tower &gt; Floor 6 Refuse chute<br/> <b>Category:</b> Construction<br/> <b>Issue:</b> The Bin shoot cover was damaged which was removed compromising fire integrity </p> <p> <b>Risk:</b> Moderate<br/> <b>Responsible:</b><br/> <b>Completed By:</b> Insert Name </p> <p> <b>Sub-Category:</b> Separation of Special Fire Risks<br/> <b>Remedial:</b> Refit the cover to provide adequate protection.<br/> <b>Priority:</b> Medium<br/> <b>Due Date:</b> 22/07/2026<br/> <b>Completed Date:</b> DD/MM/YYYY </p> |

| <b>Comment</b> | <p>The bin shoot which is on each floor, is separated from the stair lobby but not by fire rated doors or partitions. The shoot is fire rated and each level had natural ventilation from outside. It was also noted that the sprinkler system has been extended into the shoot area on each level for added protection.</p> |
